Architect's Field Report

201 Park Court, Suite B Ridgeland, MS 39157 P 601.790.9432 F 888.281.0547	26 February 2020	
	18043-BW Beechwood Elementary / Report Number 023	
	Contract	Thrash Construction
One Jackson Place, Suite 250	Date / Time	25 February 2020 / 3:20 PM
188 East Capitol Street	Weather / Temp	Sunny and clear / 63 ° F
Jackson, MS 39201-2100	Est % Complete	71%
P 601.352.5411	Sched Conformance	+/- 00 days
F 601.352.5362	Work in Progress	None
161 Lameuse Street, Suite 201	Present at Site	School Staff Paul Purser, DBA
Biloxi, MS 39530	Observations	Arriving on site, I spoke with receptionists. She mentioned that the smell
P 228.374.1409		from the epoxy floor installations was causing issues to people with asthma and a pregnant teacher. She requested that flooring install to
F 228.374.1414		happen at the beginning of the week end.
		I reviewed installation of epoxy. For the most part it looked good, however, there are some repairs needed: I noted in images below.

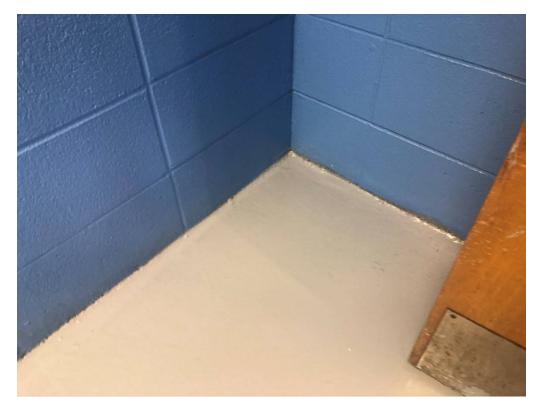
Figure 2 – Corner Cut In's Look Good

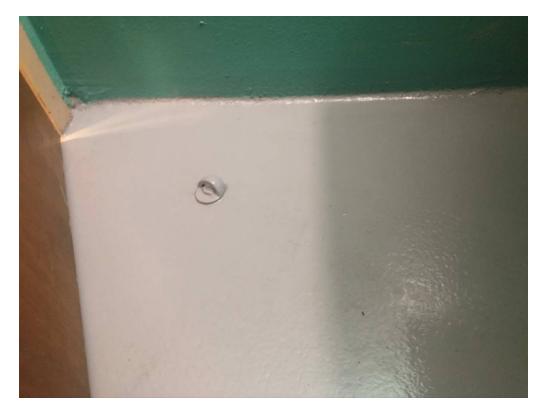
Figure 3 – Paint Over Door Stop (typical)

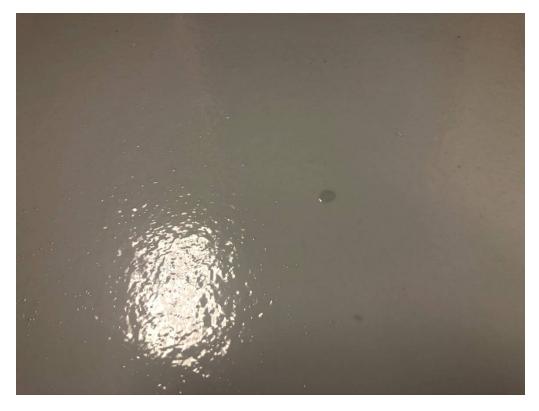
Figure 5 – Building 2 Gym (T06): discolored drips evident after install

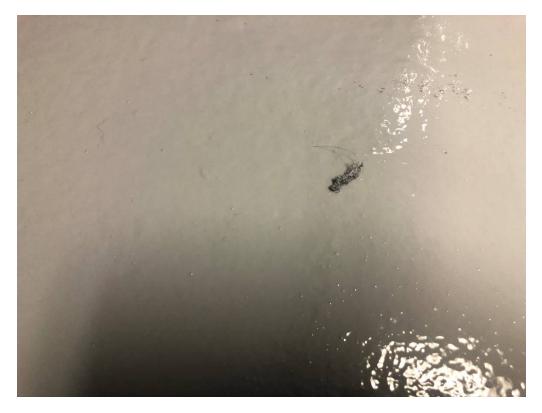
Figure 7 – T06: debris left embedded in Epoxy

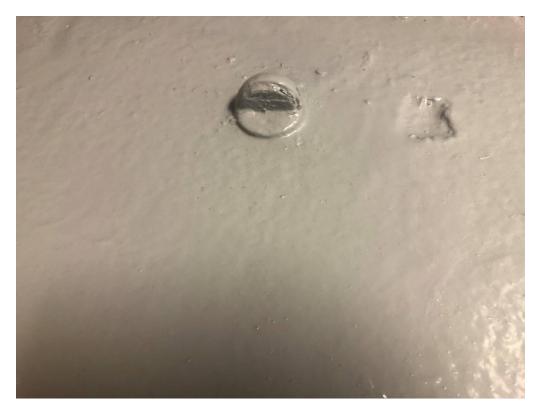
Figure 8 – Painted Door Stops

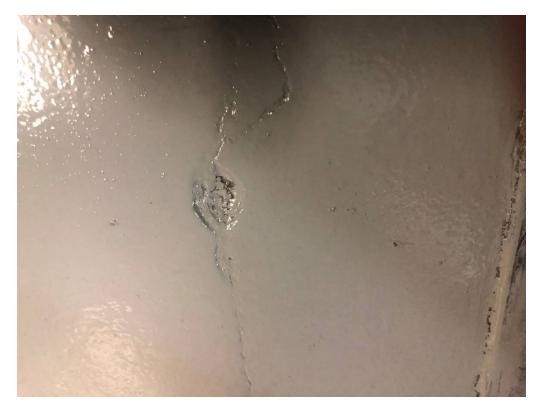
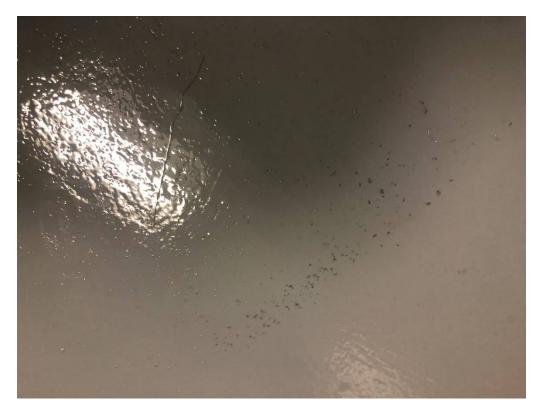
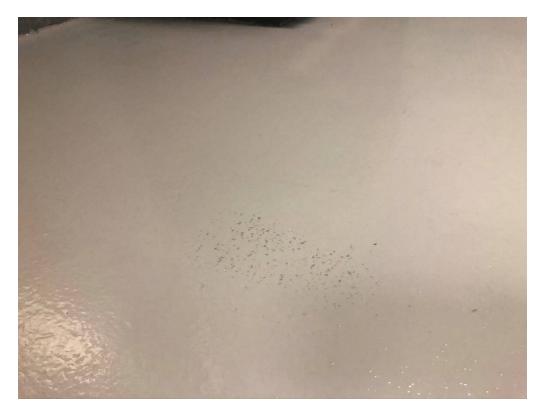
Figure 9 – Additional Coat Required in T06 for Full Coverage

Figure 10 – Additional Coat Required in T06 for Full Coverage

Figure 11 – Additional Coat Required in T06 for Full Coverage

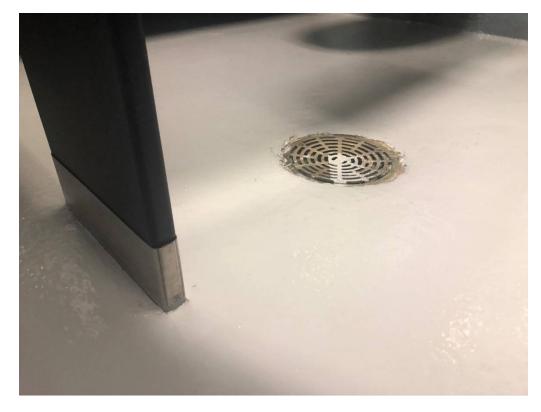
Figure 12 – Paint on Drain Cover in T06

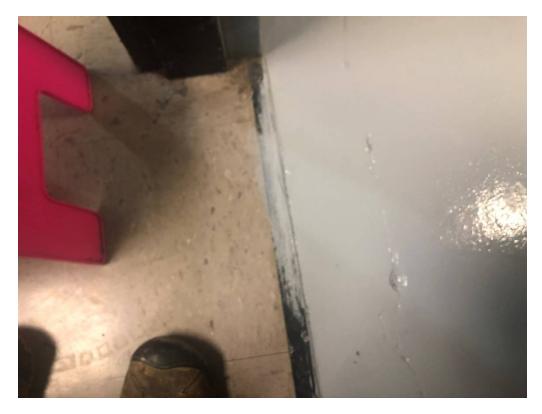
Figure 13 – Paint on Threshold in T06

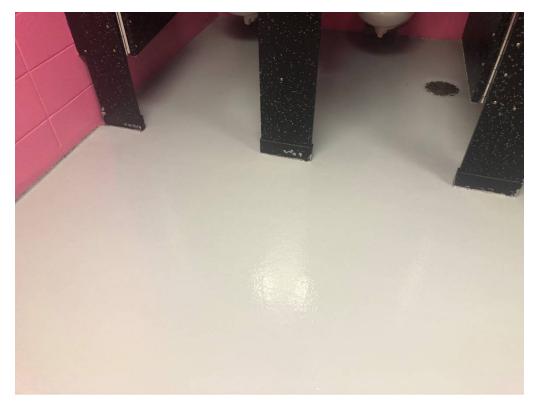
Figure 14 – Girls Bathroom in Building 1 (Paint on Partitions Existed Before Install)
