Architect's Field Report

03 March 2020

18043-BW Beechwood Elementary / Report Number 024

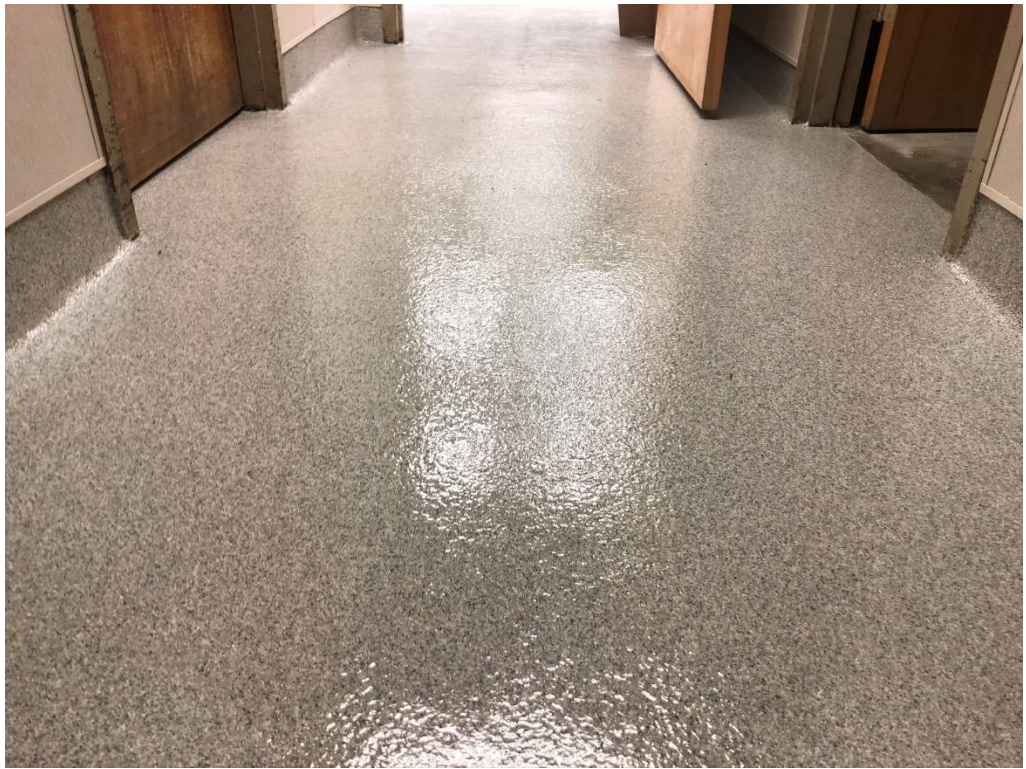
Figure 1 – Vestibule @ Building 3

Observations Arriving on site, I met with our Monthly OAC Meeting Group members. After our meeting, I walked the site to review final floor finishes at vestibules and lunch serving areas. The floors look much better and are up to industry standards.

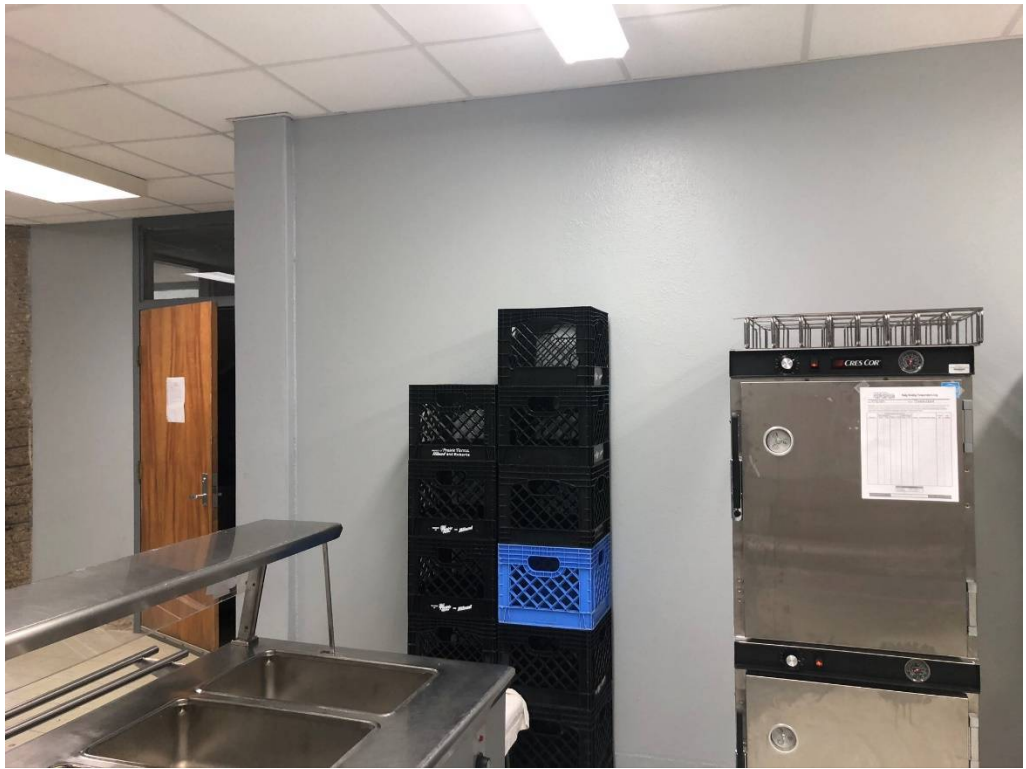
Figure 5 – Painted Serving Walls

I also reviewed paint at cafeterias and serving areas. This all seemed to be complete and in order save a few minor touch ups.

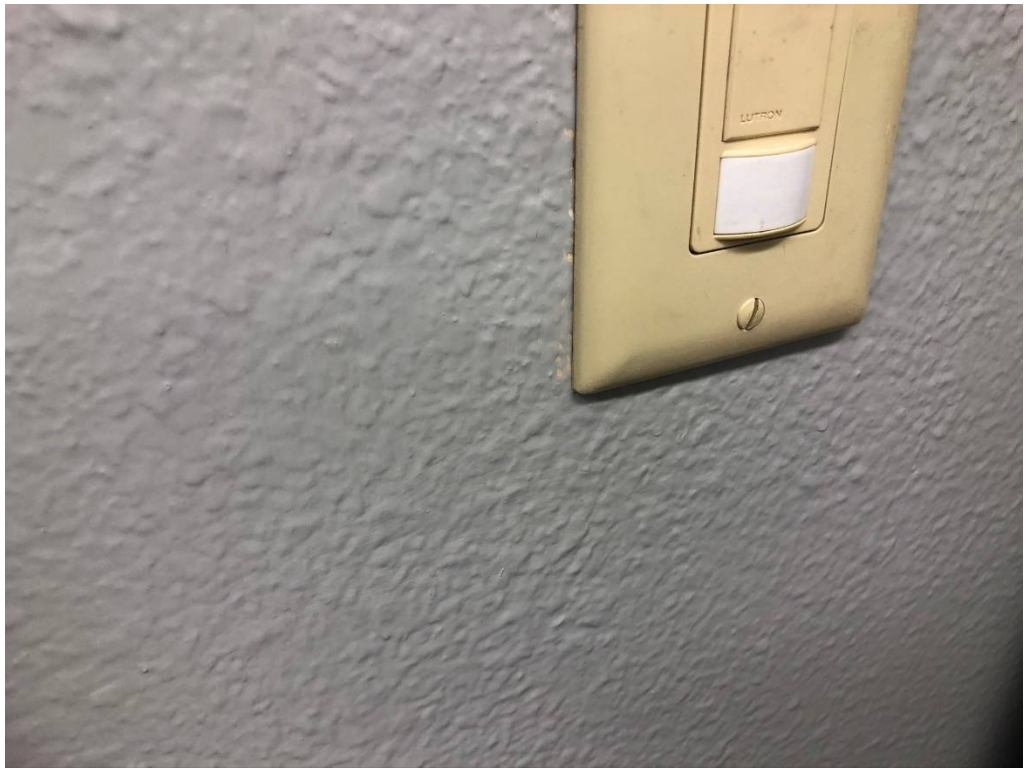
Figure 7 – Minor Touch up around Receptacle Building 3 Serving Room

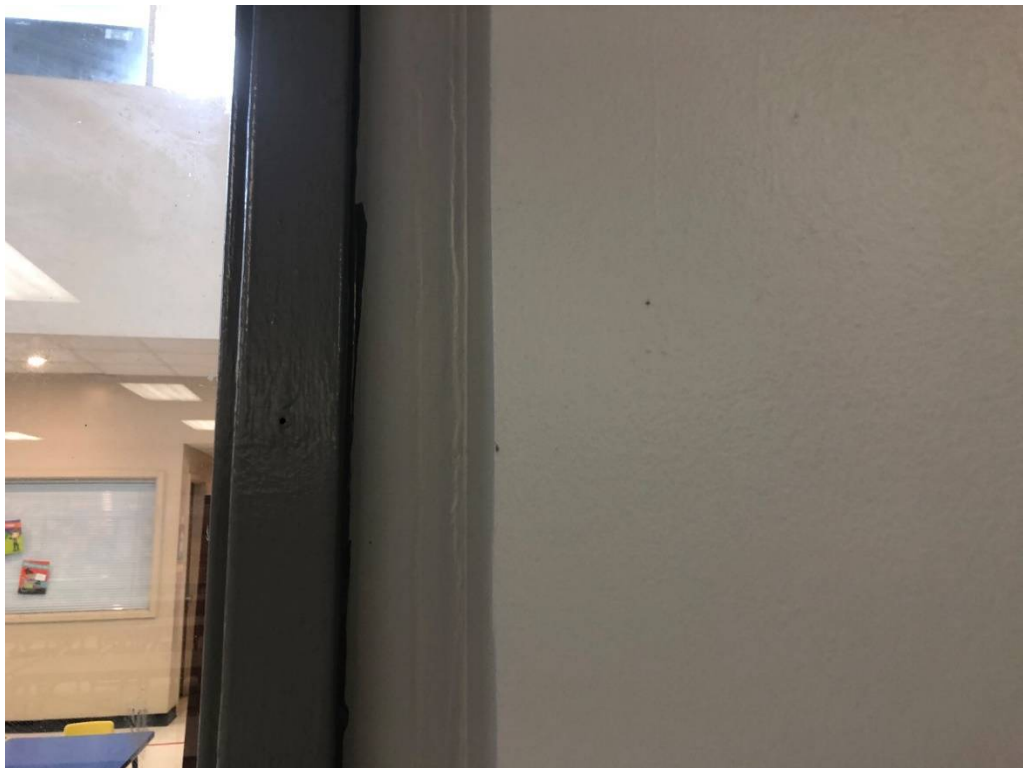
Figure 8 – Minor Touch Ups @ Window Jamb in Cafeteria Building 1

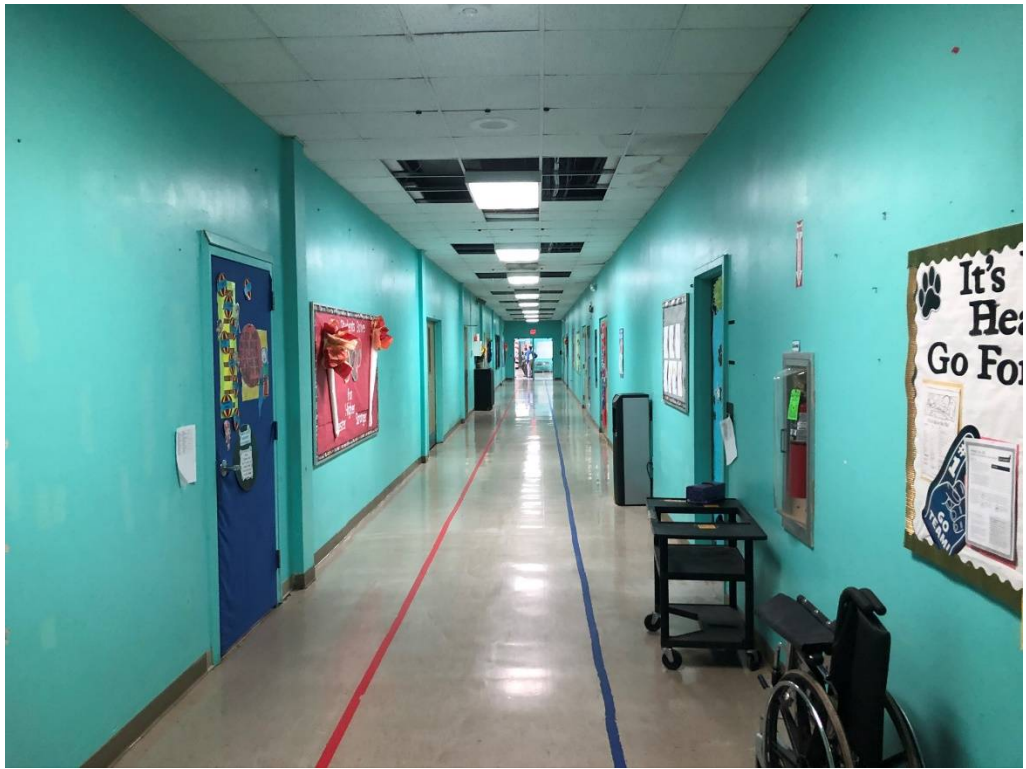
Figure 9 – Building 2 Wall and Ceiling Prep and Main Hall Begun

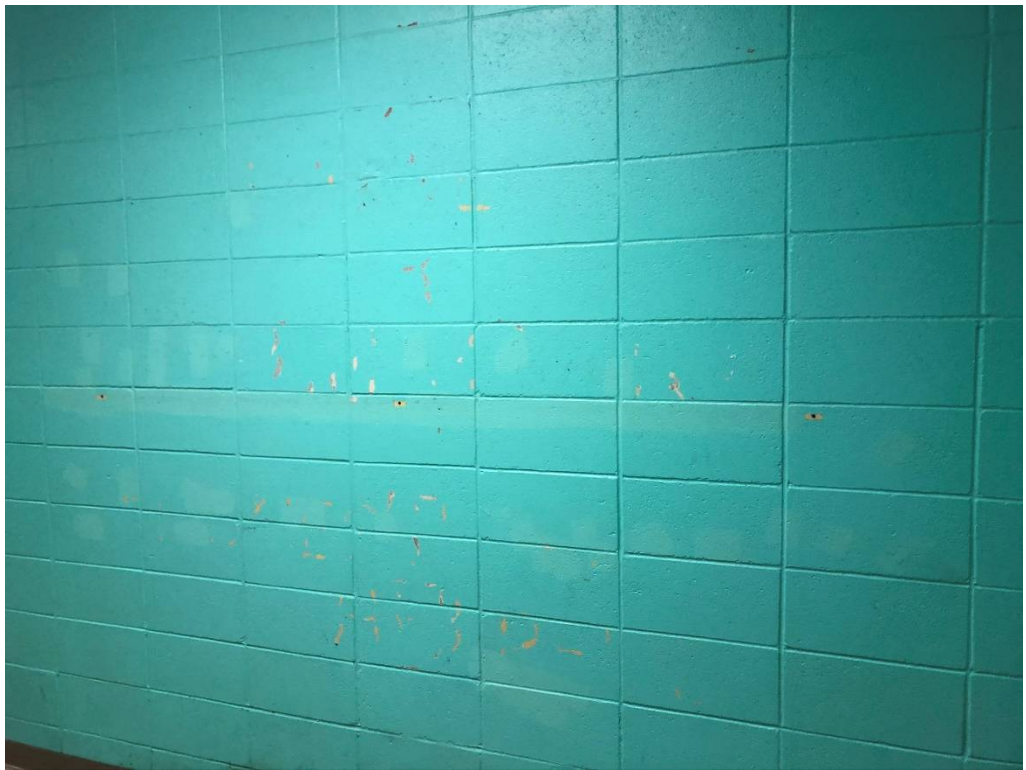
Figure 10 – Most Wall Hangings have Been Removed

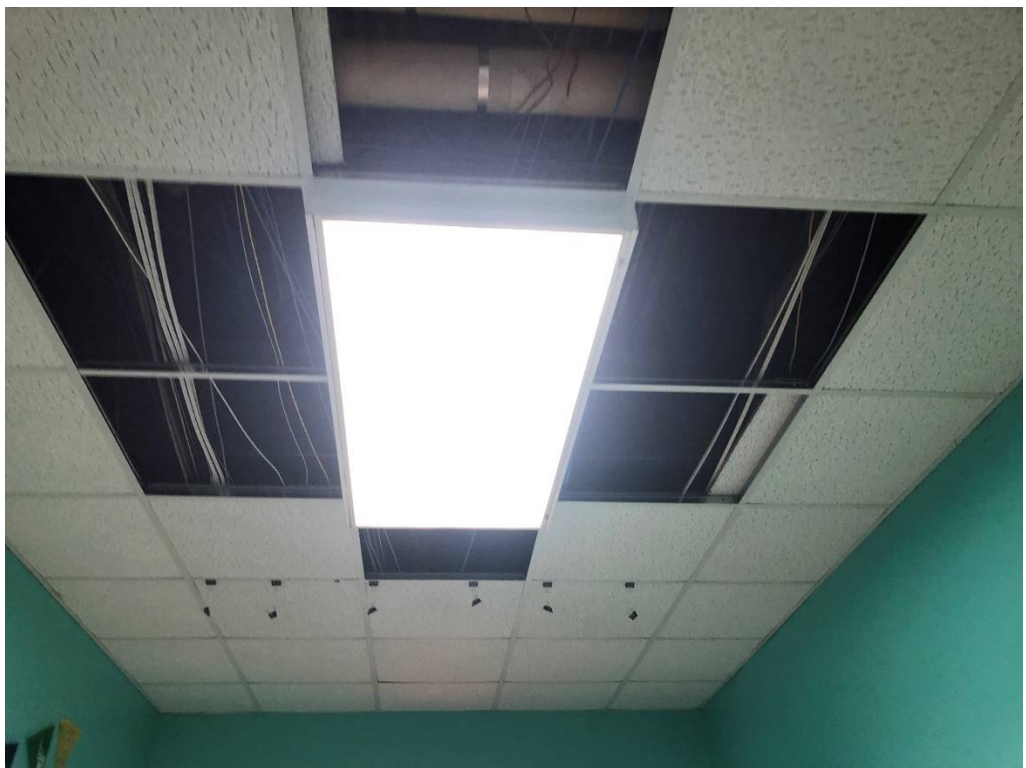
Figure 12 – Ceiling Work Began at Main Hall
