## Architect's Field Report

11 March 2020

18043-BW Beechwood Elementary / Report Number 025

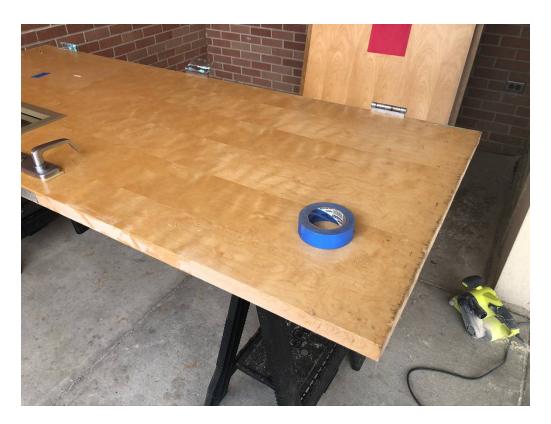
Figure 1 – Door Cut for Floor Overlay

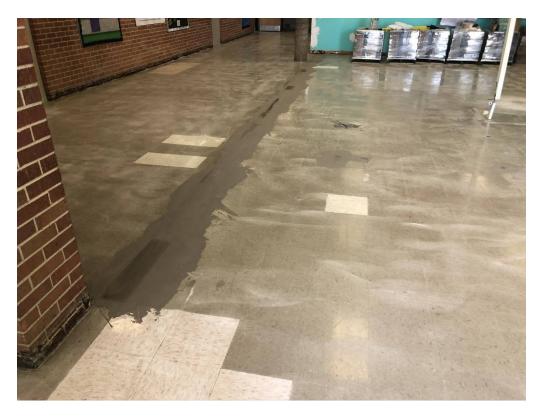
Figure 2 – Floor Prep at Entry (vct sanded and leveling compound added)

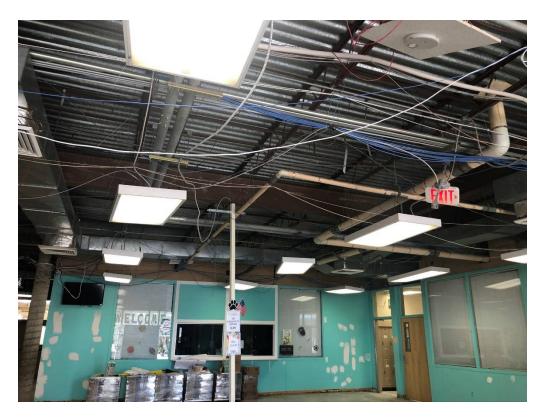
Figure 3 – Vestibule @ Building 3

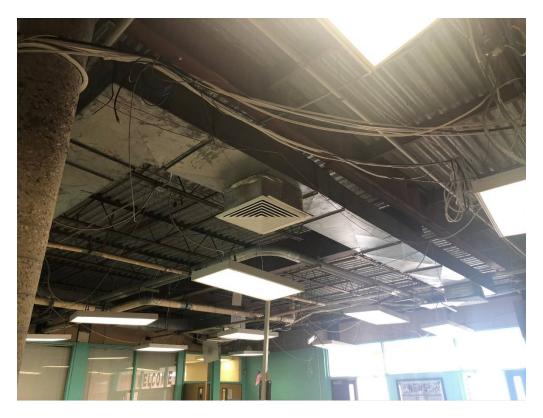
Figure 4 – Entry Lobby Ceiling Removed

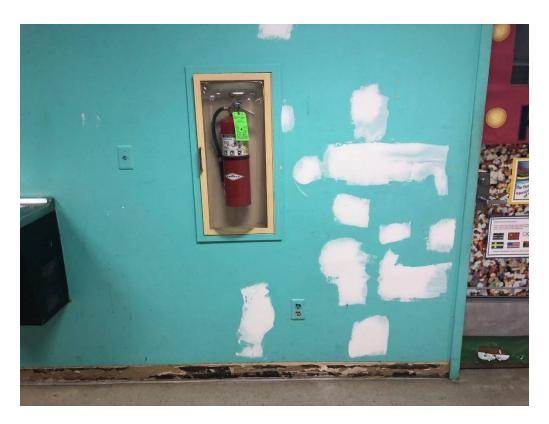
Figure 5 – Wall Prep Begun

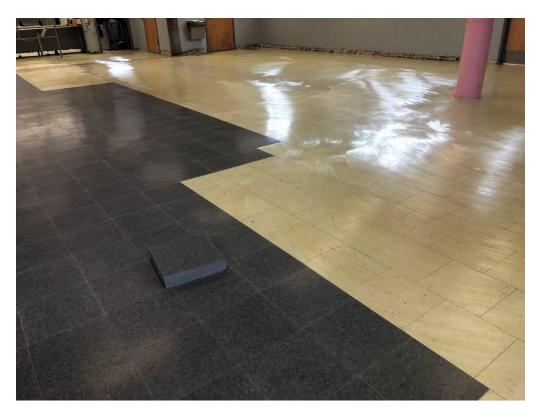
P 228.374.1409 F 228.374.1414 I arrived on site and saw that work on flooring was ongoing. Building 3 Cafeteria is the only section where install has started of final product.

Figure 6 – New VCT Install Ongoing in Building 3 Cafeteria

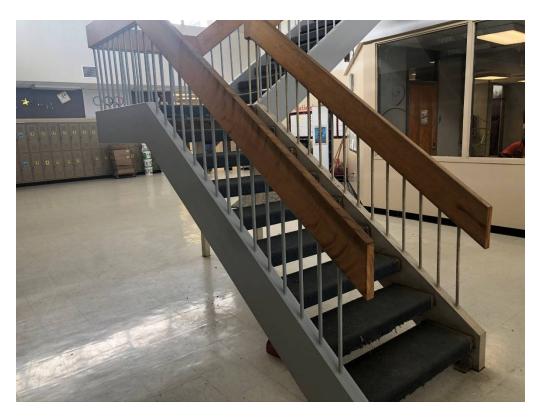
Figure 7 – Stair in Building 3 Exterior and Balusters Painted

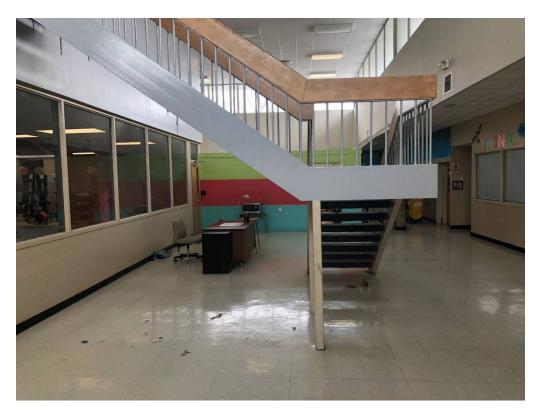
Figure 8 – Stair in Building 3 Exterior and Balusters Painted

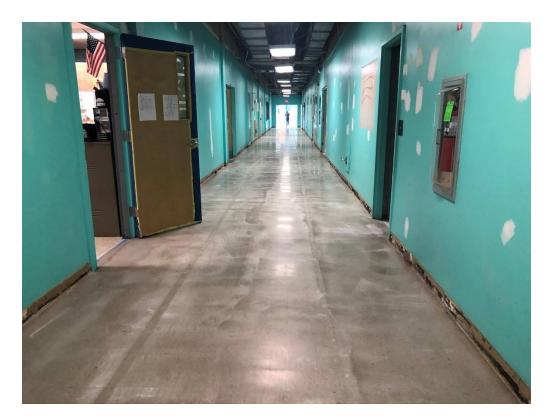
Figure 9 – Hall in Building 2 Prepped

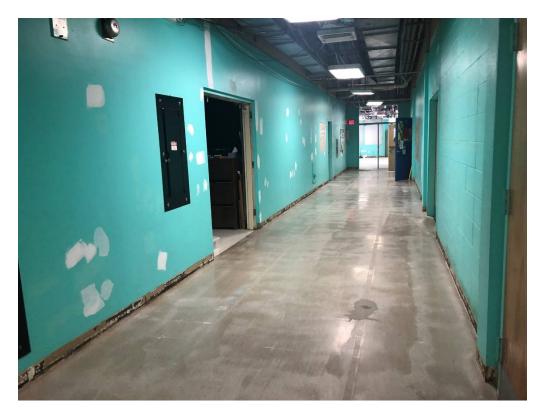
Figure 10 – Wall Prep Begun

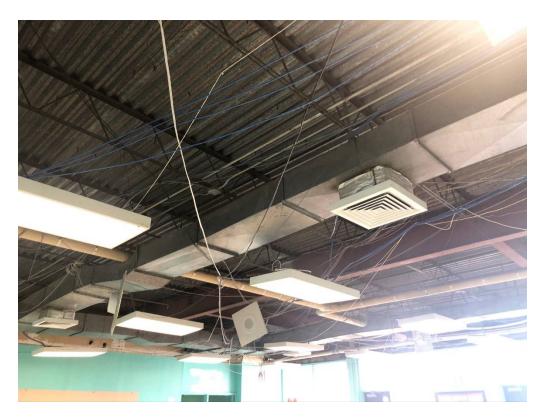
Figure 11 – Lobby @ Building 1 Ceiling Demoed

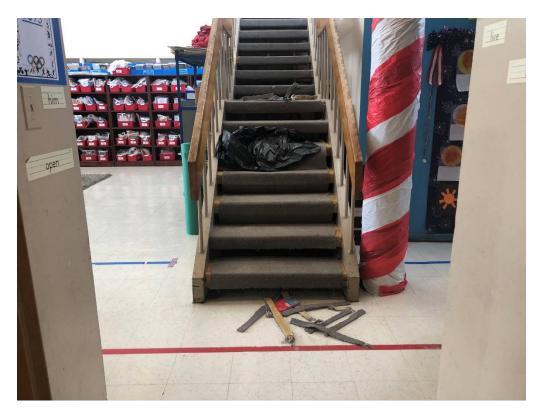
Figure 12 – Building 1 Stair Work
