02 April 2020

18043-BW Beechwood Elementary / Report Number 028

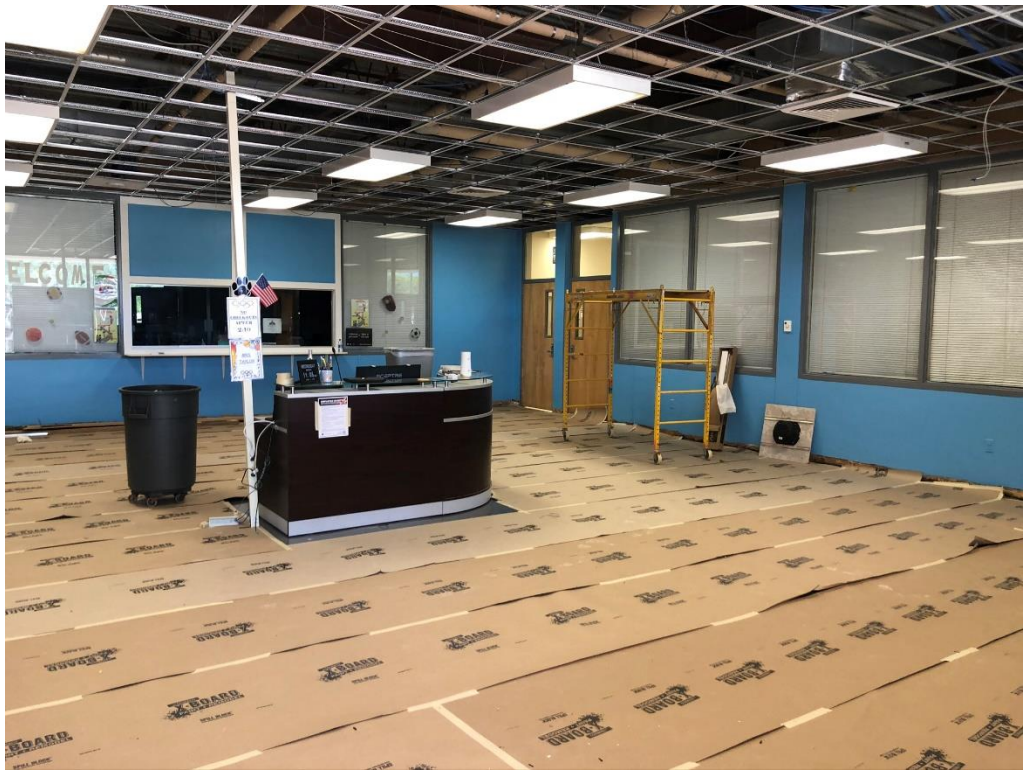
Figure 1 – Main Lobby Ceiling Grid

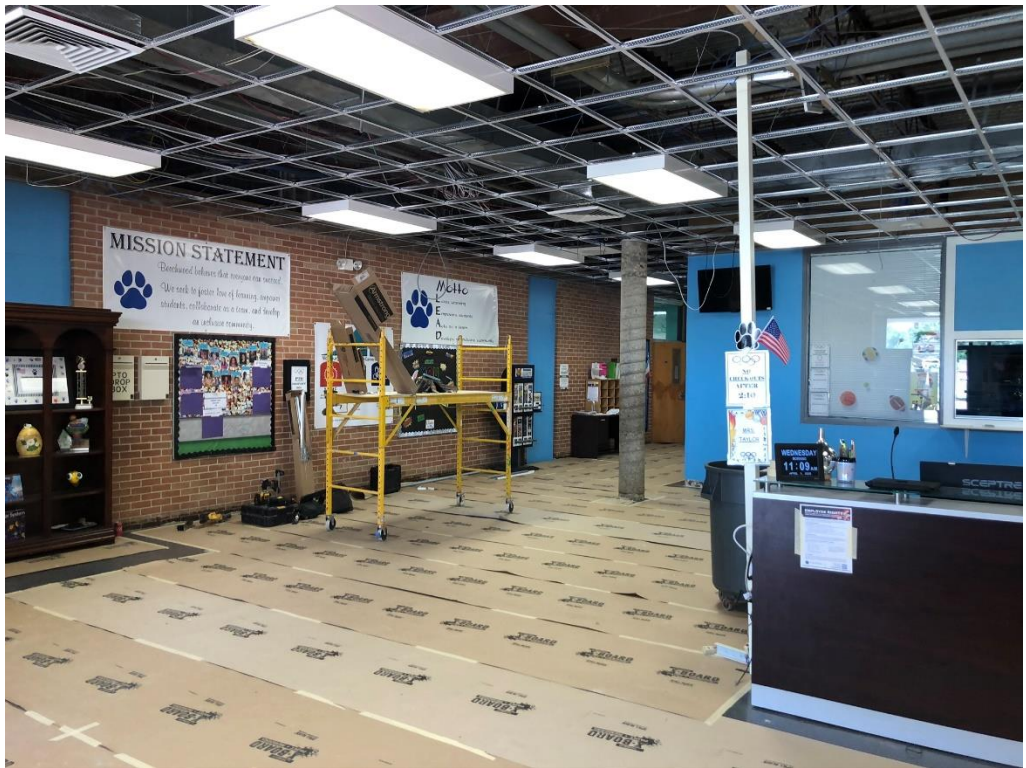
Figure 2 – Main Lobby Ceiling Grid

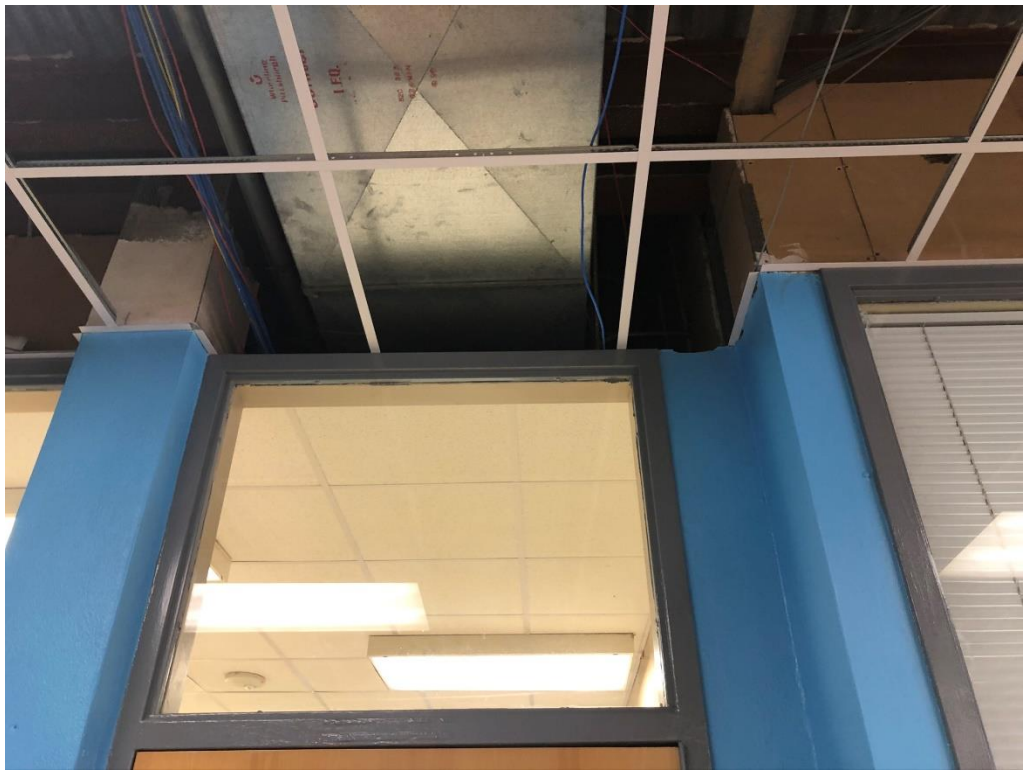
Figure 3 – Right of Door Frame Needs Corner Support

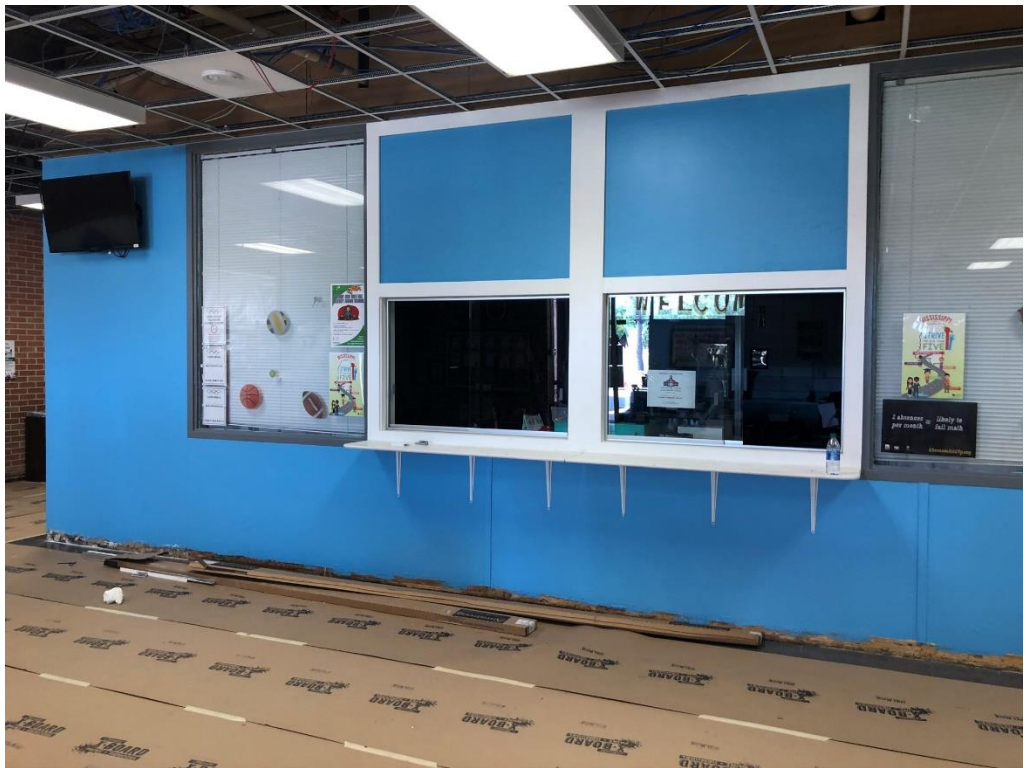
Figure 4 – Main Lobby Paint Complete

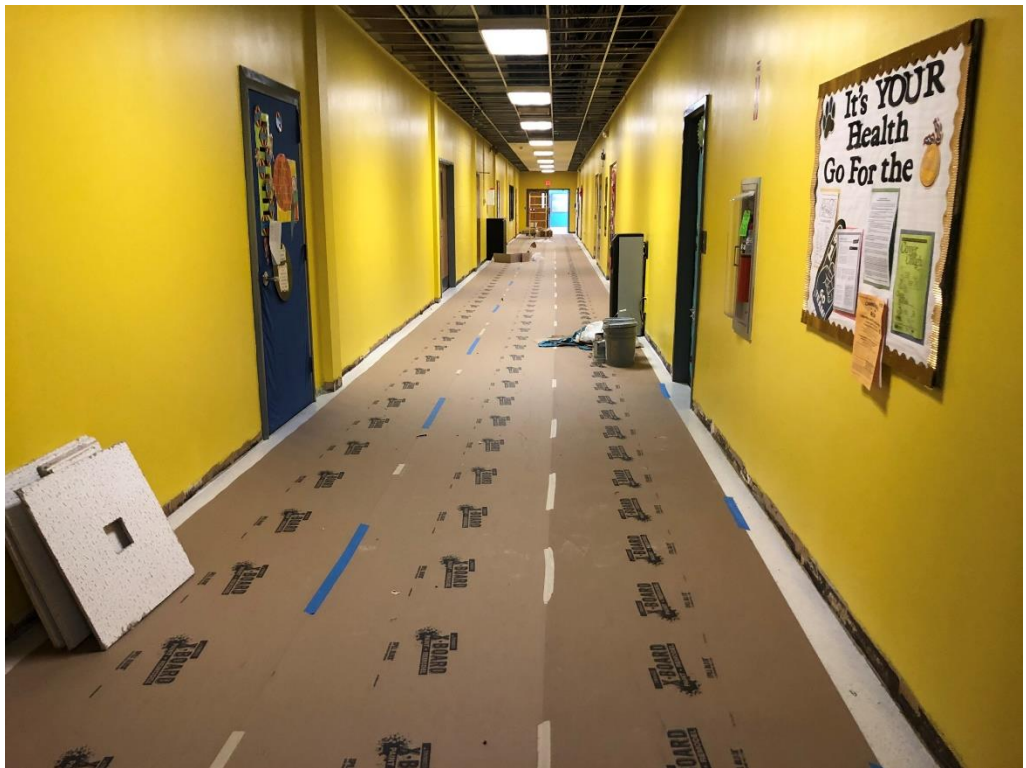
Figure 5 – Building 2 Hall, West End Looking SE

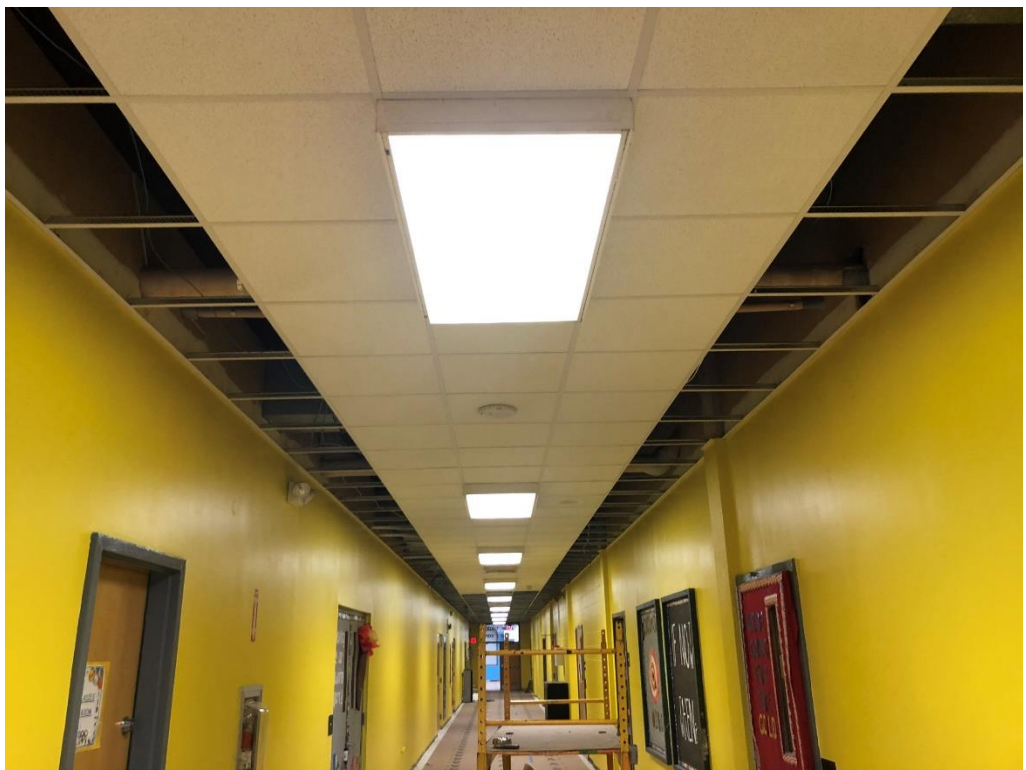
Figure 6 – Building 2 Hall, East End Looking NW

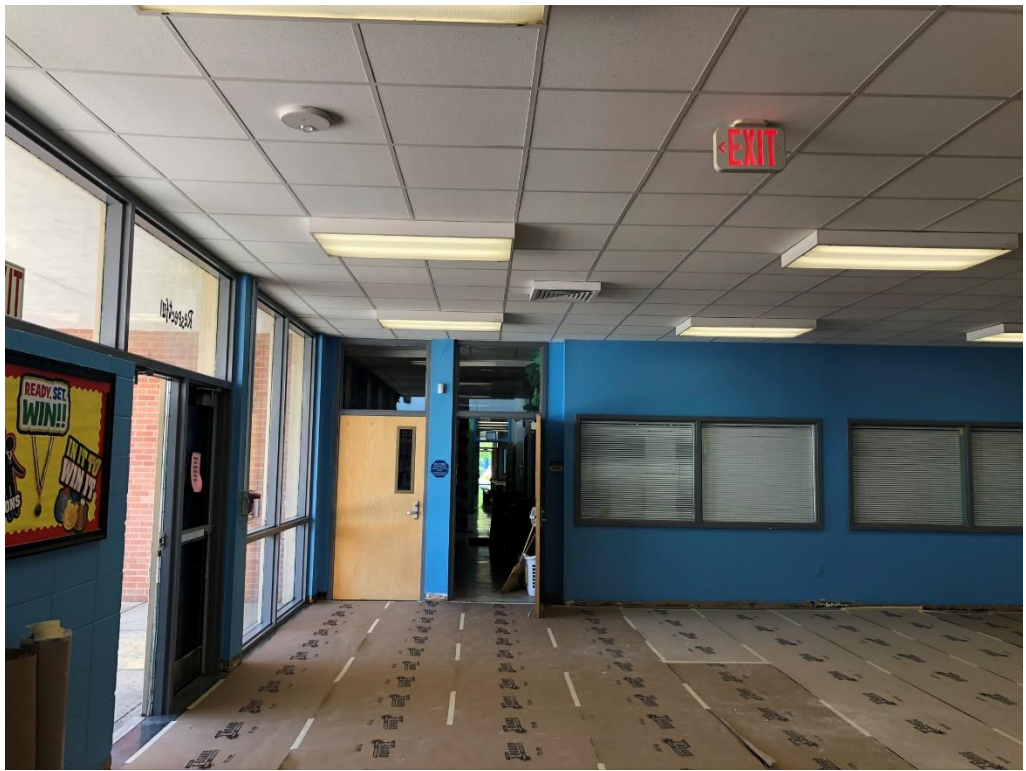
Figure 7 – East Lobby Ceiling Complete (N Corner Looking SE)

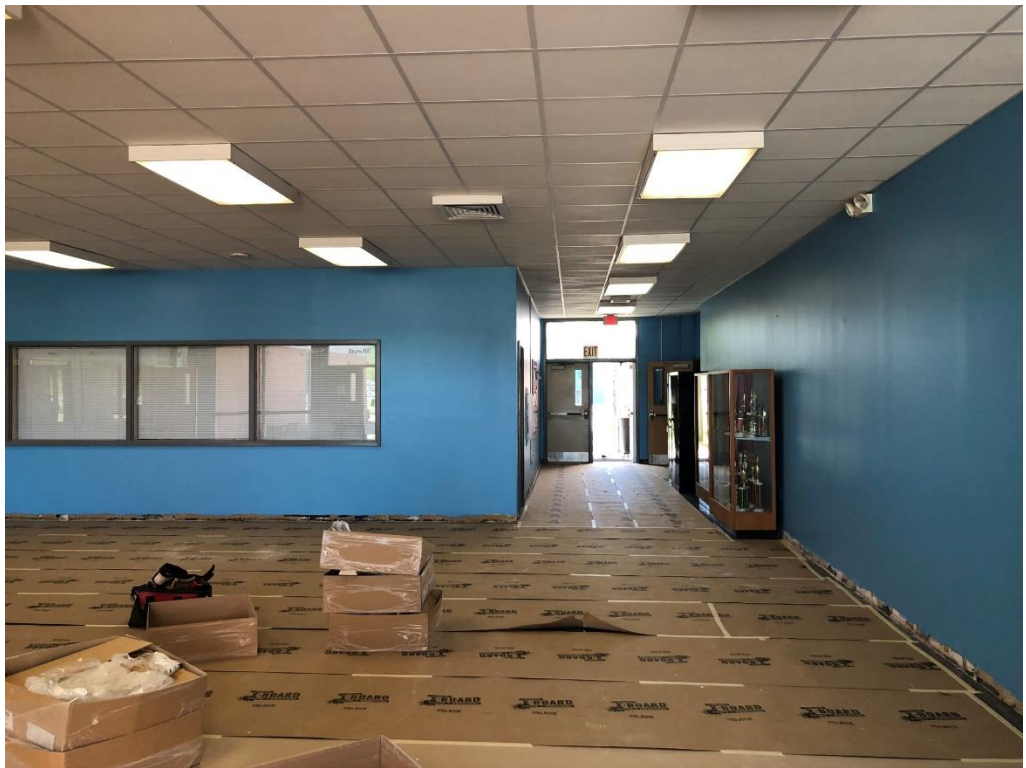
Figure 8 – East Lobby Ceiling Complete (N Corner Looking SW)

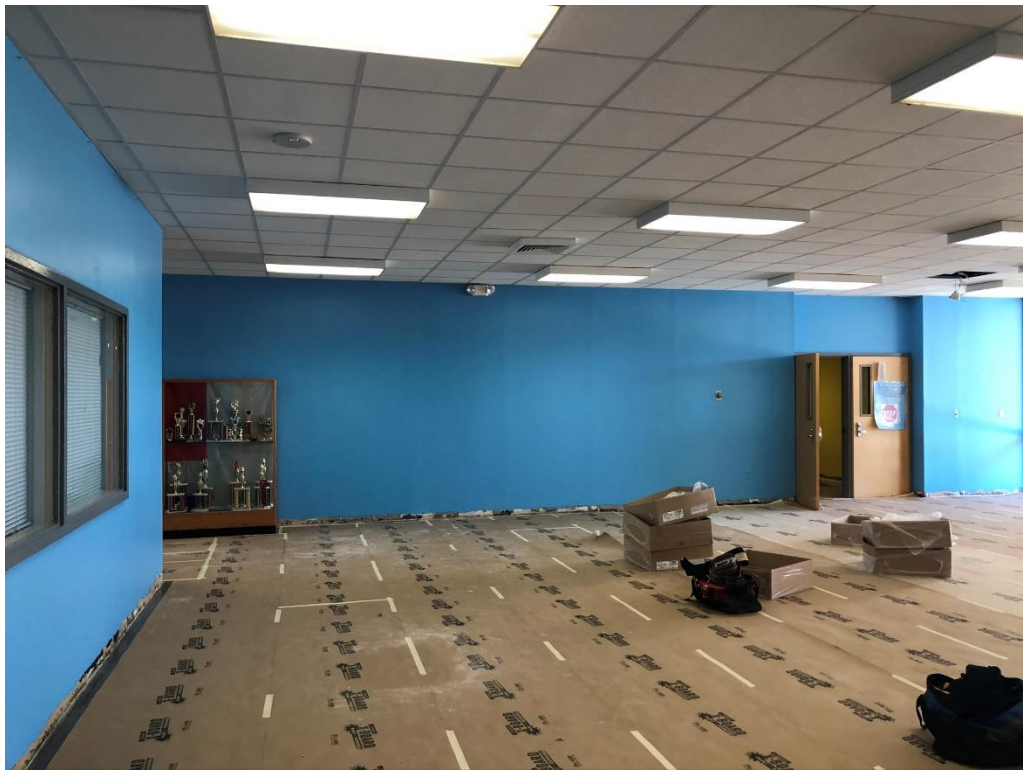
Figure 9 – East Lobby Ceiling Complete (S Corner Looking NW)

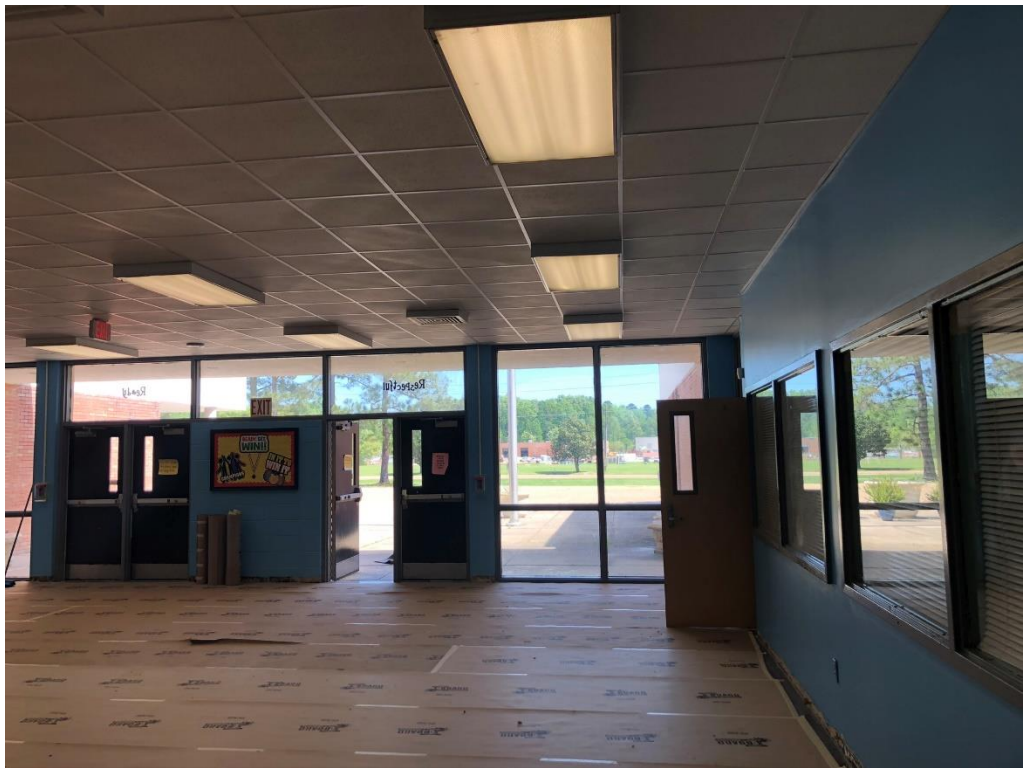
Figure 10 – East Lobby Ceiling Complete (S Corner Looking NE)

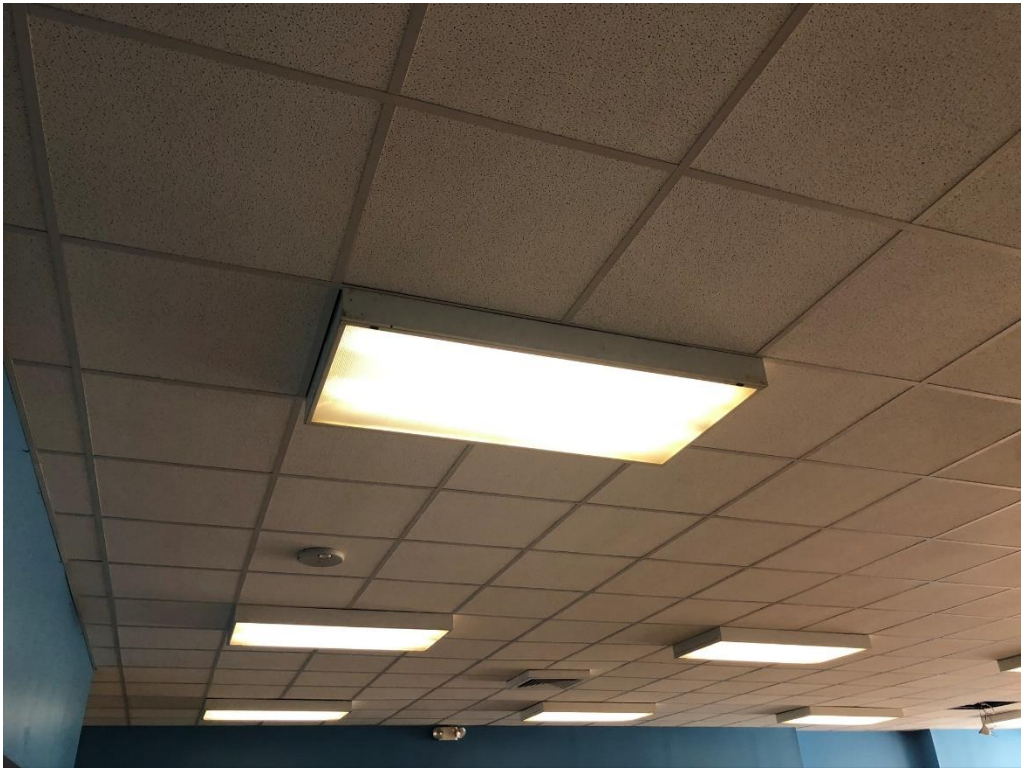
Figure 11 – Light Mis-aligned and above ceiling revealed (needs correction)

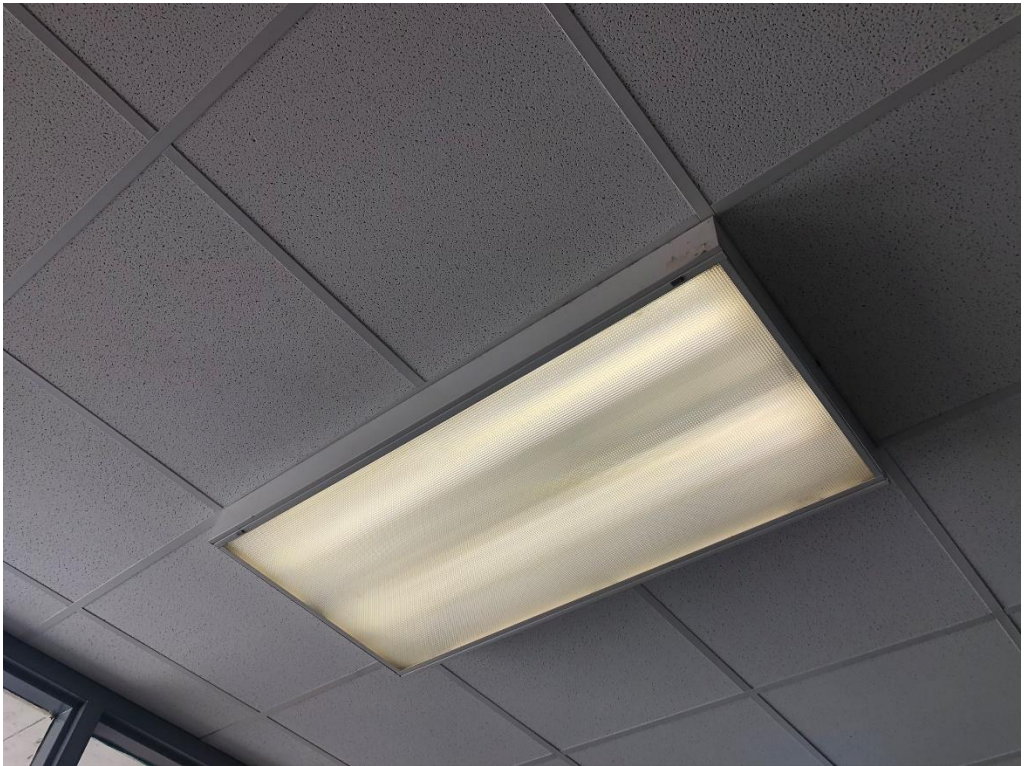
Figure 12 – Some Lights Not Lined up (at slight angle, needs correction)

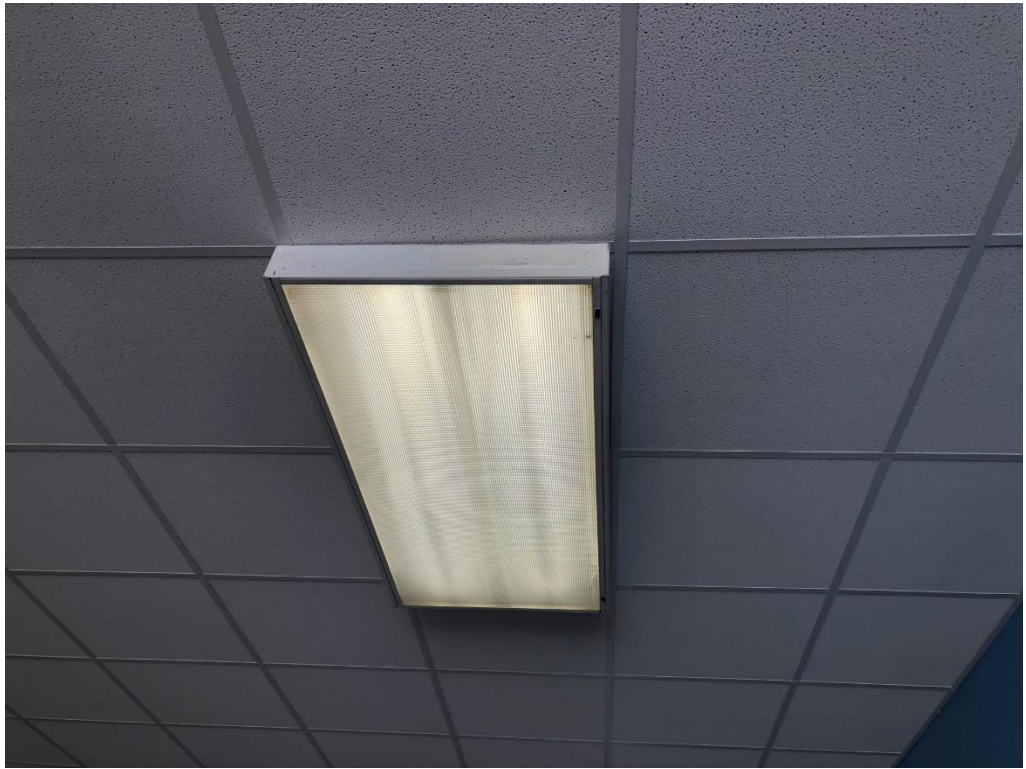
Figure 13 – Light Mis-aligned, Offset from Grid Center

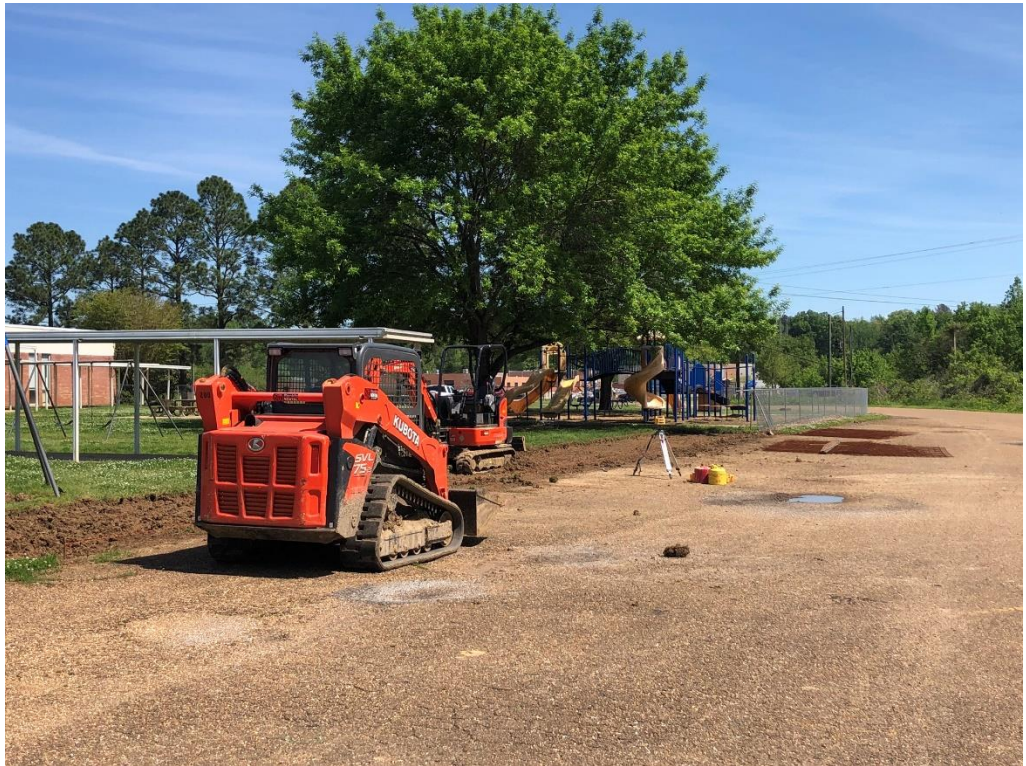
Figure 14 – Demo and Layout Work At SE Covered Drop Off
