06 May 2020

18043-BW Beechwood Elementary / Report Number 033

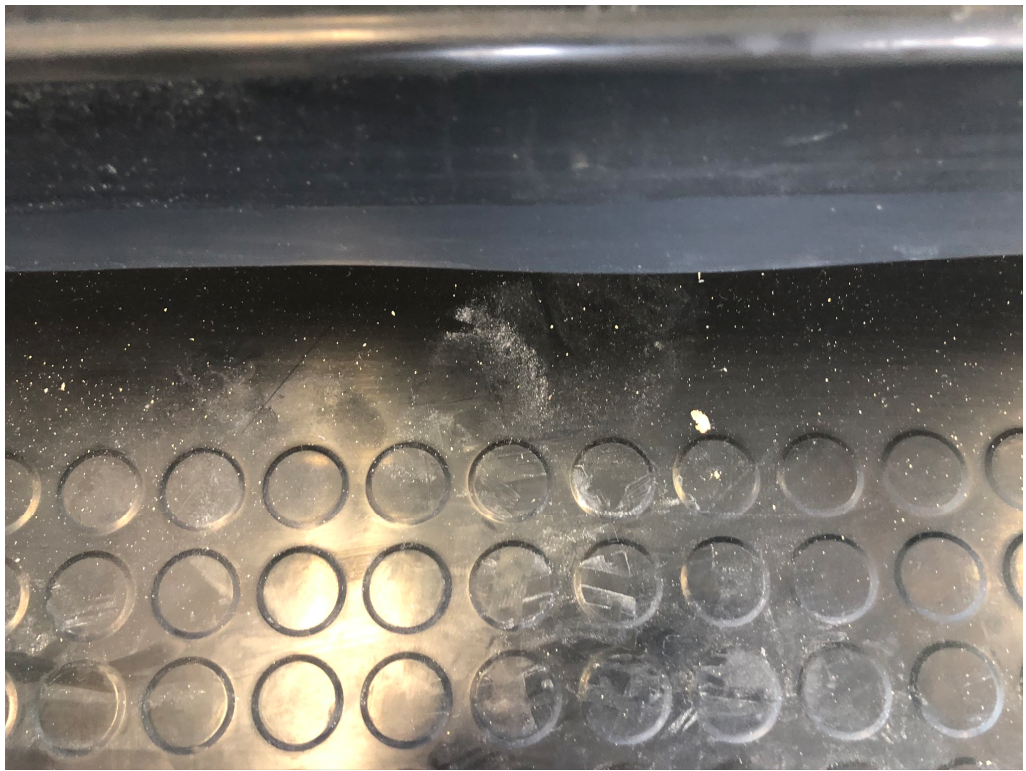
Figure 1 – Rubber Face is Not fully adhered to Step and appears wavy

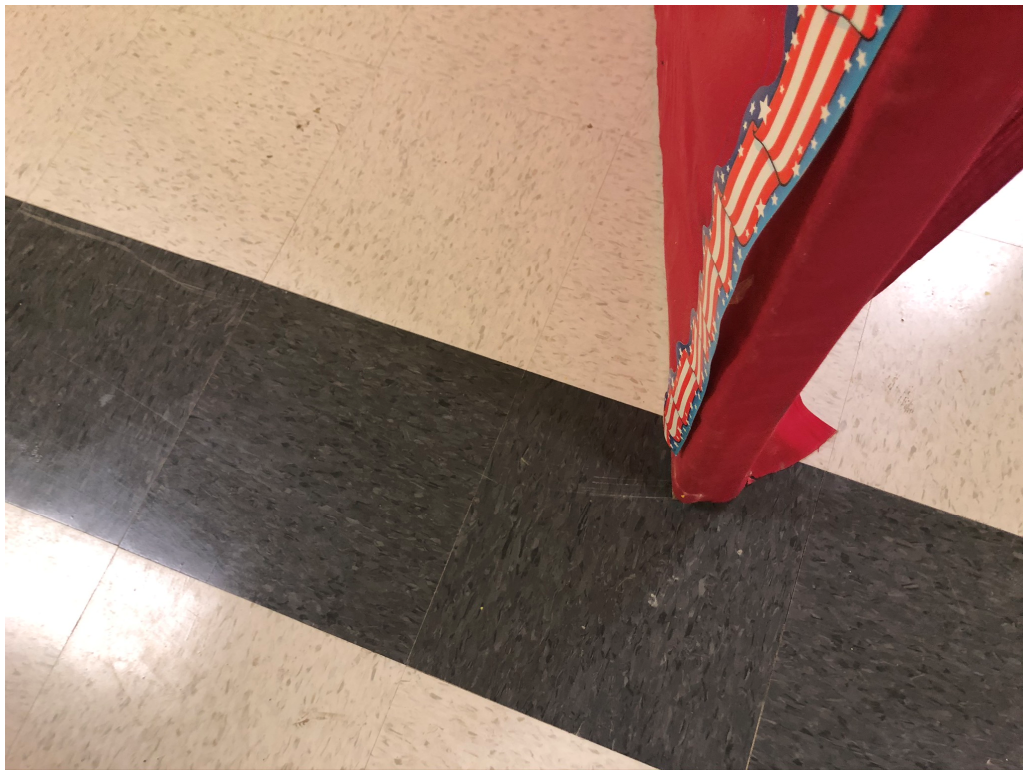
Figure 2 – Door dragging in hall needs undercut

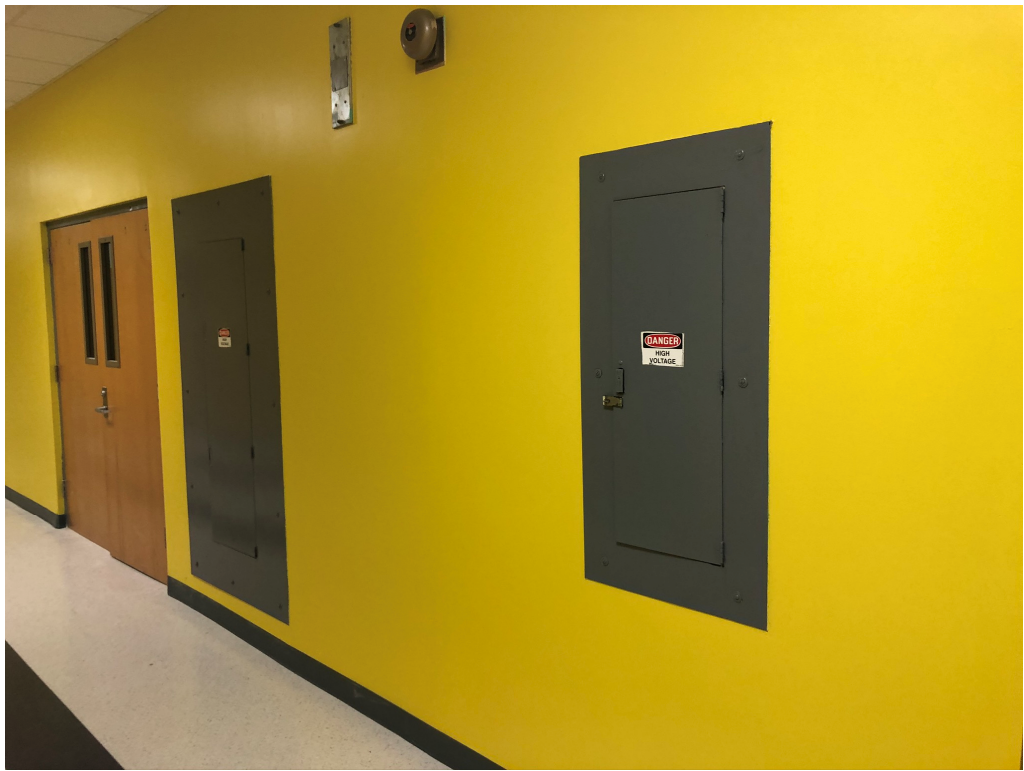
Figure 3 – Panels Painted

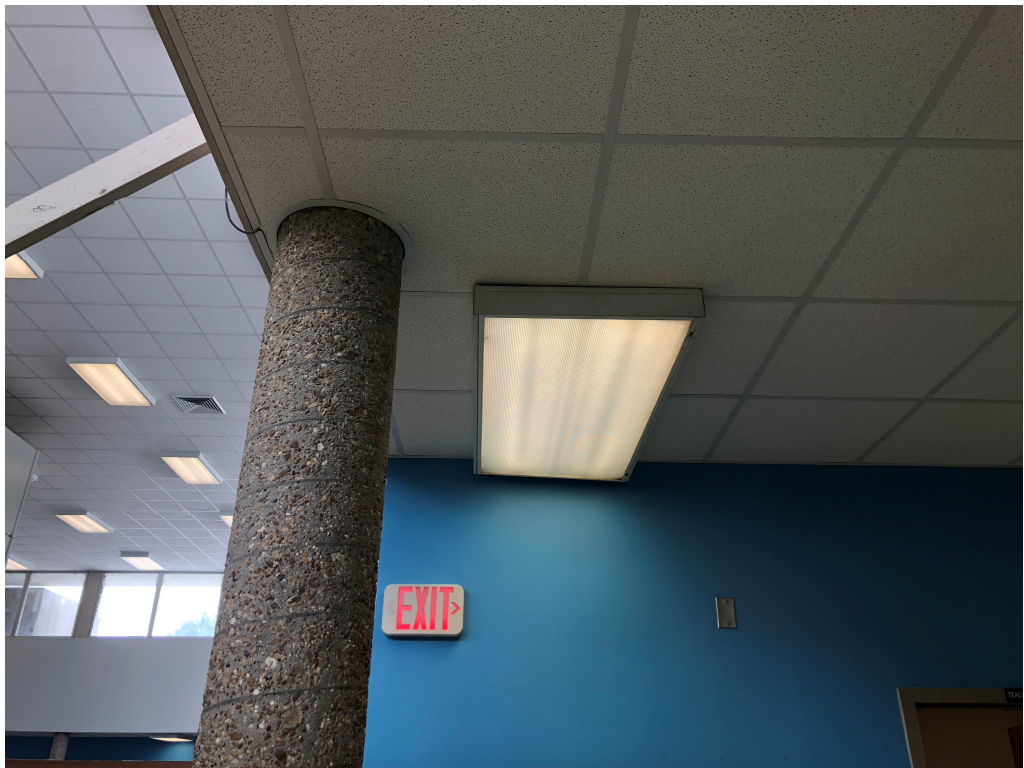
Figure 4 – This light in Building 3 has a gap on 2 corners and is not flush with ceiling

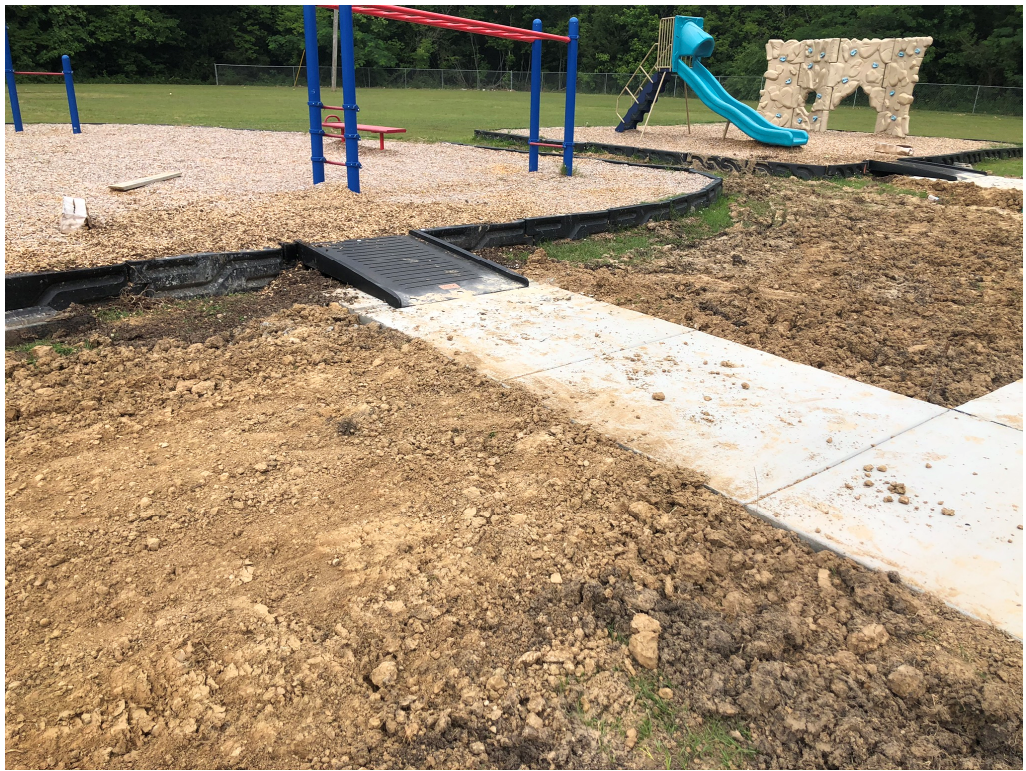
Figure 5 – Ramps installed

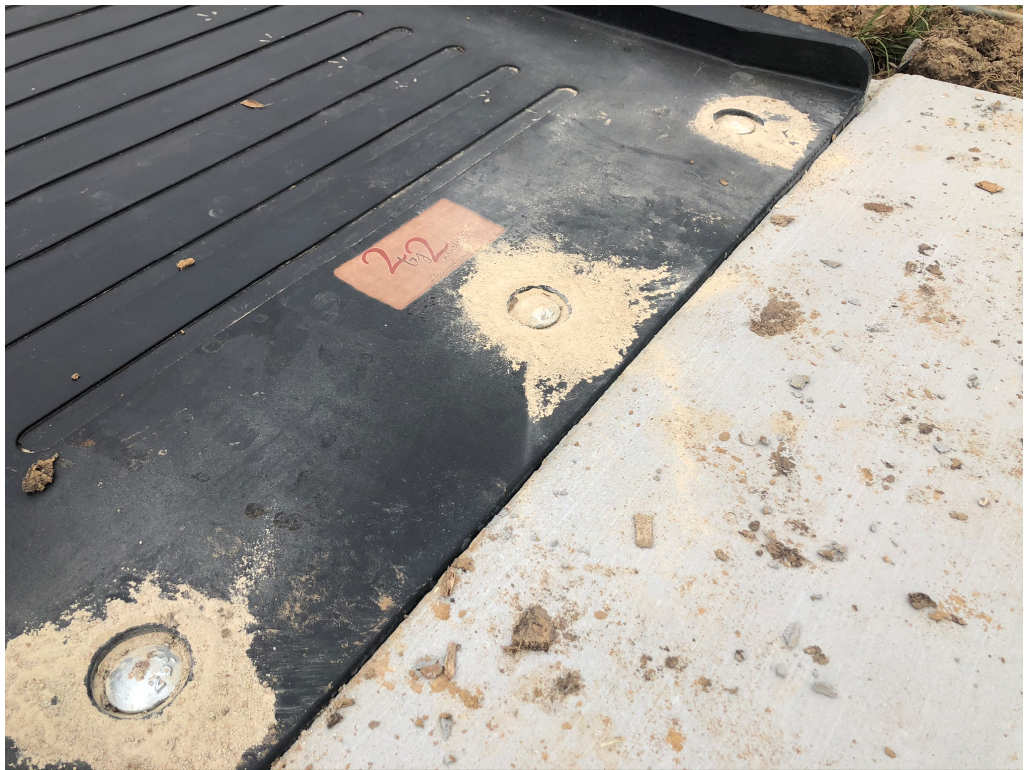
Figure 6 – Ramps Secured

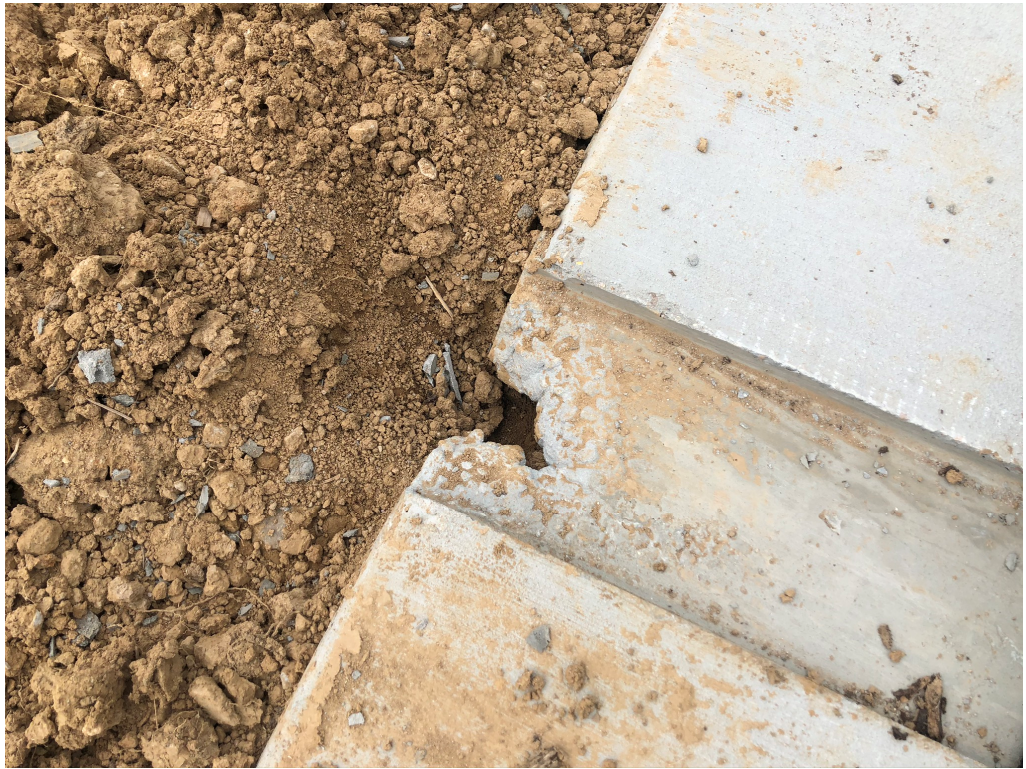
Figure 7 – Can we fill this recess with a Cementitious material and repair this void?

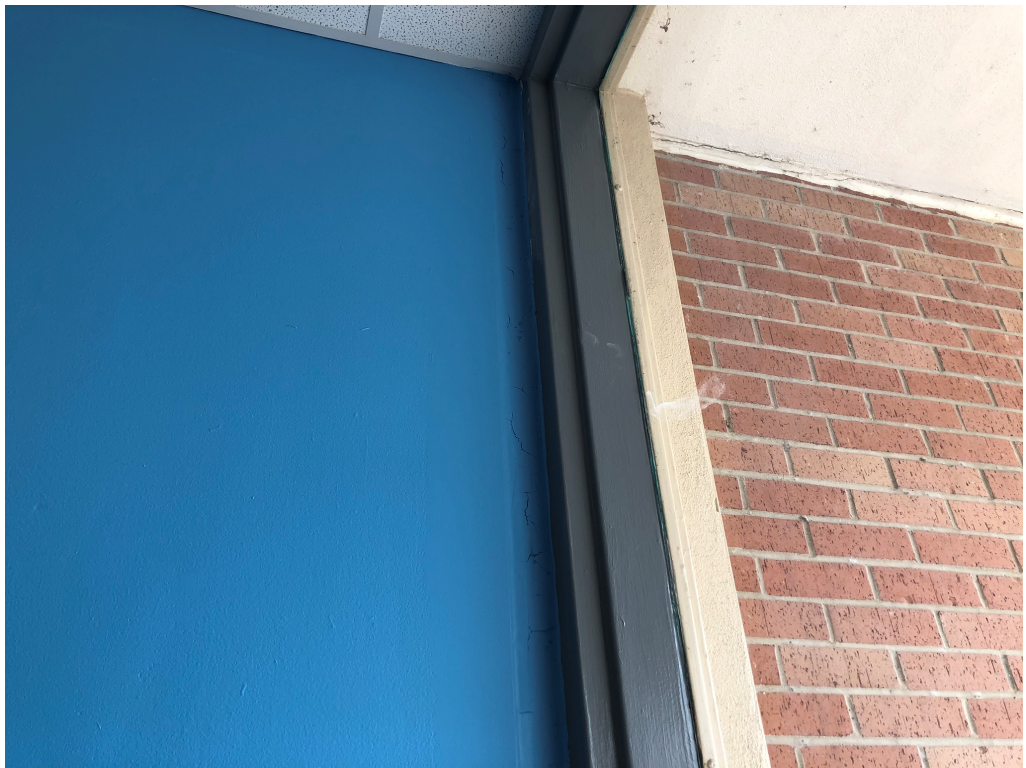
Figure 8 – The drywall at this window Jamb needs patching in Building 1 Lobby
