21 July 2020

18043.01-BWF Beechwood Elementary / Report Number 009

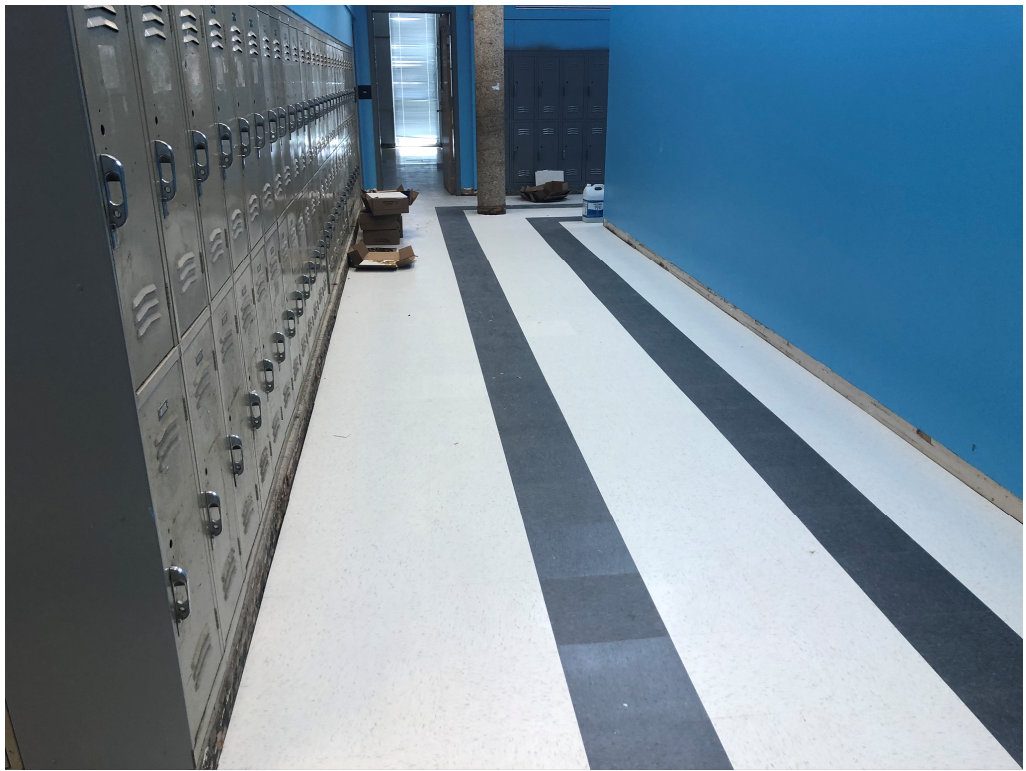
Figure 1 – VCT in Building 100

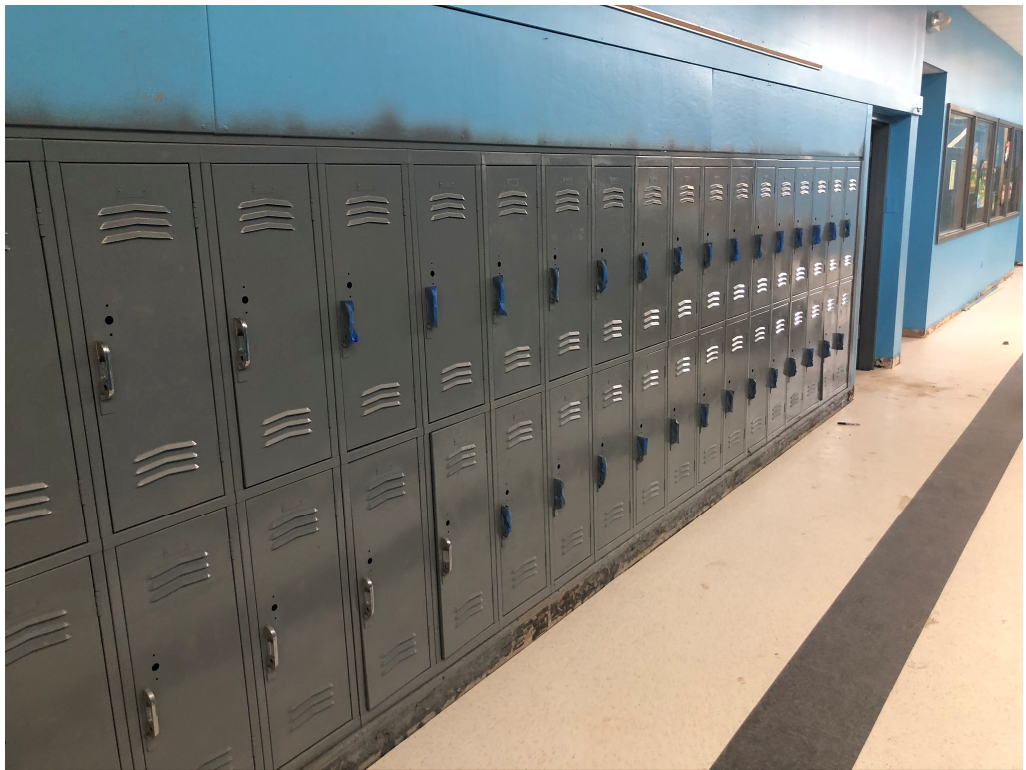
Figure 4 – Lockers Painted using a Sprayer

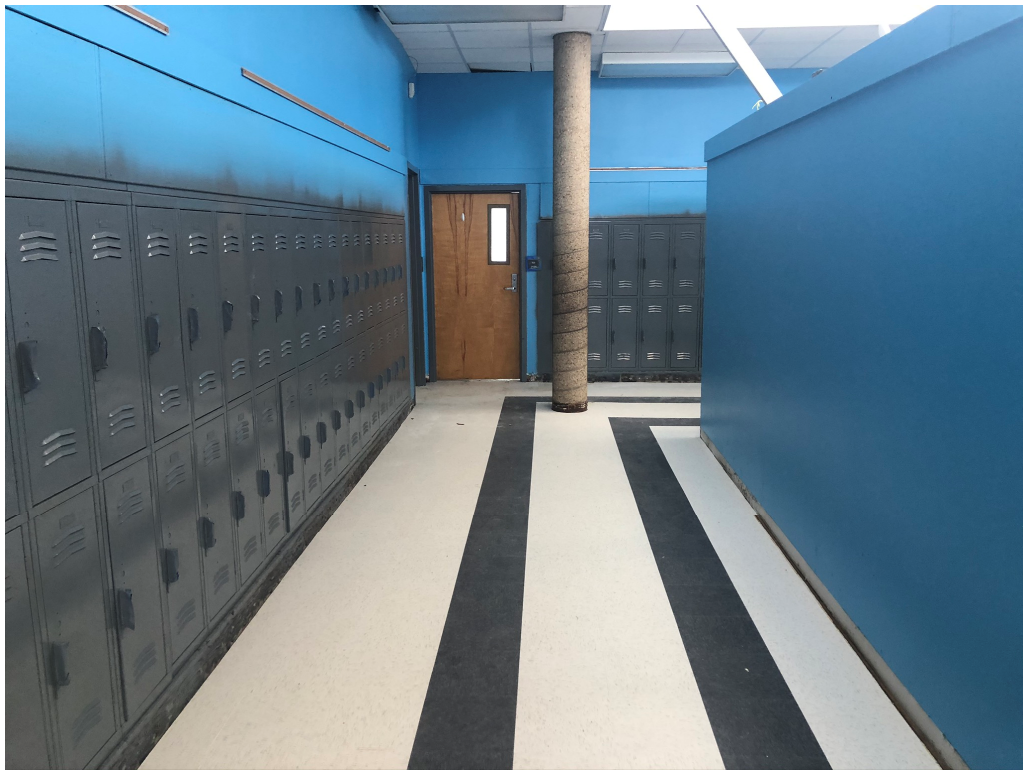
Figure 6 – Lockers Painted using a Sprayer

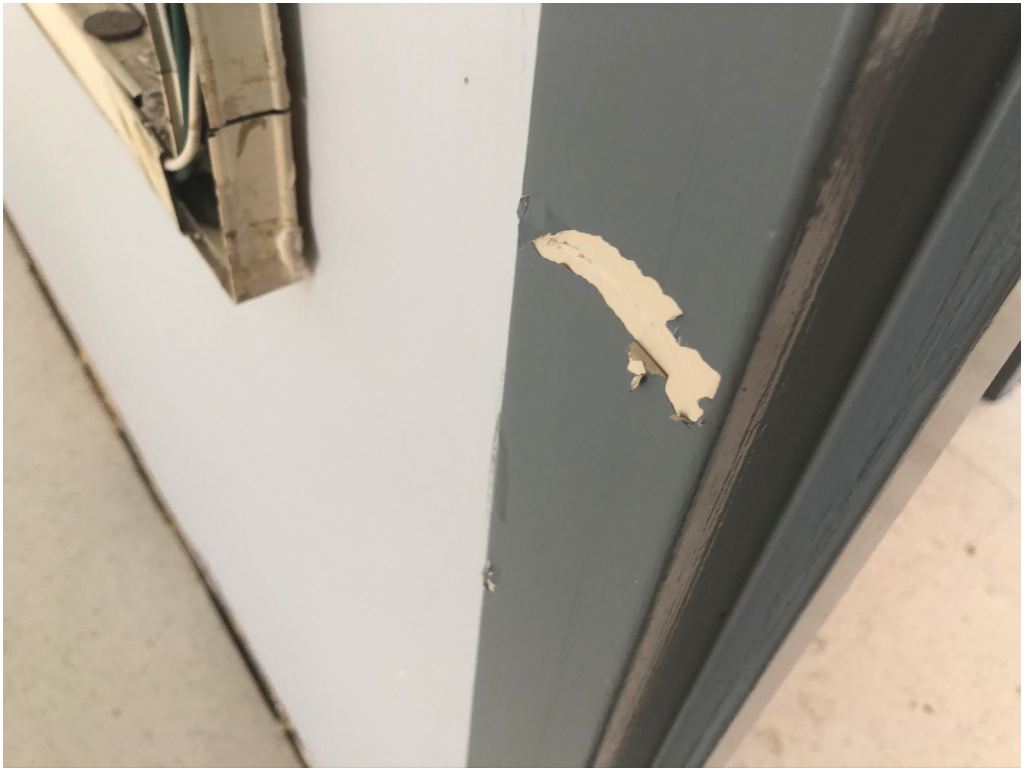
Figure 7 – Peeling Paint at Door Jambs

Items to Verify	Please confirm that these jambs were properly primed. Please confirm that an industrial acrylic was used at Metal Door Jambs.
	Action Required	None
	Report By:

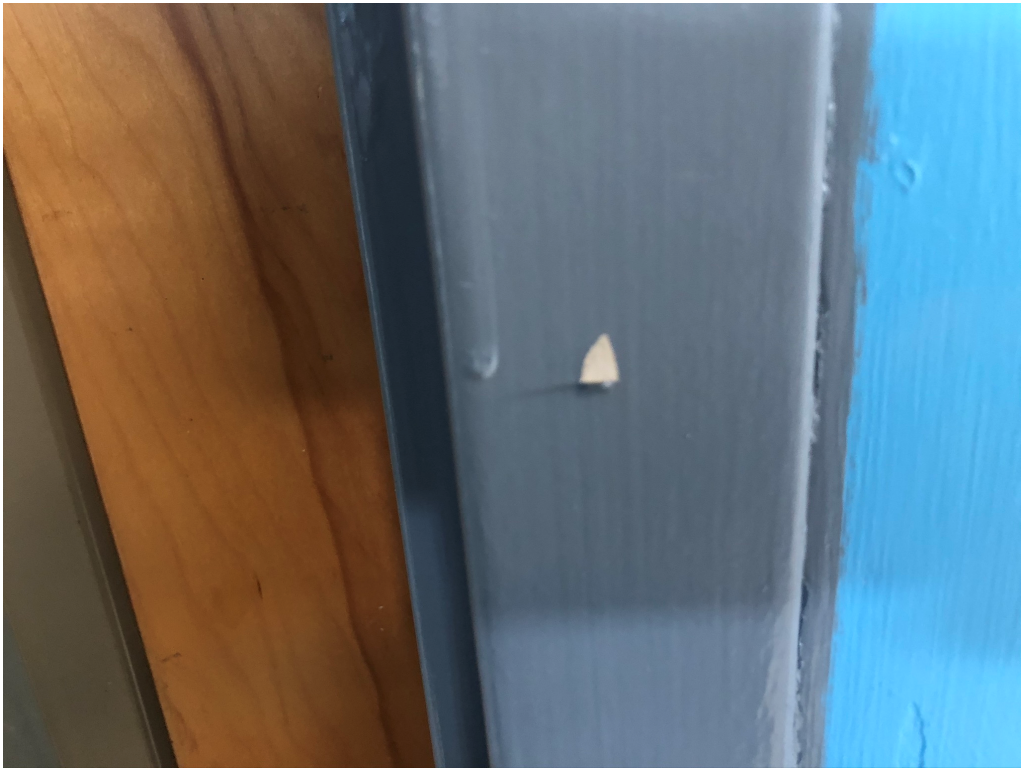
Figure 8 – Peeling Paint at Door Jambs

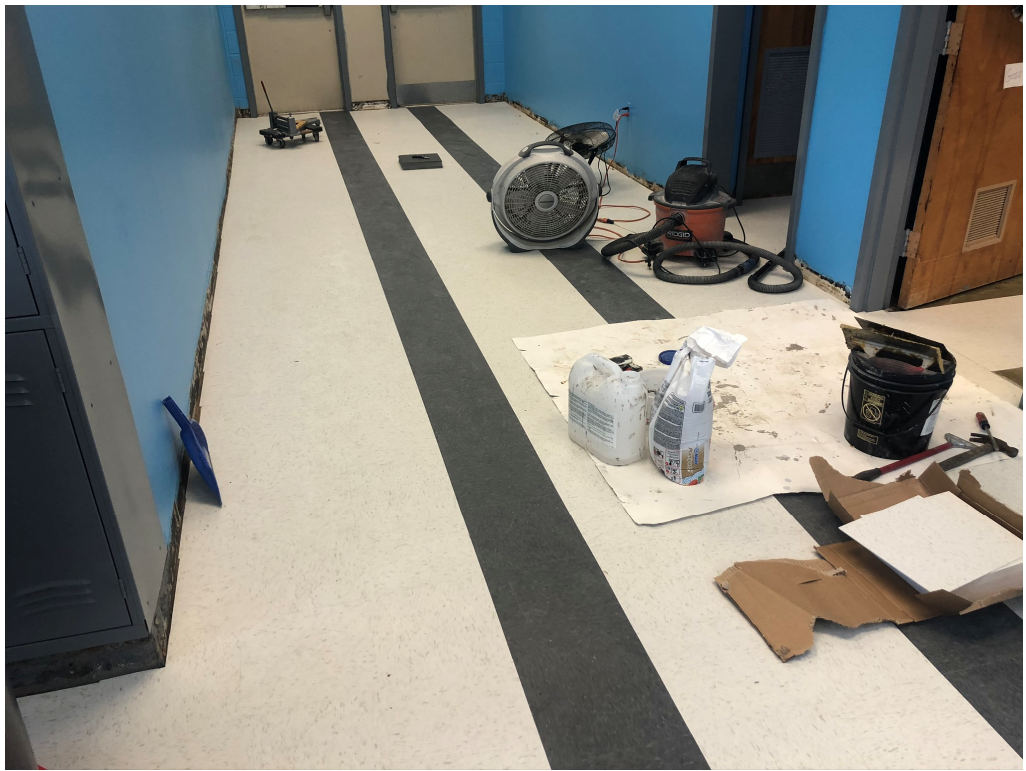
Figure 9 – VCT in Corridor

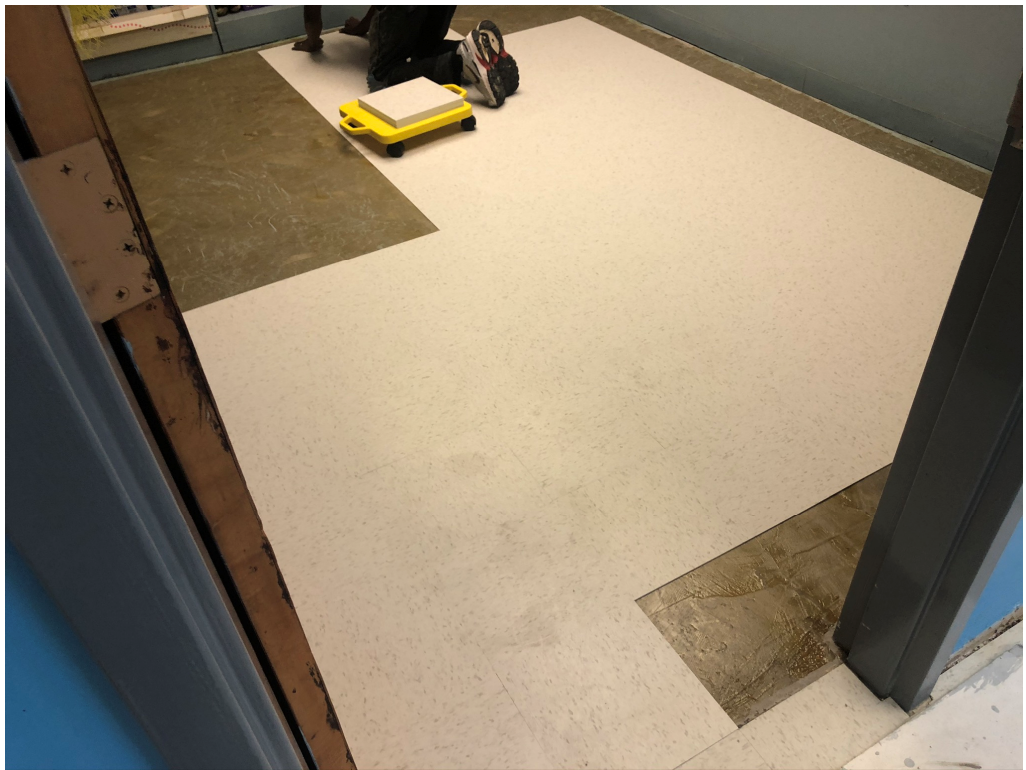
Figure 10 – VCT at Building 100 Work Room

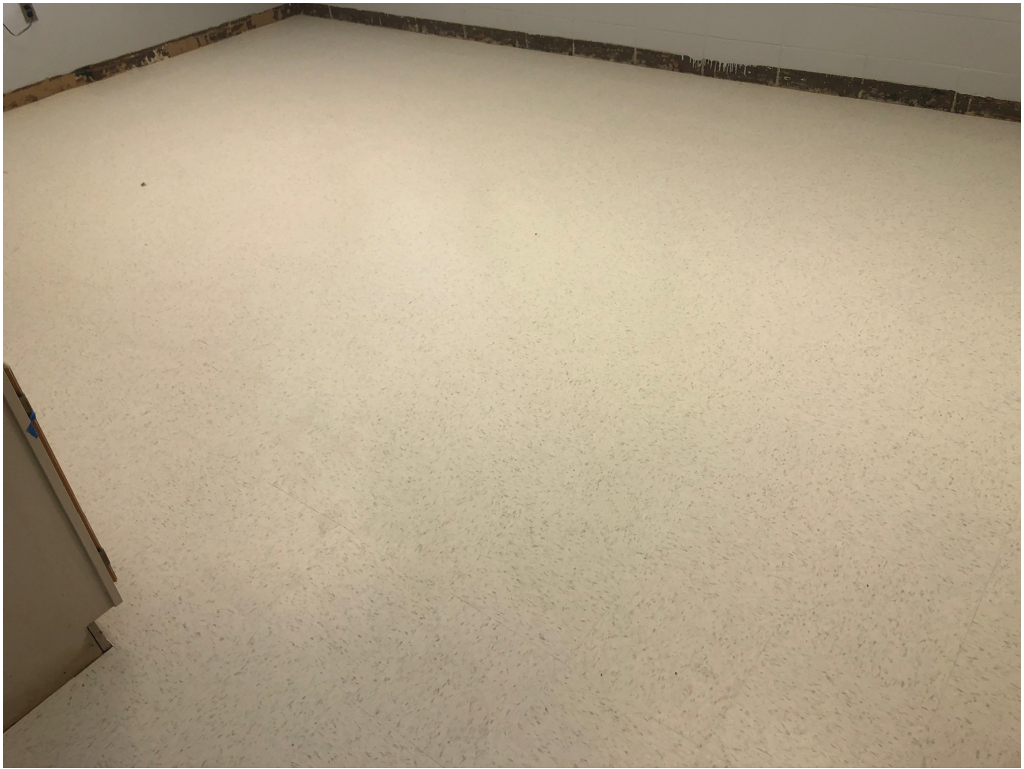
Figure 11 – VCT at South Classrooms in Building 100

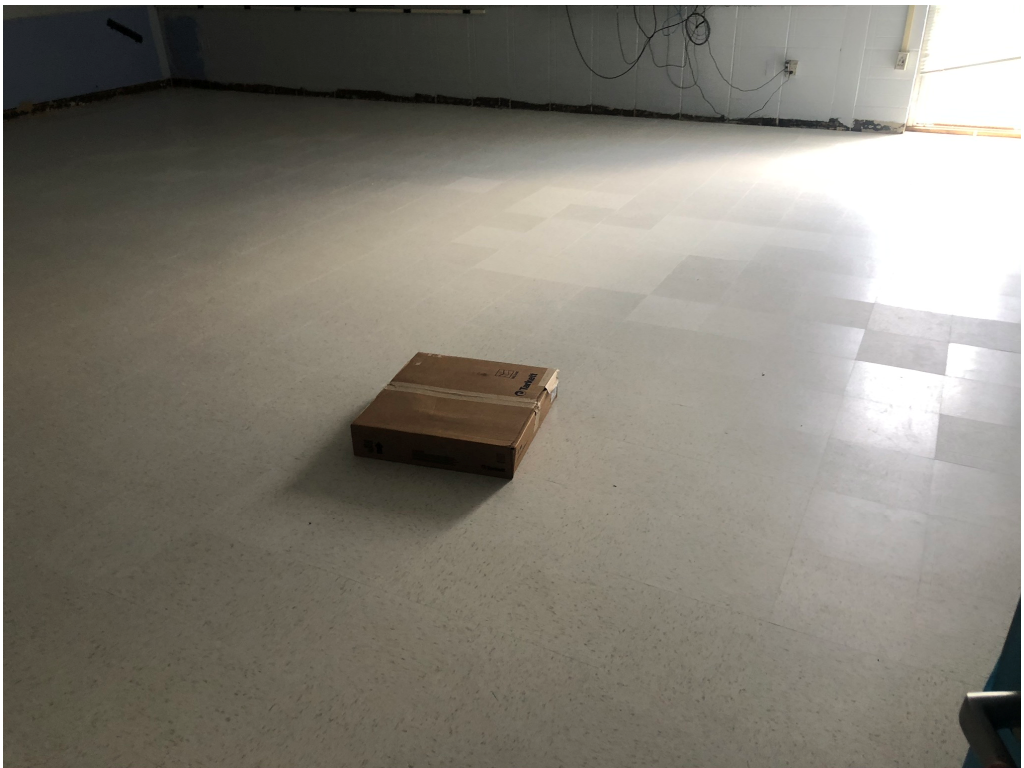
Figure 12 – VCT at South Classrooms in Building 100

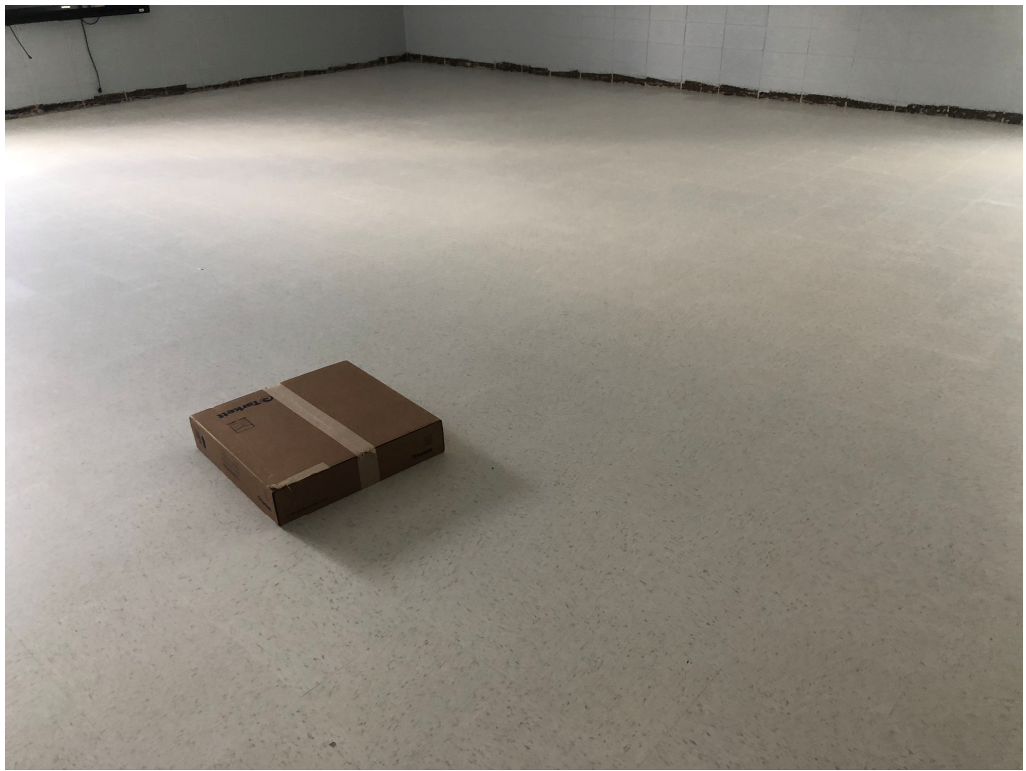
Figure 13 – VCT at South Classrooms in Building 100

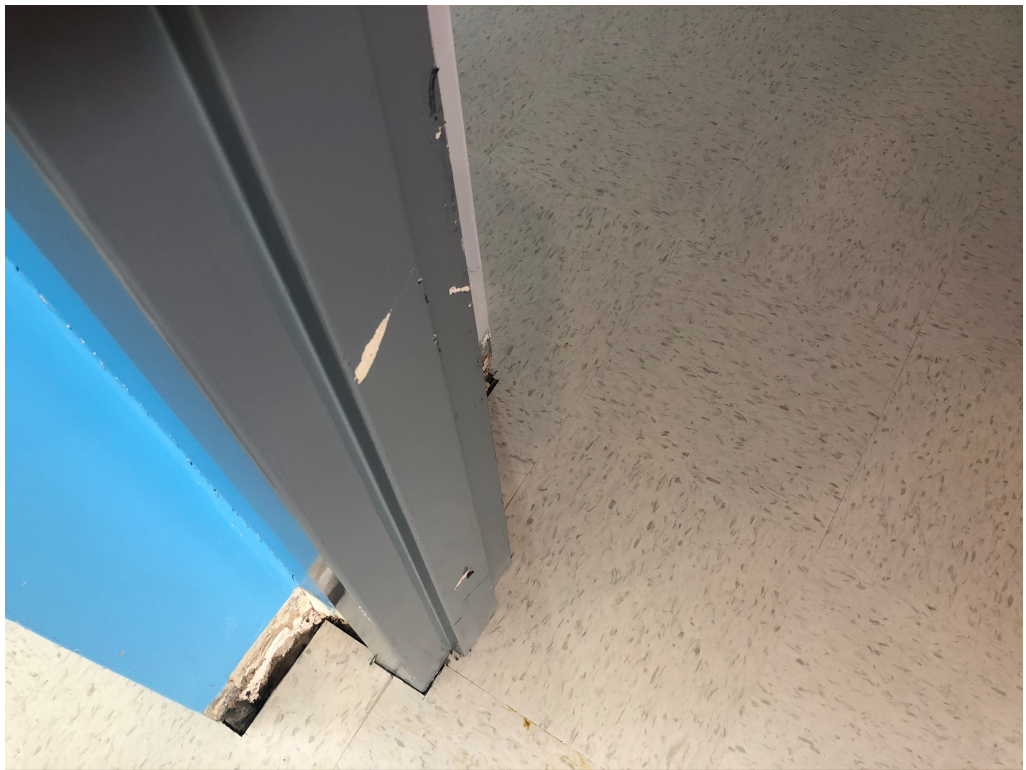
Figure 14 – Peeling Paint at Door Jambs

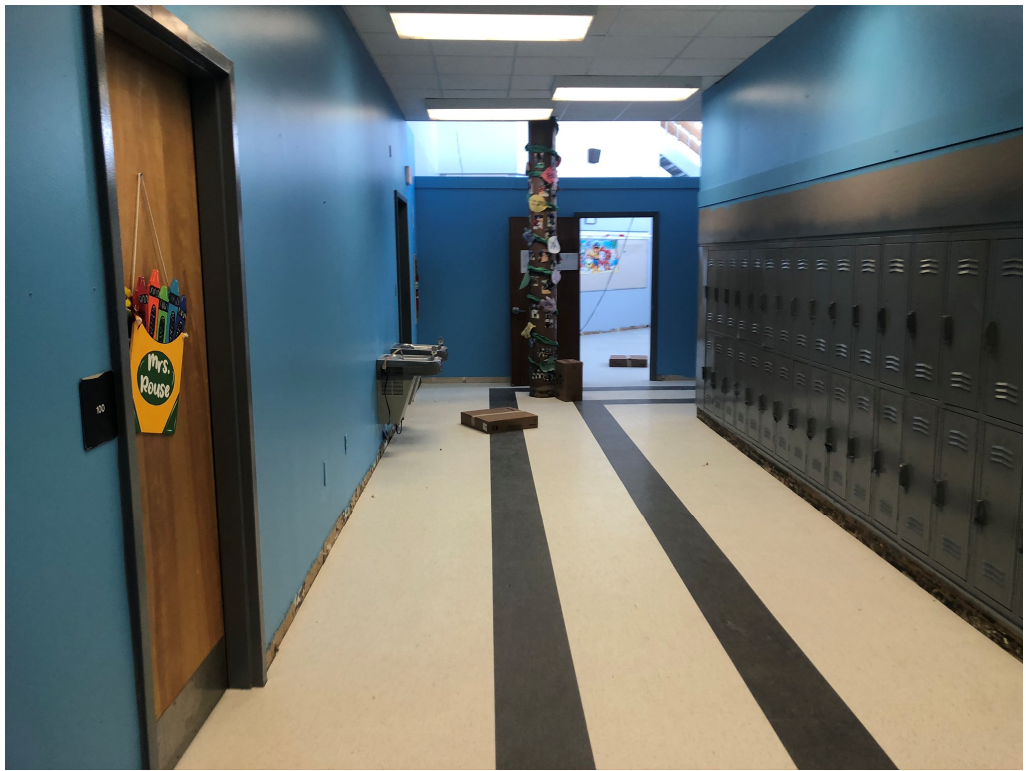
Figure 15 – VCT at Building 100

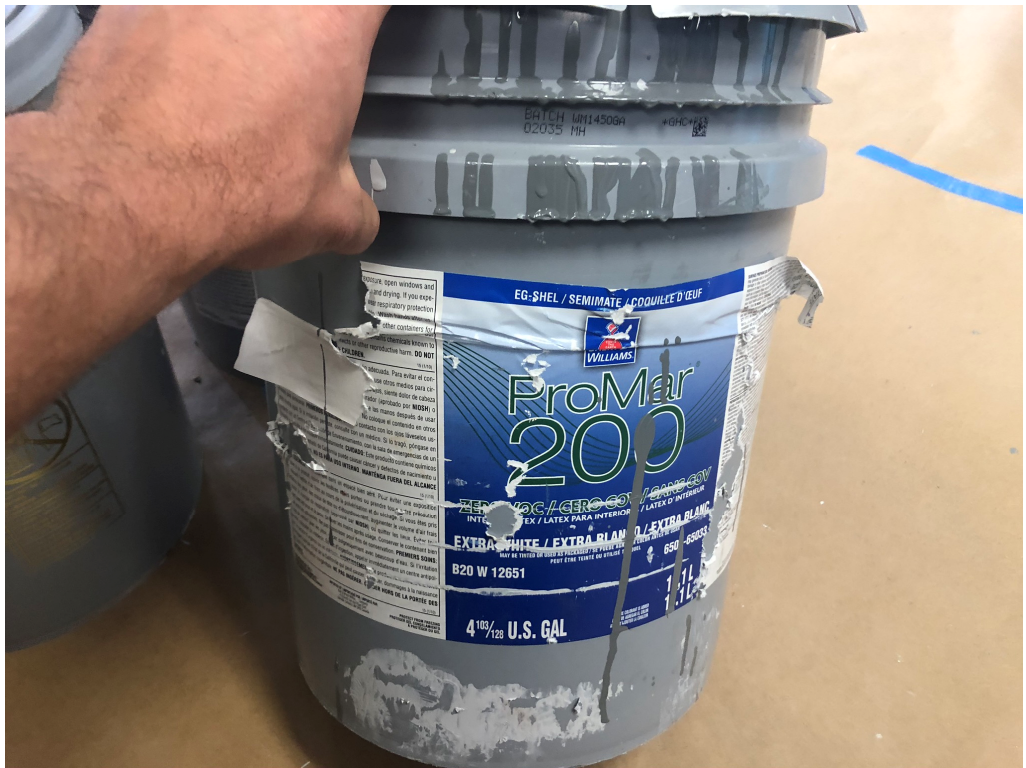
Figure 16 – Possible Door Jamb Paint

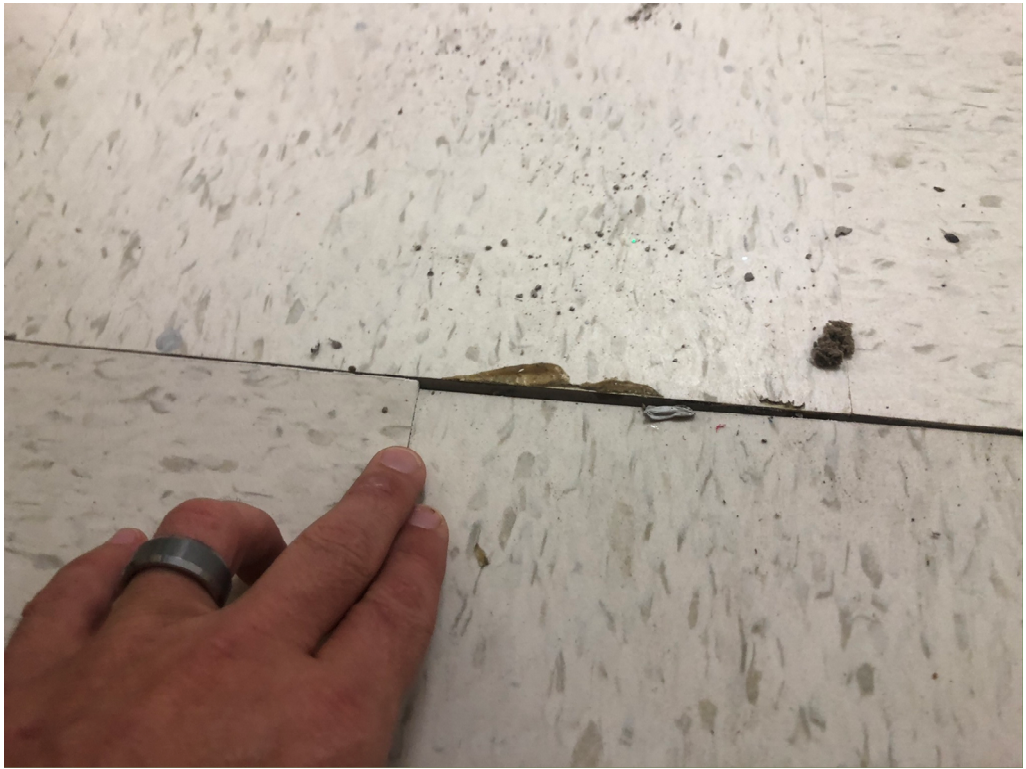
Figure 17 – VCT at Library Threshold is uneven and Needs to be reworked

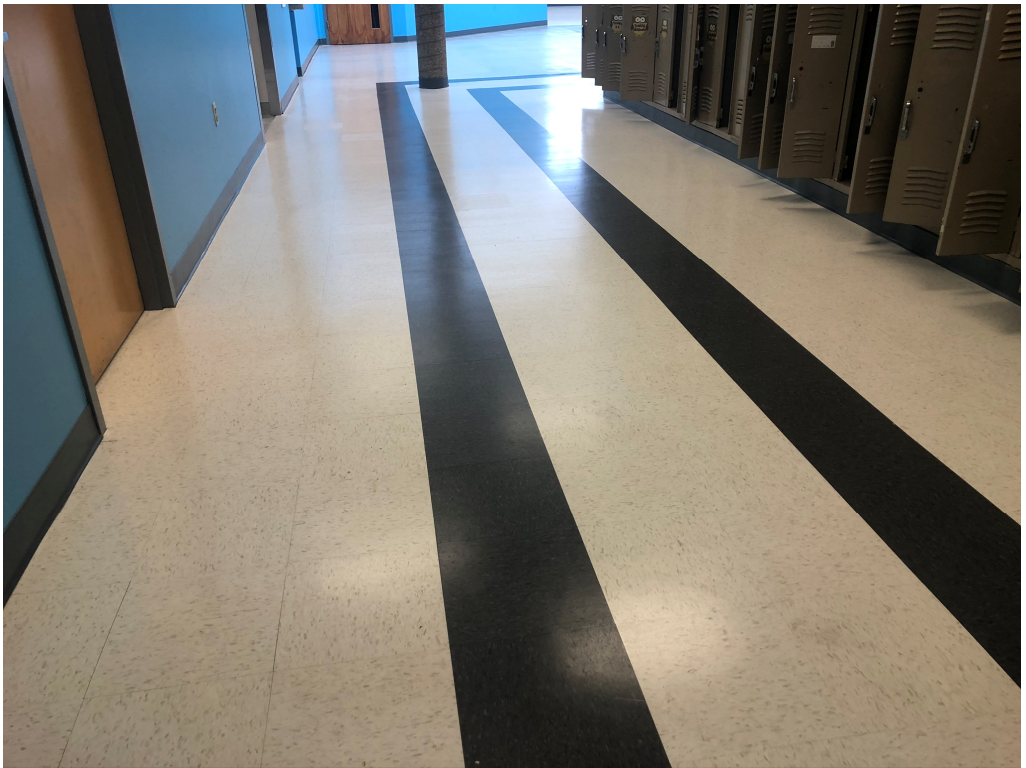
Figure 18 – Building 300 Wax is Ongoing
