29 July 2020

18043.01-BWF Beechwood Elementary / Report Number 010

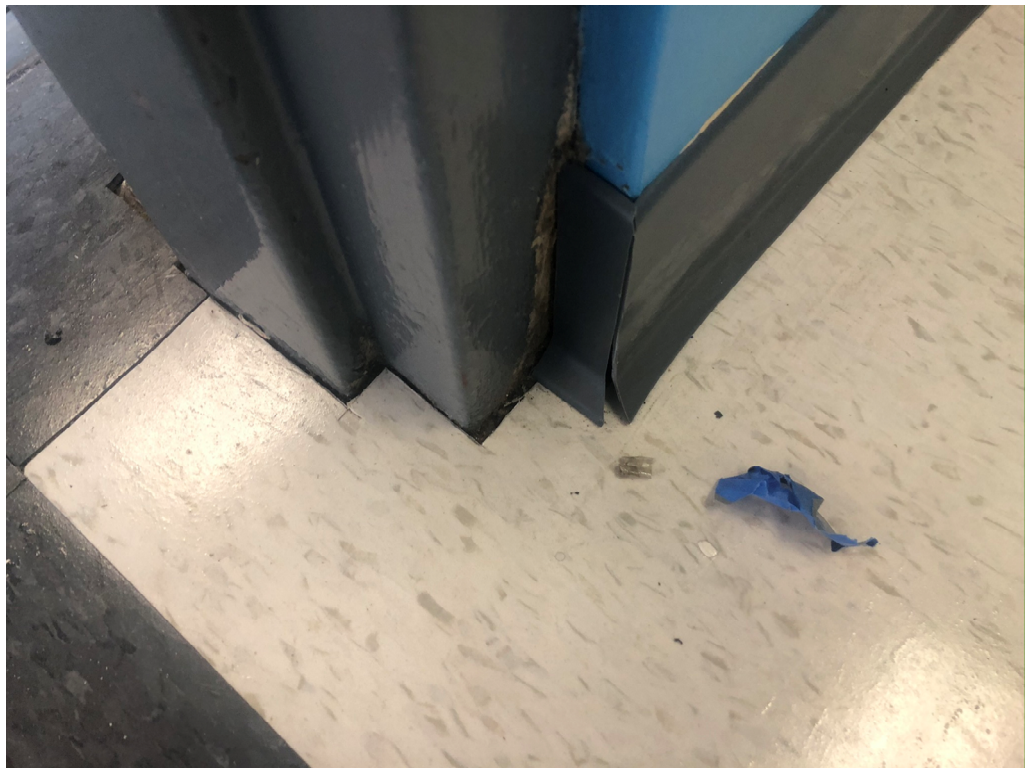
Figure 2 – Rubber Base Corner does not meet up

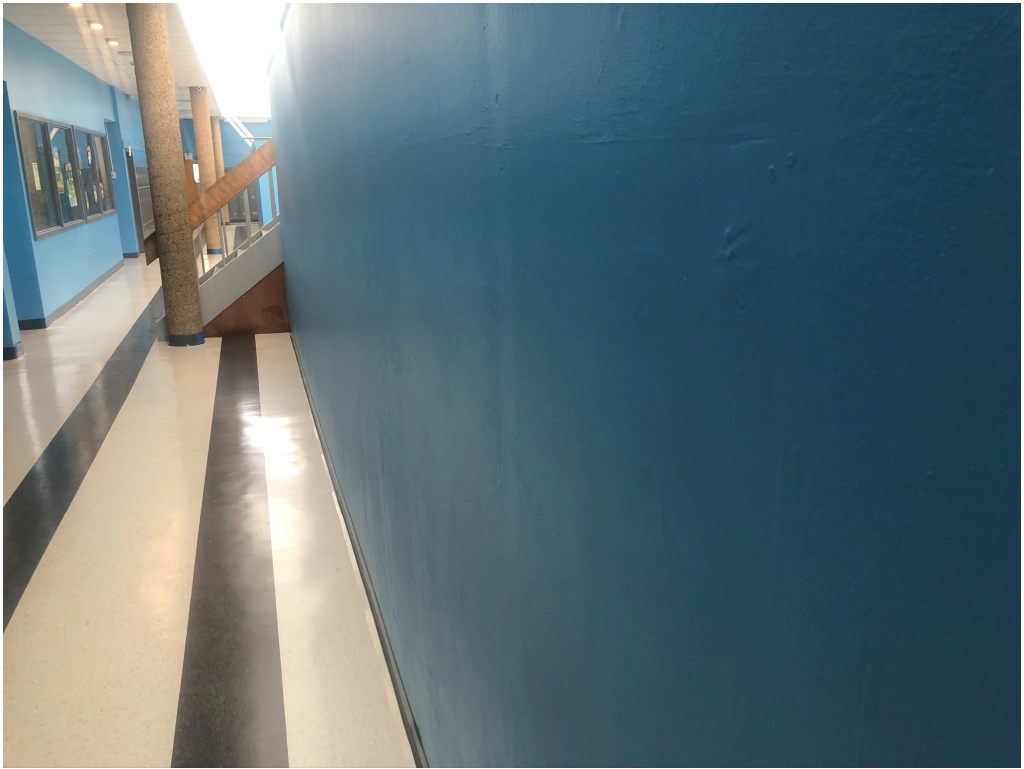
Figure 3 – Wall Prep still needed at this wall

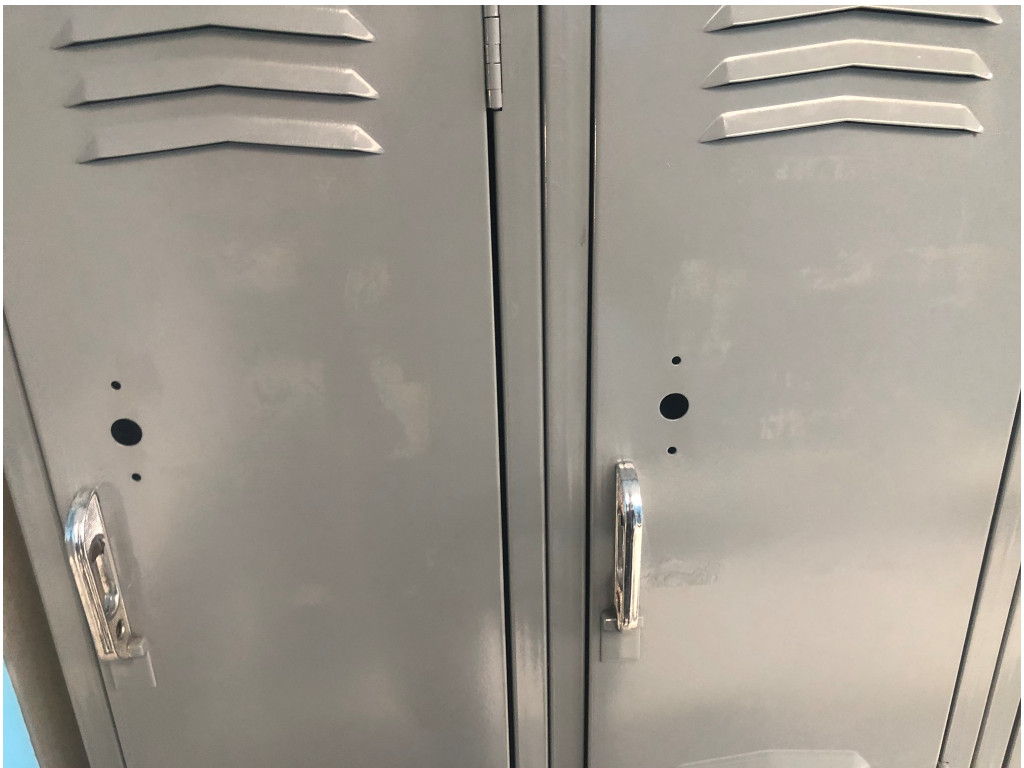
Figure 4 – Some Locker Finishes are uneven

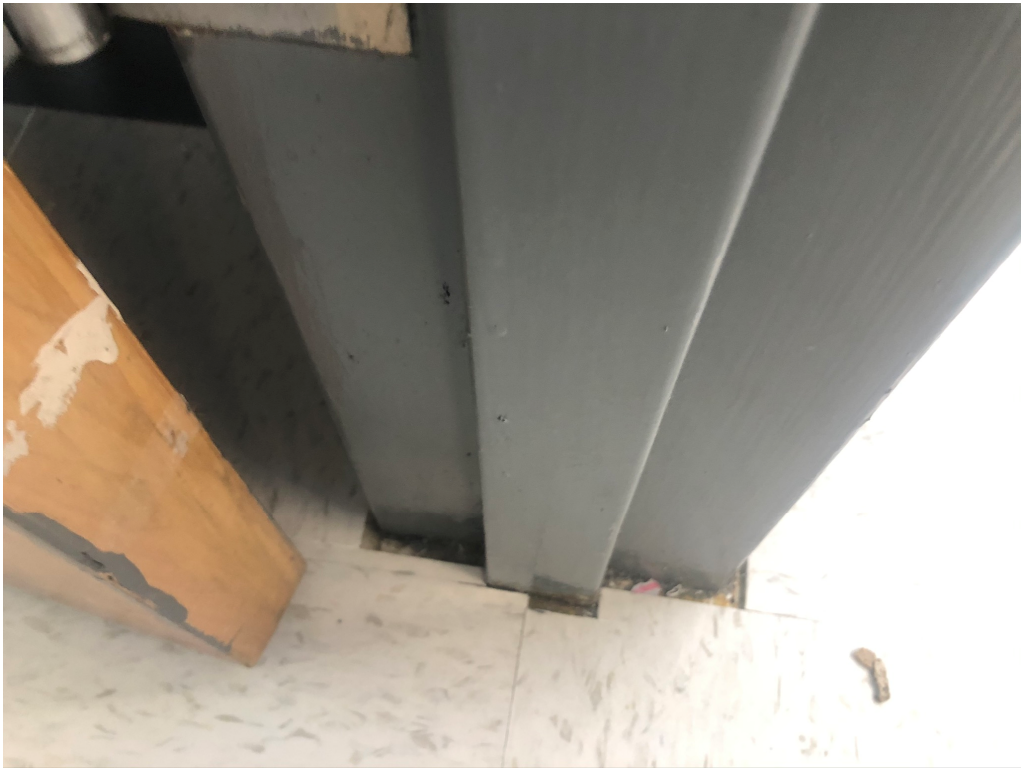
Figure 7 – Poorly notched Tile at Jamb

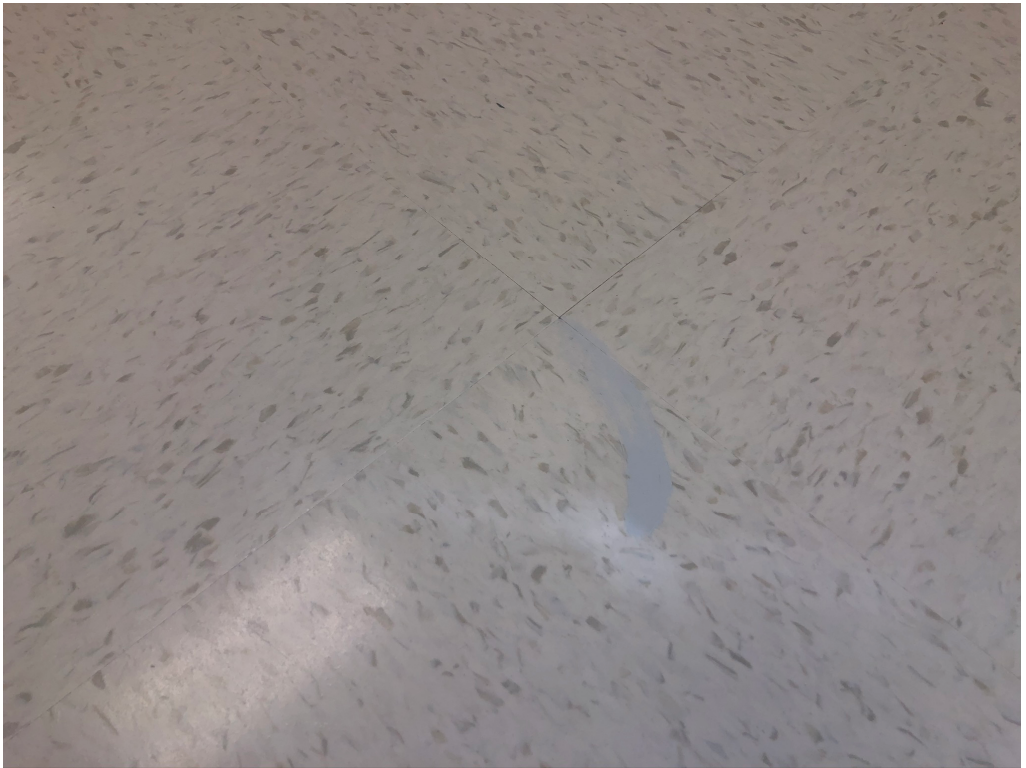
Figure 8 – Paint Under Floor Wax

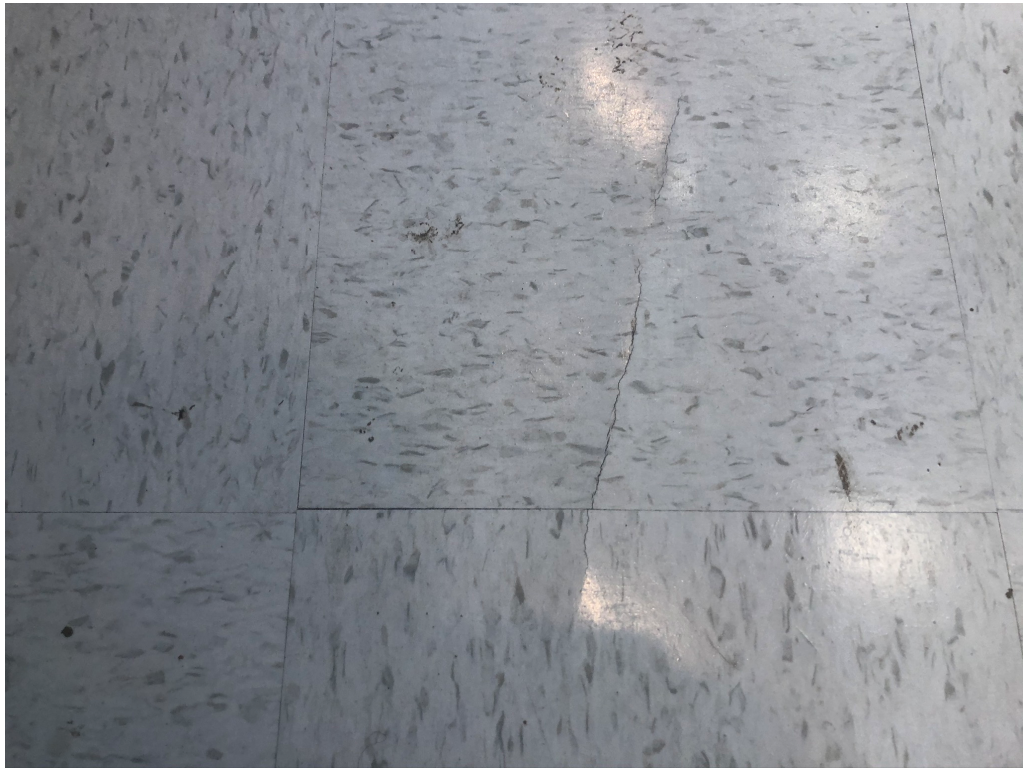
Figure 9 – Cracked Tile due to debris and/or lacked of floor prep

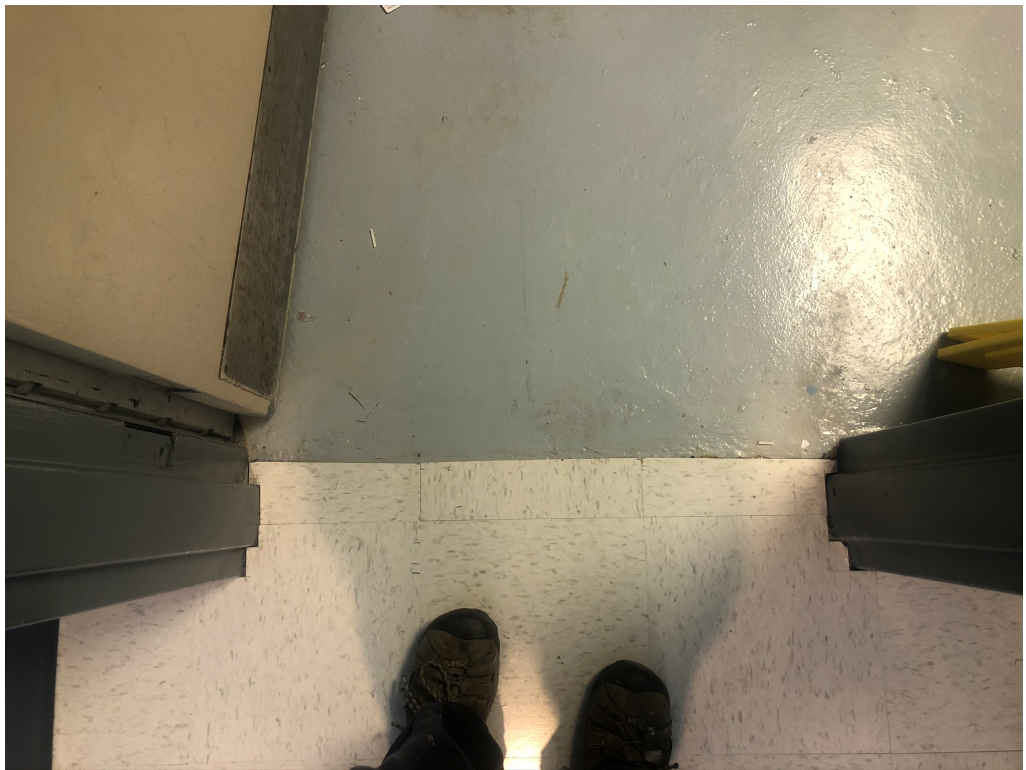
Figure 10 – Rubber Threshold Required at Unfinished VCT Edges in Doorways

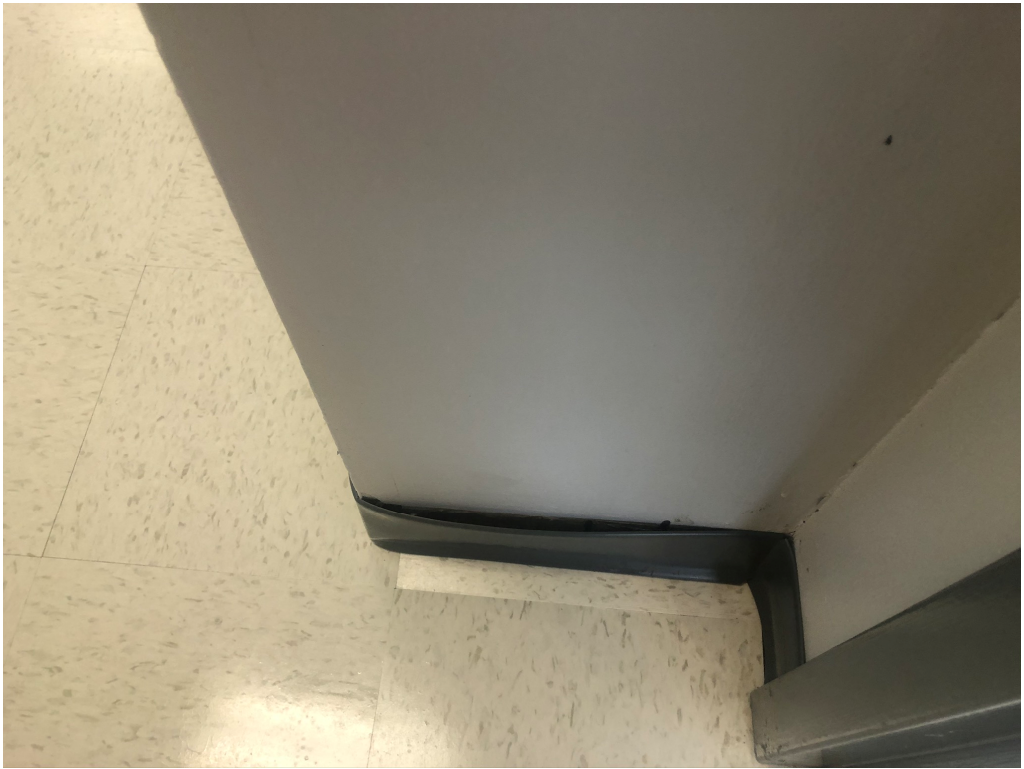
Figure 11 – Rubber Base Lacking adhesion

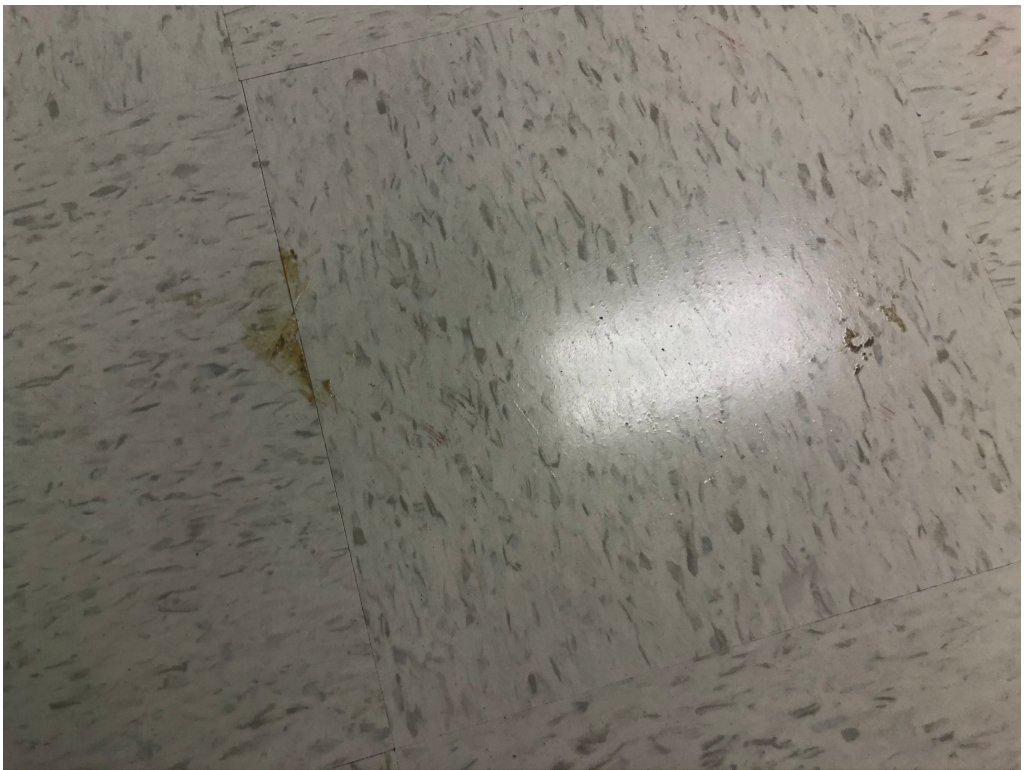
Figure 12 – Glue at Tile

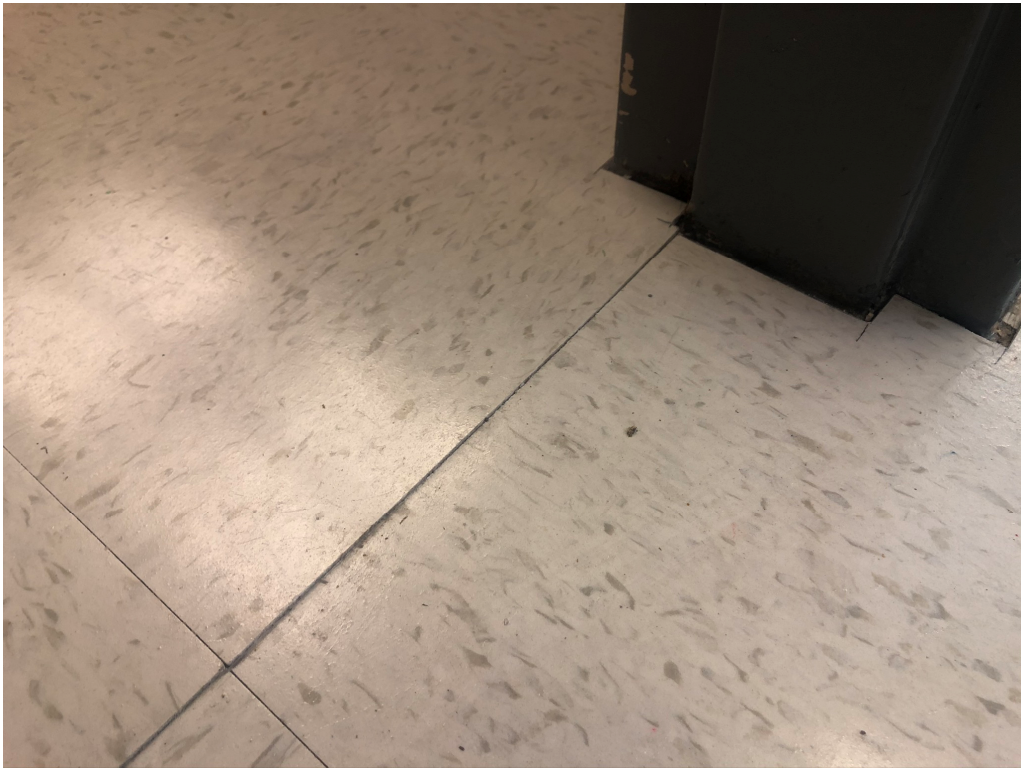
Figure 13 – Floor Tiles Mainly Around Thresholds and Floor Perimeters Not Flush

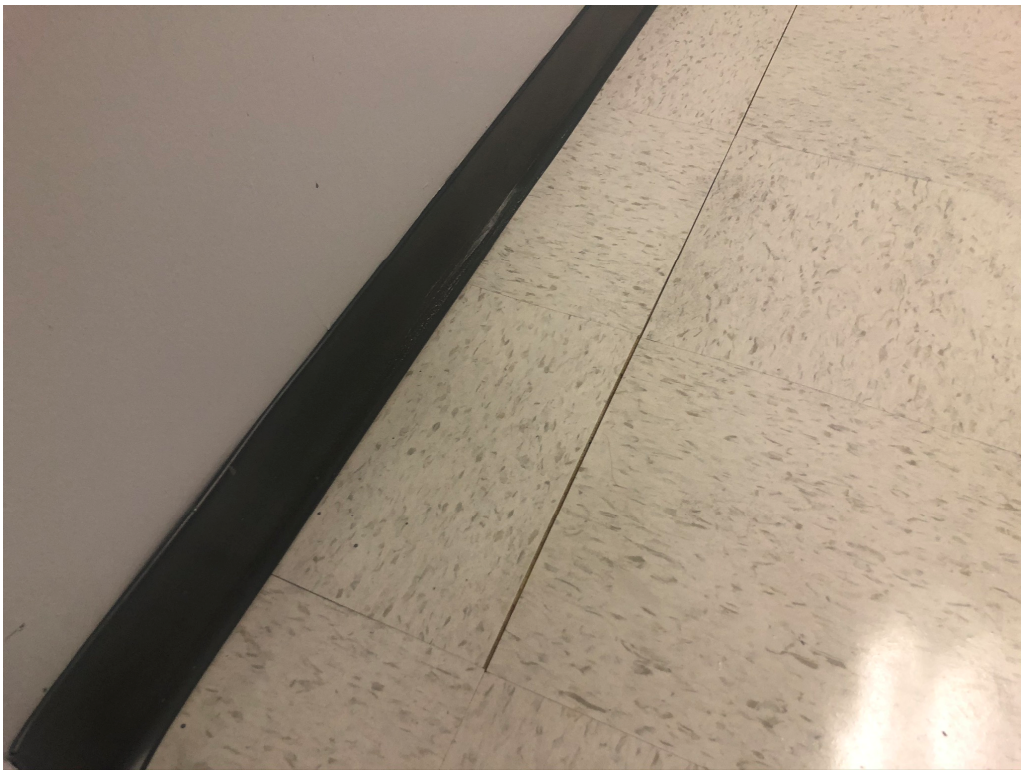
Figure 14 – Gaps Between Tiles

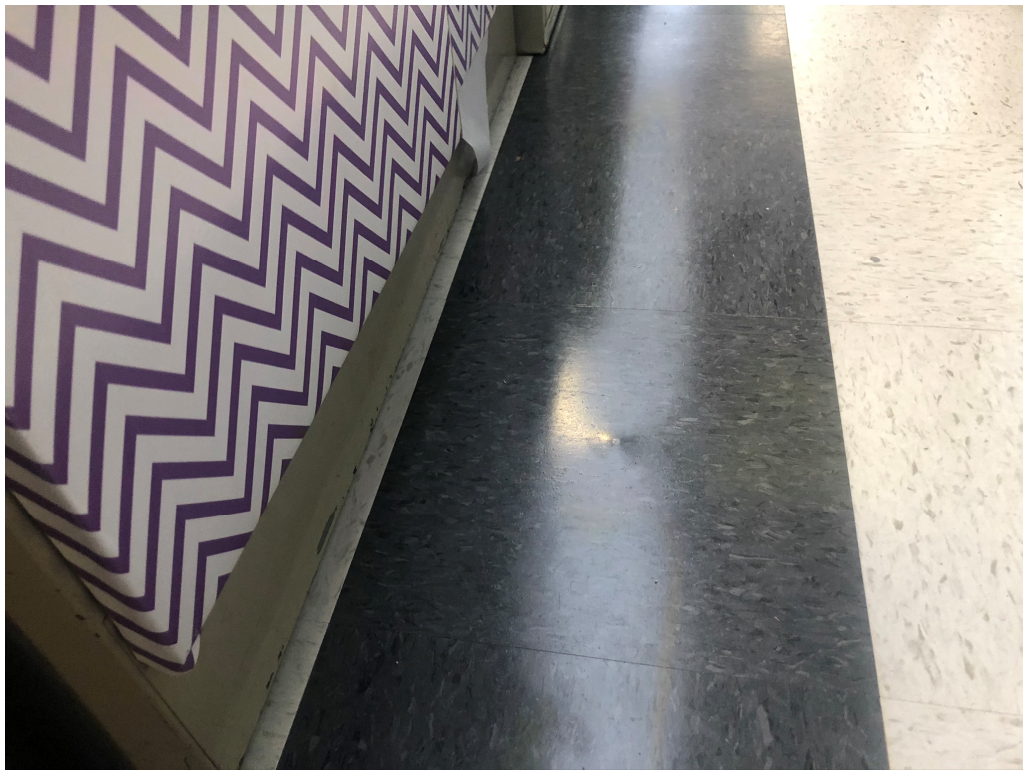
Figure 15 – Debris Under Tile

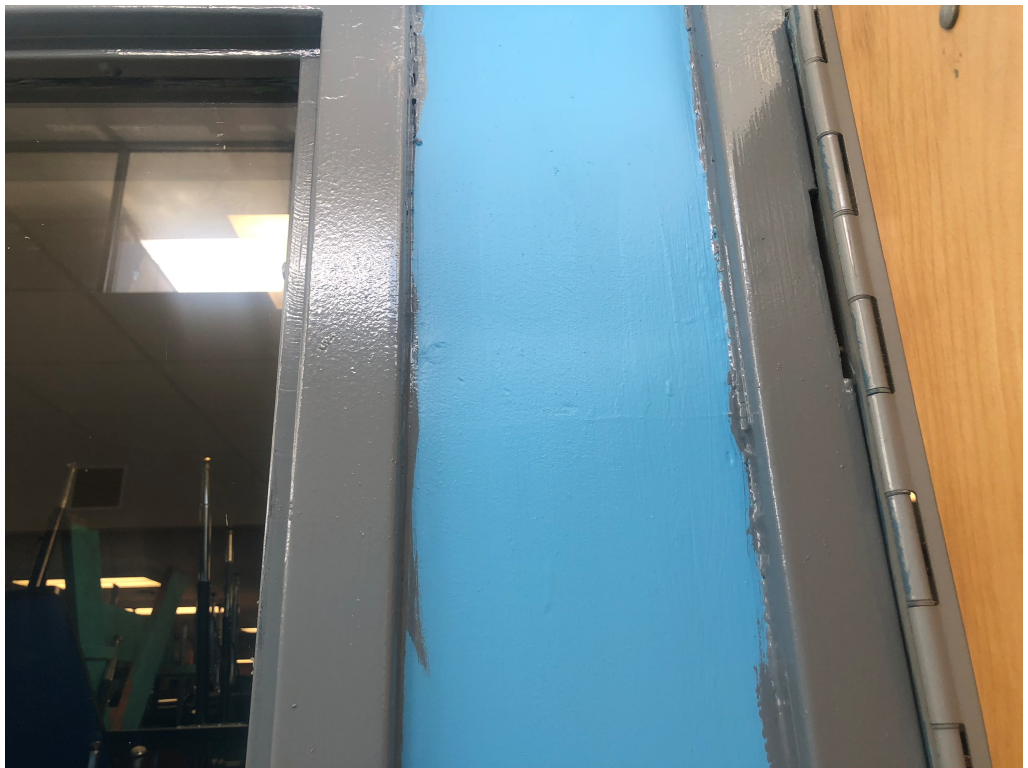
Figure 16 – Some Paint Touchups Required at Jambs and Walls
