07 August 2020

18043.01-BWF Beechwood Elementary / Report Number 011

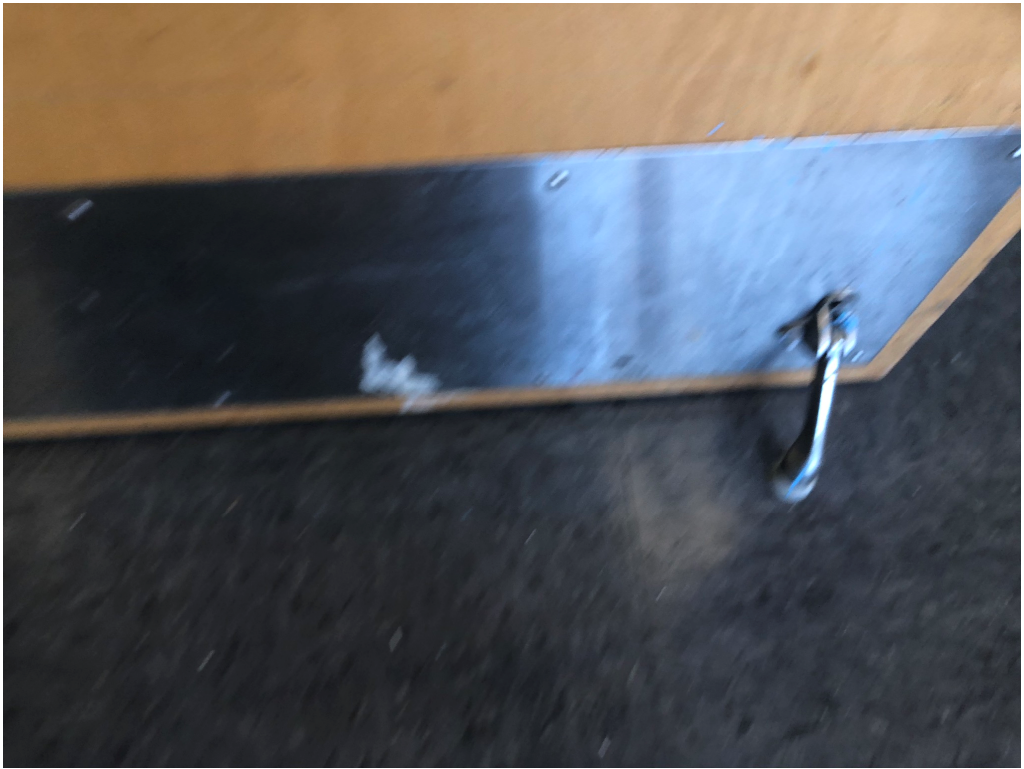
Figure 1 – Paint on Door

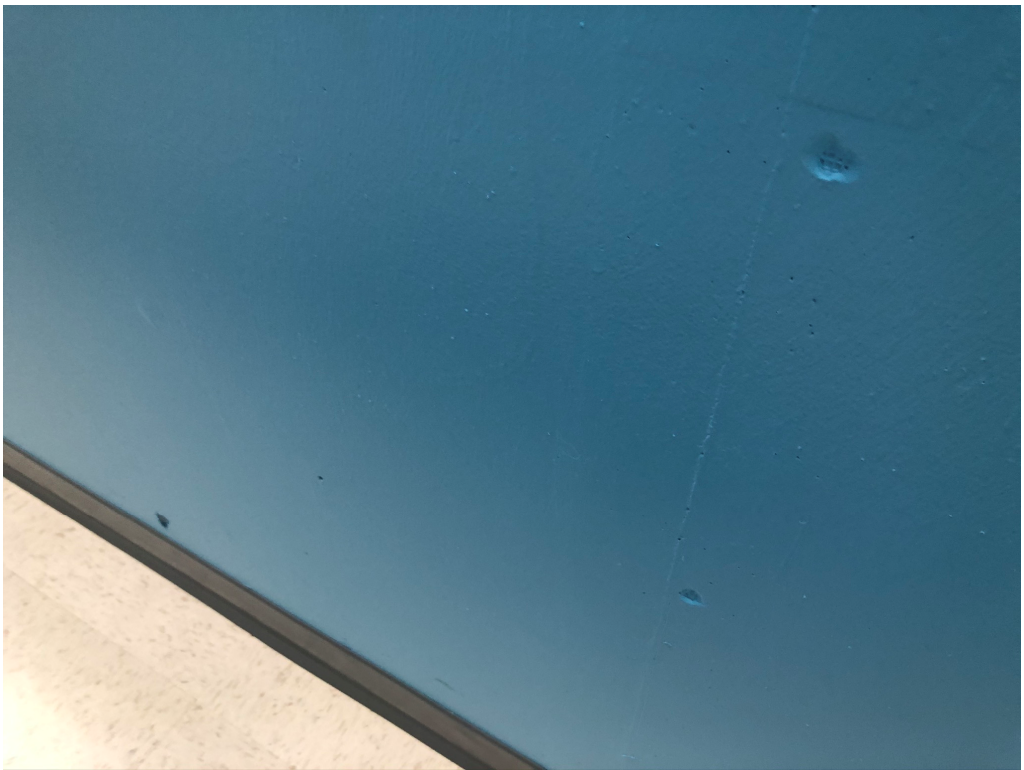
Figure 2 – Divots that should be Filled as is standard wall prep for paint

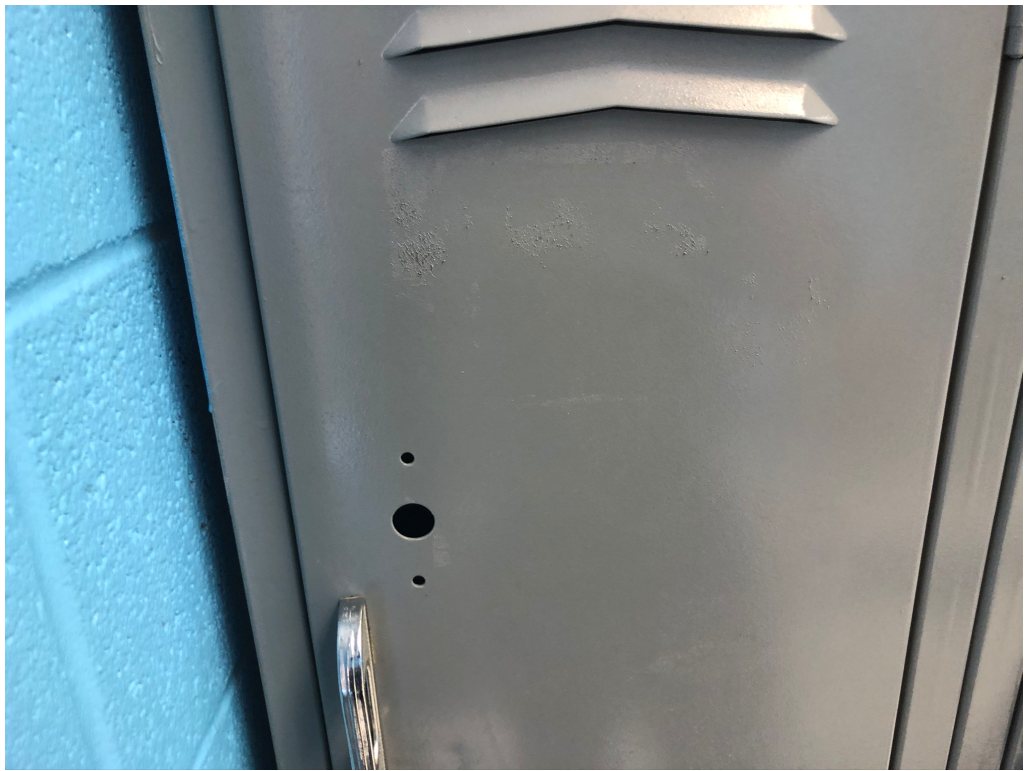
Figure 3 – Rough surfaces at lockers that should be prepped more thoroughly

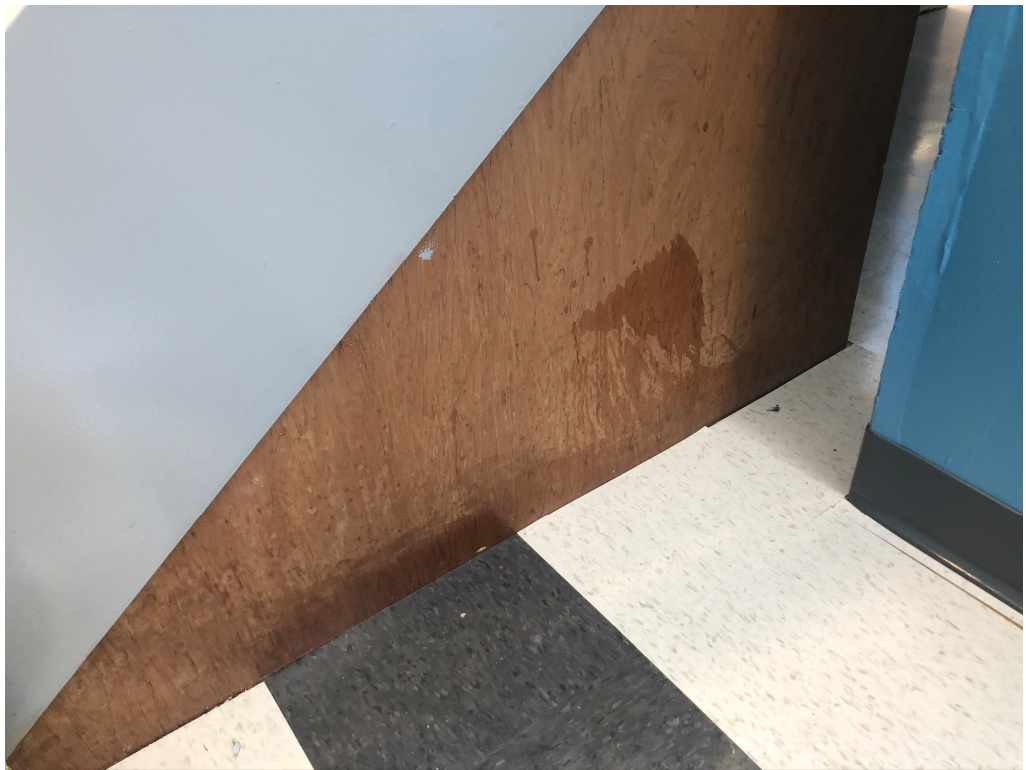
Figure 4 – Wax on Wall Panel & Missing Rubber Base

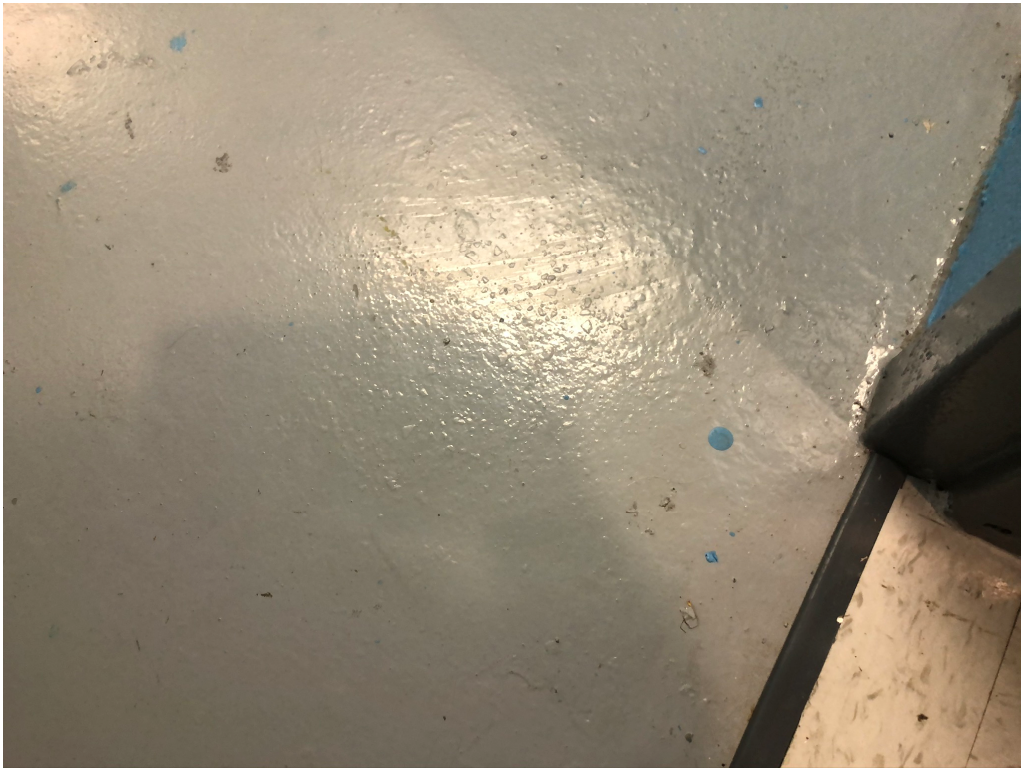
Figure 5 – Paint on Floors at Bathrooms

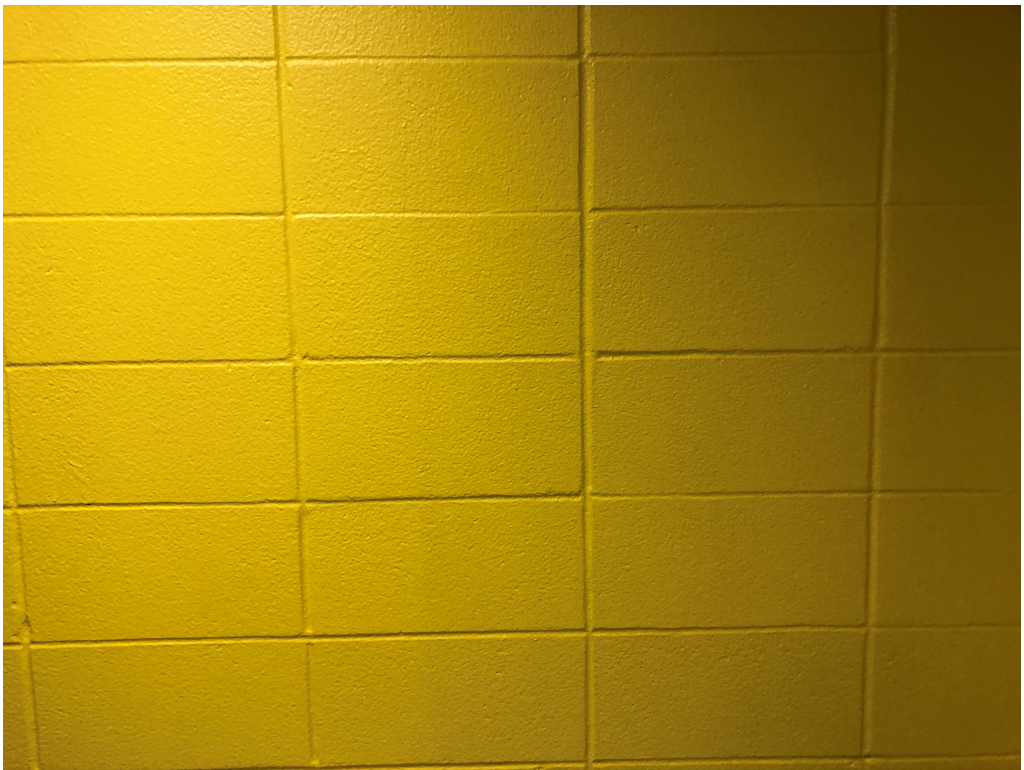
Figure 6 – Uneven Coverage at Walls

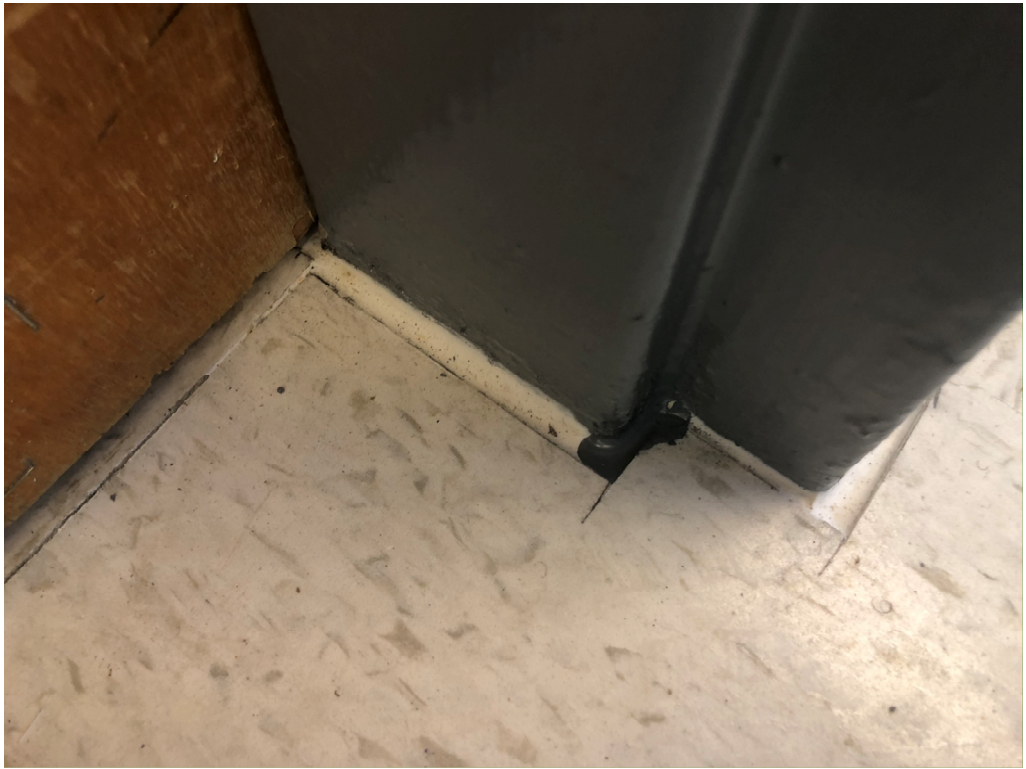
Figure 7 – Pencil Marks at Door Thresholds & Paint On Floor

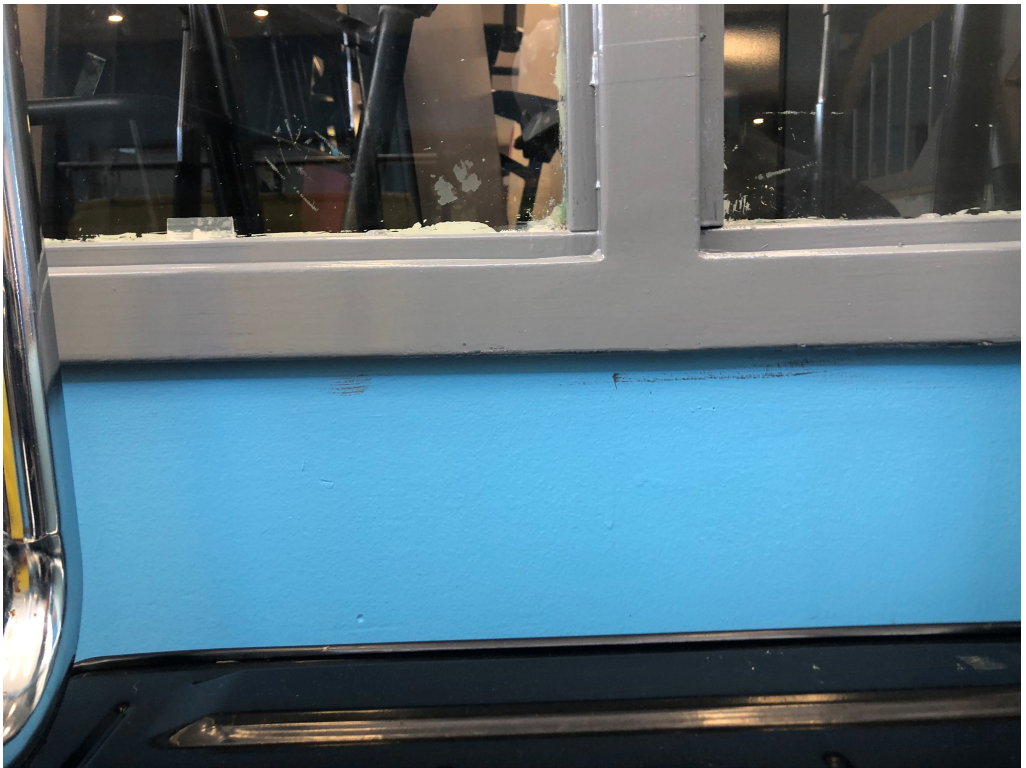
Figure 8 – General Paint Touchups throughout

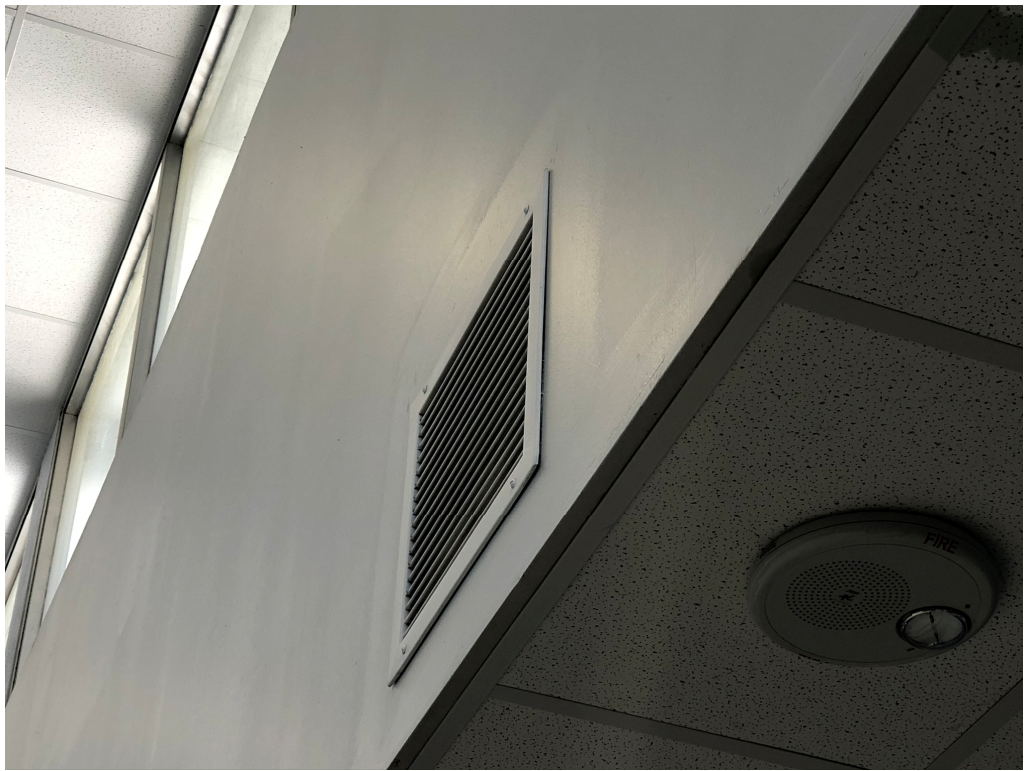
Figure 9 – Uneven Sheen at Walls in several Locations

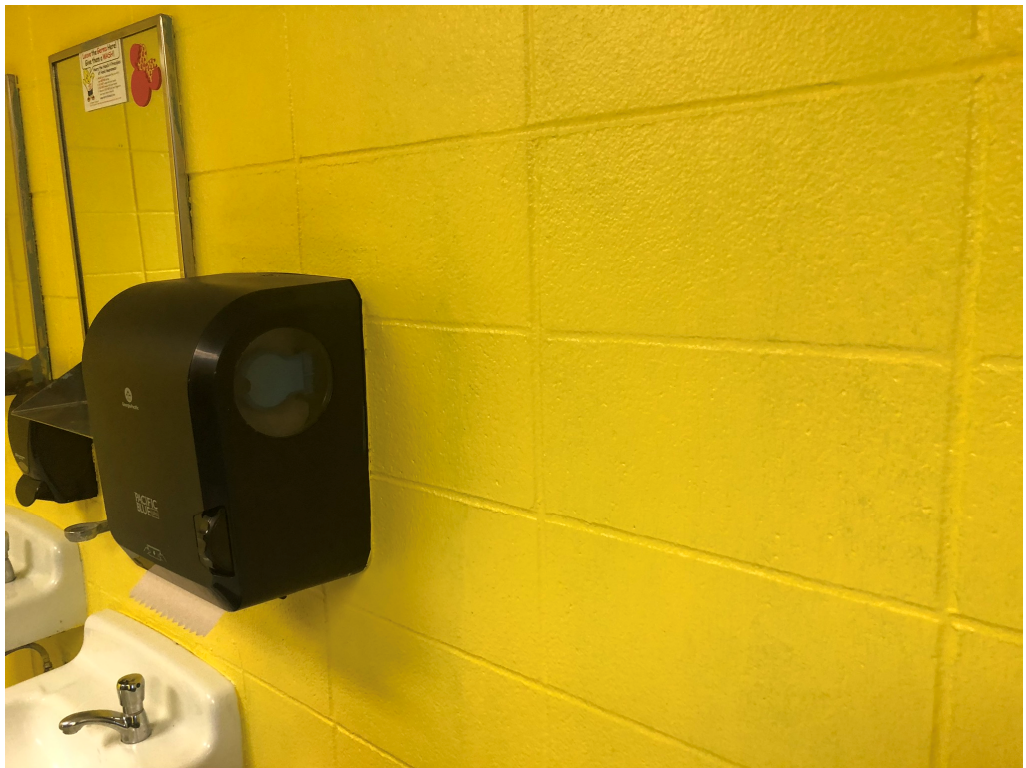
Figure 10 – Poor Paint Coverage

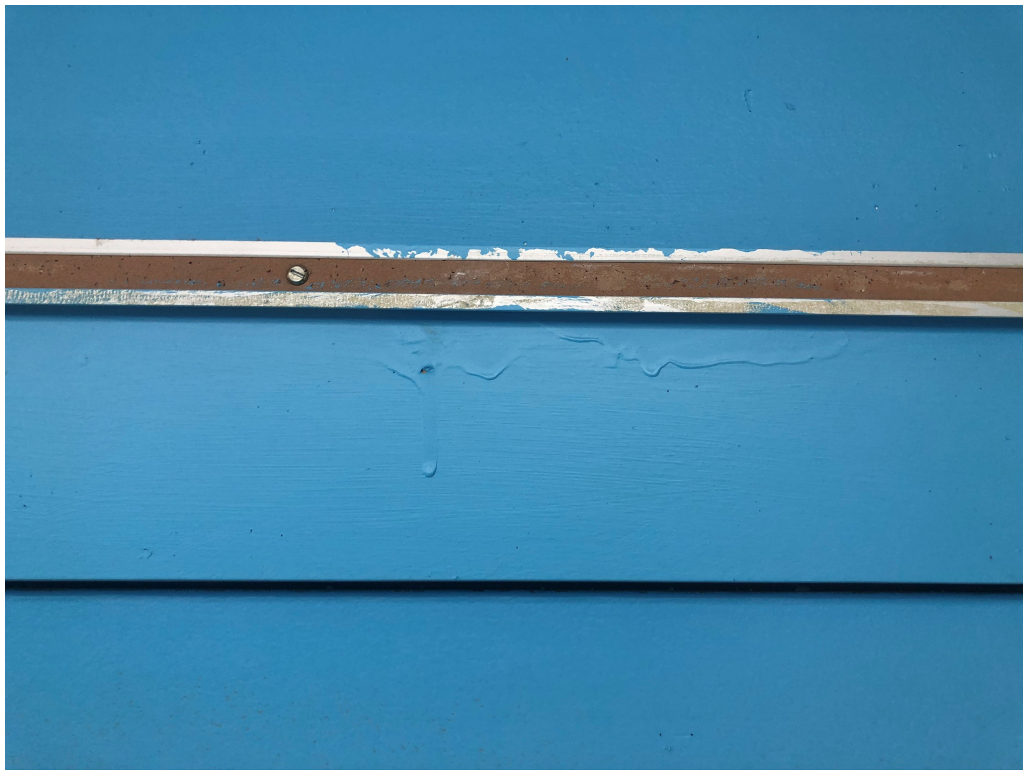
Figure 11 – Drips and Painted Hardware

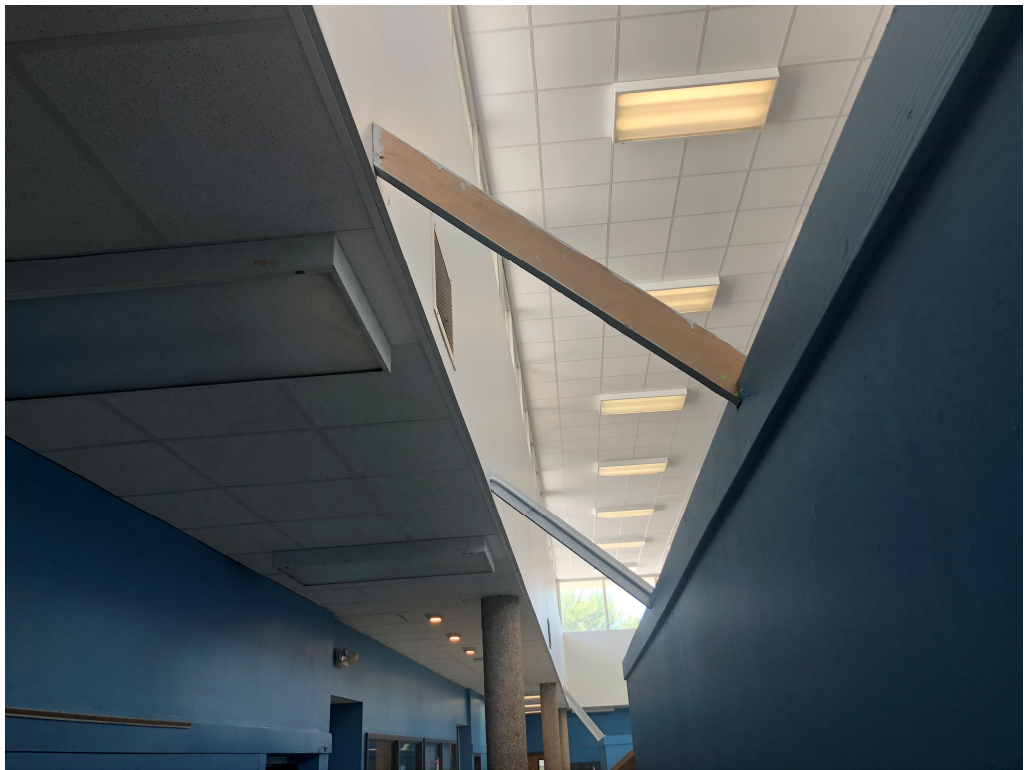
Figure 12 – Missing Paint

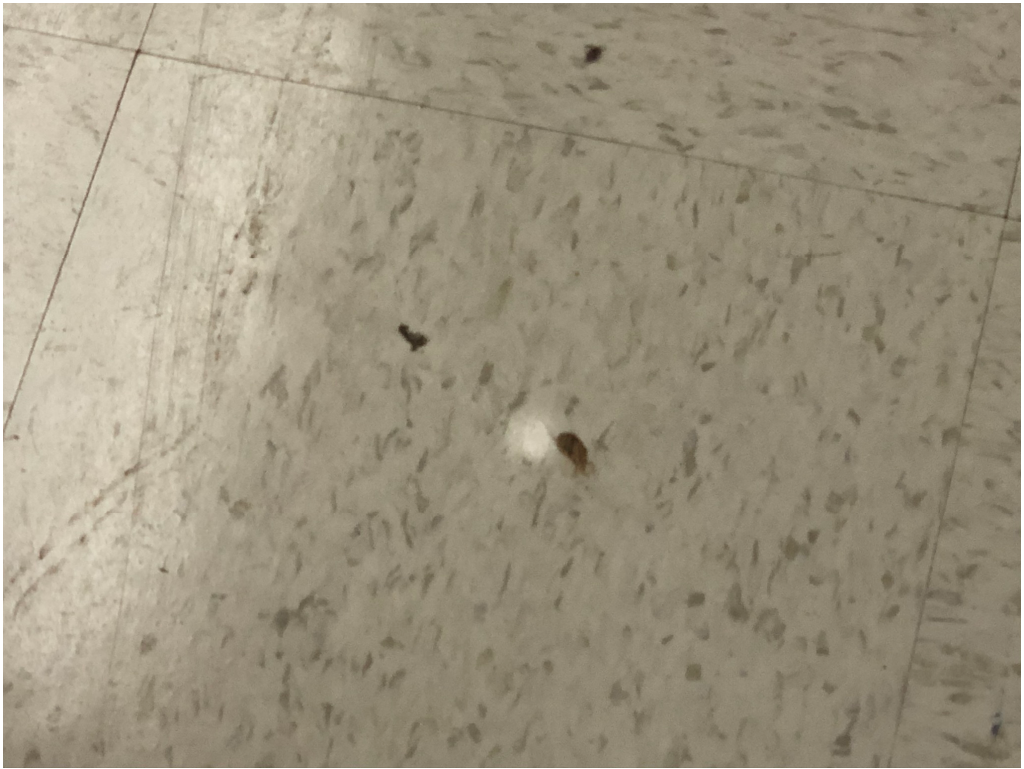
Figure 13 – Debris Under Tiles

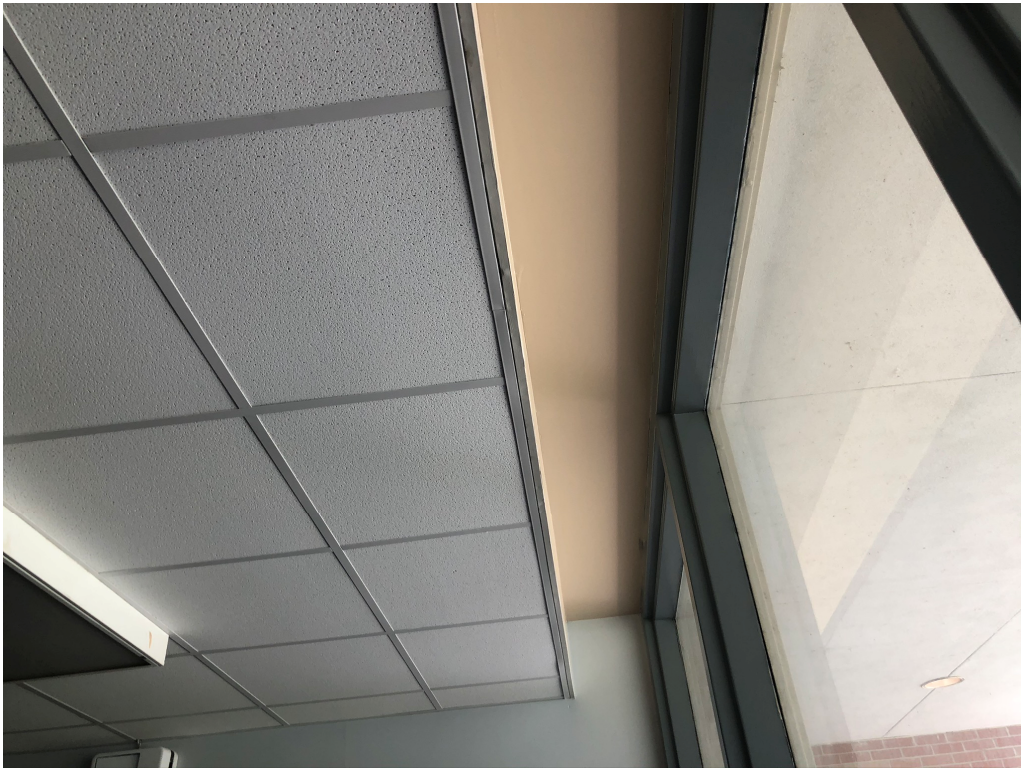
Figure 14 – Missing Paint

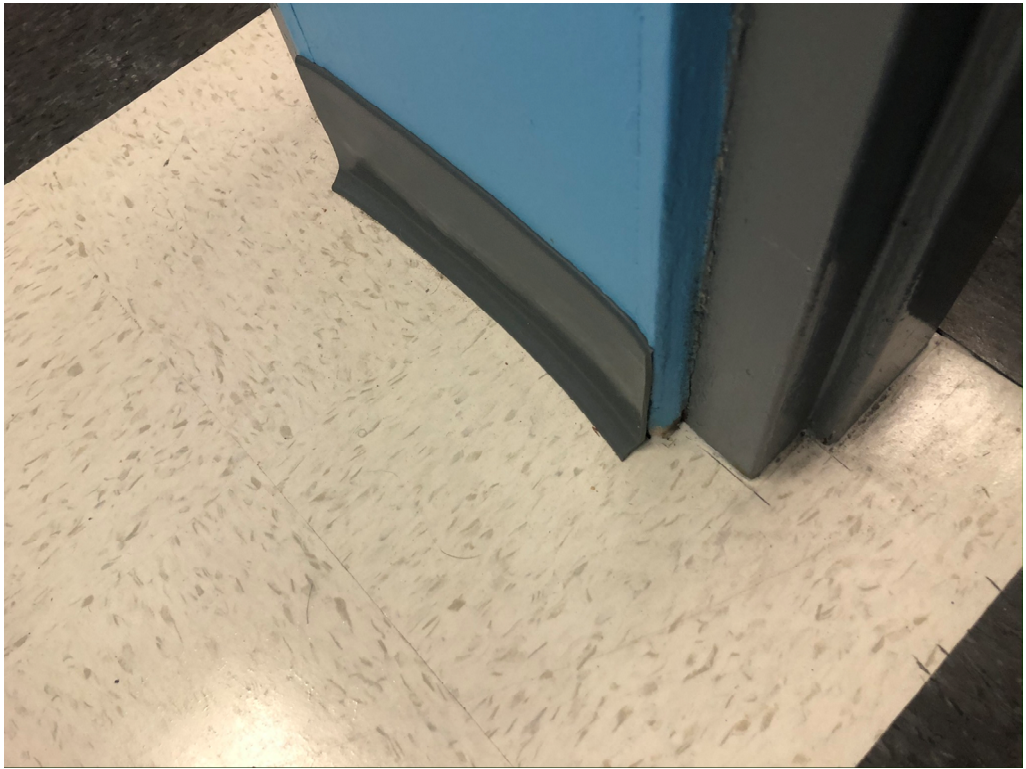
Figure 15 – Base Not Wrapped Around Corner

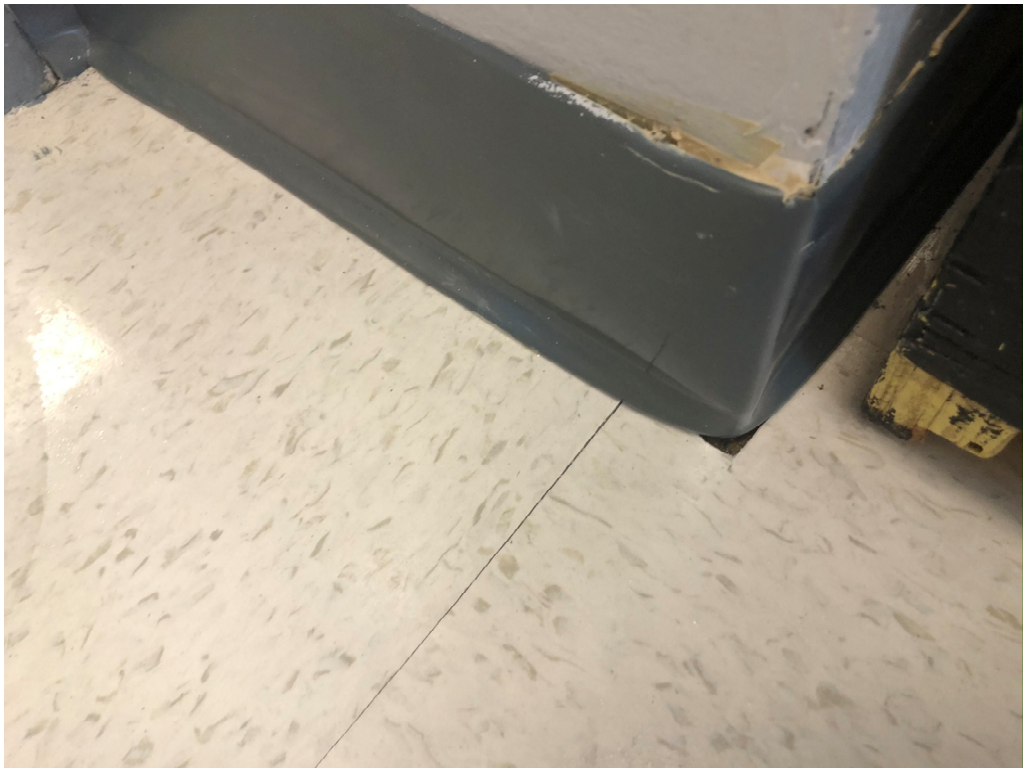
Figure 16 – Poorly Adhered Base and Unmitered/Preformed corners

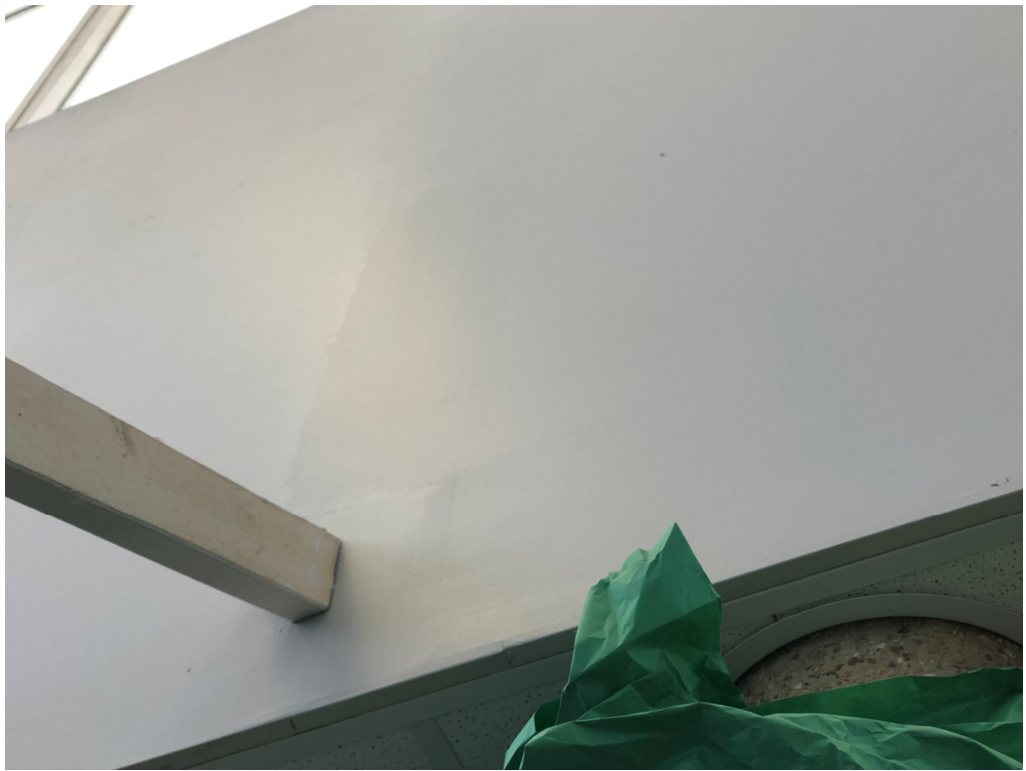
Figure 17 – Uneven/unmatching paint

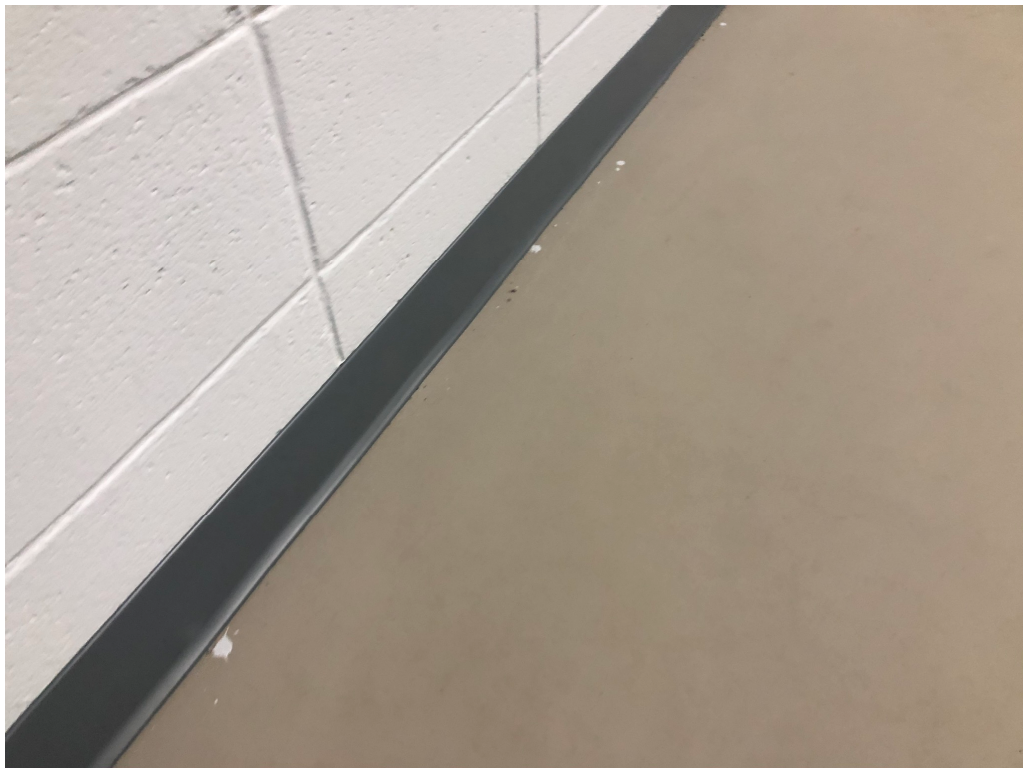
Figure 18 – Drips at Many Wall and Especially in Gym

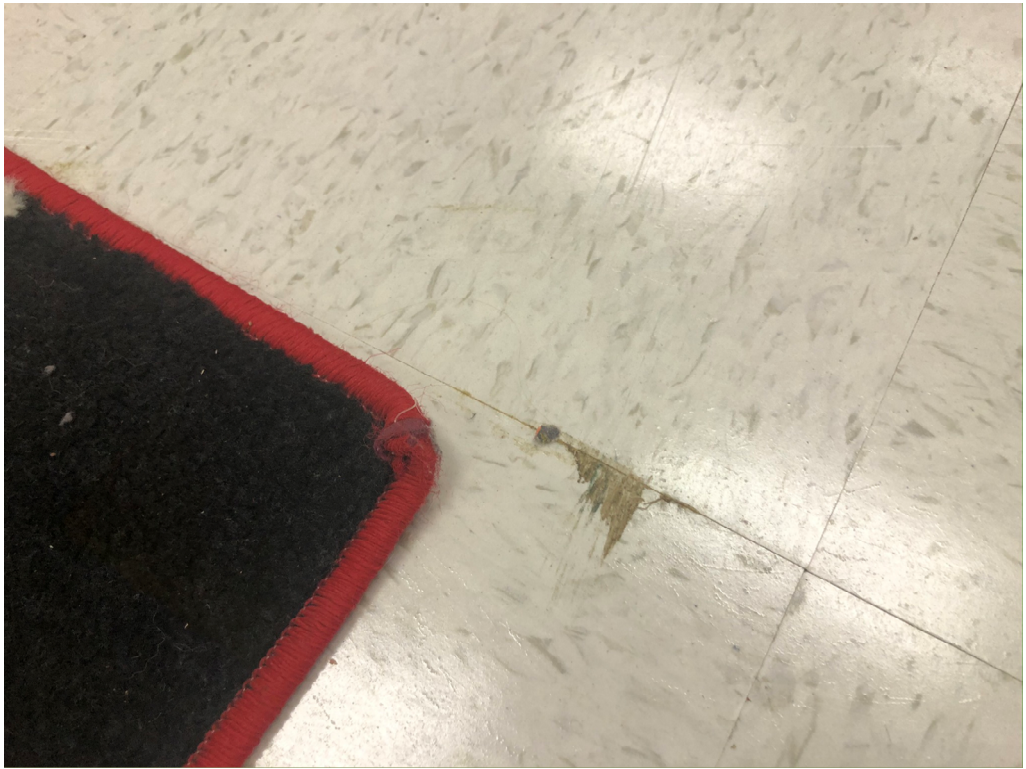
Figure 19 Glue at Floor Tiles

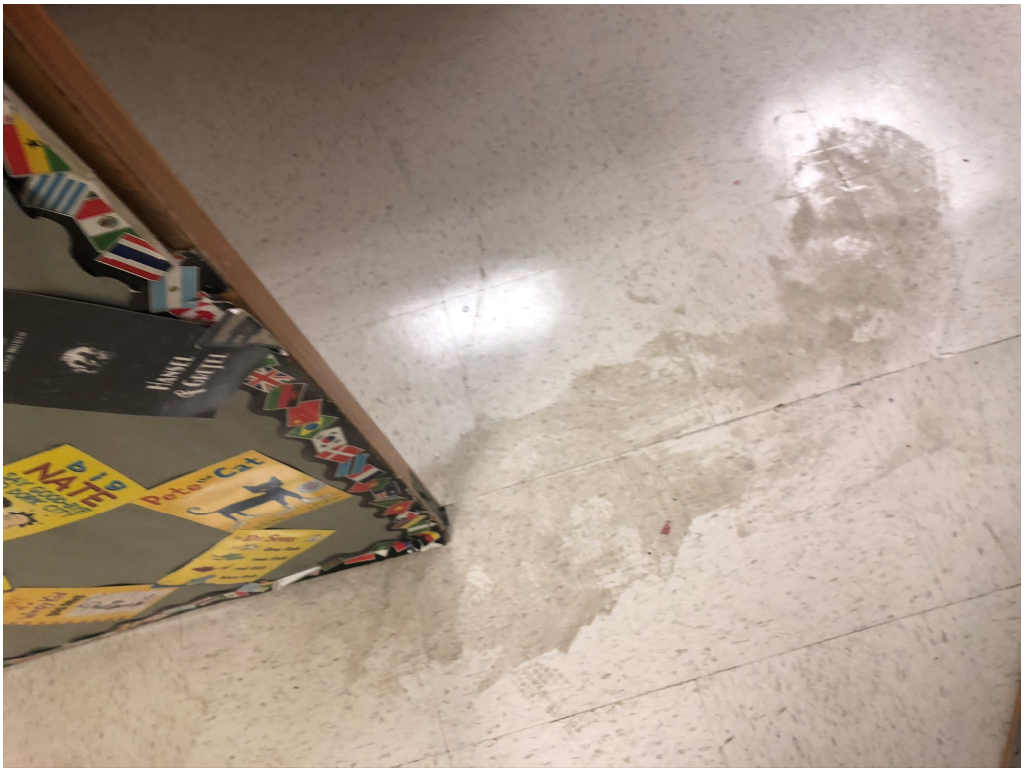
Figure 20 – Dirt Collected at Unwaxed/reworked Tiles

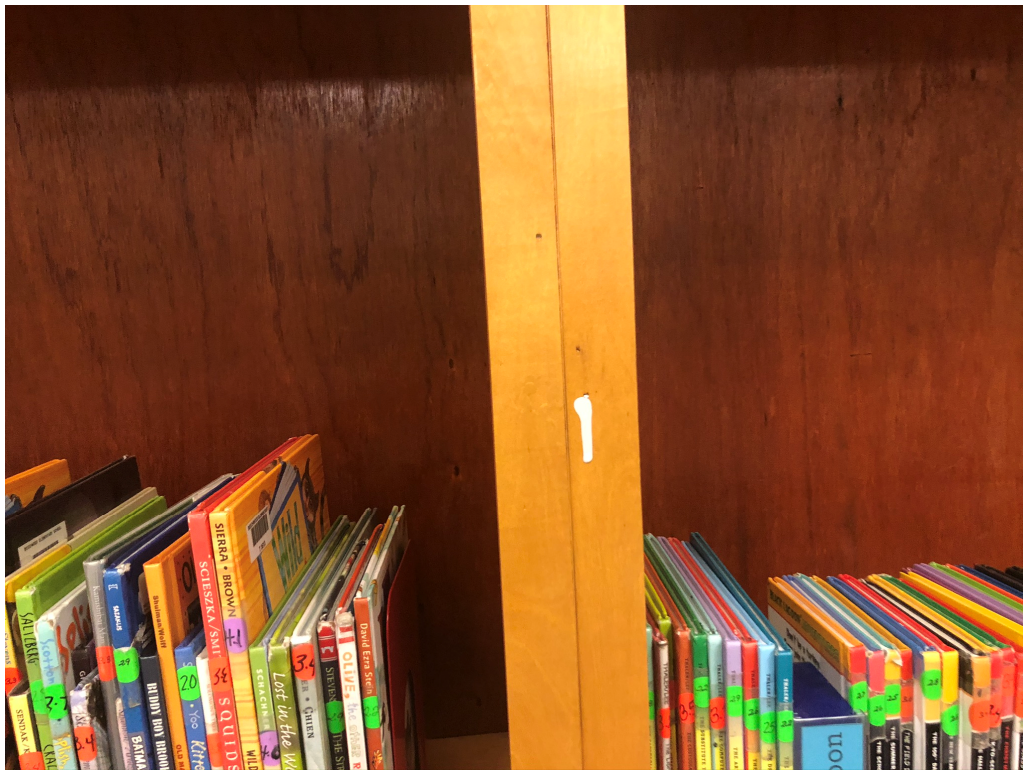
Figure 21 – Drips at Surfaces and Especially in Library including Books

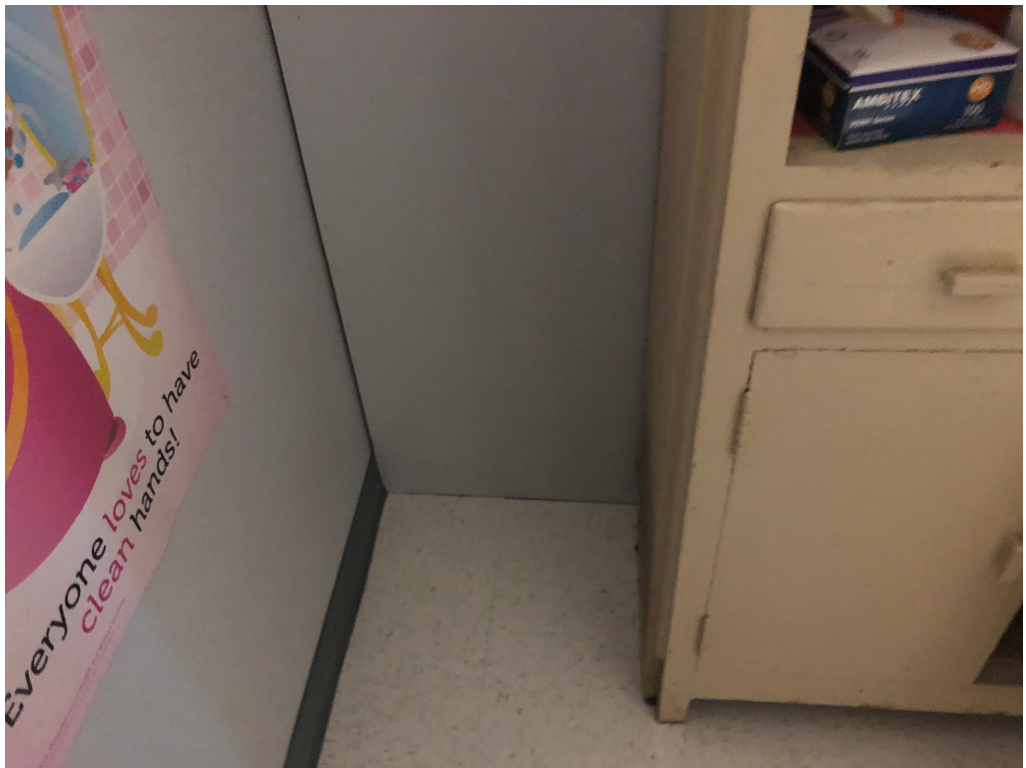
Figure 22 – Missing Base

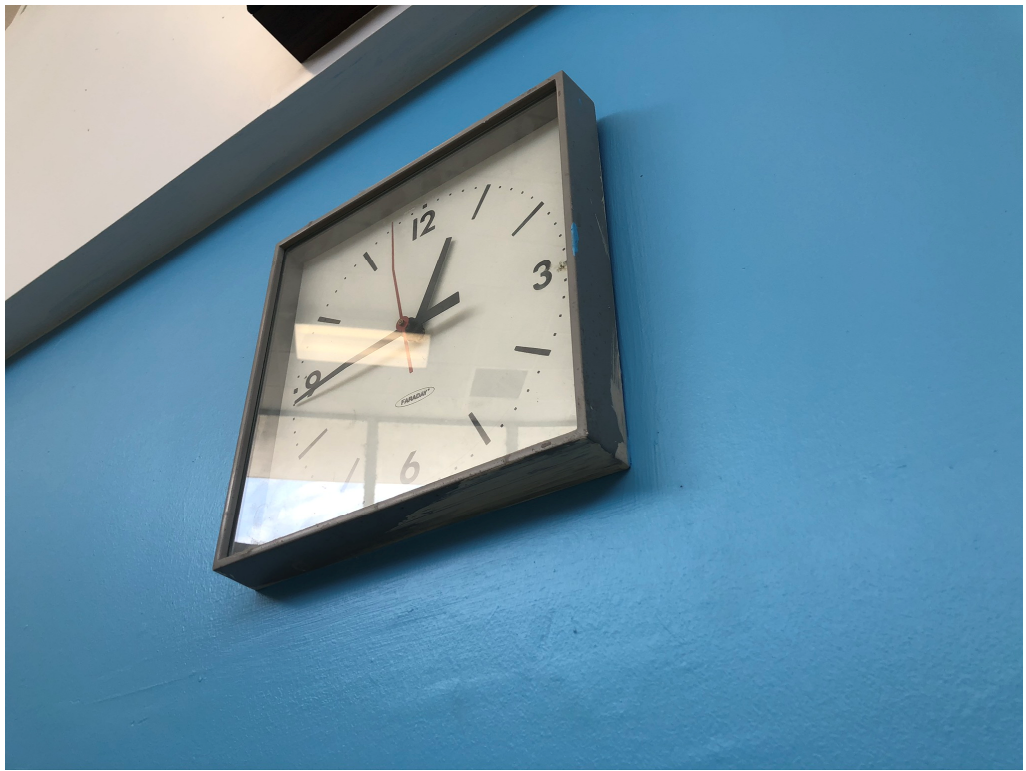
Figure 23 – Paint at School Owned Items

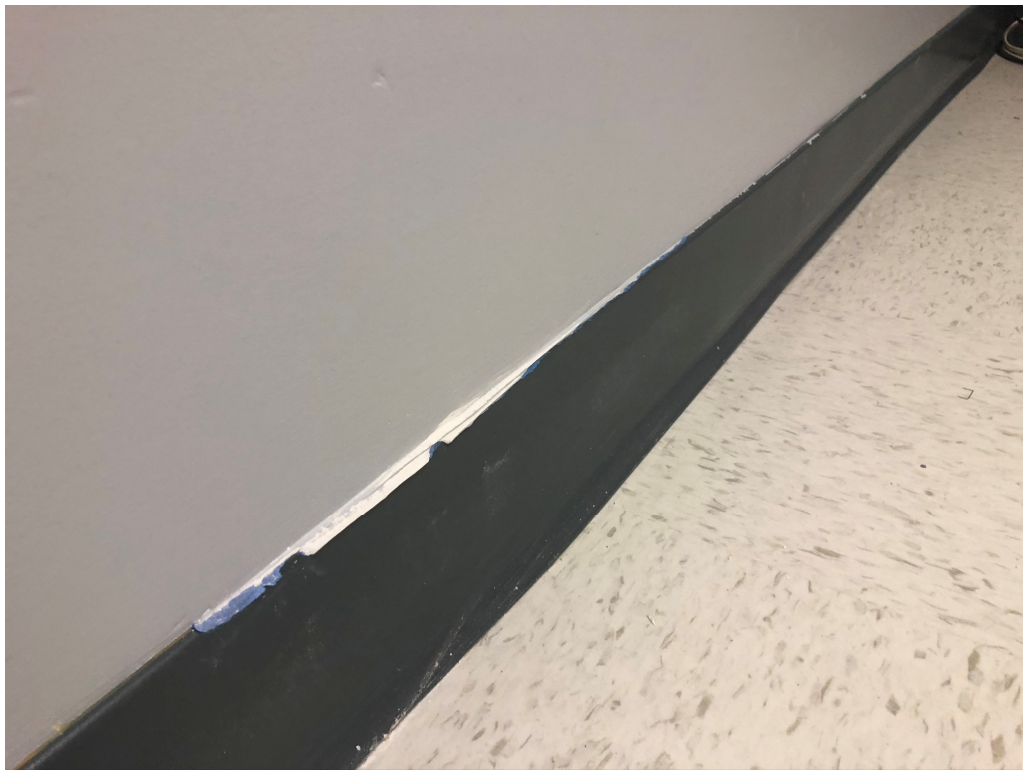
Figure 24 – Base with Tape Still Adhered
