Architect's Field Report

19 February 2020

18044-Bovina Elementary / Report Number 001

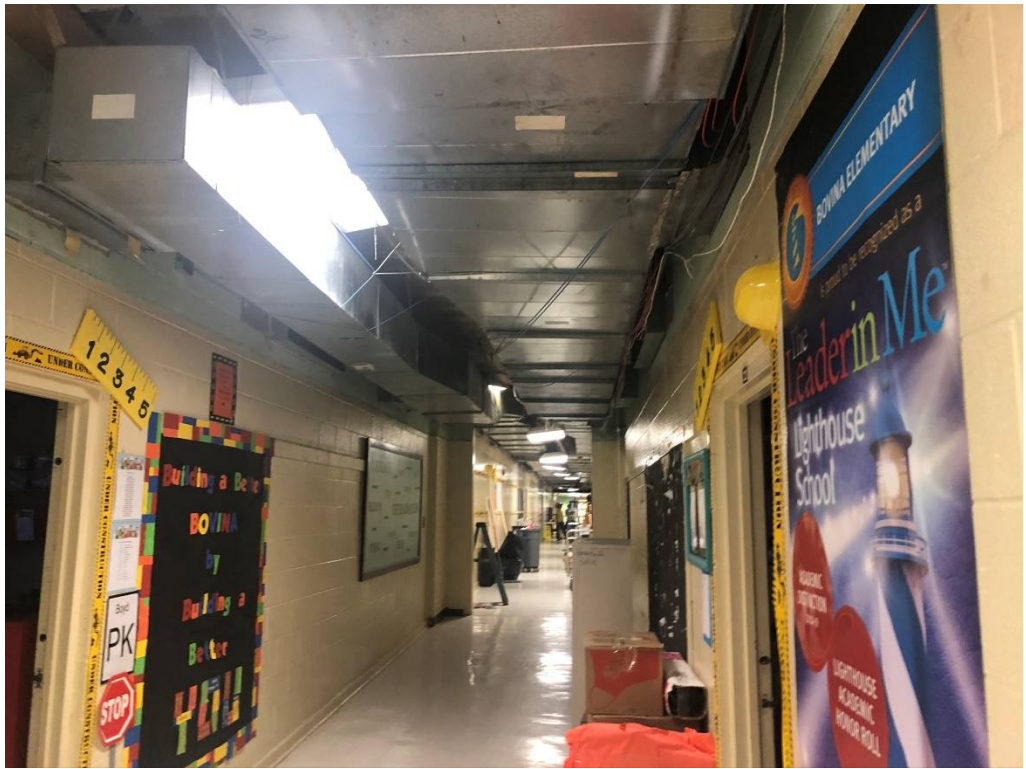
Ceiling installation was ongoing in the South Corridor. Demo has been performed in all of the ceiling in the South Corridor and adjoining classrooms.

Figure 1 – South West Corridor Ceiling Demoed

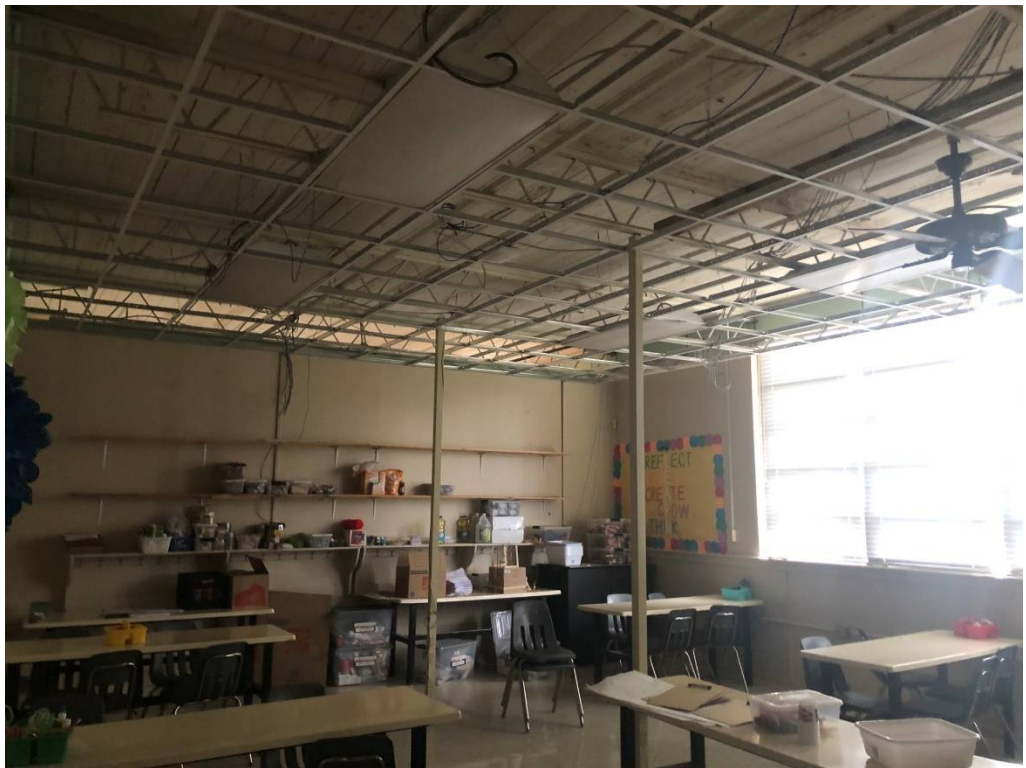
Figure 2 – Class 1 Demo

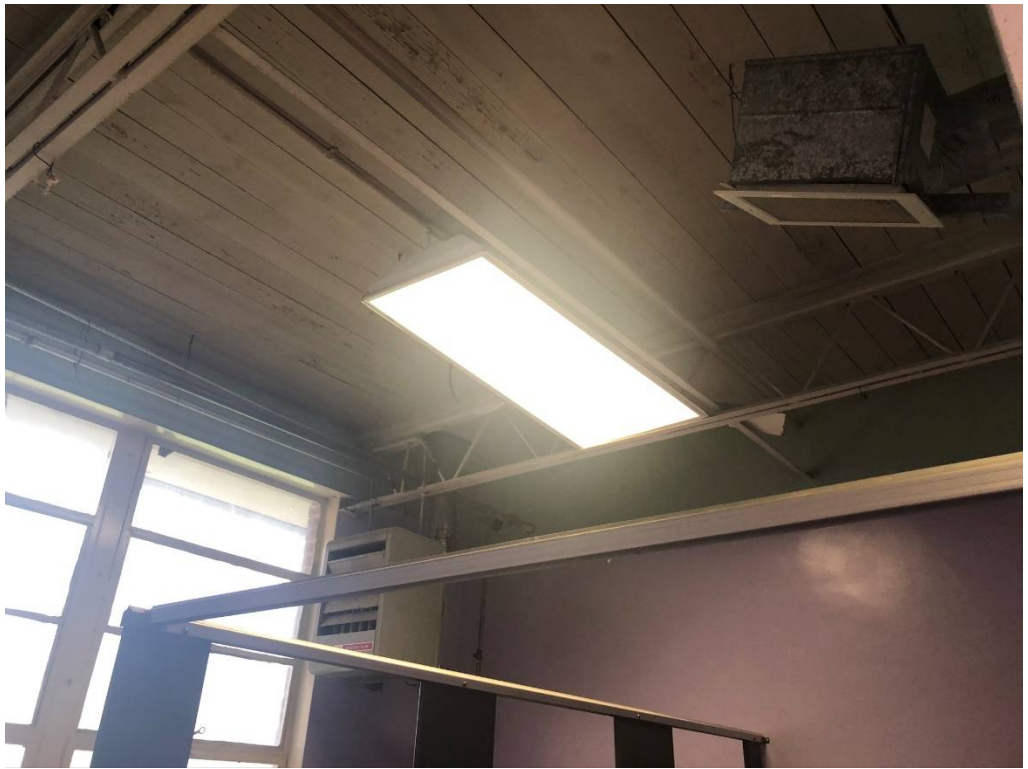
Figure 3 – T9 Demo

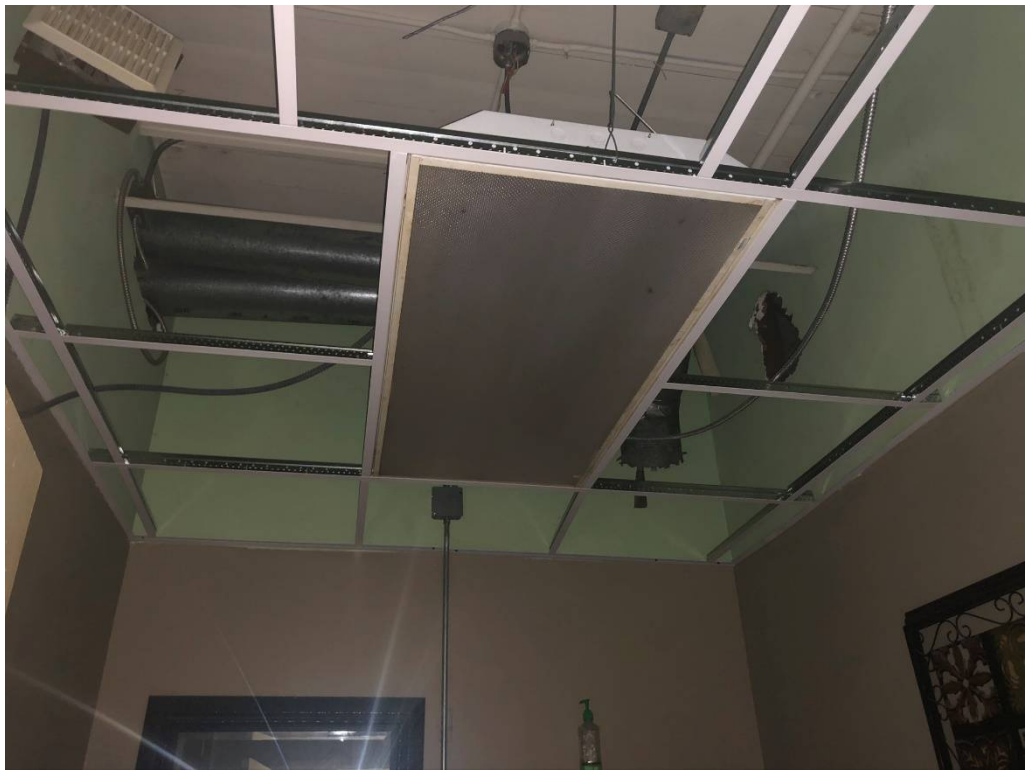
Figure 4 – T7 Demo

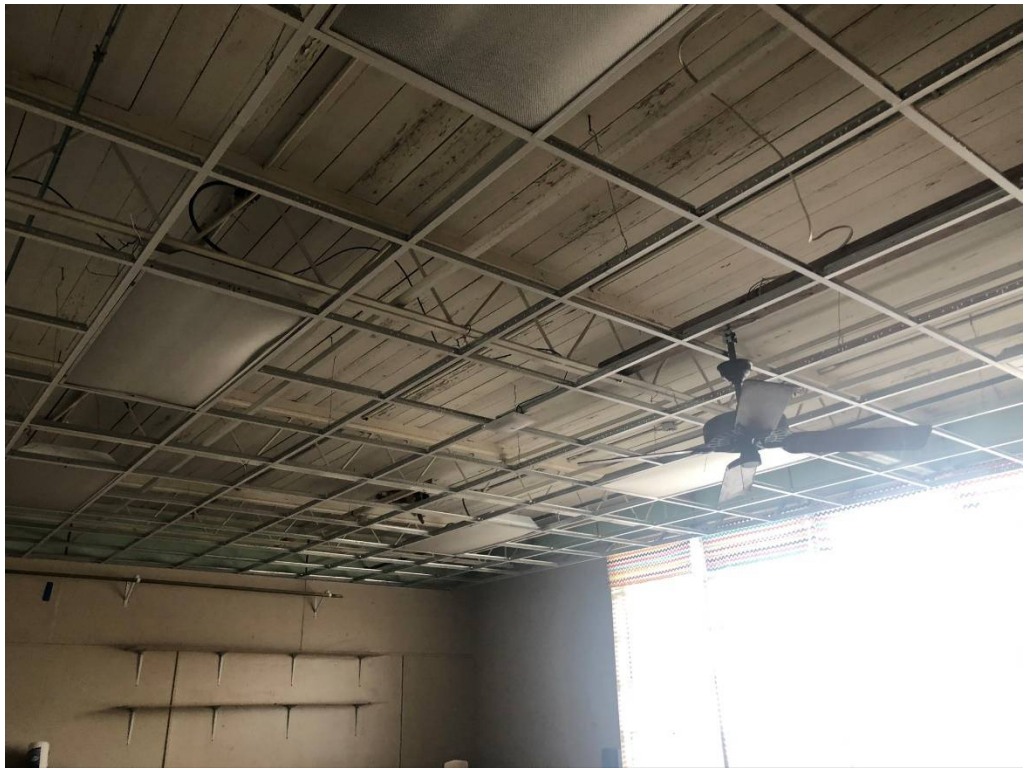
Figure 5 – Class 6 Demo

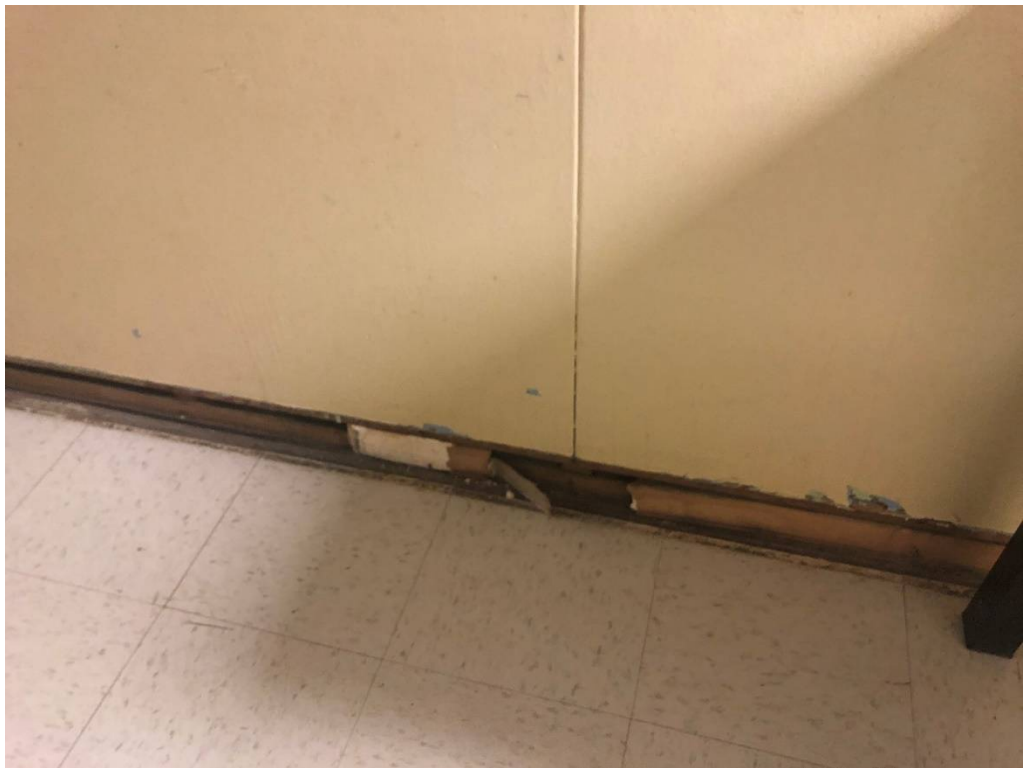
On the Northwest corner of the site, I met Richard Creel who was setting up temporary lights for outside work. He mentioned that the weather was prohibiting him from beginning footing work for the addition in this location. He also mentioned that after removing base board in the south hallway, it was discovered that additional substrate was needed for installing rubber base.

Figure 6 – Lower Section of Drywall Requires Smooth/Solid Backing for Rubber Base Install

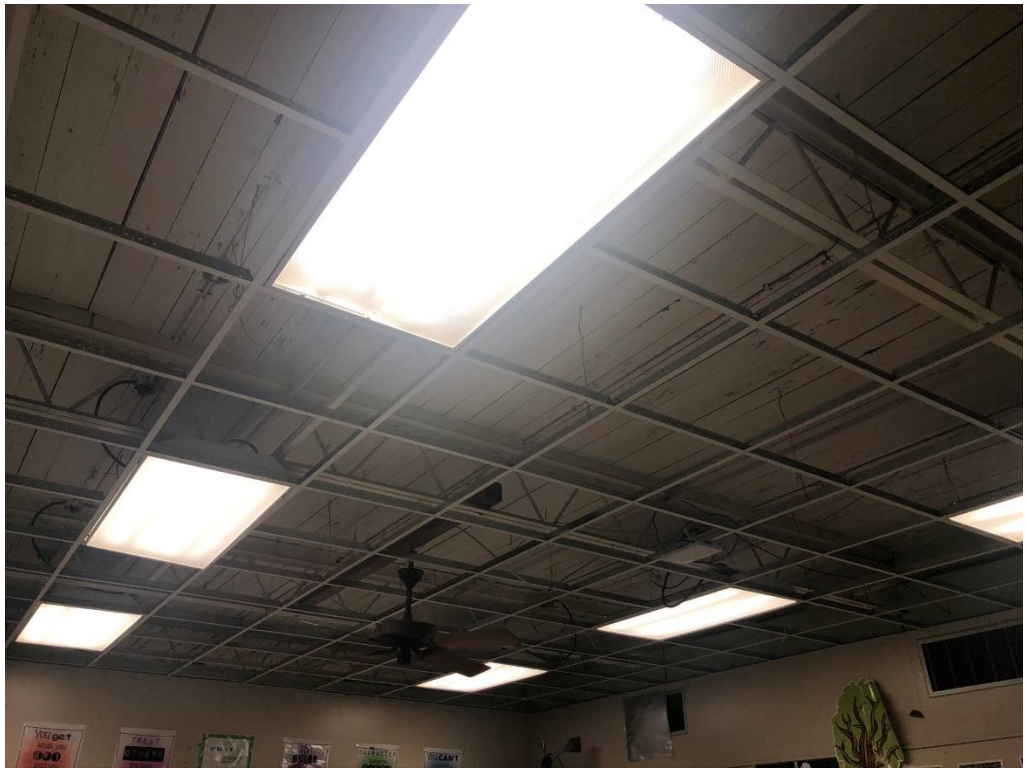
Figure 7 – Class 7 Demo

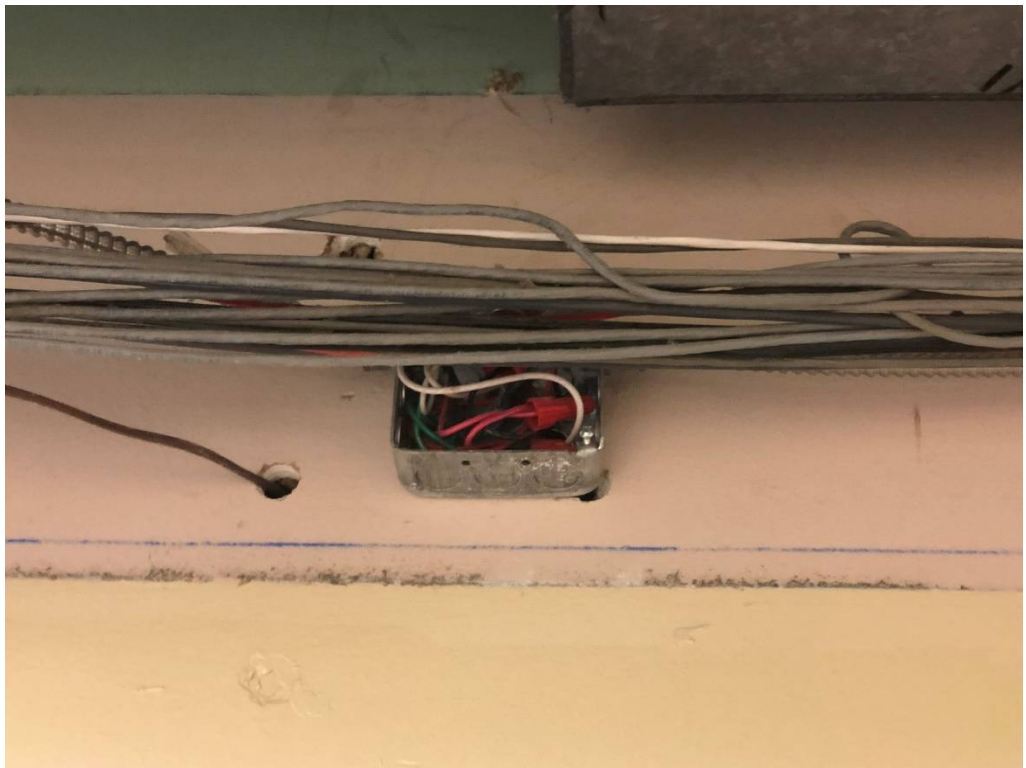
Figure 8 – Electrical Box Requires Plate Before Closing In Ceiling

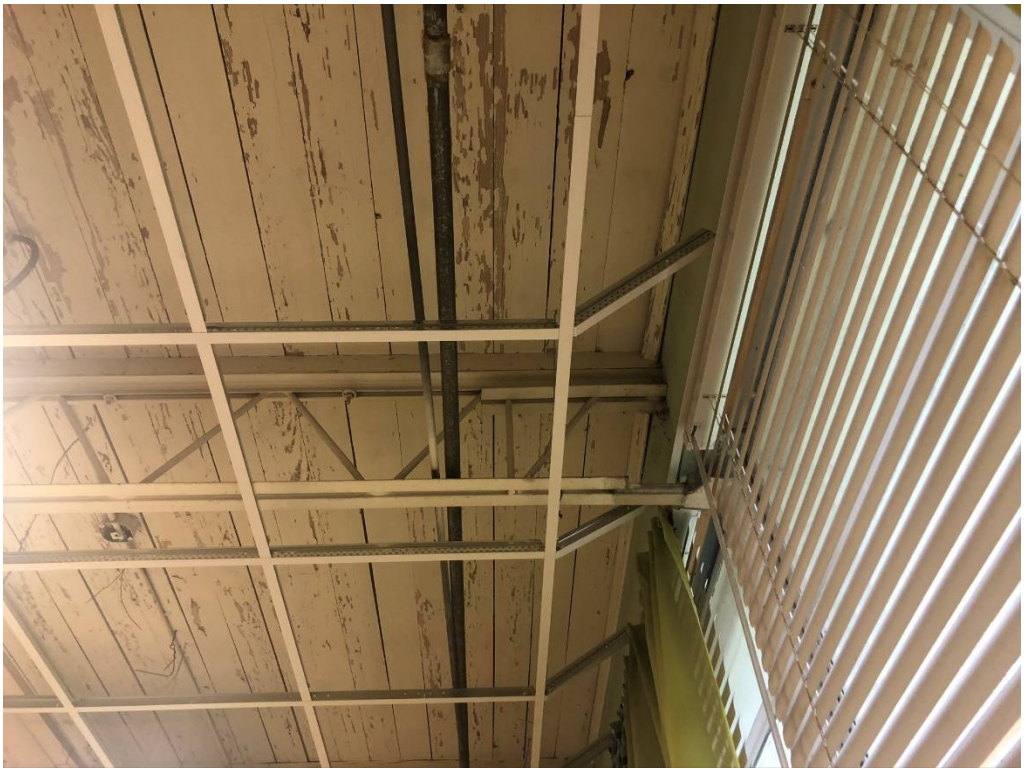
Figure 9 – Class 2 Demo

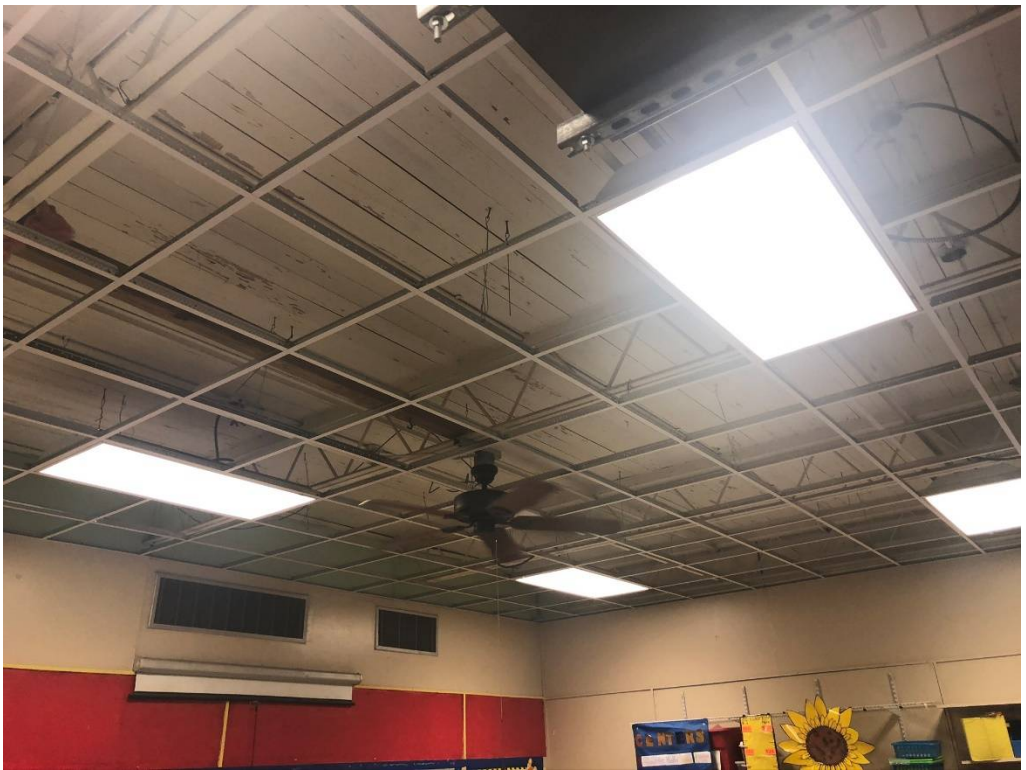
Figure 10 – Class 8 Demo

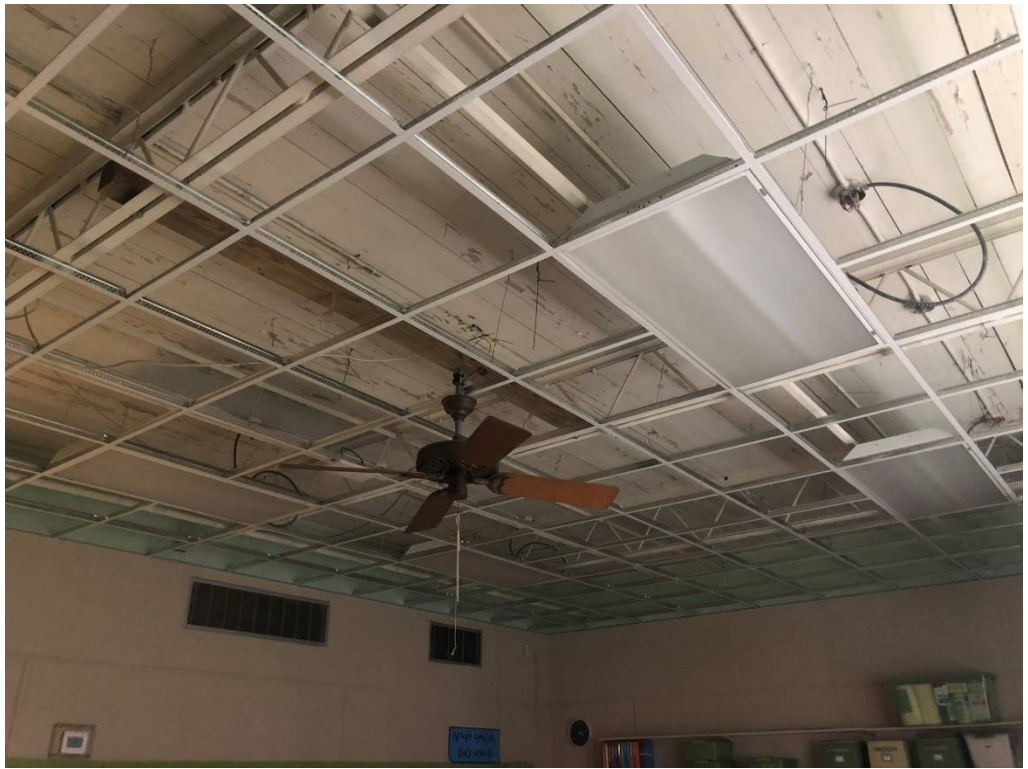
Figure 11 – Class 3 Demo

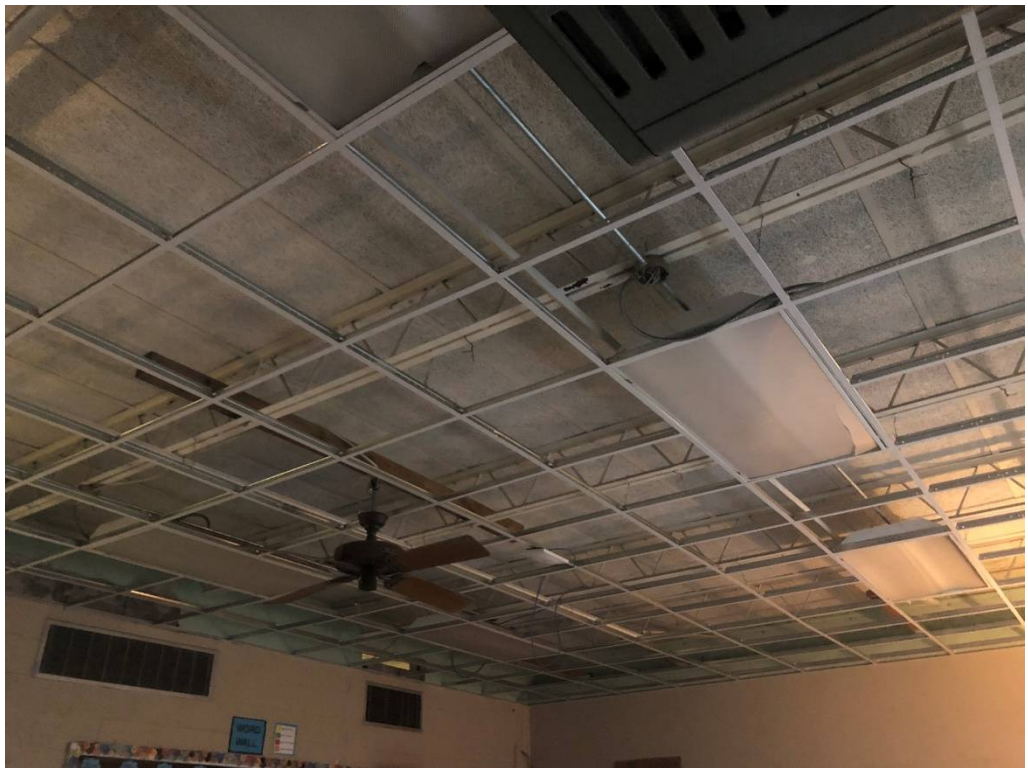
Figure 12 – Class 9 Demo

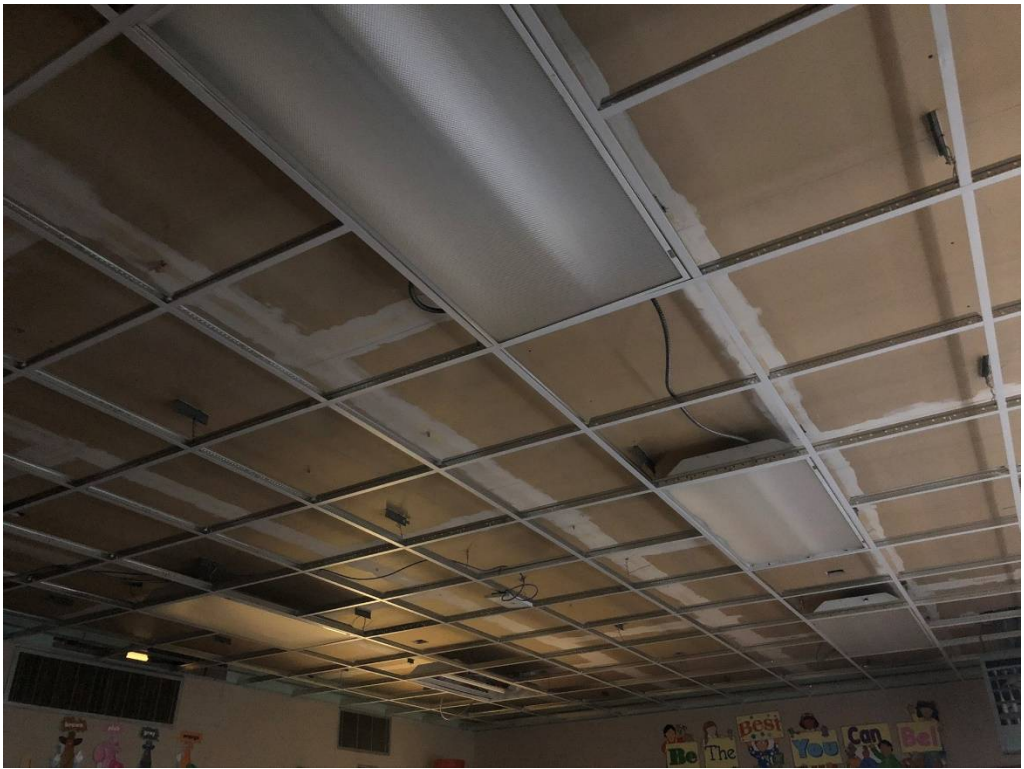
Figure 13 – Class 5 Demo

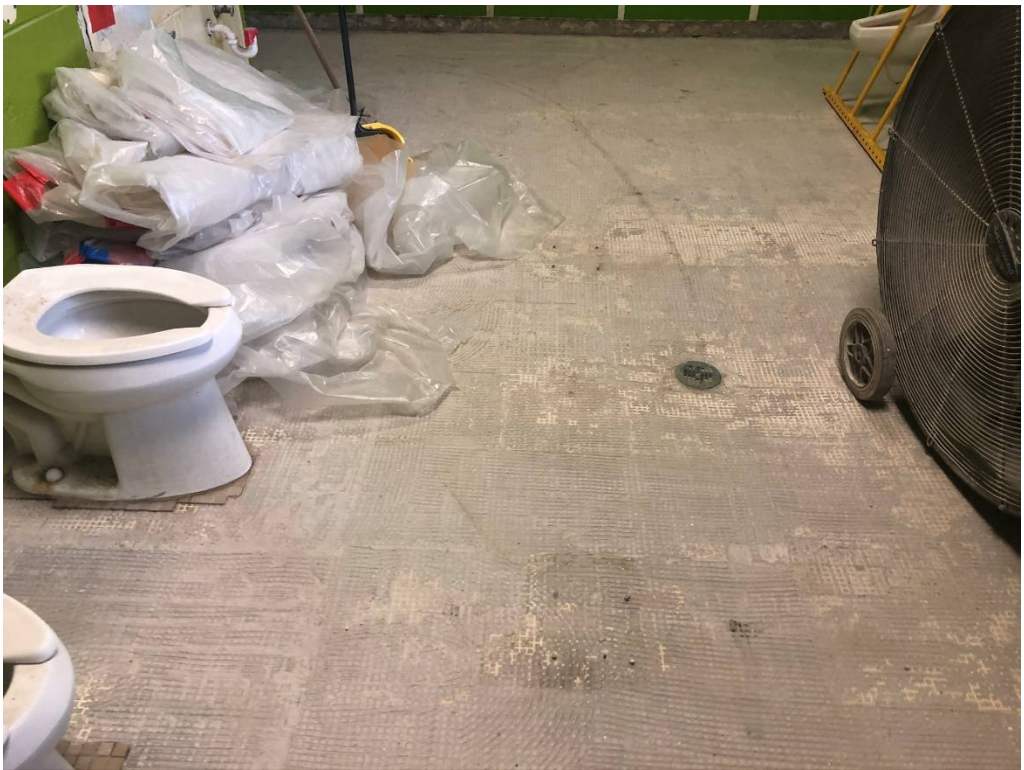
Figure 14 – T1 Demo

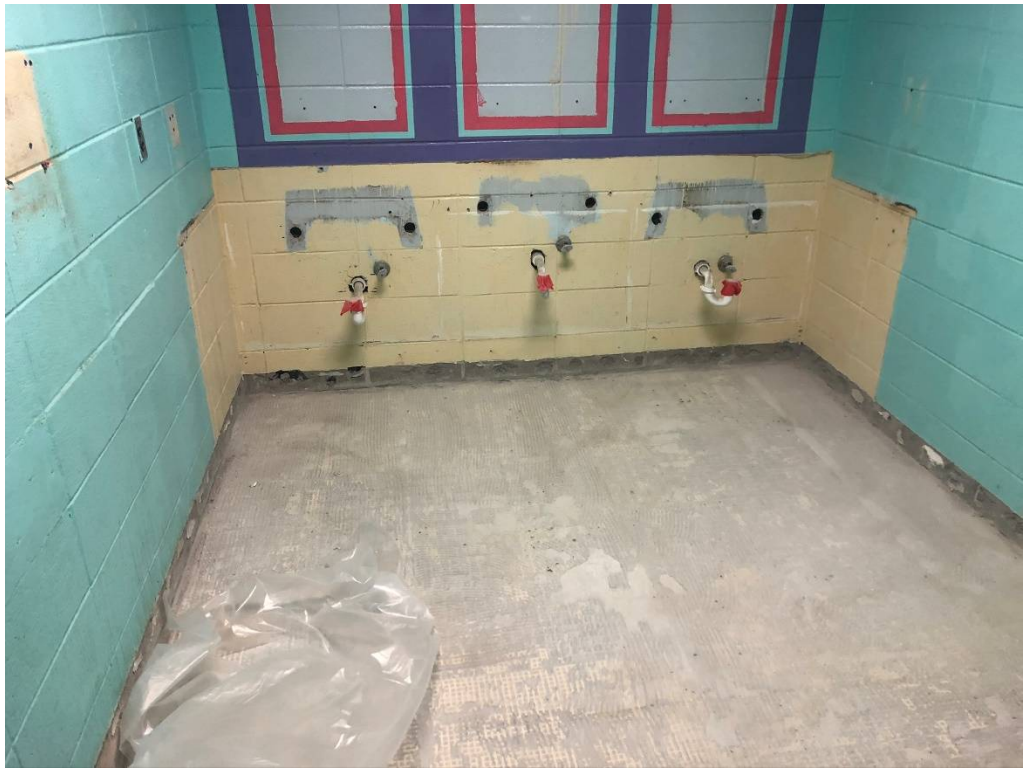
Figure 15 – T2 Demo

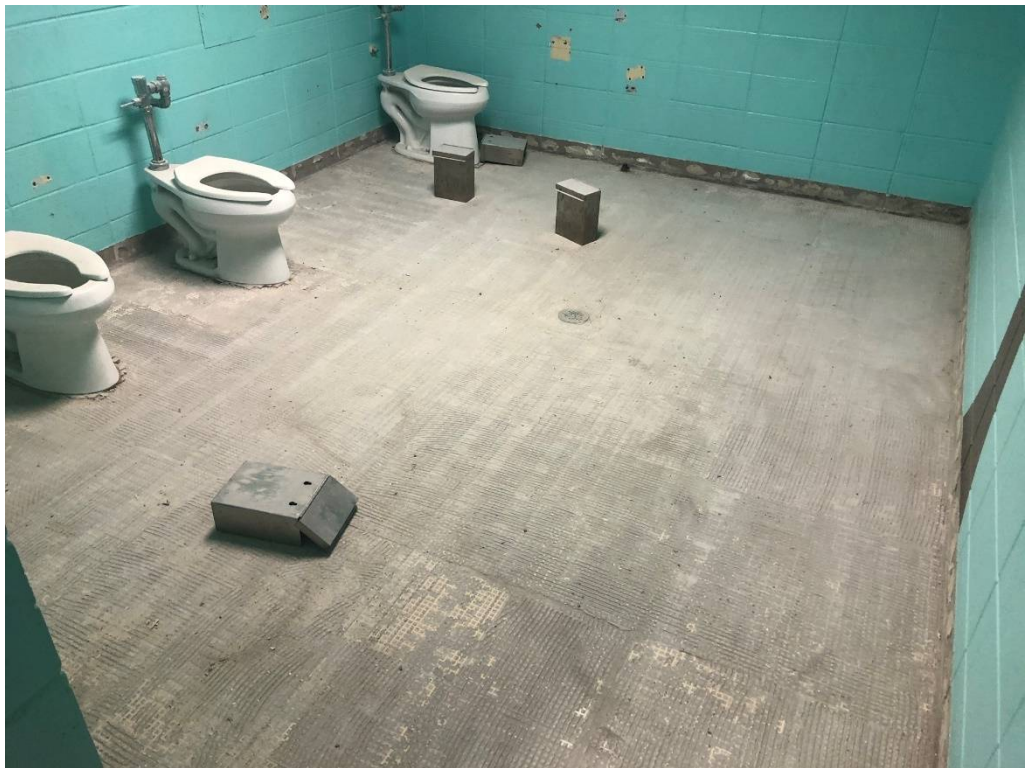
Figure 16 – T2 Demo

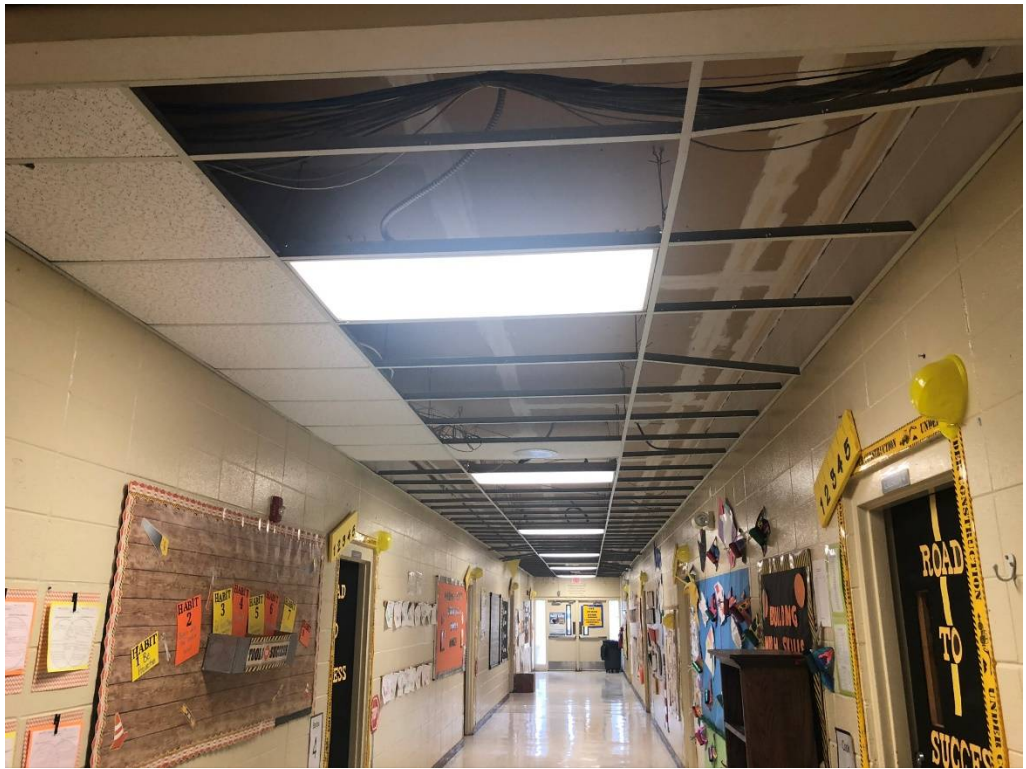
Figure 17 – North Corridor Partial Demo

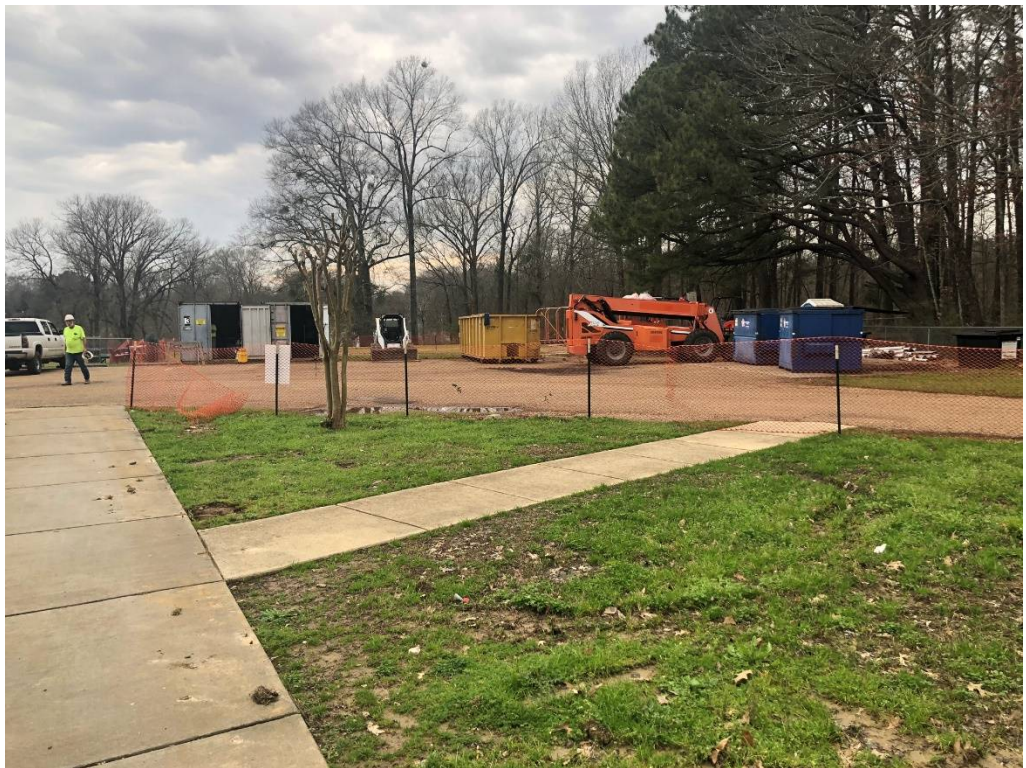
Figure 18 – Construction Trailer & Staging at North West Section of Site
