Architect's Field Report

11 March 2020

18044-Bovina Elementary / Report Number 003

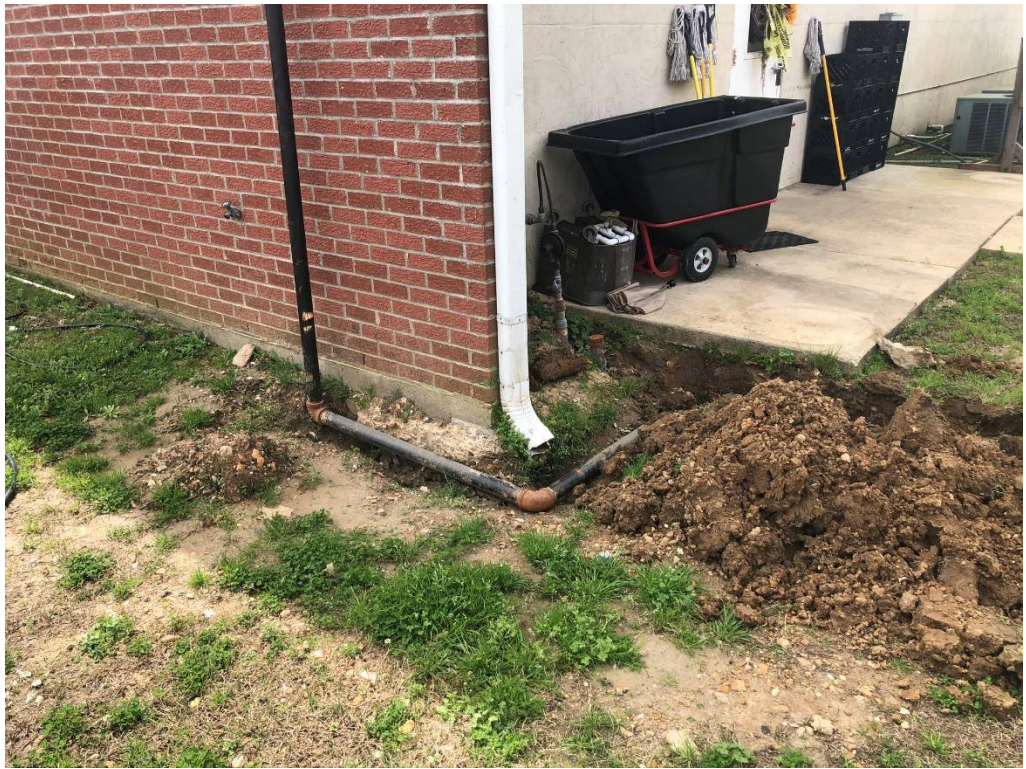
We also discussed that foundation work for addition had not begun and would not begin until gas pipe (which has been located) was moved per scope of work.

Figure 1 – Gas Line Uncovered at NW Corner of South Hall/Cafeteria

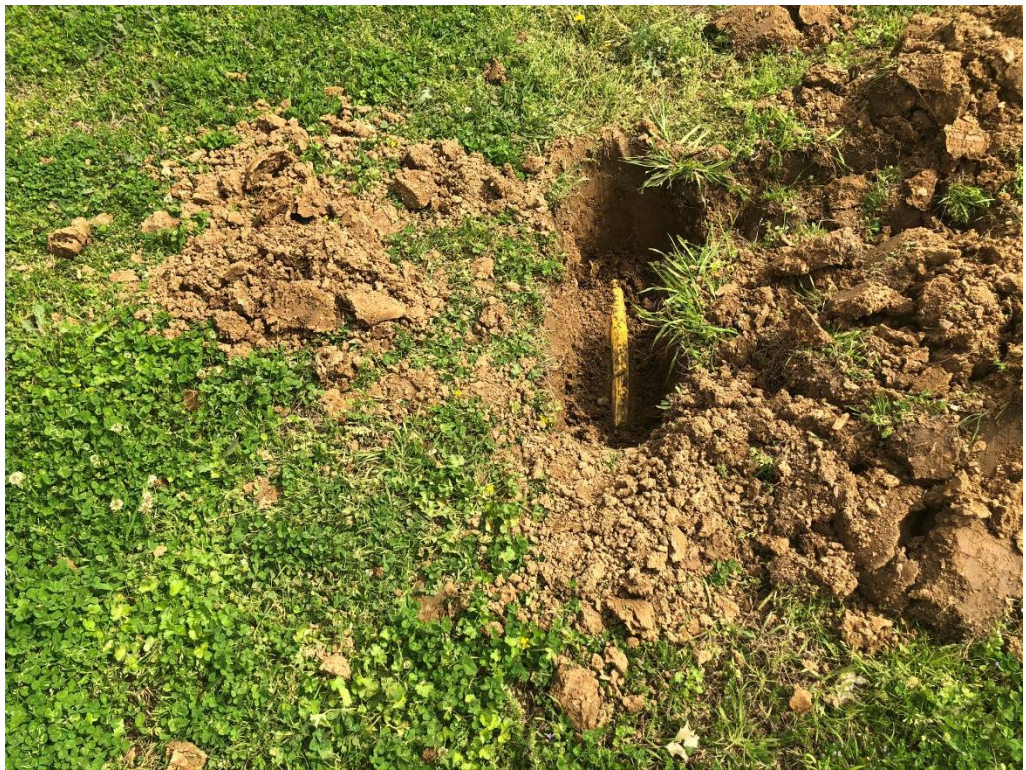
Figure 2 – Gas Pipe Uncovered Between Halls at Exterior

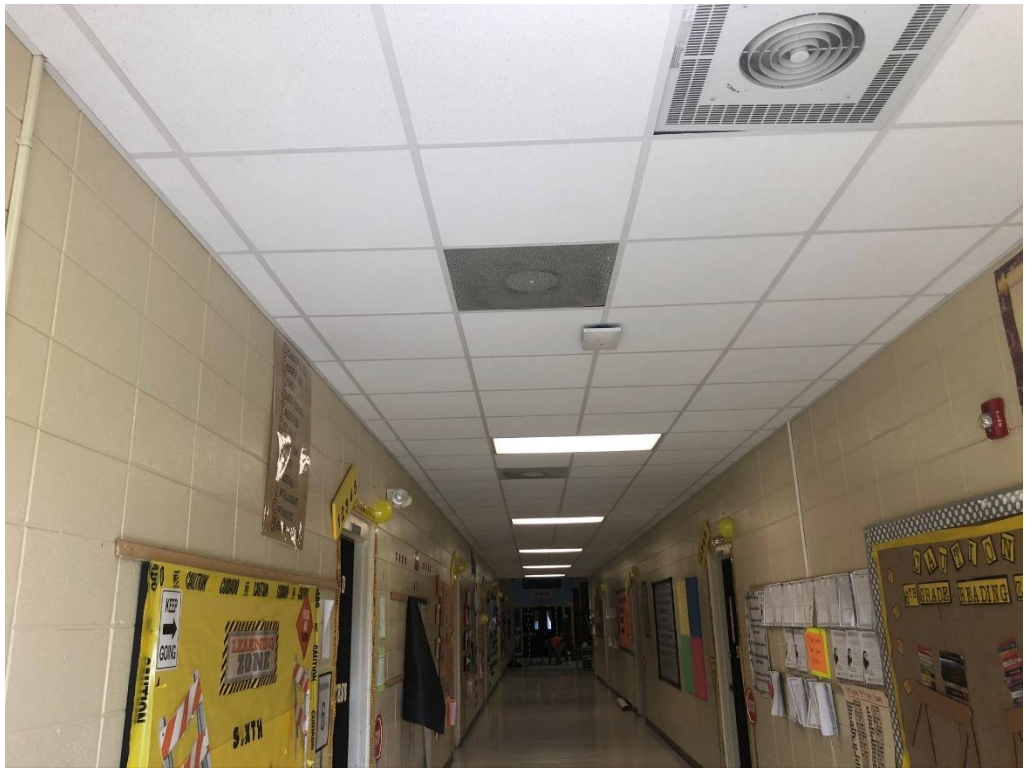
Figure 3 – North Hall Ceiling Grid Complete

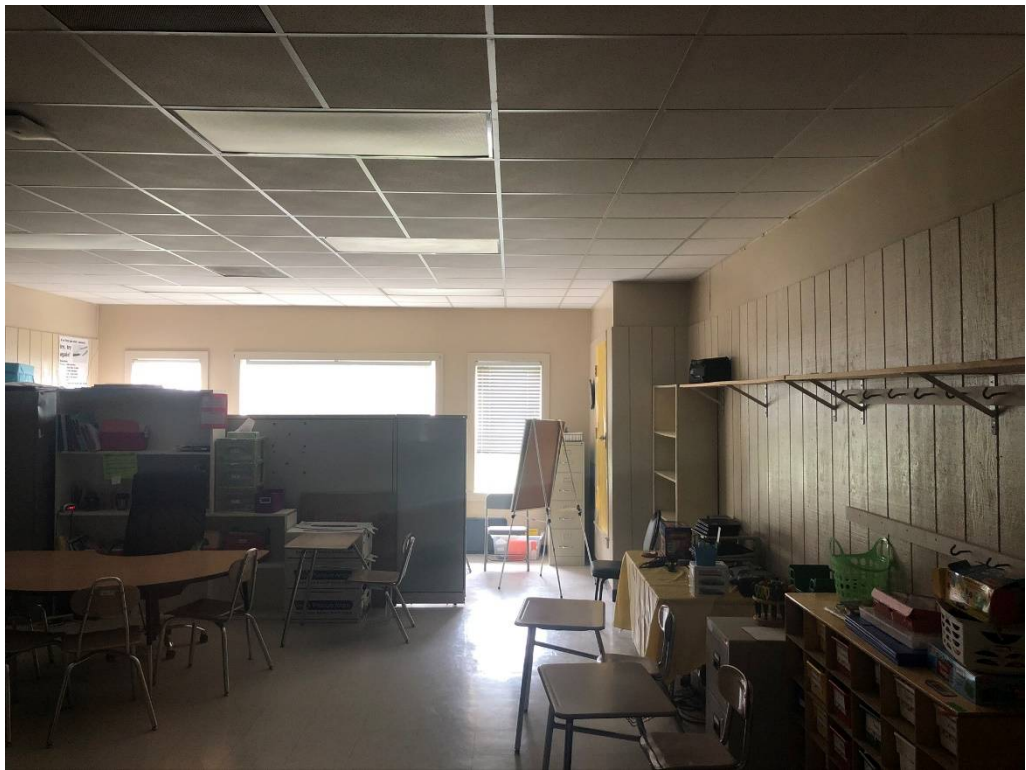
Figure 4 – North Hall Classroom (typical)

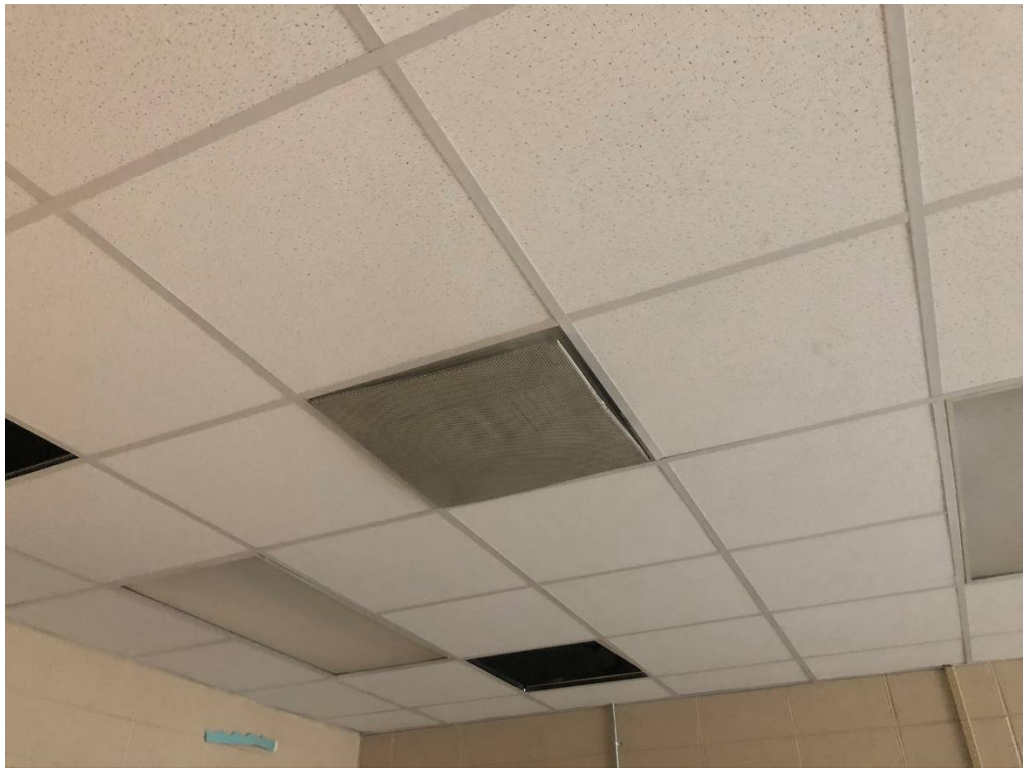
Figure 5 – Hanging Vent Cover (Classroom 7 in North Hall as noted by Sign Above Door)

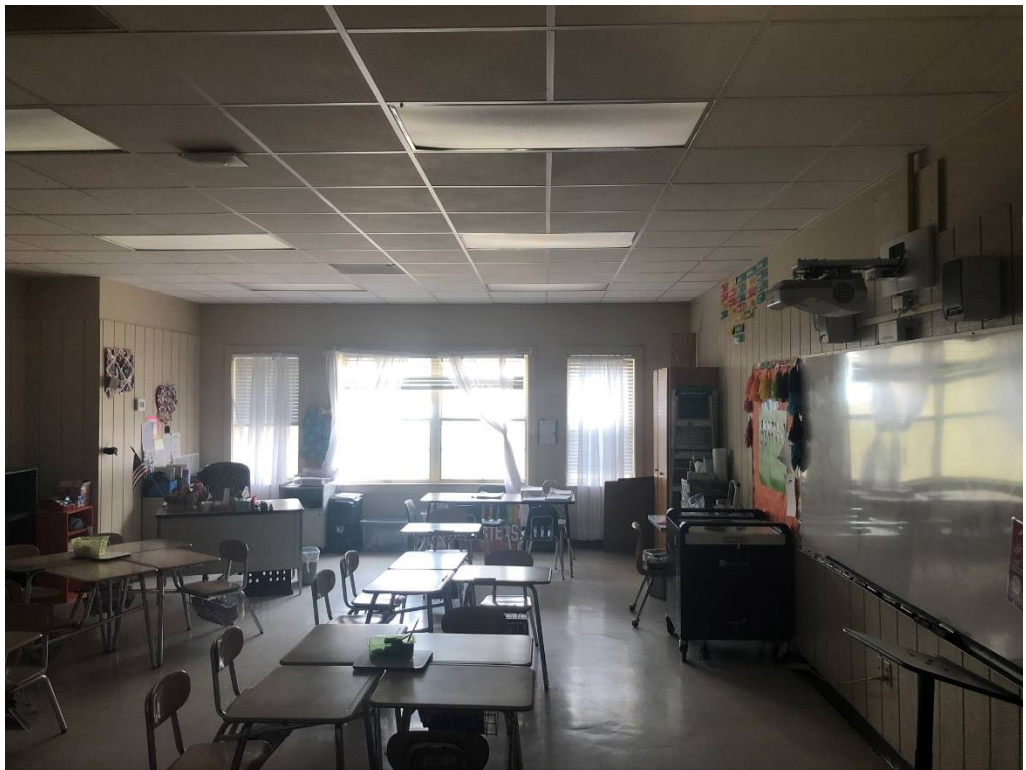
Figure 6 – North Hall Classroom (typical)

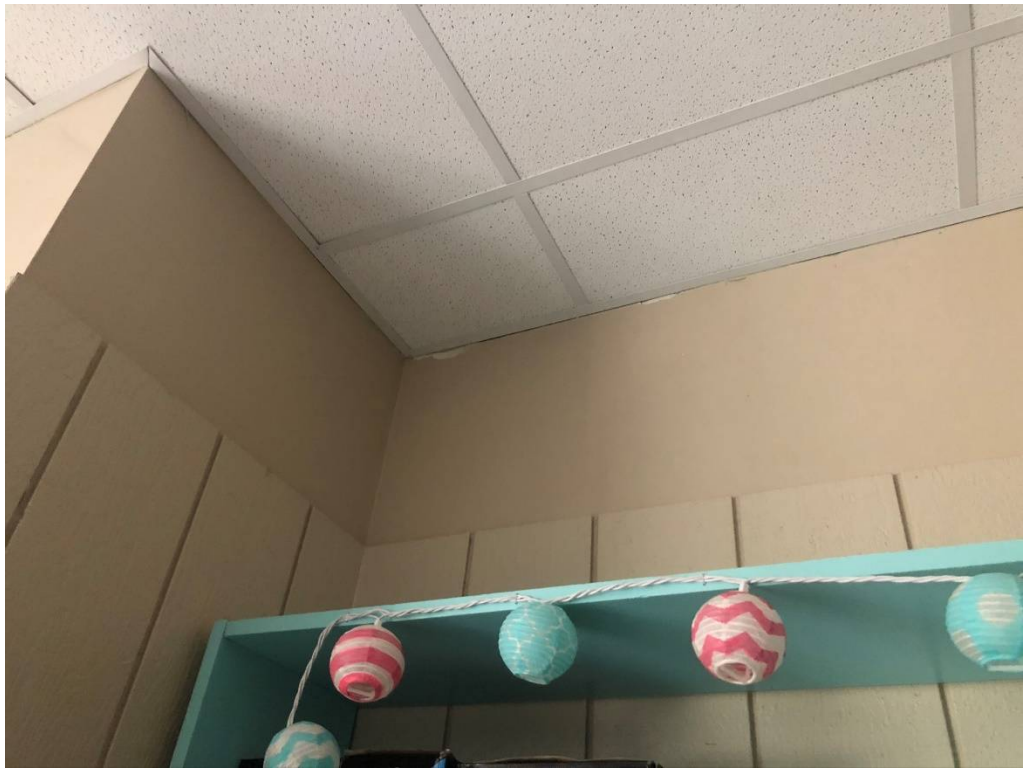
Figure 7 – Some Wall Damage Noted in Classroom 14 on North Hall

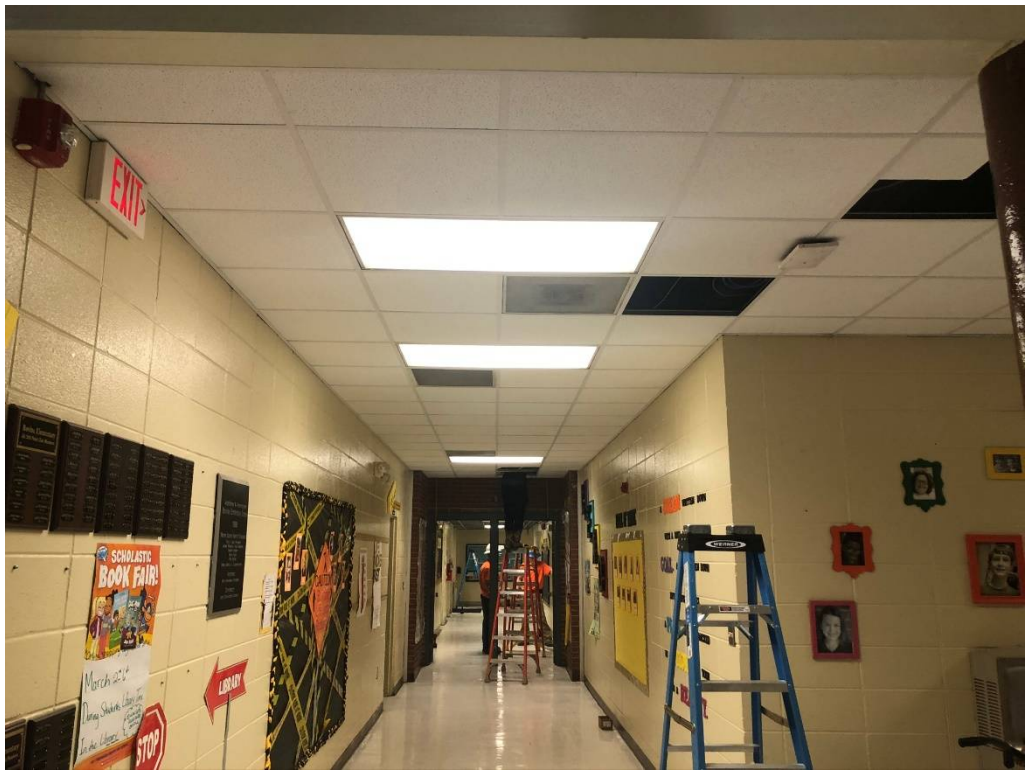
Figure 8 – North Hall Looking South from Classroom 15 Entry

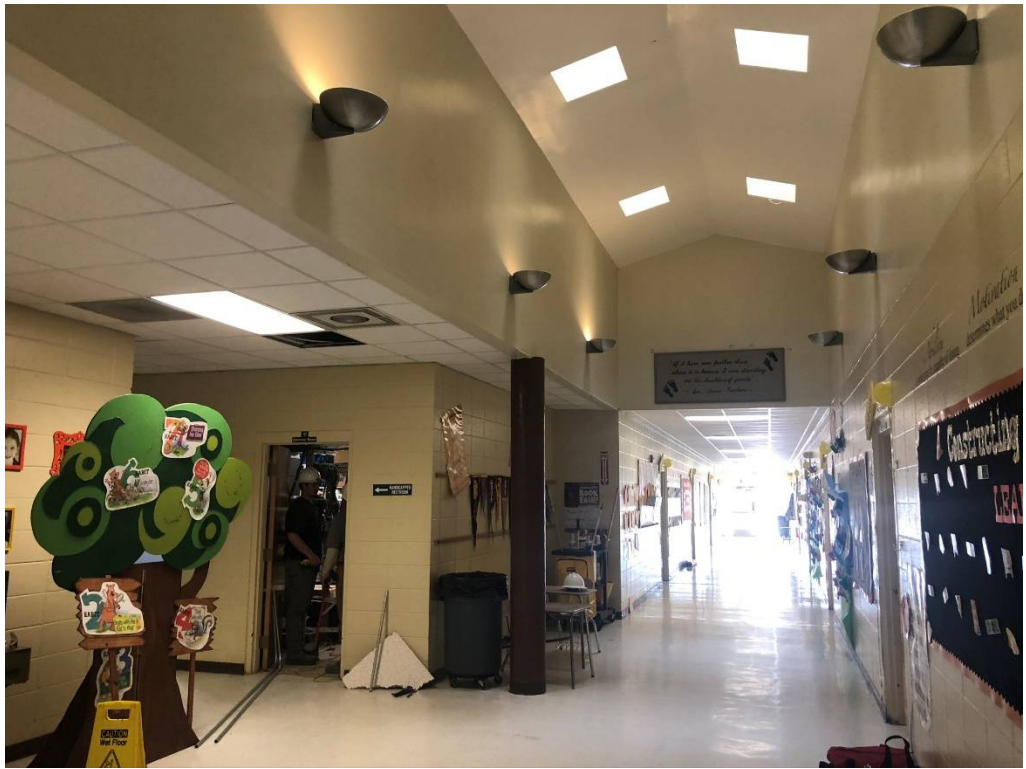
Figure 9 – North Hall Looking West from Classroom 15 Entry

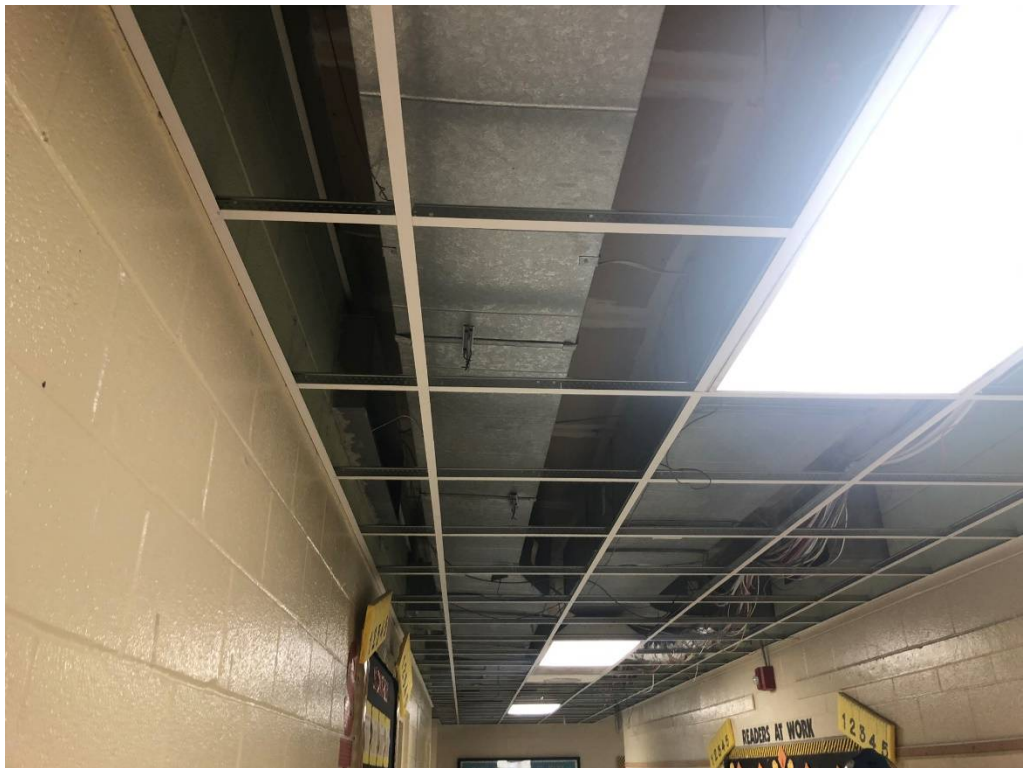
Figure 10 – Connecting Hall @ Double Door Looking South Near Teacher's Workroom

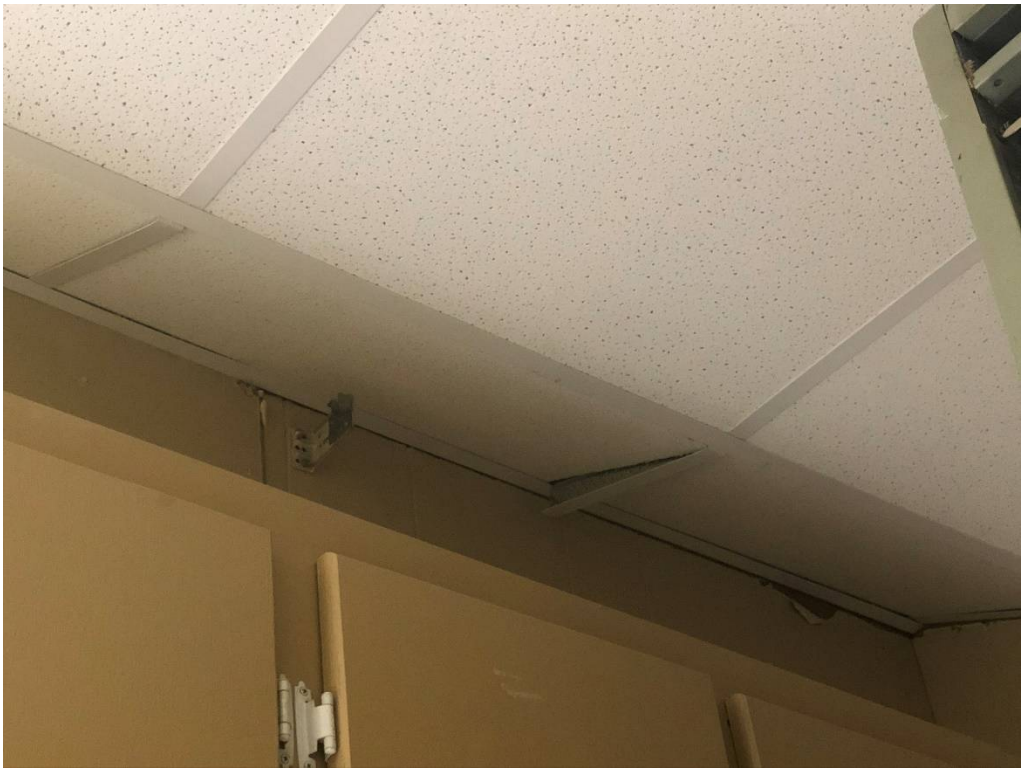
Figure 11 – Incomplete Grid Install @ Nurse Room 26

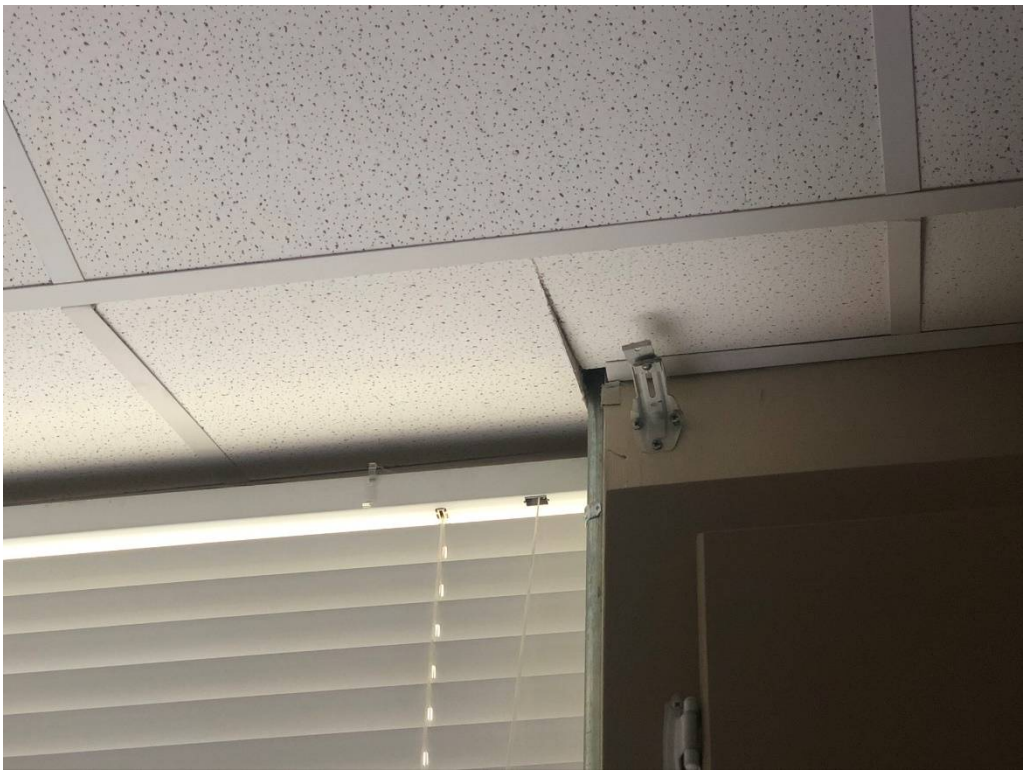
Figure 12 – Unfinished Corner @ Nurse Room 26

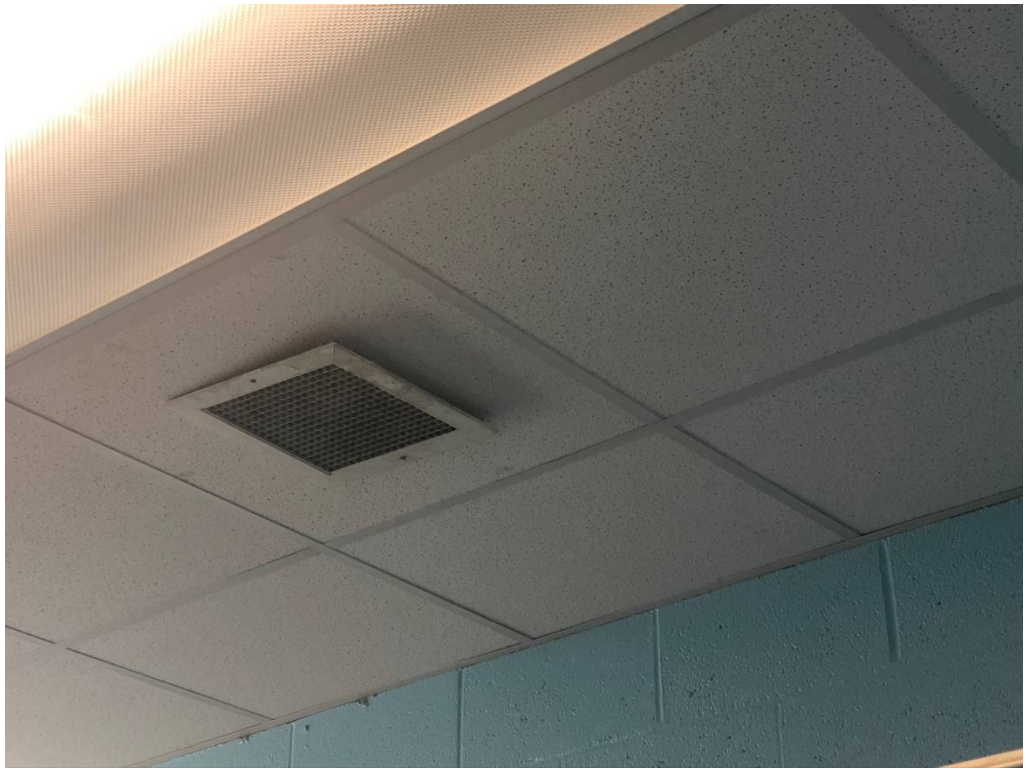
Figure 13 – Hanging Vent at Ceiling in Boys T5

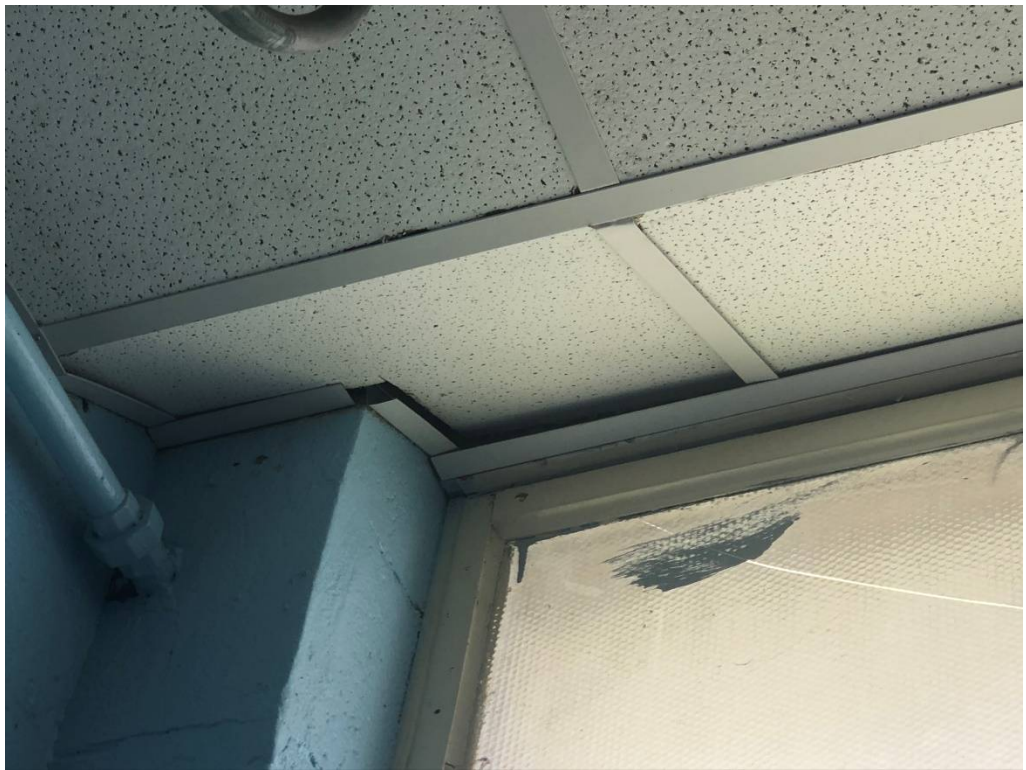
Figure 14 – Unfinished and Offset Corner at Ceiling in Boys T5

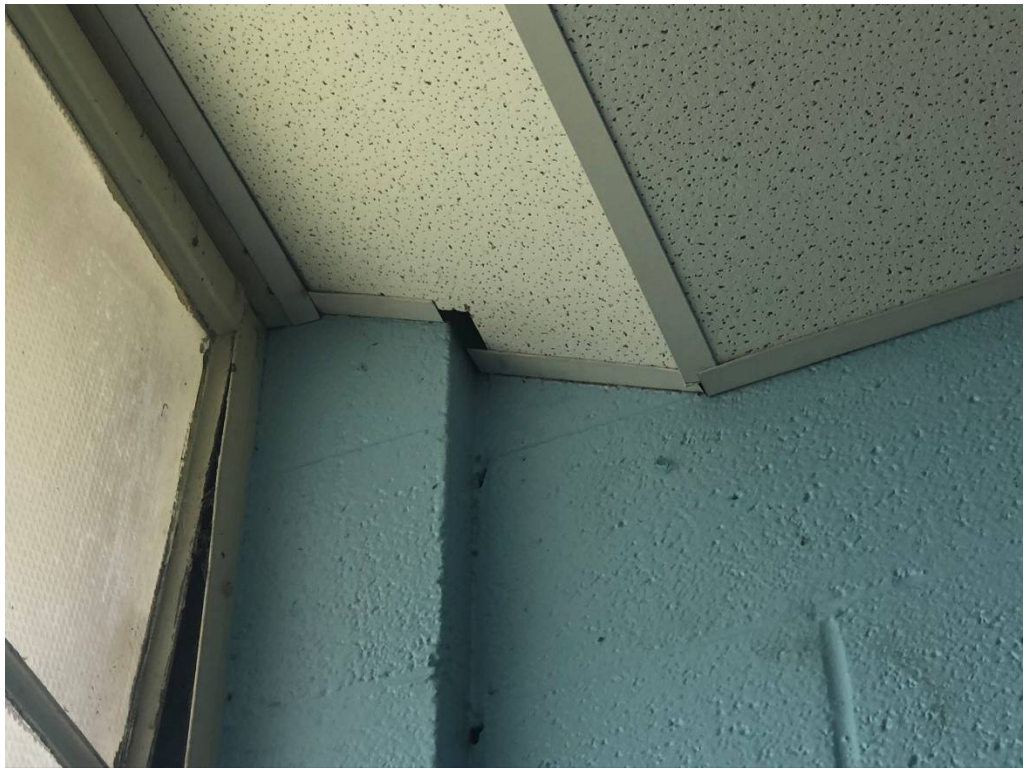
Figure 15 – Unfinished Corner at Ceiling in Boys T5

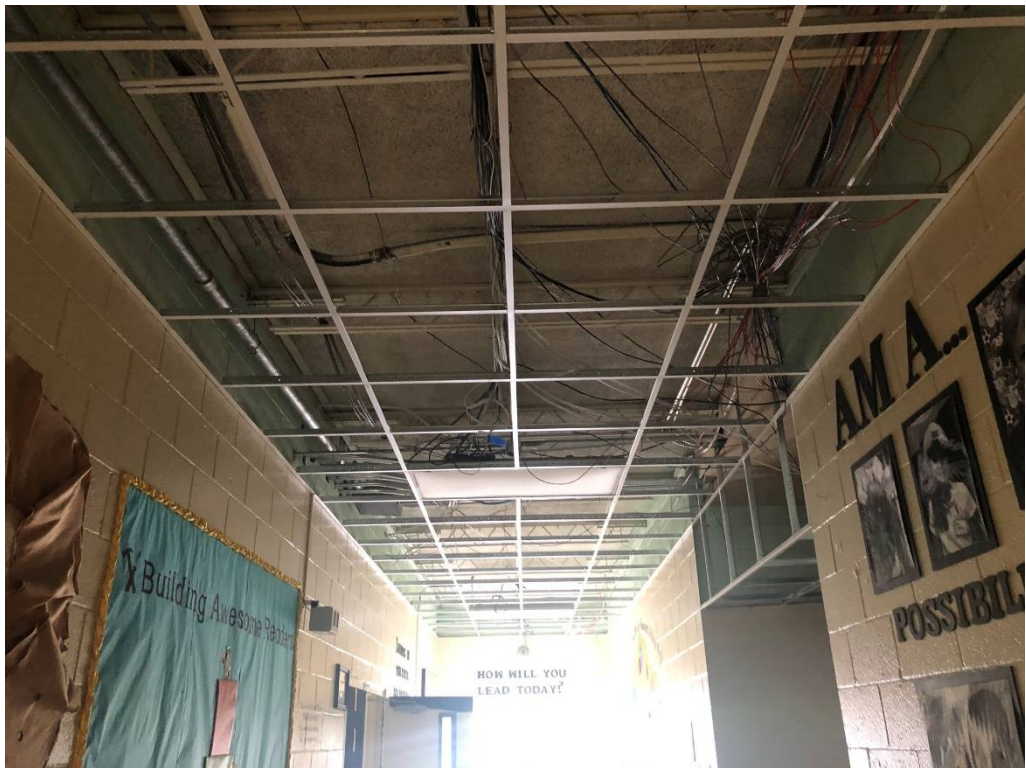
Figure 16 – South Entry Hall

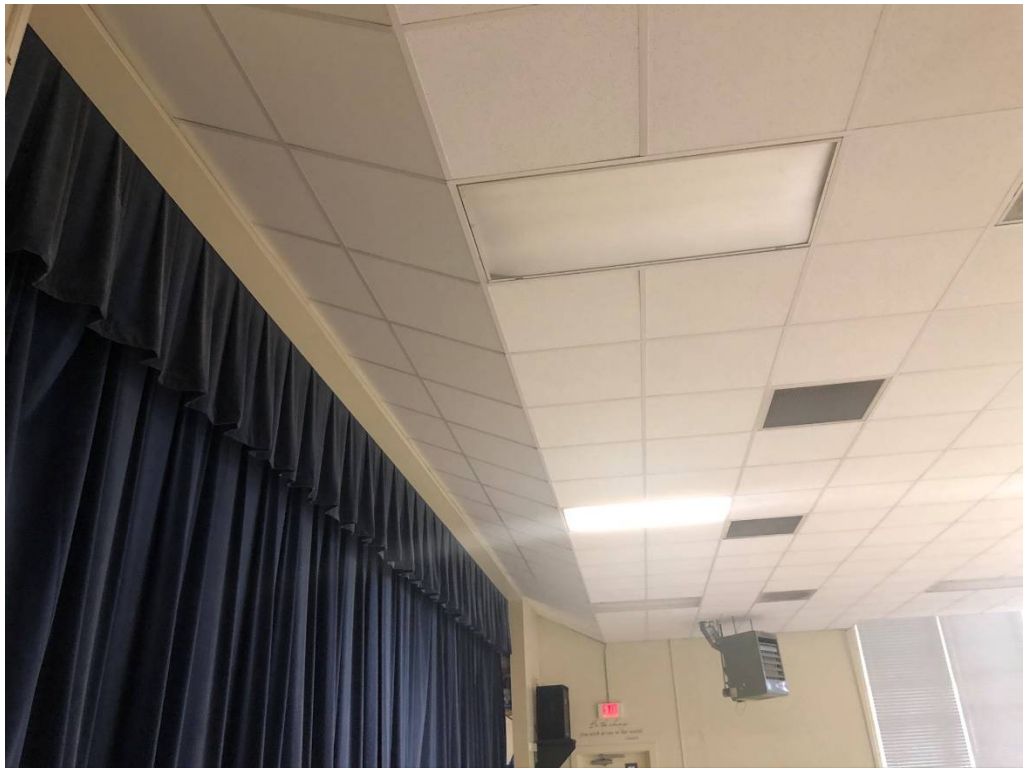
Figure 17 – Auditorium New Ceiling

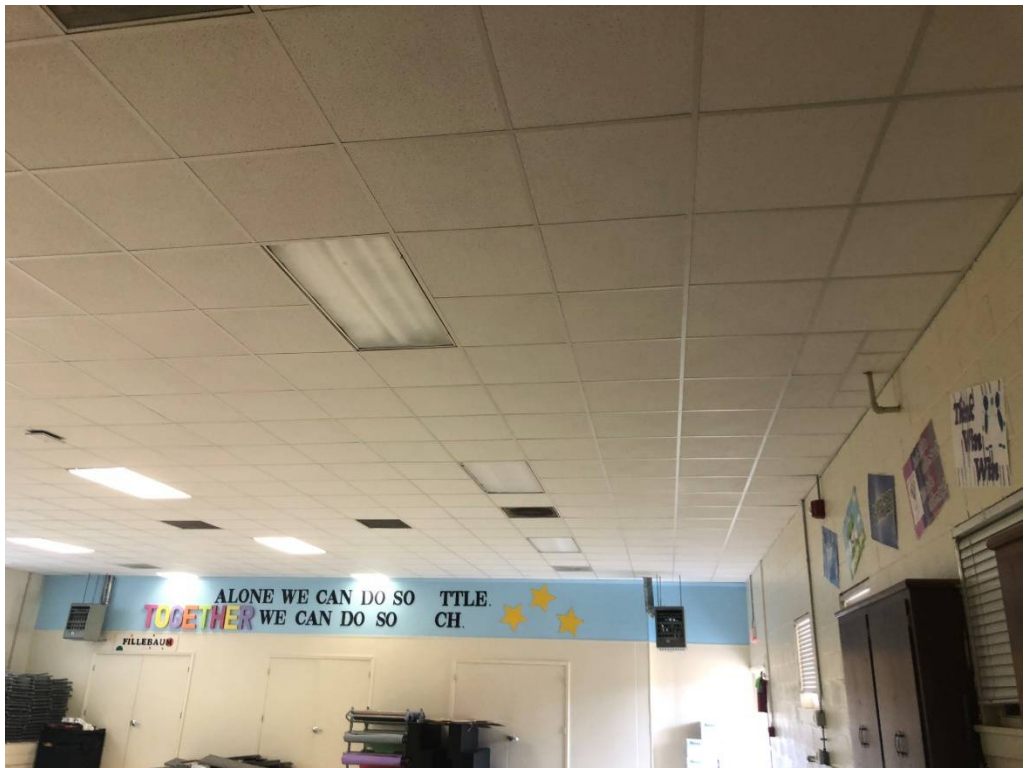
Figure 18 – Auditorium New Ceiling

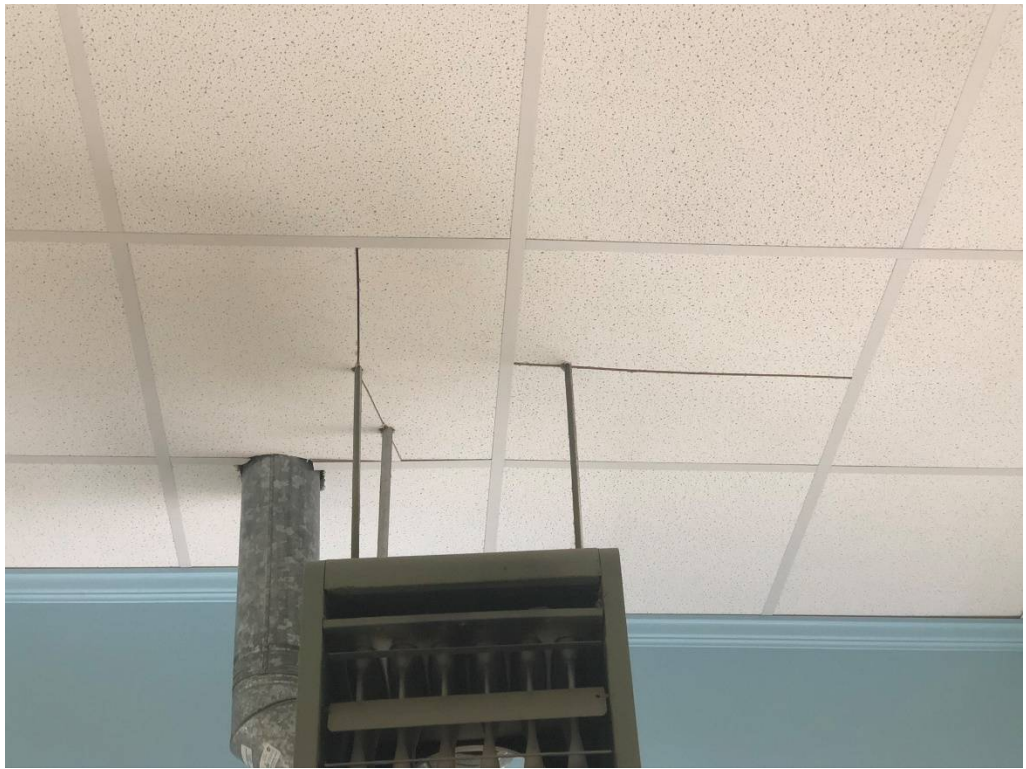
Figure 19 – Is there something to be done to Blend Cuts @ grid?

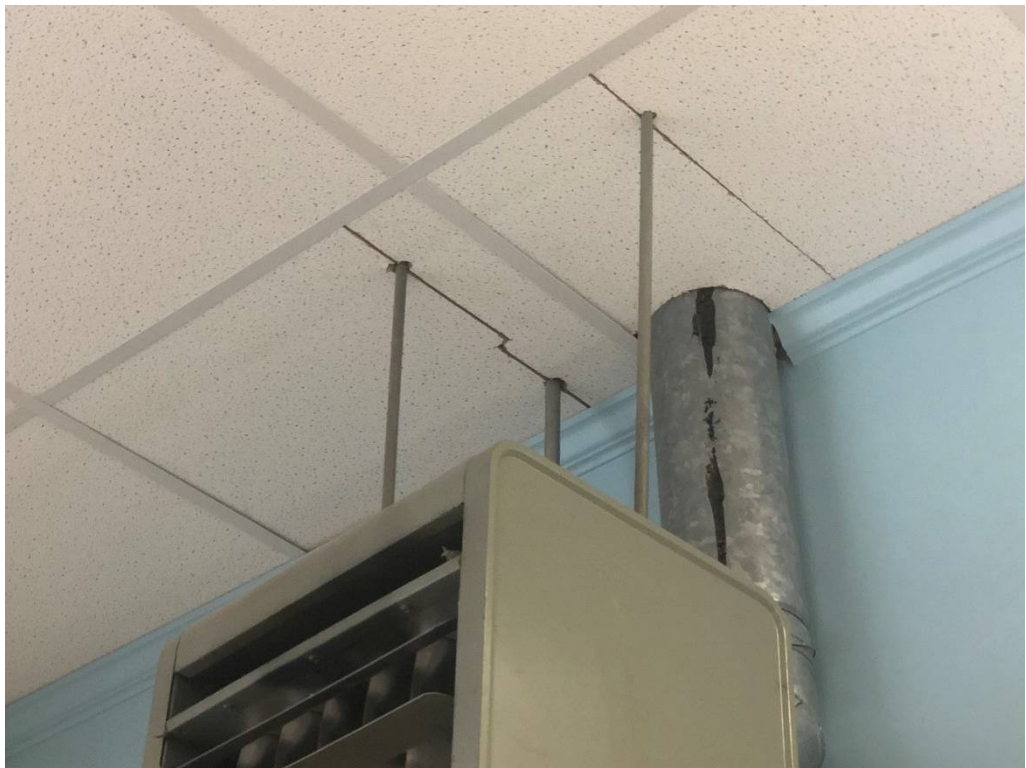
Figure 20 – Is there something to be done to Blend Cuts @ grid?

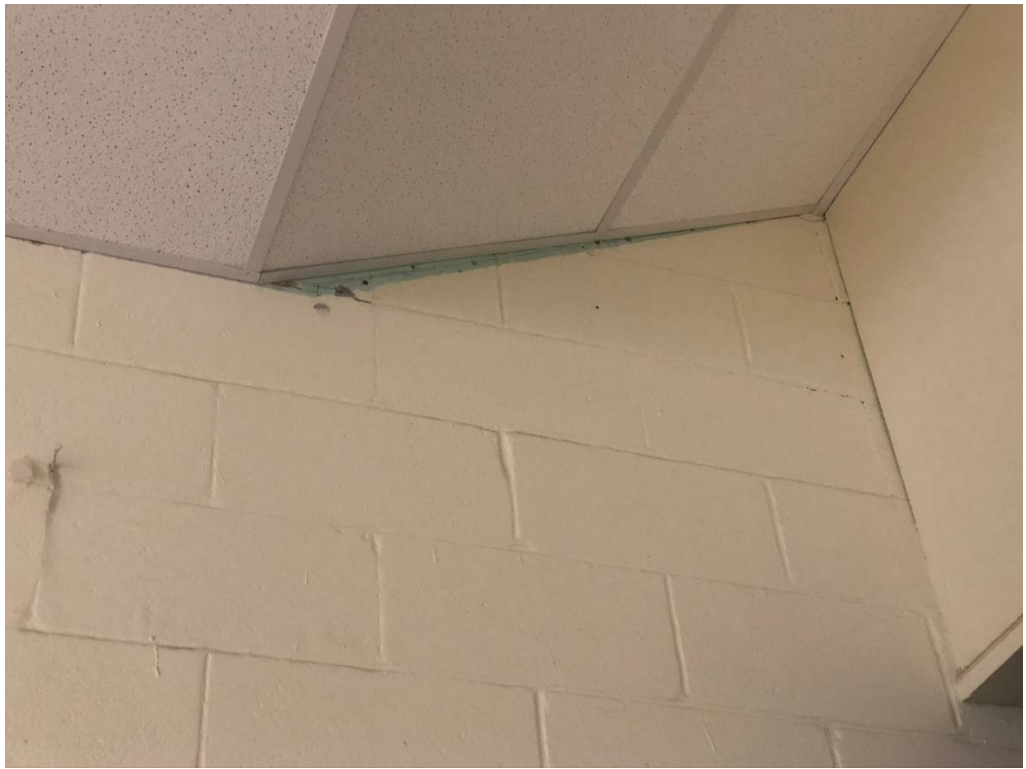
Figure 21 – Change of Angle Reveals Old Paint Color (touch up with wall paint)

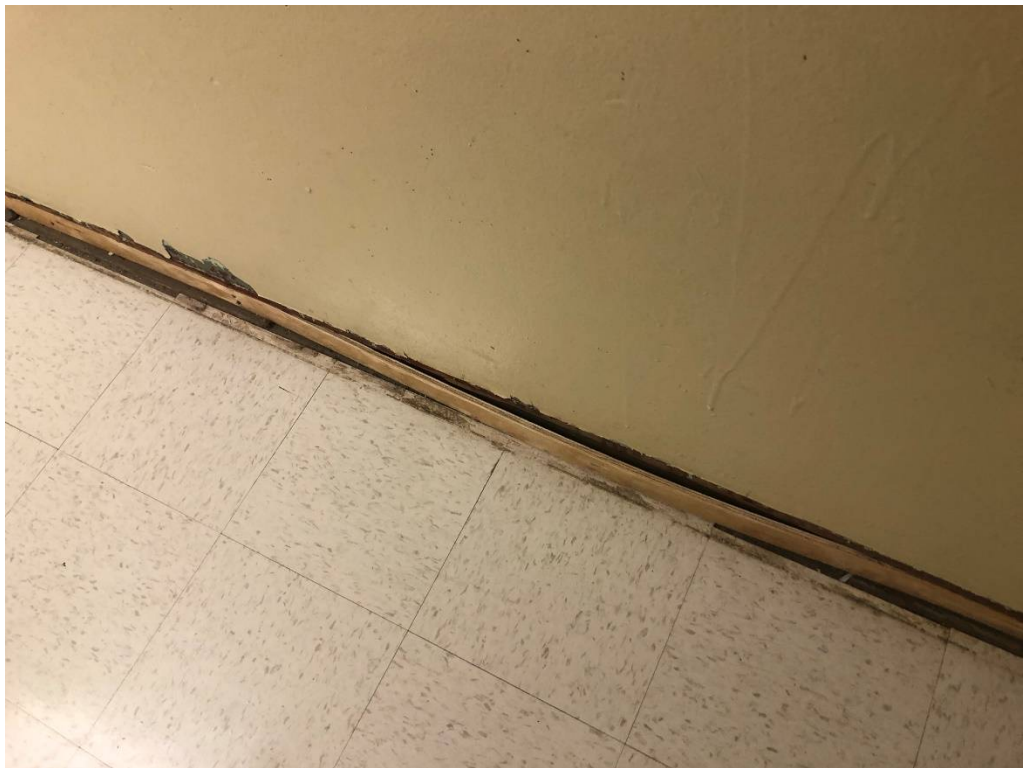
Figure 22 – Bulge in Plywood will prevent Base from Laying Flat

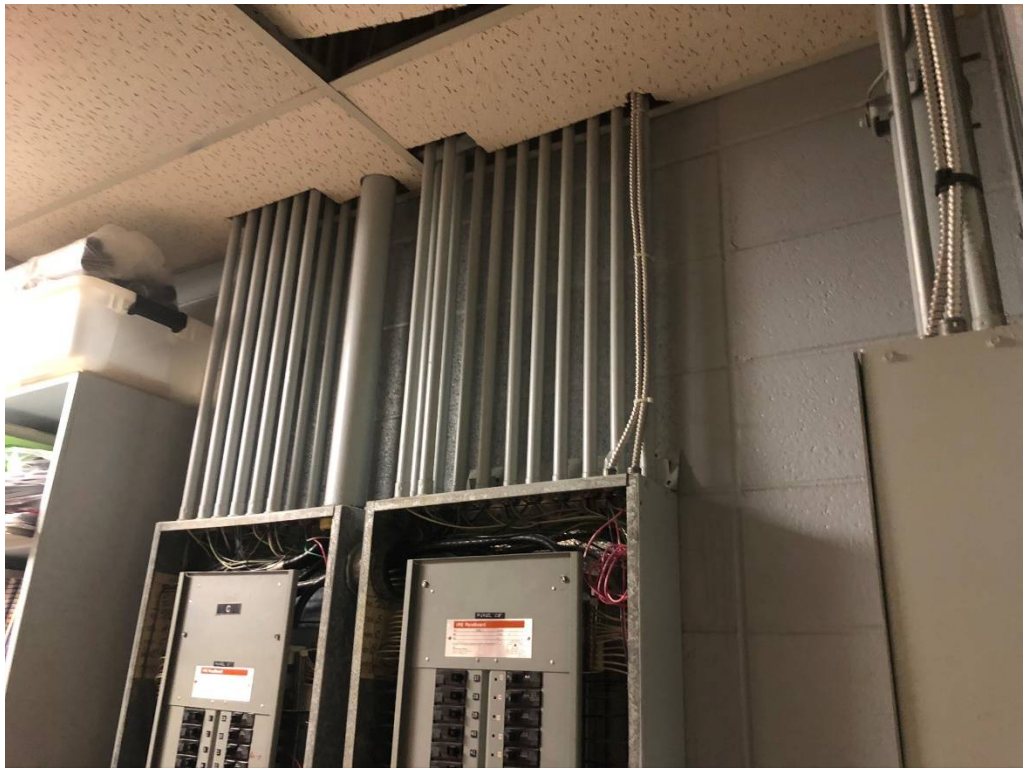
Figure 23 – Electrical Panel Work

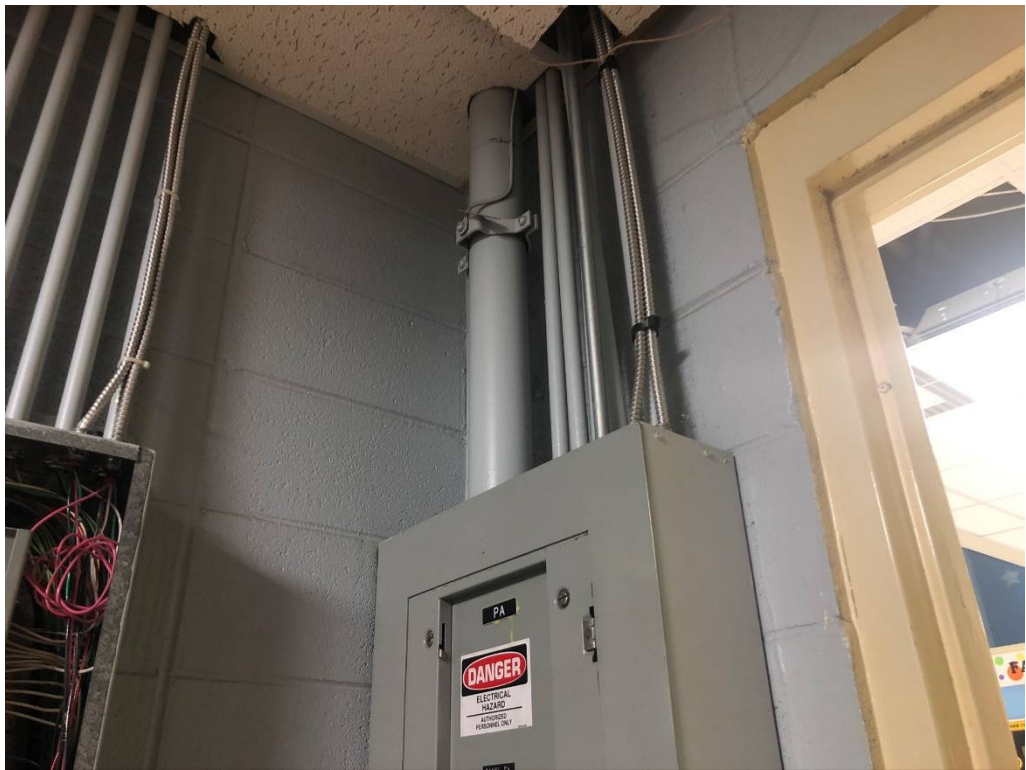
Figure 24 – Electrical Panel Work
