Architect's Field Report

17 March 2020

18044-Bovina Elementary / Report Number 004

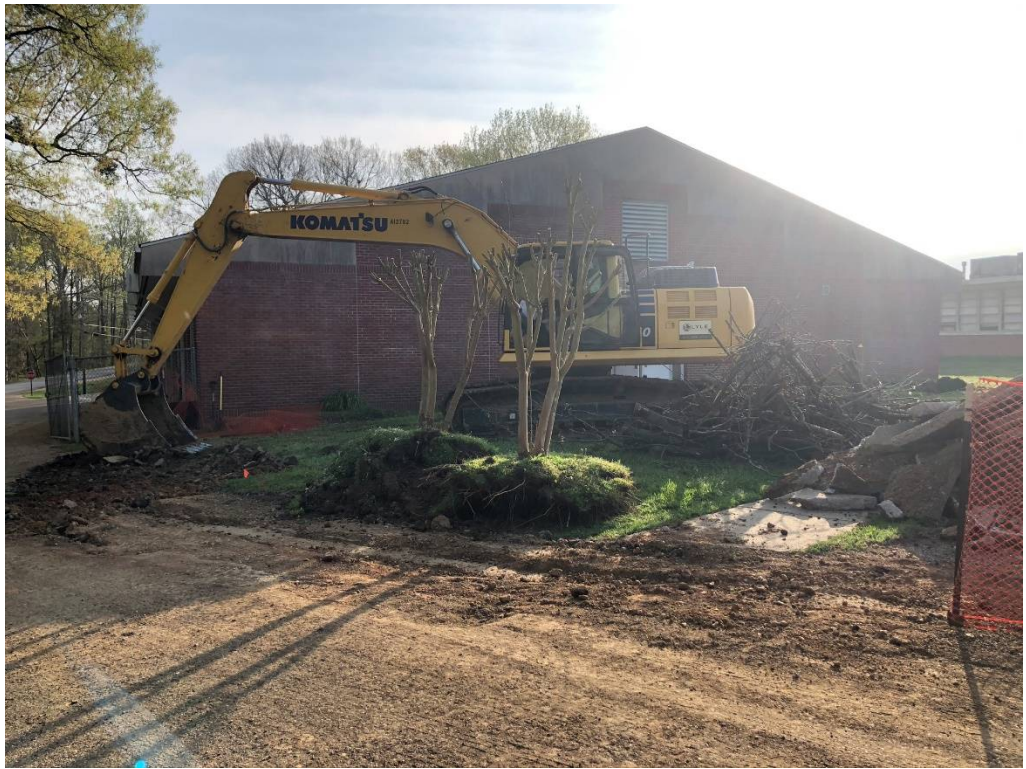
Figure 1 – Excavation Work at Addition

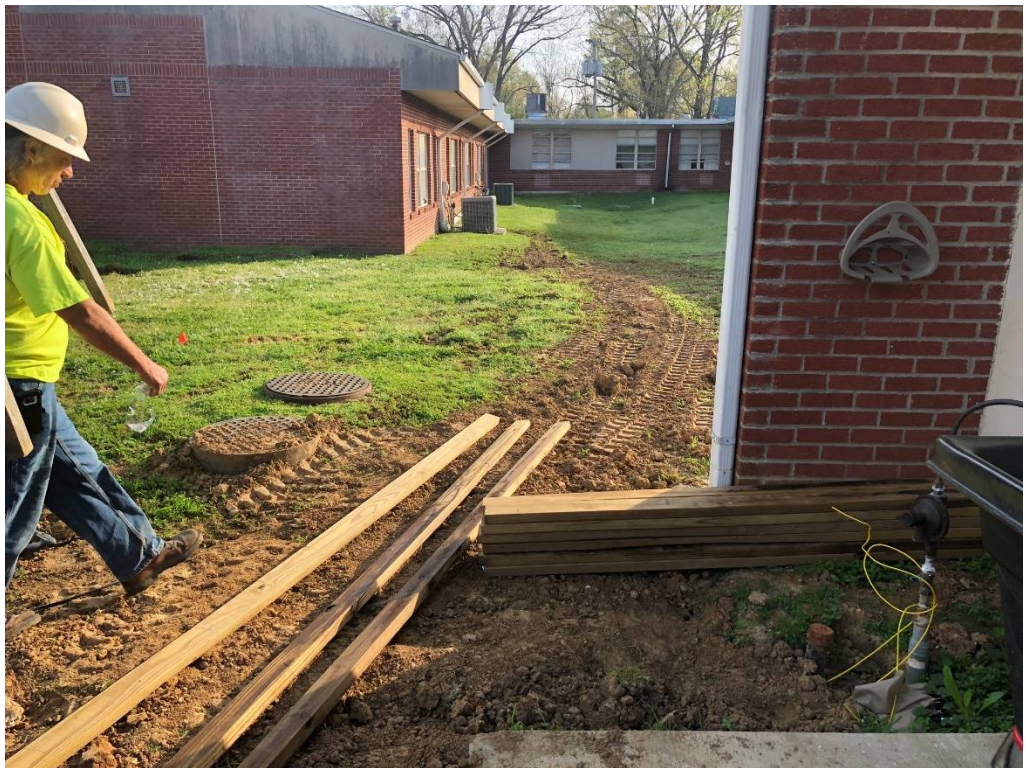
Figure 2 – Gas Pipe Relocated and Excavation Covered

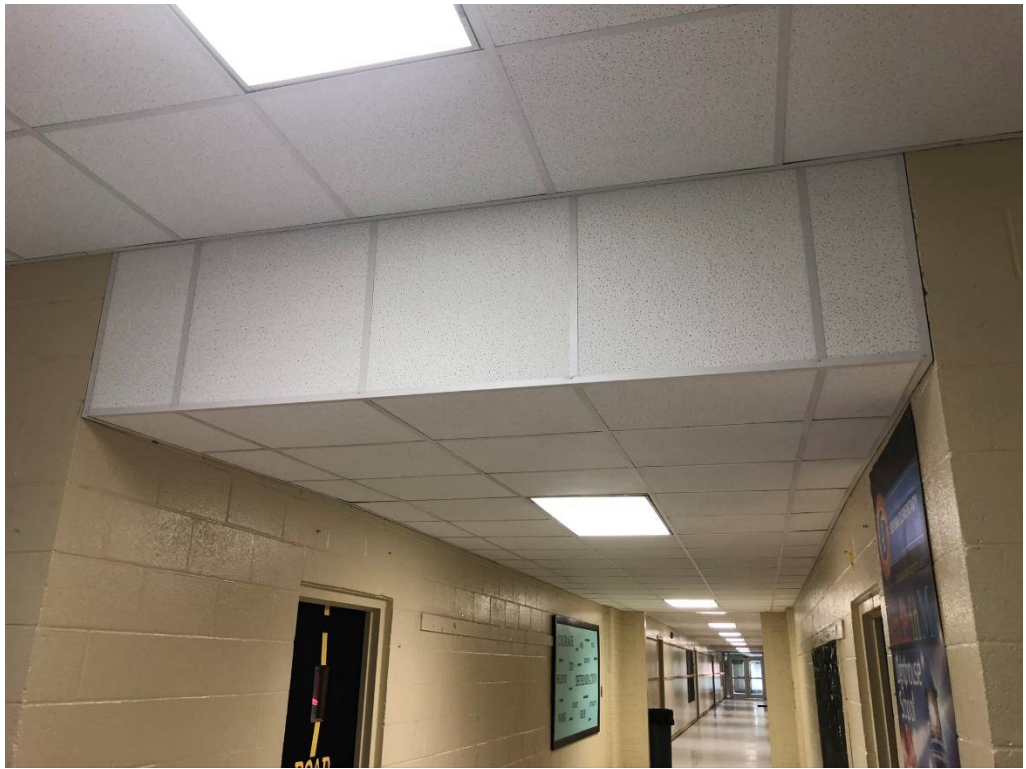
Figure 3 – Ceiling Tile Complete in Main Hall

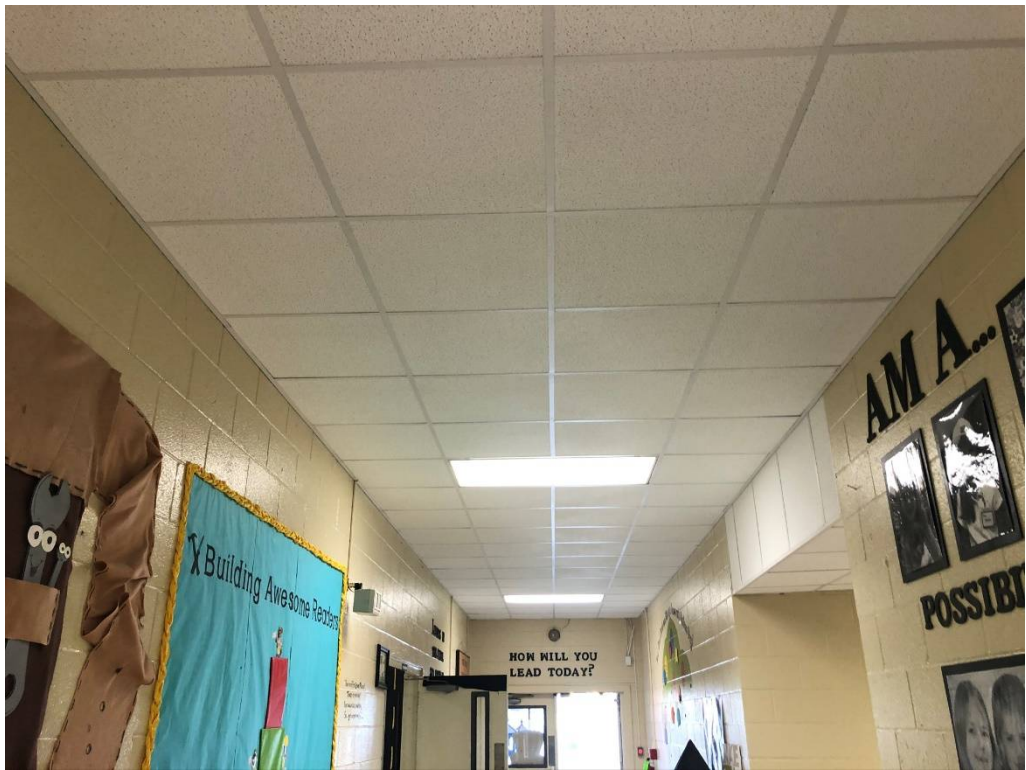
Figure 4 – Ceiling Tile Complete in Main Hall
