Architect's Field Report

16 April 2020

18044-Bovina Elementary / Report Number 008

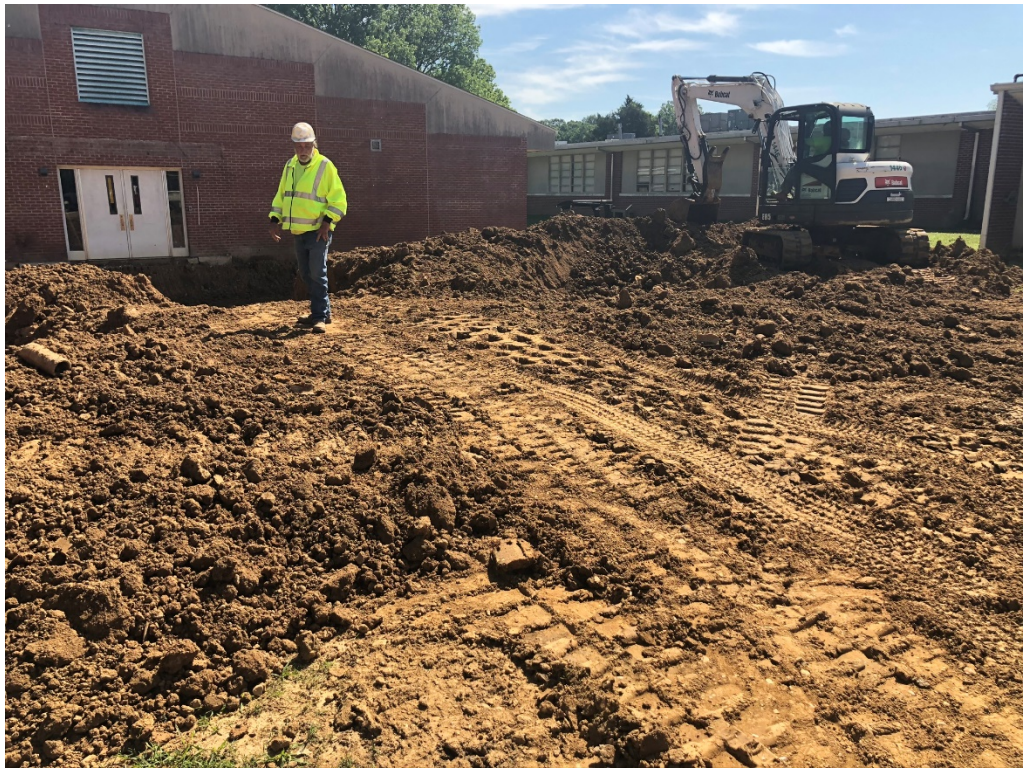
Observations Arriving on site, I made my way to the area that our addition that is to be located. Dirt has been dug up for drying; also, 2 drains have been removed to the extents of the work are.

Figure 1 – North Addition Dirt Work

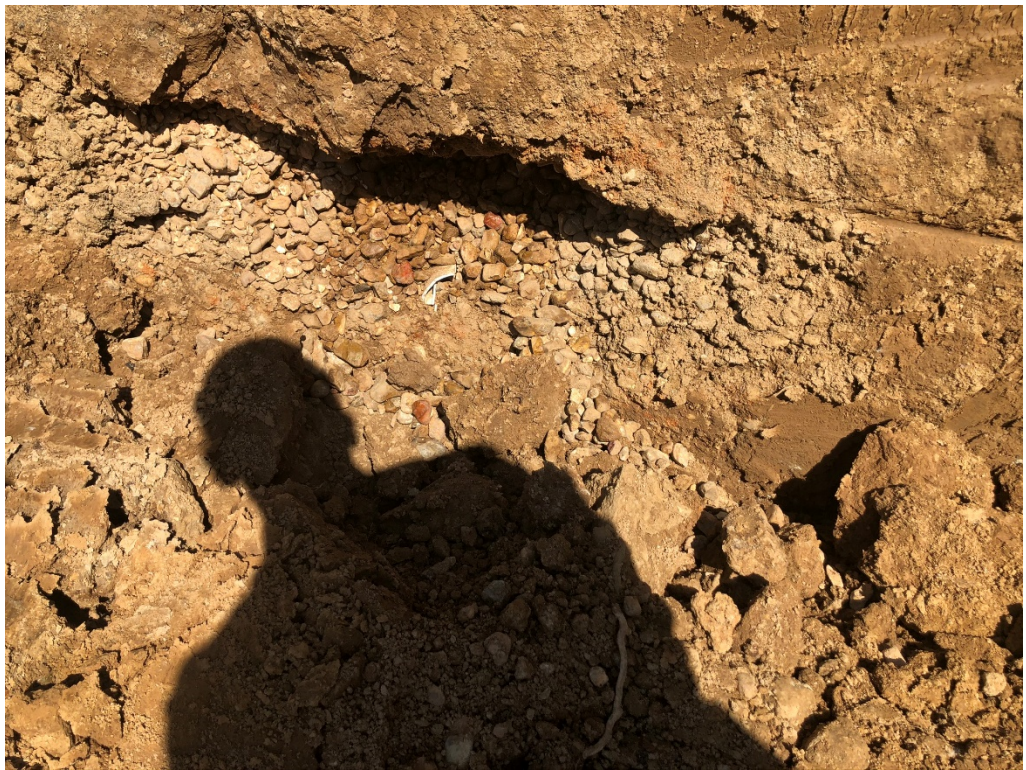
Figure 2 – Drain at Extent of Project Bounds

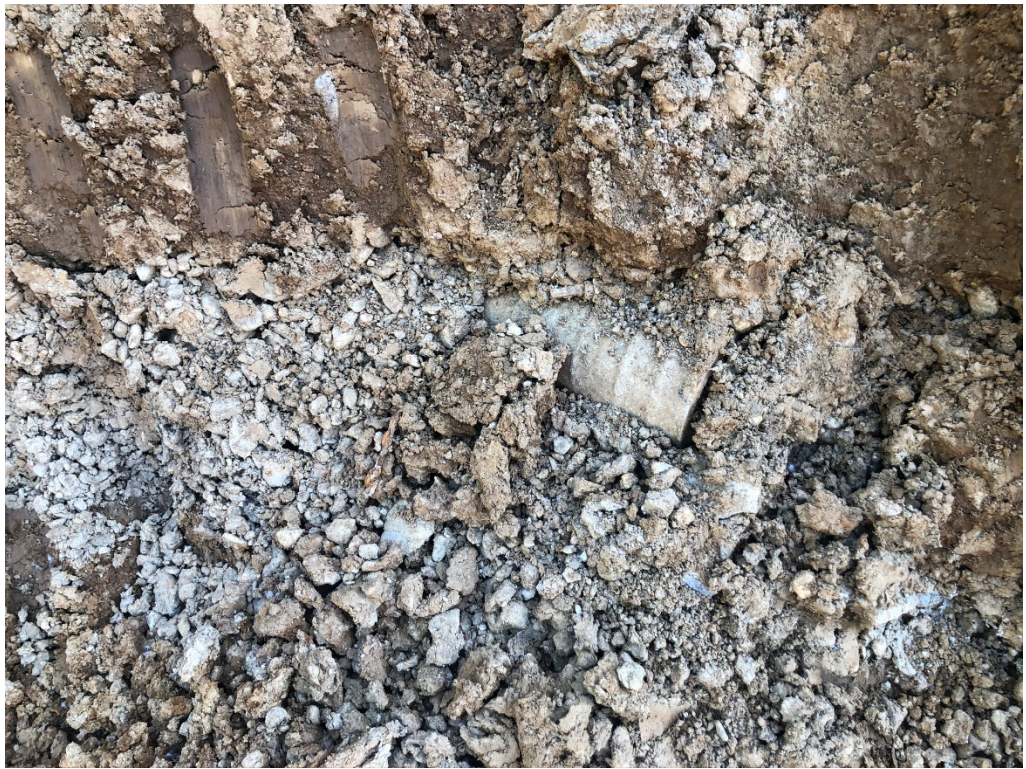
Figure 3 – Drain that Moves Below Building Footing

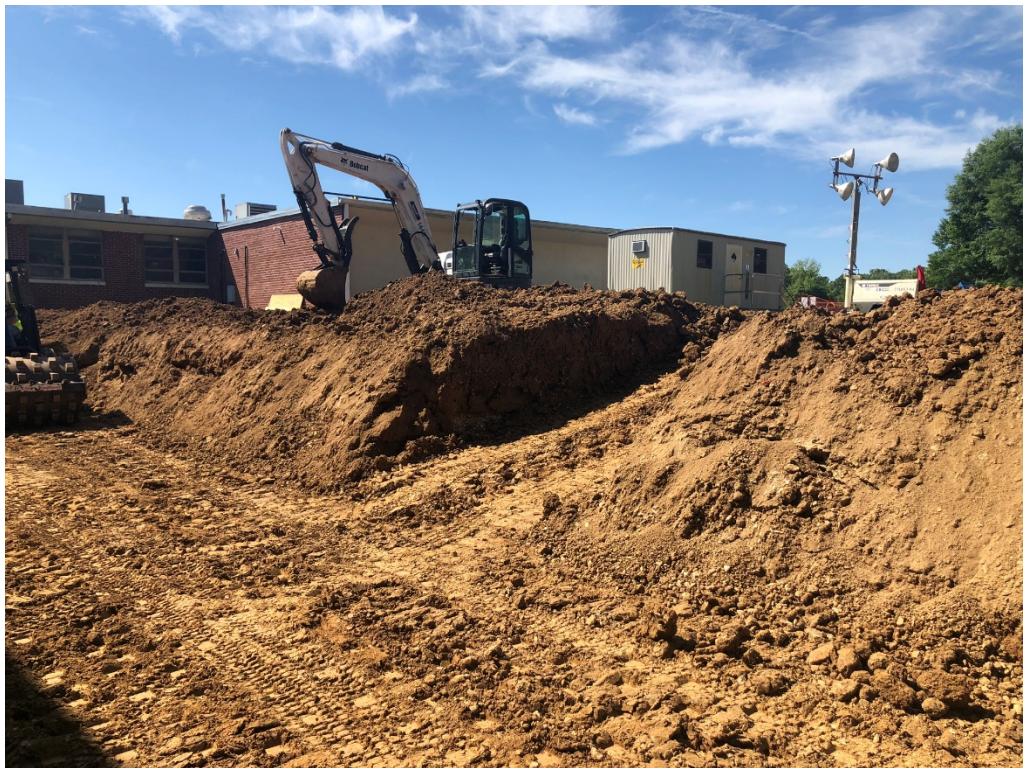
Figure 4 – Excavation Depth

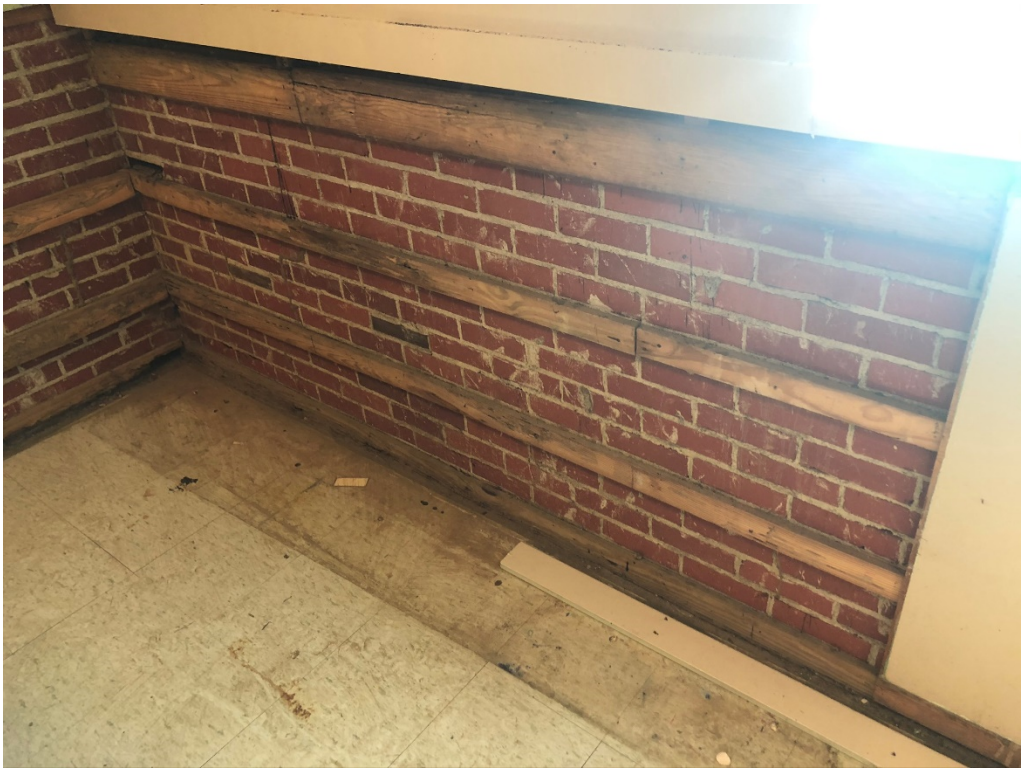
I made my way through the school to note any other changes; the area on the southern wall that was noted to have termite damage has been uncovered. There appears to be more damage further up the wall but it has not been uncovered. The lower section of the wall is made of material that is impervious to termites, however the above section is unknown at the point but does appear to have a wood base plate supported at 30-36" center to center atop the masonry lower wall. This base plate shows termite damage.

Figure 5 – Southern Wall Paneling Removed @ Classroom 4

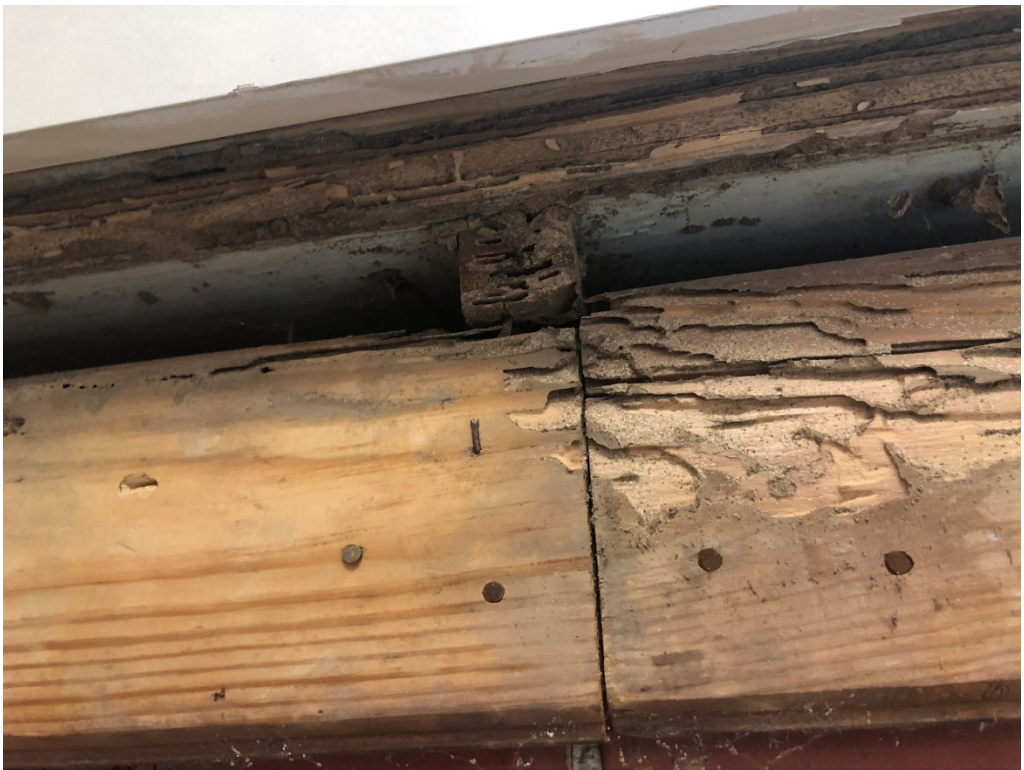
Figure 6 – Termite Damage @ Base Plate

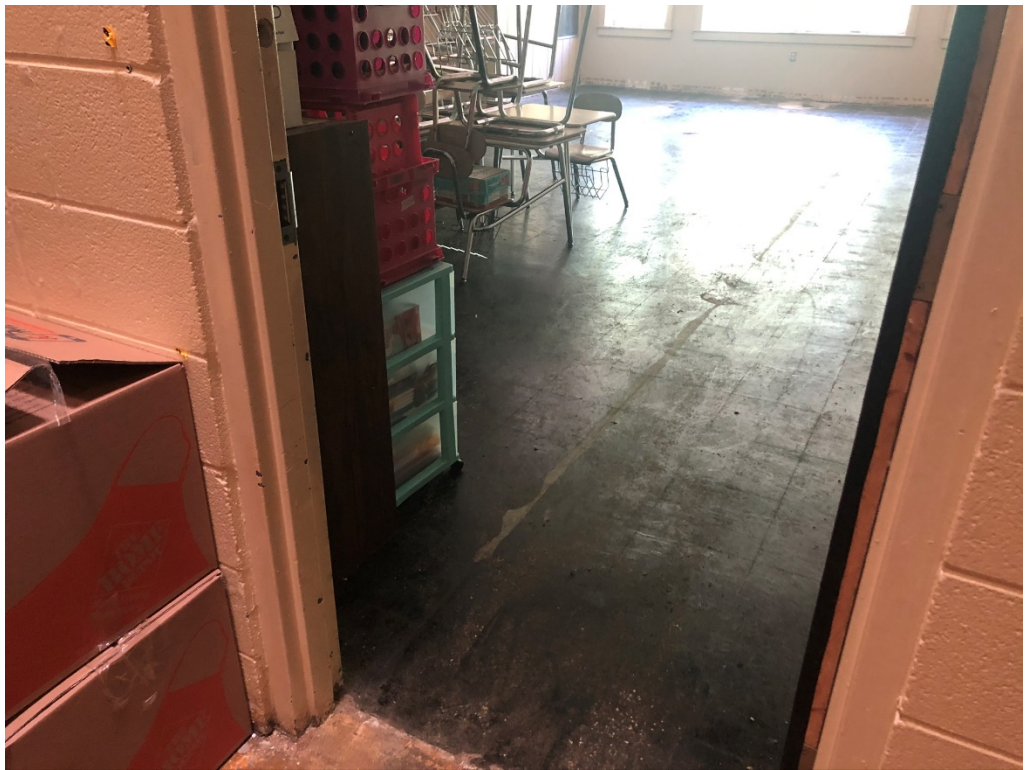
Floor demo has been complete, aside from the mech/elec room.

Figure 8 – North Hall Demo Complete (typical class)
