Architect's Field Report

19 May 2020

18044-Bovina Elementary / Report Number 012

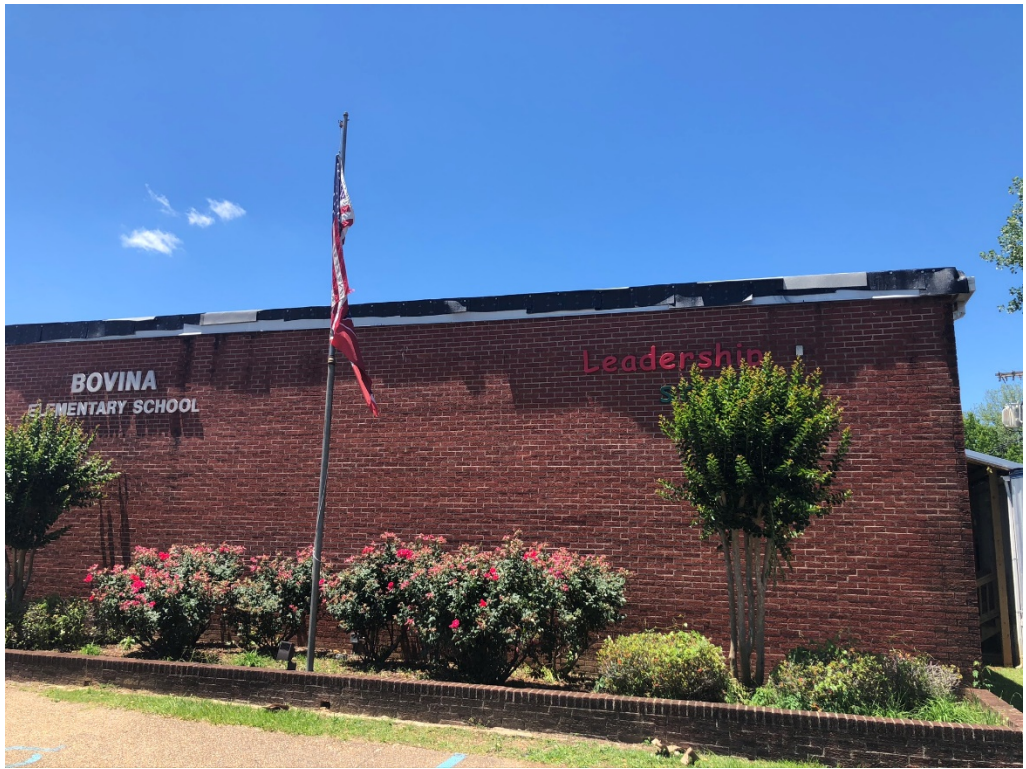
Figure 1 – Roofing Material @ Roof Edge

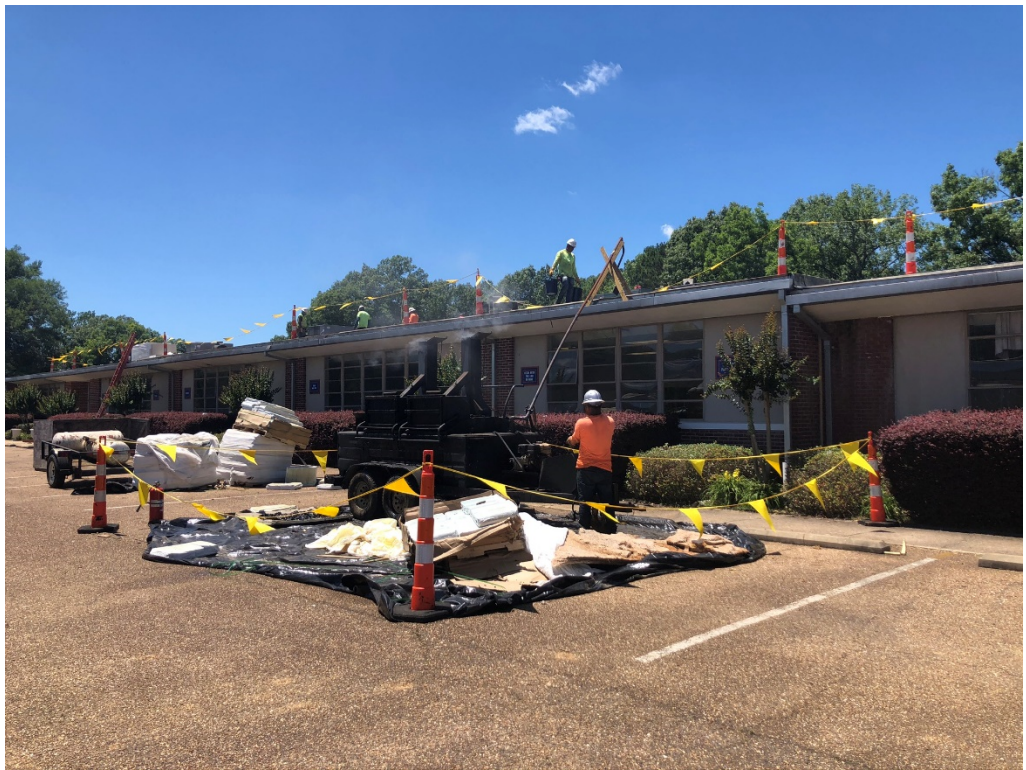
Observations I arrived on site and noted that roof work was ongoing. Asphalt was being applied to south section of building's roof.

Figure 2 – Roofing Work

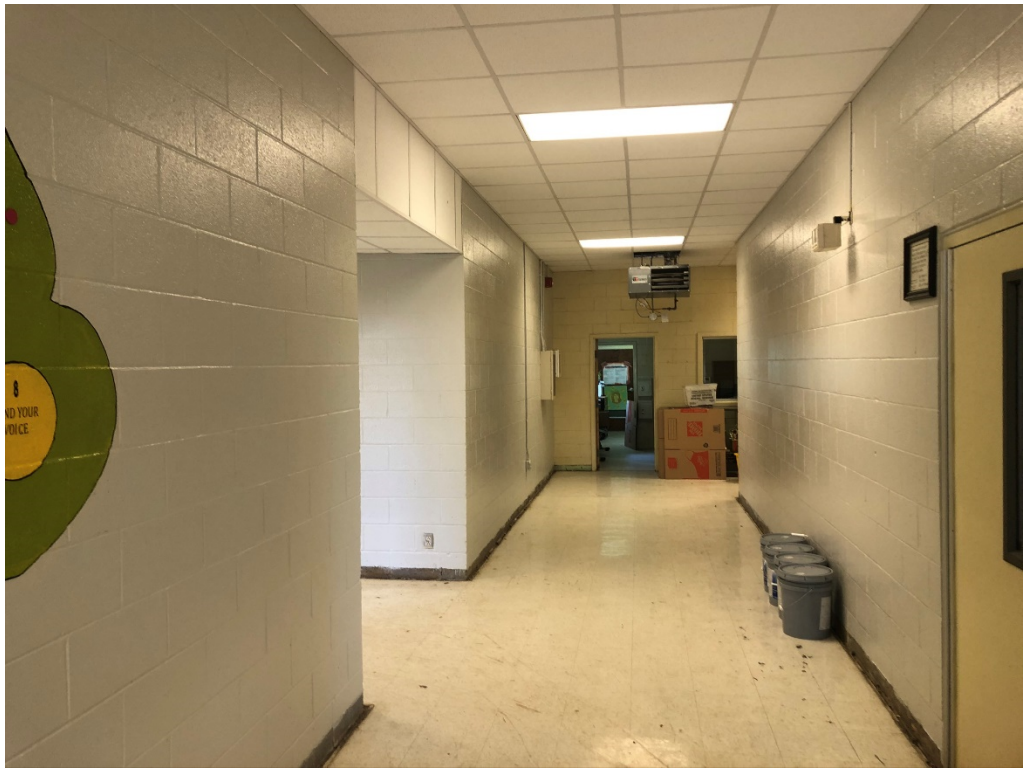
Figure 3 – Painting has begun and is ongoing; some areas are near completion such as here

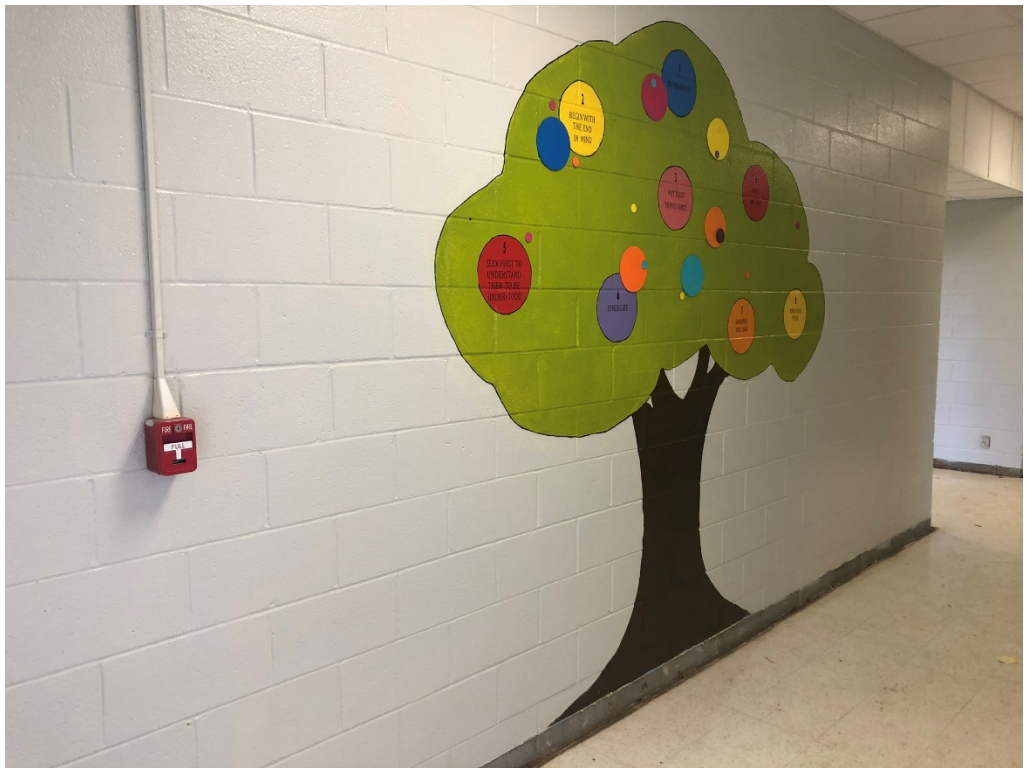
Figure 4 – Tree Preserved by Contractor

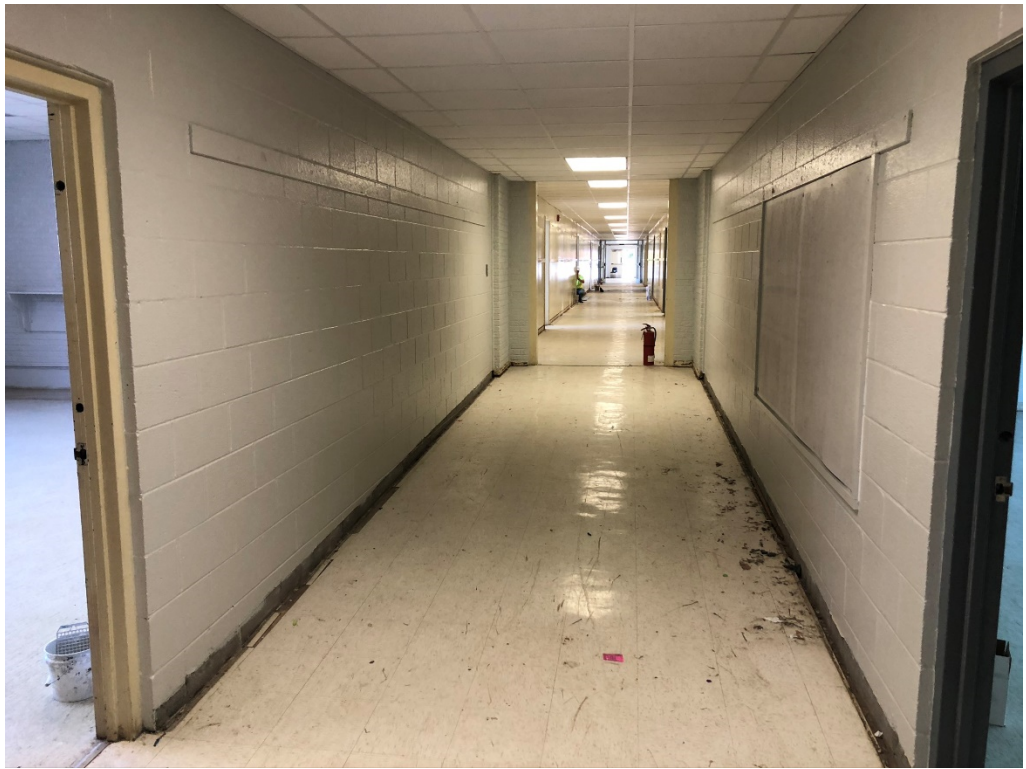
Figure 5 – Painting is ongoing in south hall

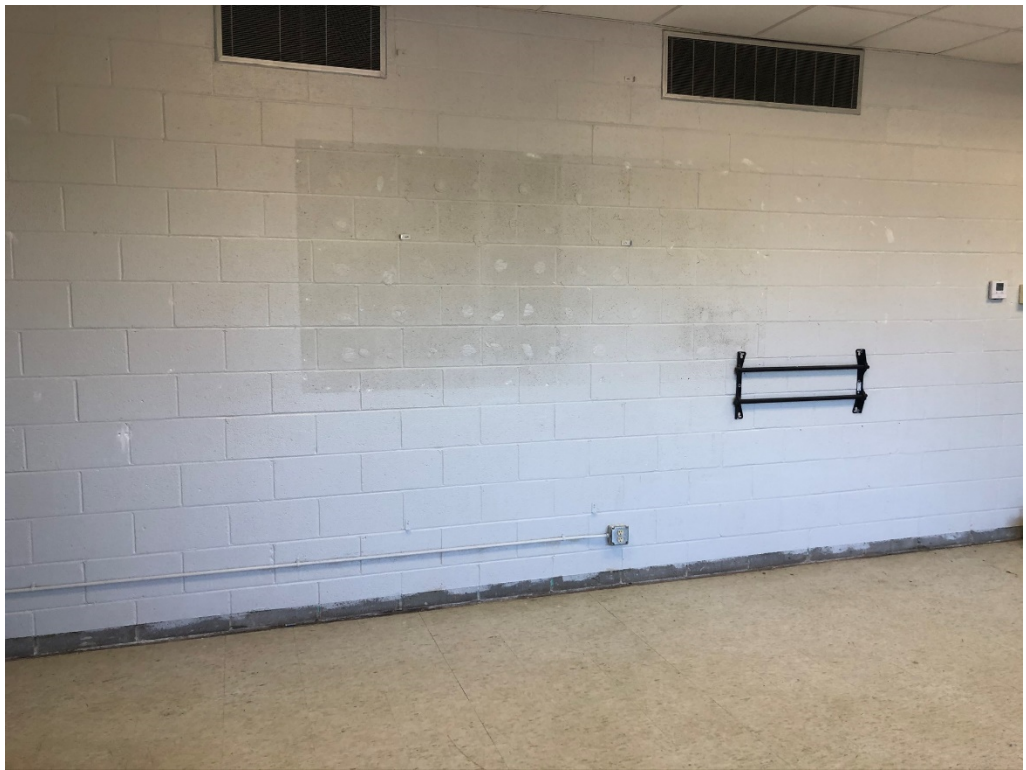
Figure 6 – Paint Prep at Walls

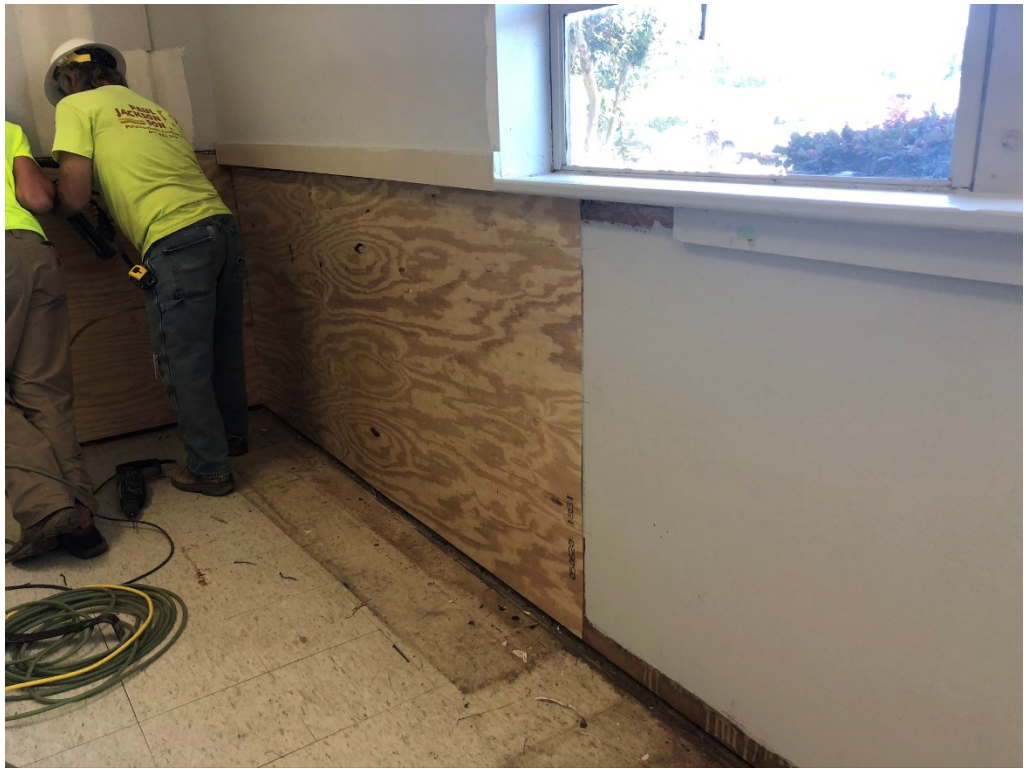
Figure 7 – Carpentry Repair at Termite Damaged Areas

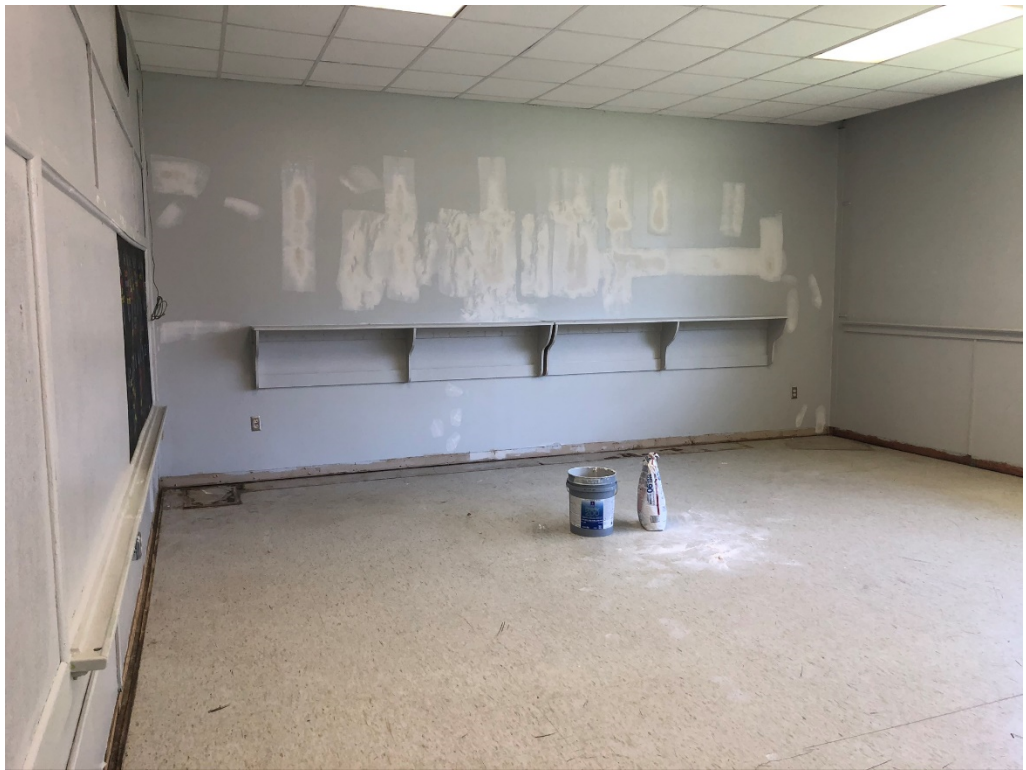
Figure 8 – Paint Prep

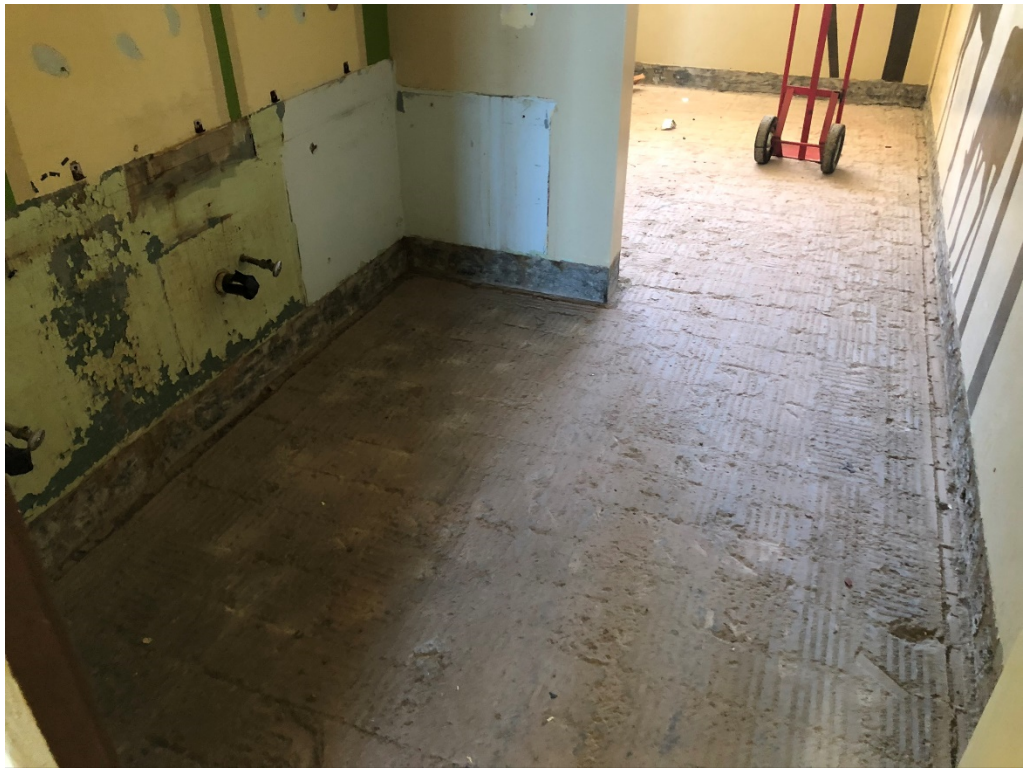
Figure 9 – Floor Demo is Complete

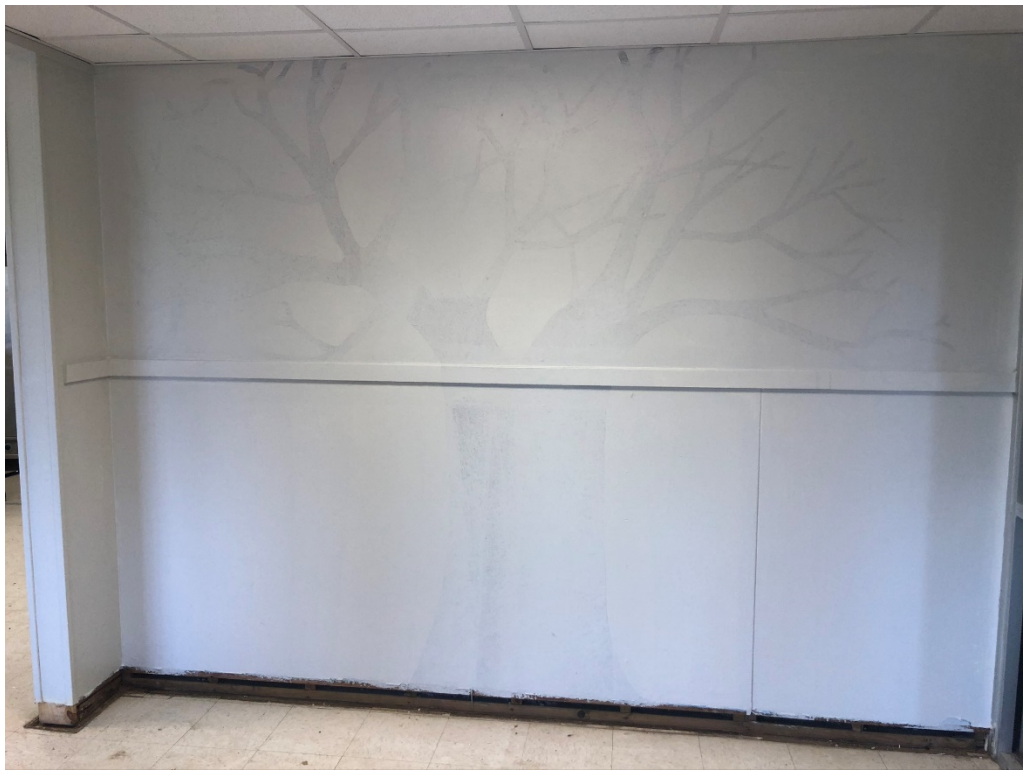
Figure 10 – Paint is ongoing

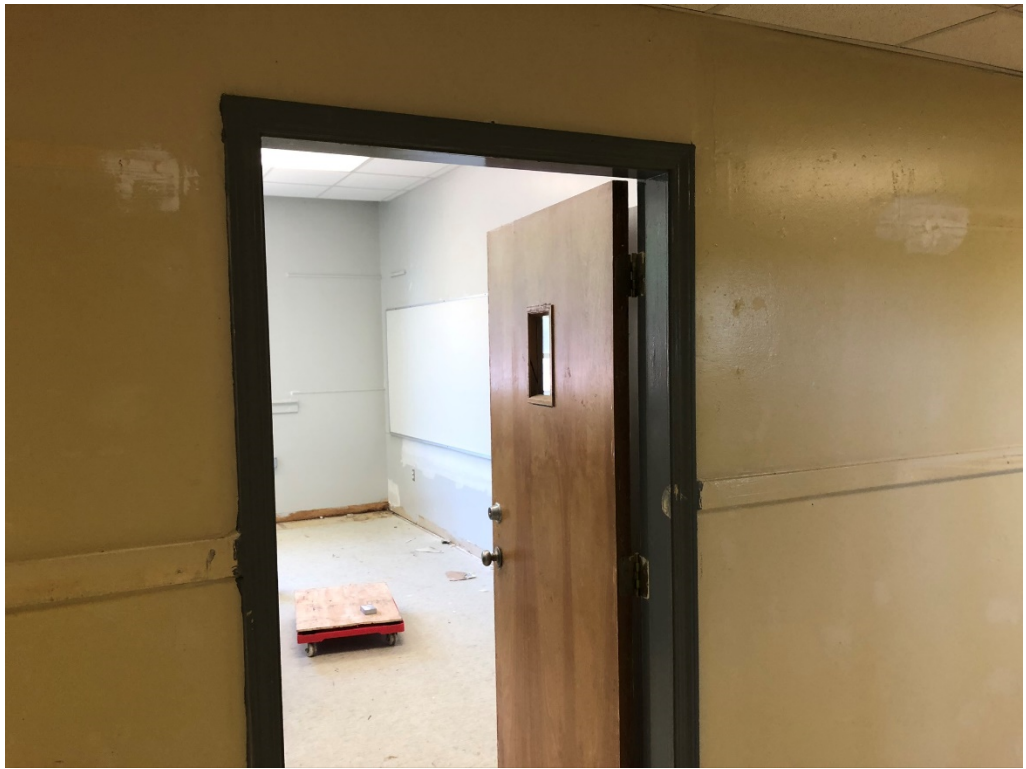
Figure 11 – Some trim paint has been applied

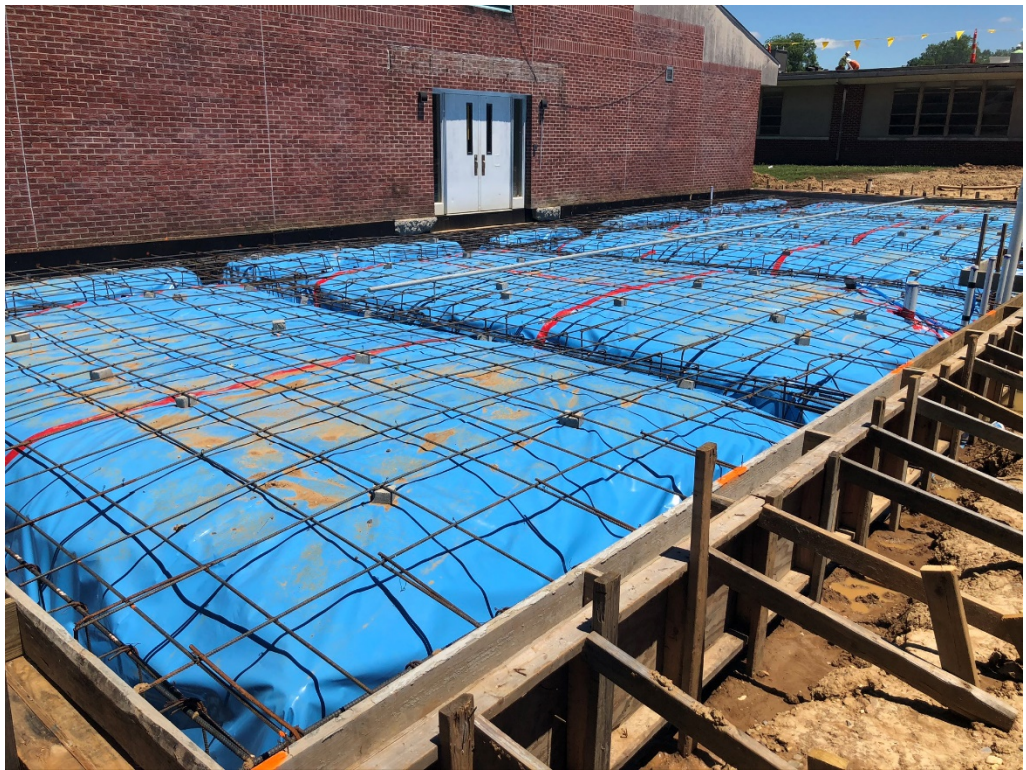
Figure 12 – Formed and Reinforced (NW Corner Looking SE)

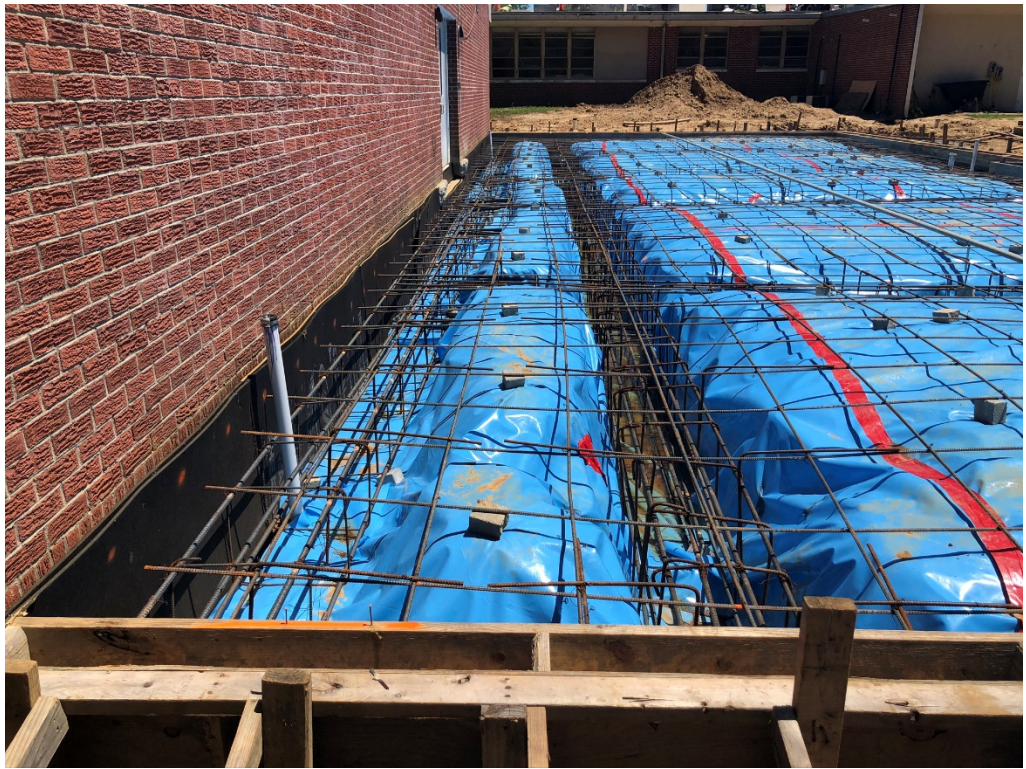
Figure 15 – Formed and Reinforced (NE Corner Looking S)

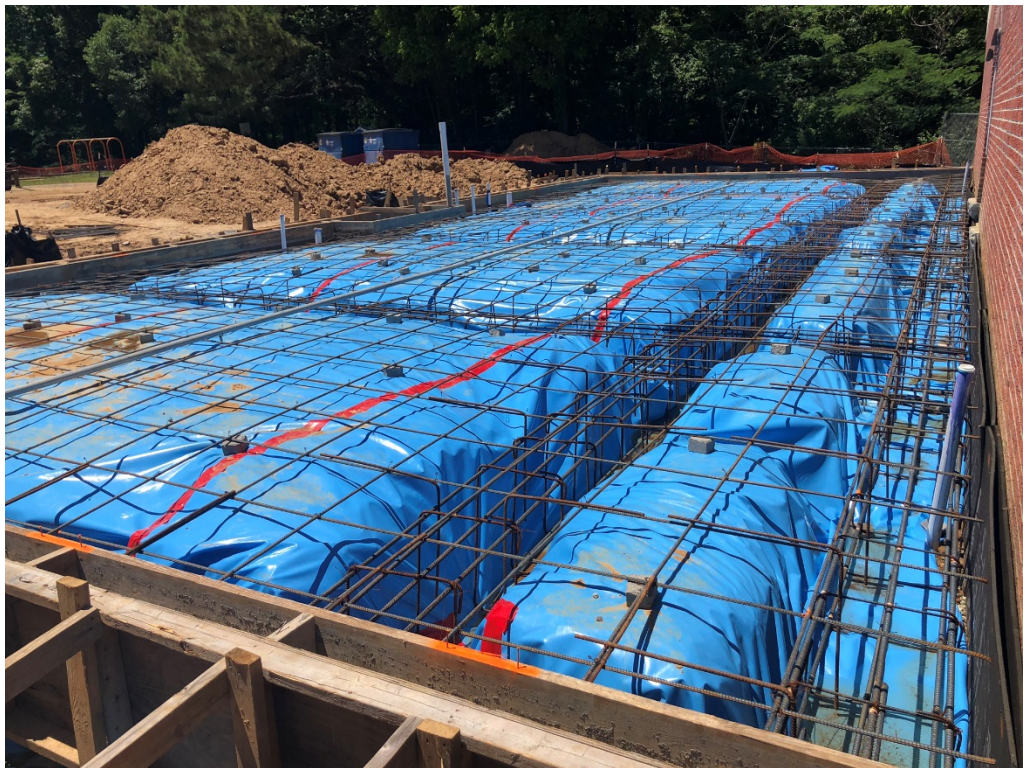
Figure 16 – Formed and Reinforced (SE Corner Looking NW)
