Architect's Field Report

28 May 2020

18044-Bovina Elementary / Report Number 012

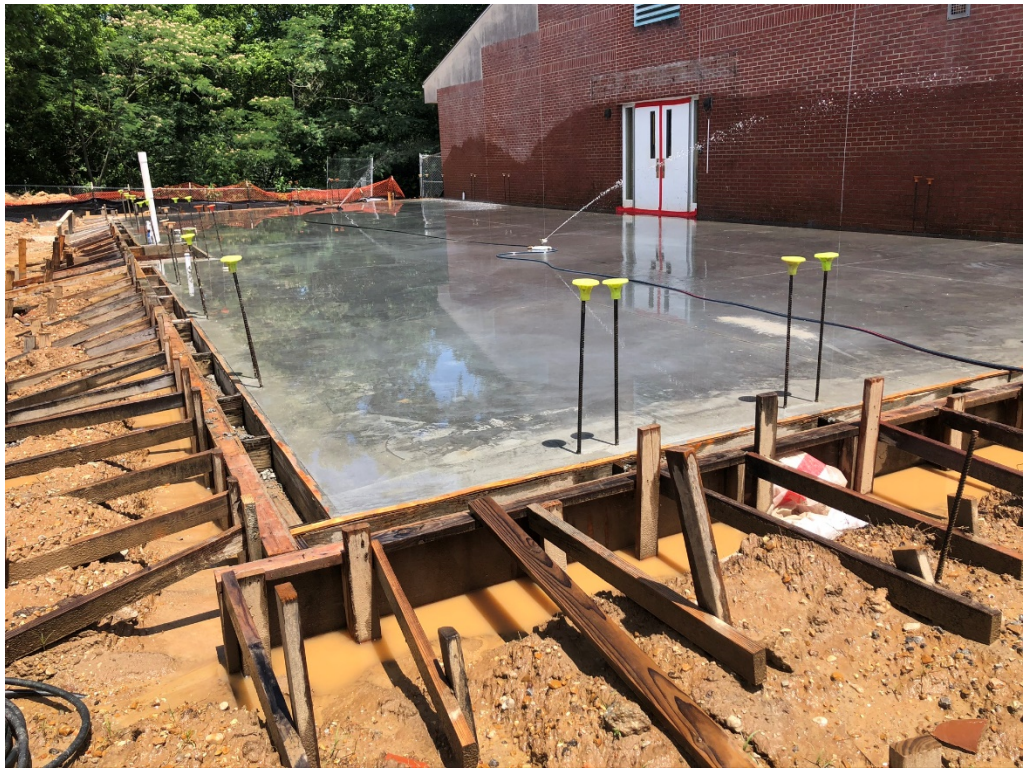
Observations Arriving on site I reviewed concrete pour from last week. The new slab is being maintained per specifications.

Figure 1 – Concrete Slab on its 5th day

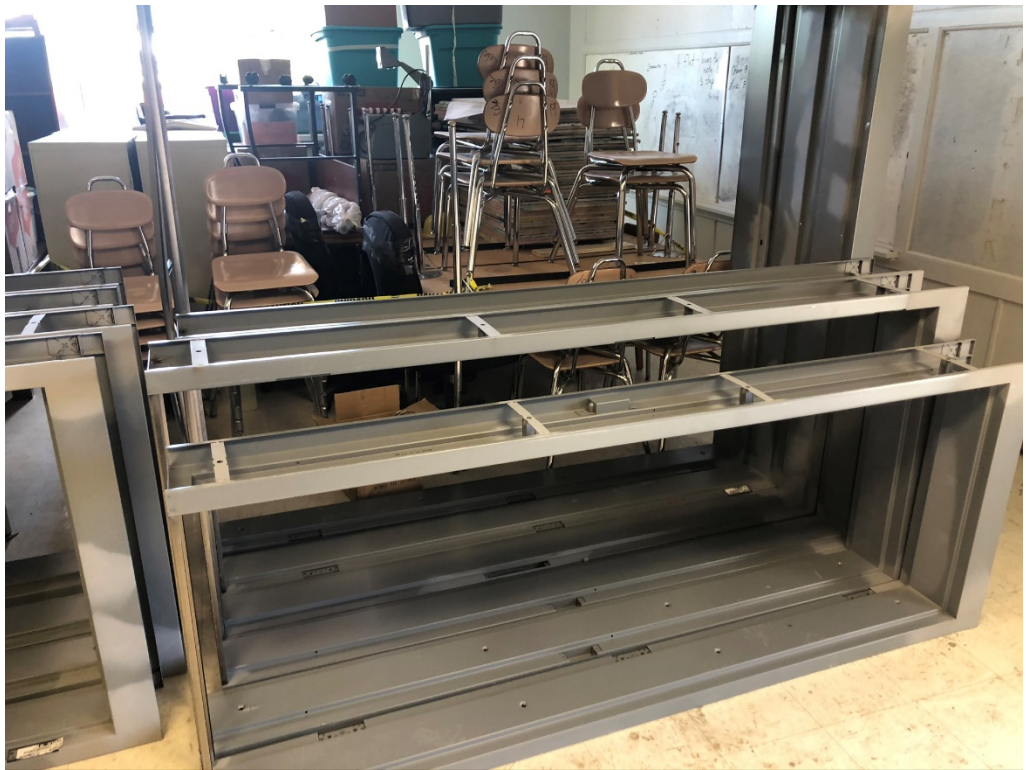
Figure 2 – HM Frames on Site

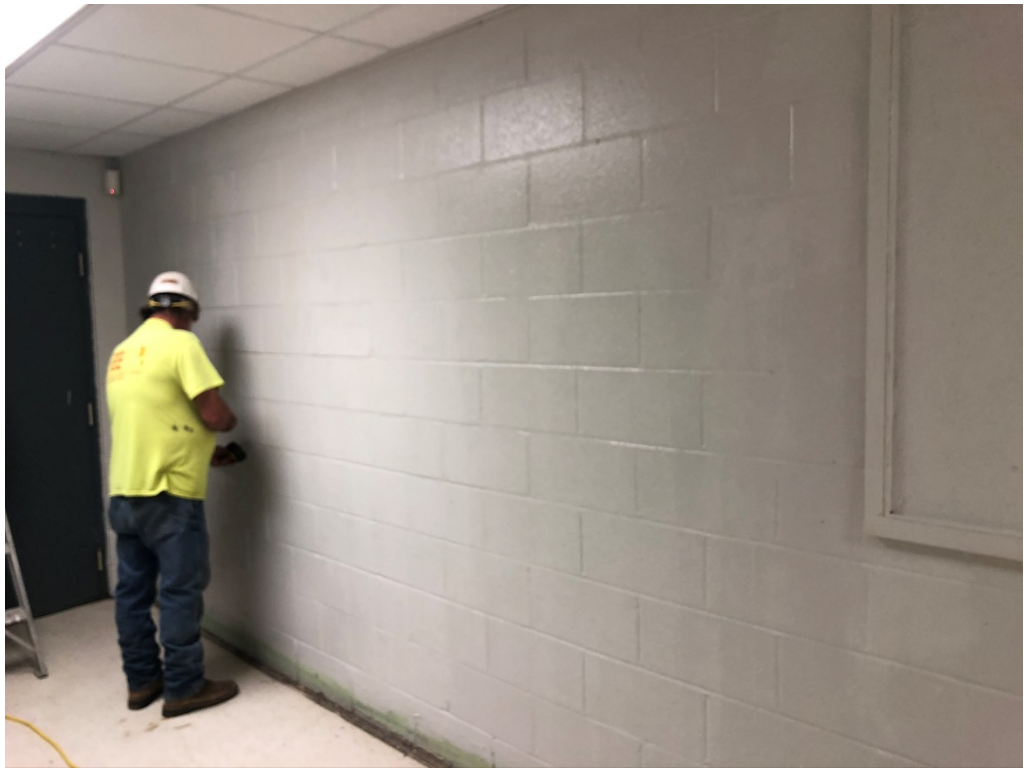
I met Matthew Goodwin, PJS, and Richard Creel, PJS, in the job site trailer. They were reviewing an issue concerning the teacher workroom on the East side of the school.

Figure 3 – Hall Side of Teacher Workroom (now used as classroom)

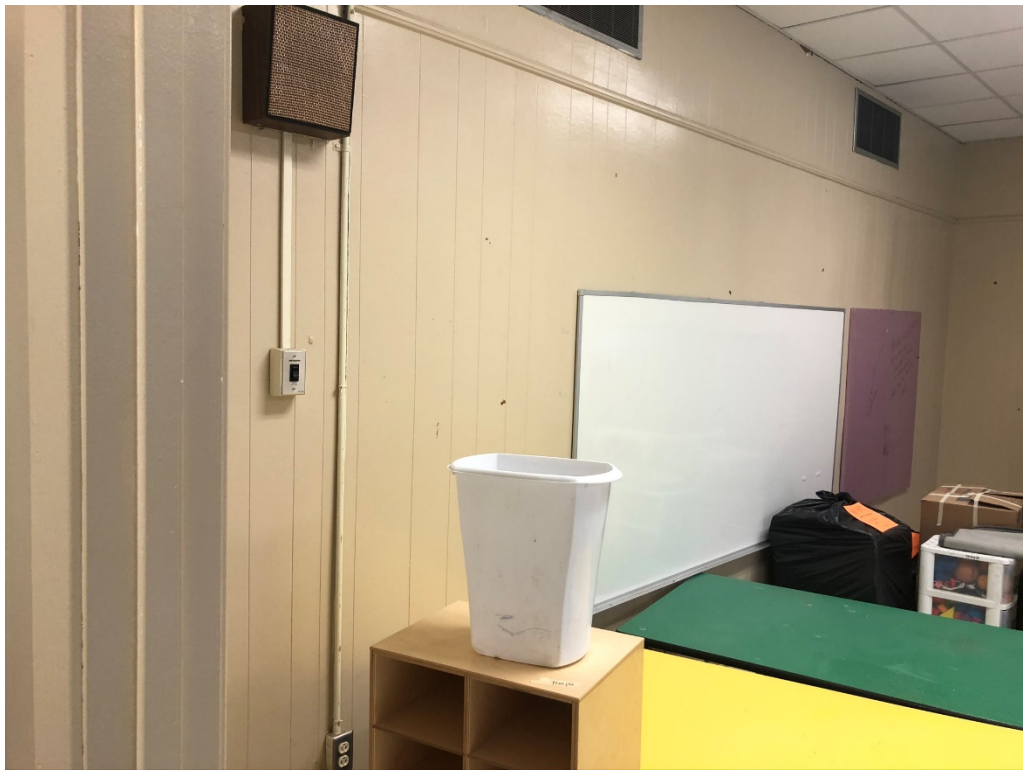
Figure 4 – Classroom Side of Teacher Workroom (now used as classroom)

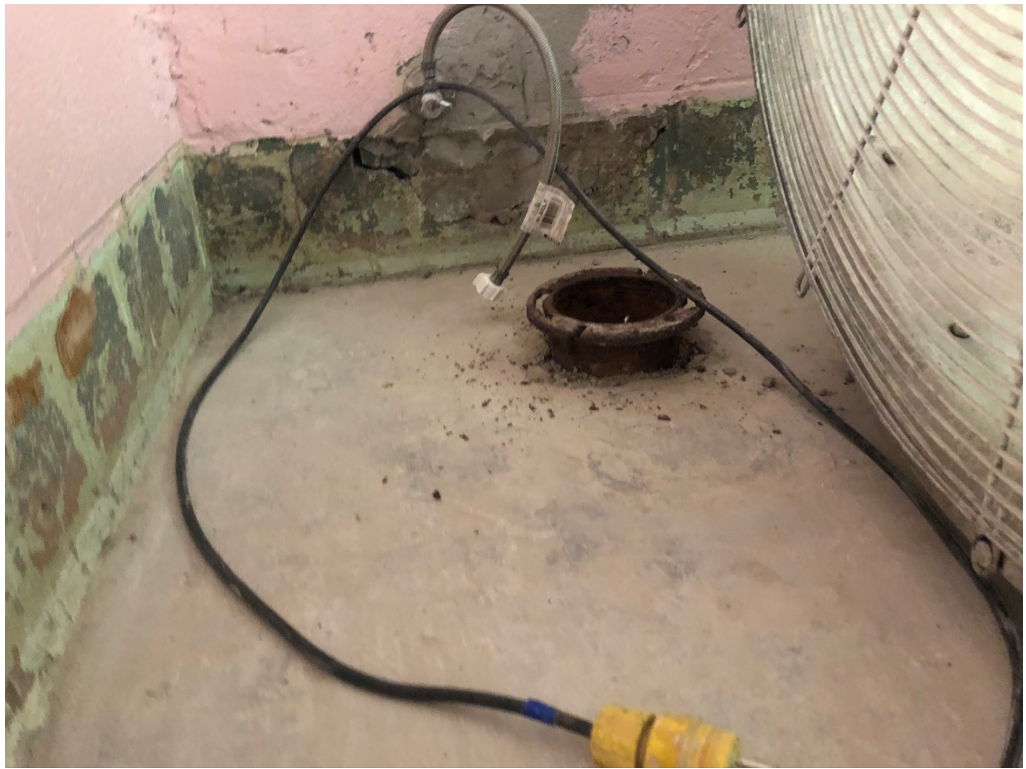
Figure 5 – Previous Large Mortar Bed in Bathrooms Requires Plumbing Rework for New

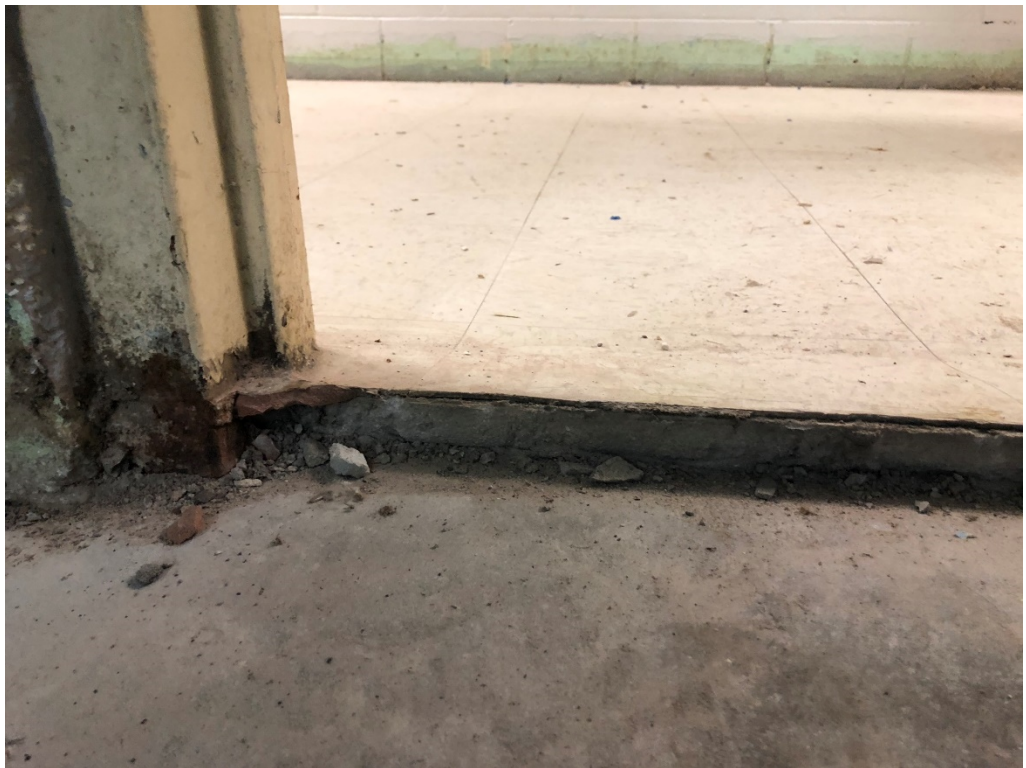
Figure 6 – Previous Large Mortar Bed in Bathrooms Requires Threshold Rework for New

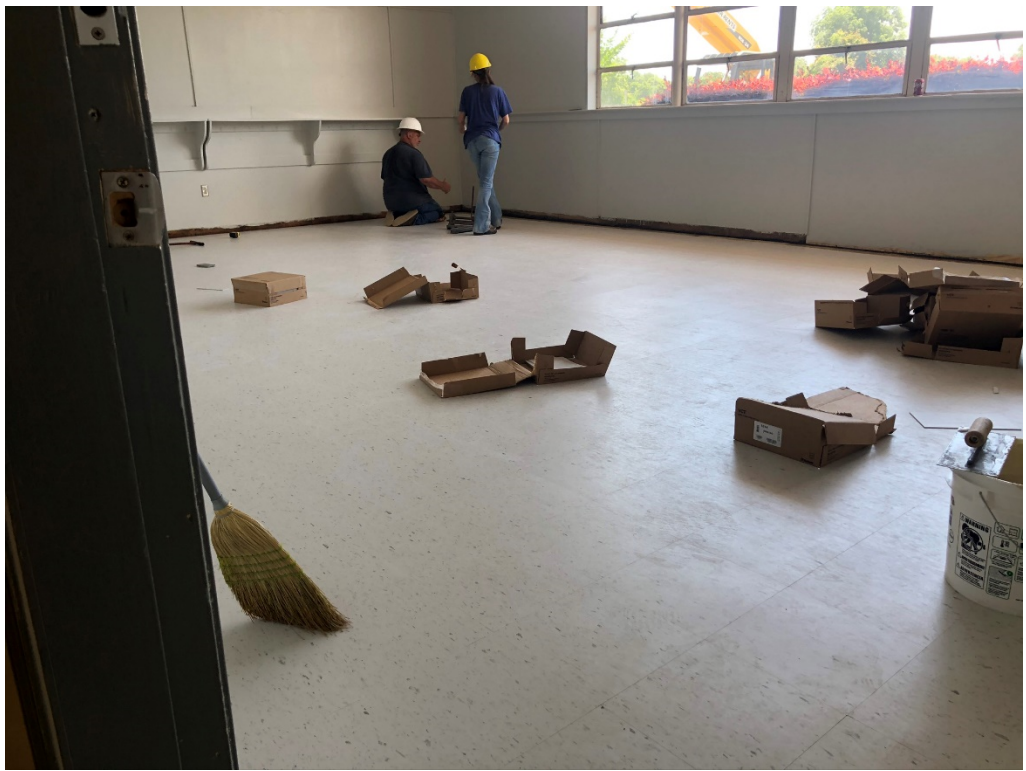
Figure 7 – Carpentry Repair at Termite Damaged Areas

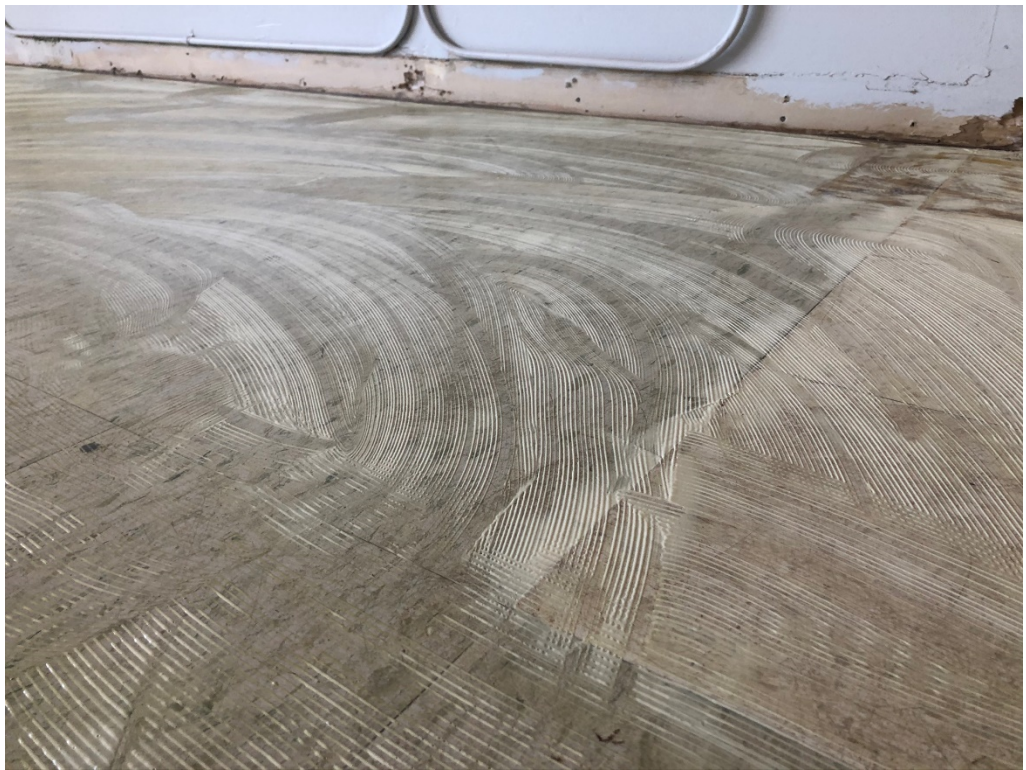
Figure 8 – Paint Prep
