## Architect's Field Report

201 Park Court, Suite B Ridgeland, MS 39157 P 601.790.9432 F 888.281.0547	04 June 2020	18044-Bovina Elementary / Report Number 014
One Jackson Place, Suite 250 188 East Capitol Street Jackson, MS 39201-2100 P 601.352.5411 F 601.352.5362	Contract	Paul Jackson & Son
161 Lameuse Street, Suite 201 Biloxi, MS 39530 P 228.374.1409 F 228.374.1414	Date / Time	03 June 2020 / 12:45 PM
	Weather / Temp	Cloudy / 83 ° F
	Est % Complete	25%
	Sched Conformance	+ 00 days
	Work in Progress	Masonry Installation Floor Preparation VCT Installation Painting
	Present at Site	Richard Creel, Paul Jackson & Son Larry Knight, Paul Jackson & Son Paul Purser, DBA
	Observations	I arrived on site at the Rear of the Project. Meeting Richard Creel, PJS, we discussed project progress. Mr. Creel stated that Mason began Monday. They have installed perimeter block over halfway on the outside.  Inside, VCT install is ongoing and nearing completion for the South Hall's South side's classrooms. These Rooms have been waxed.  Subfloor preparation is ongoing at T9 & T10.

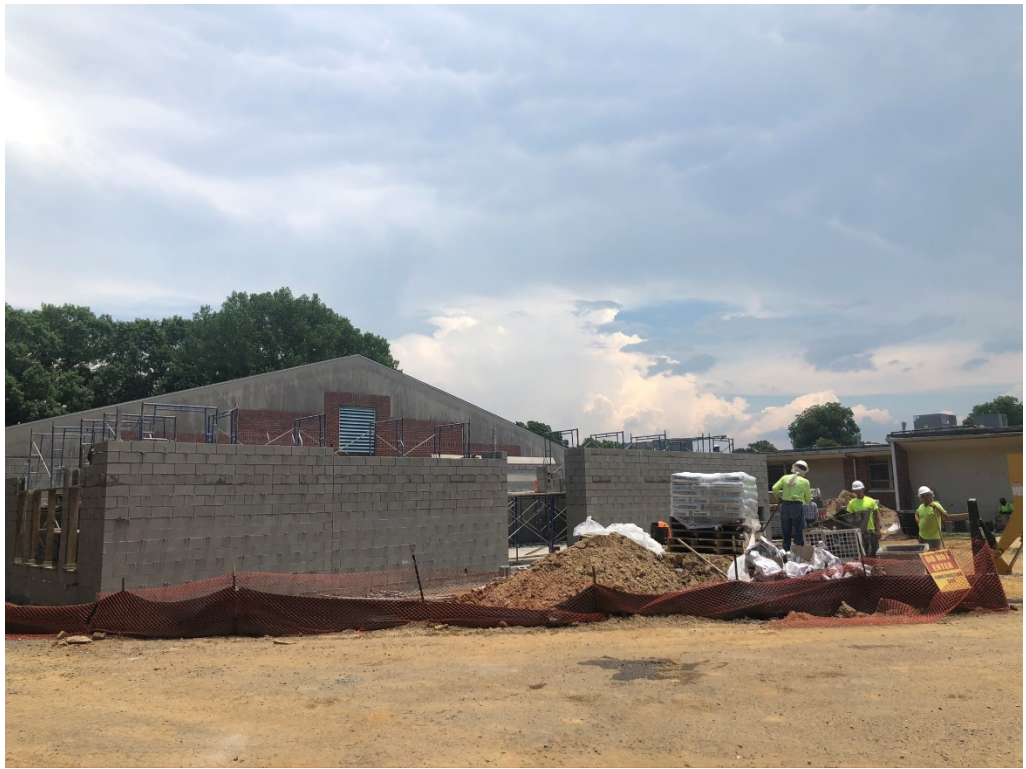
Figure 1 – Rear Addition

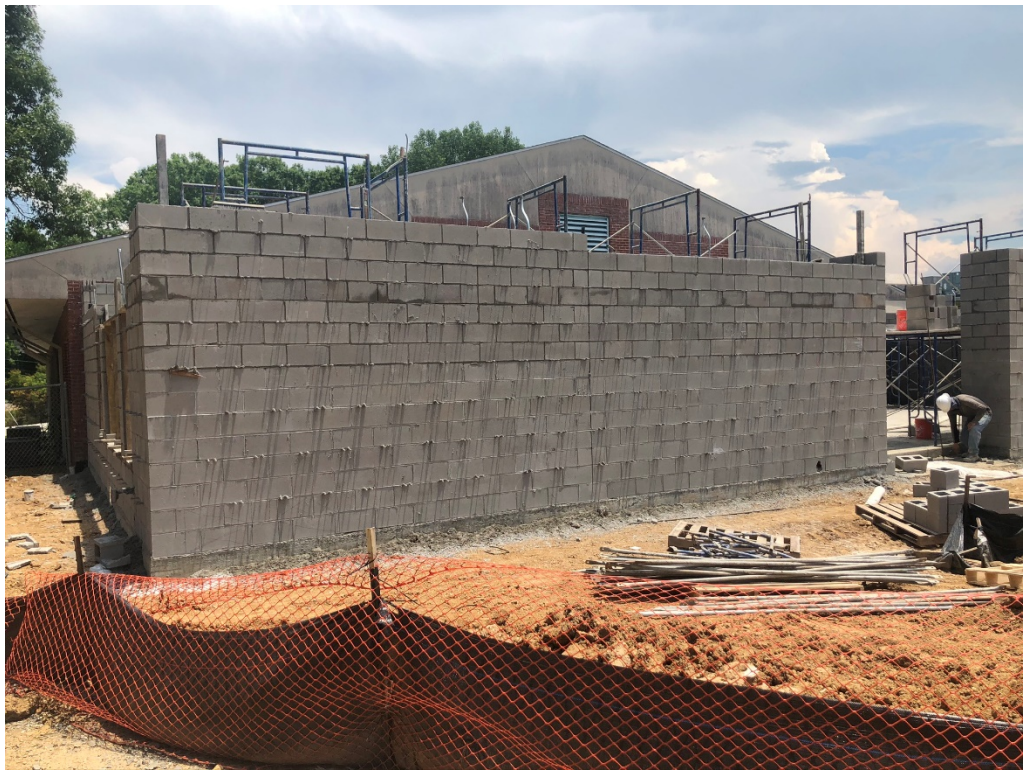
Figure 2 – NW Corner of Addition

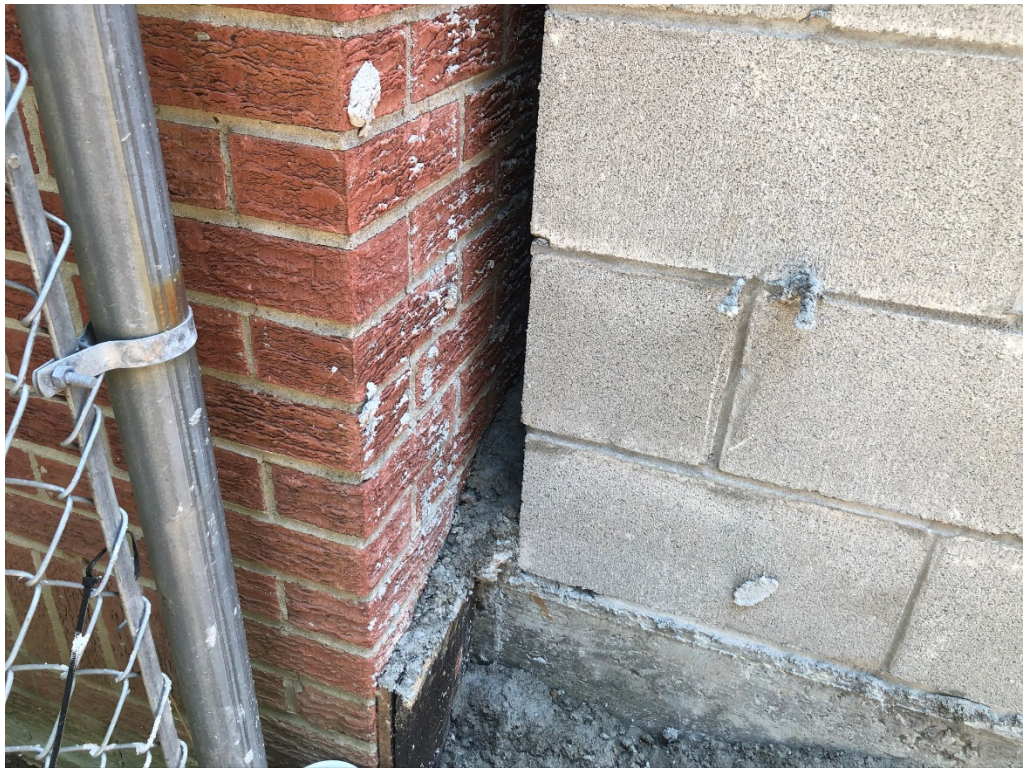
Figure 3 – Expansion joint Connection

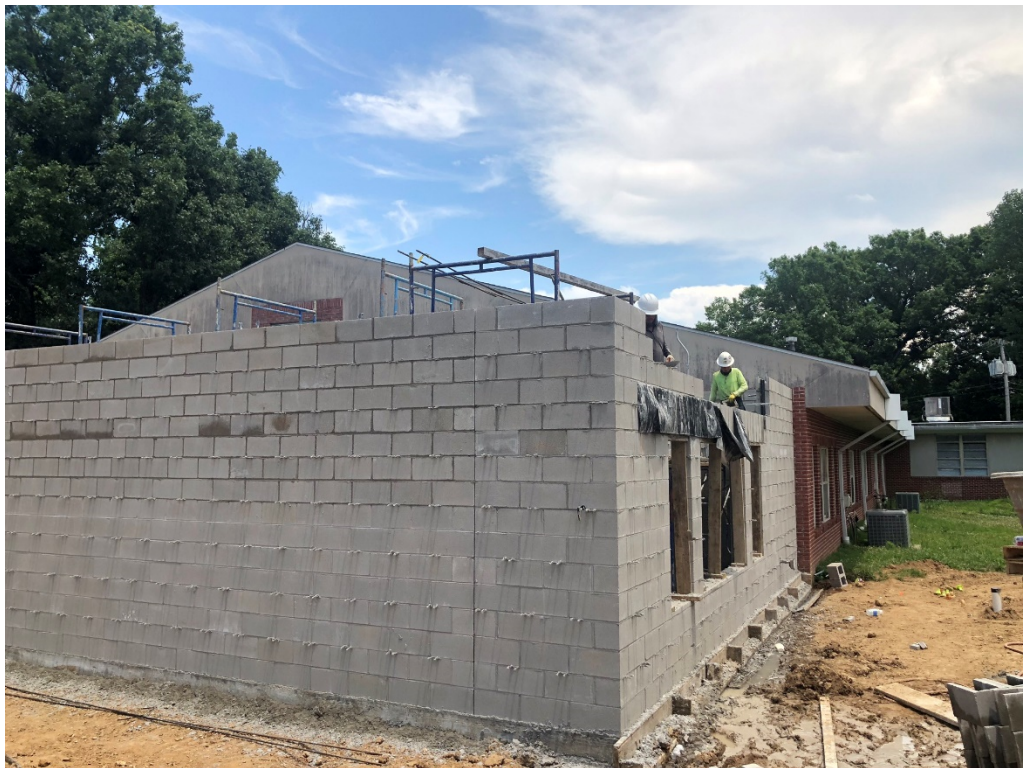
Figure 4 – SW Corner of Addition

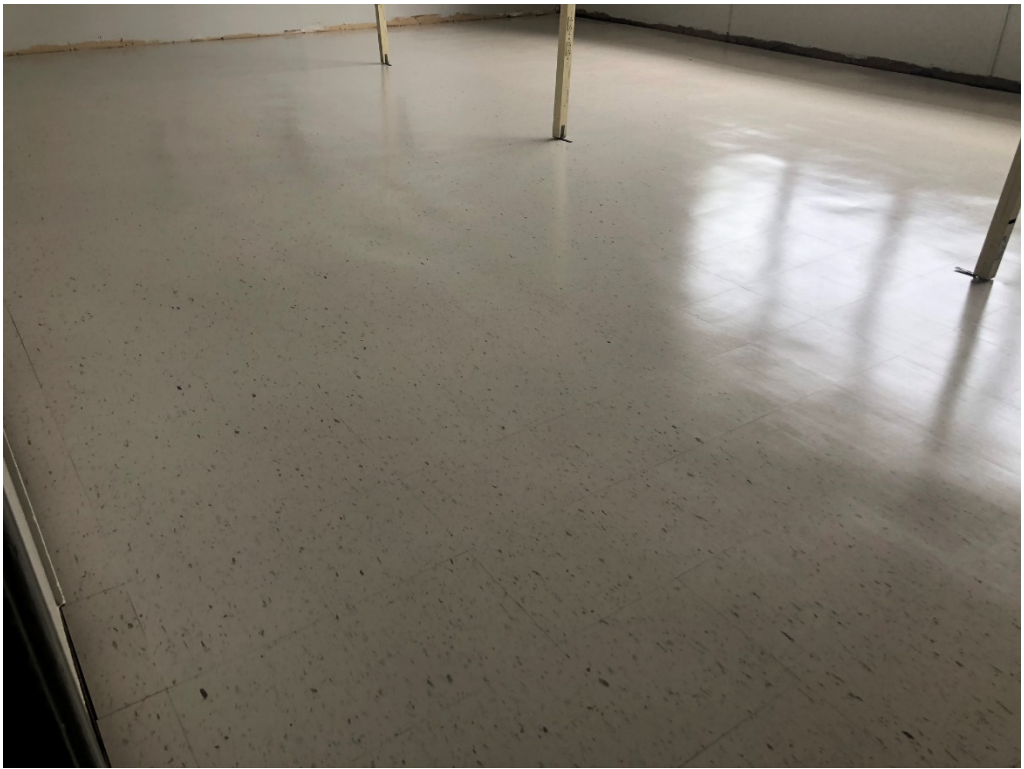
Figure 5 – New VCT Floor in South Hall Classrooms (typical)

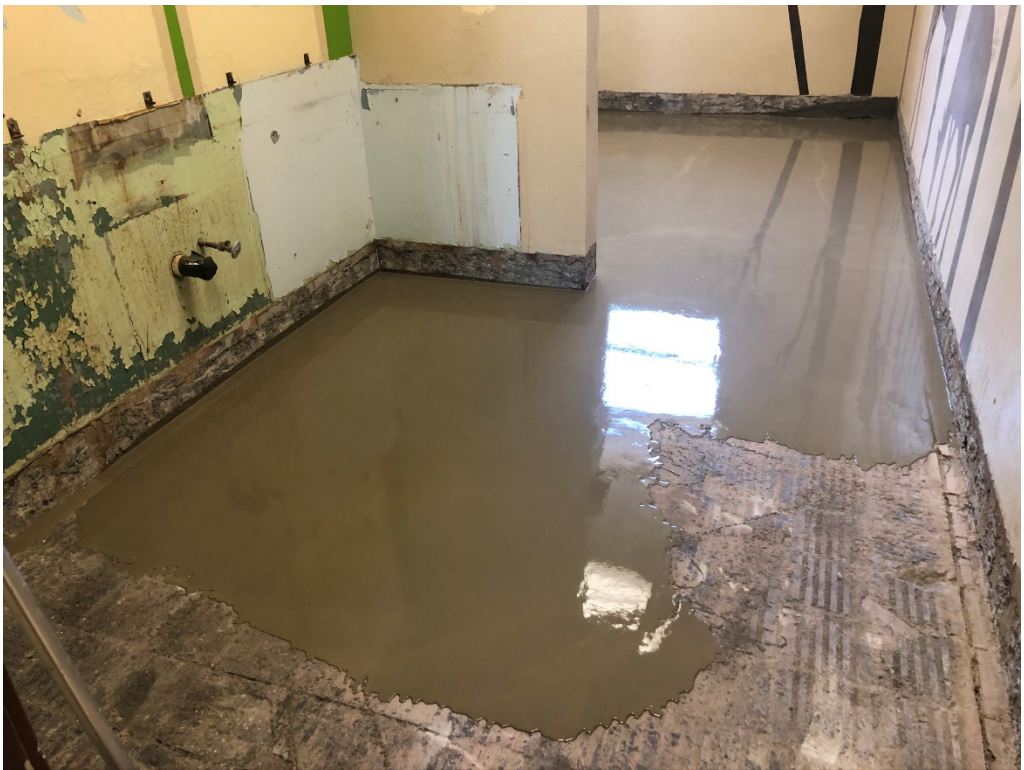
Figure 6 – Floor Leveler as Prep as Substrate for Tile

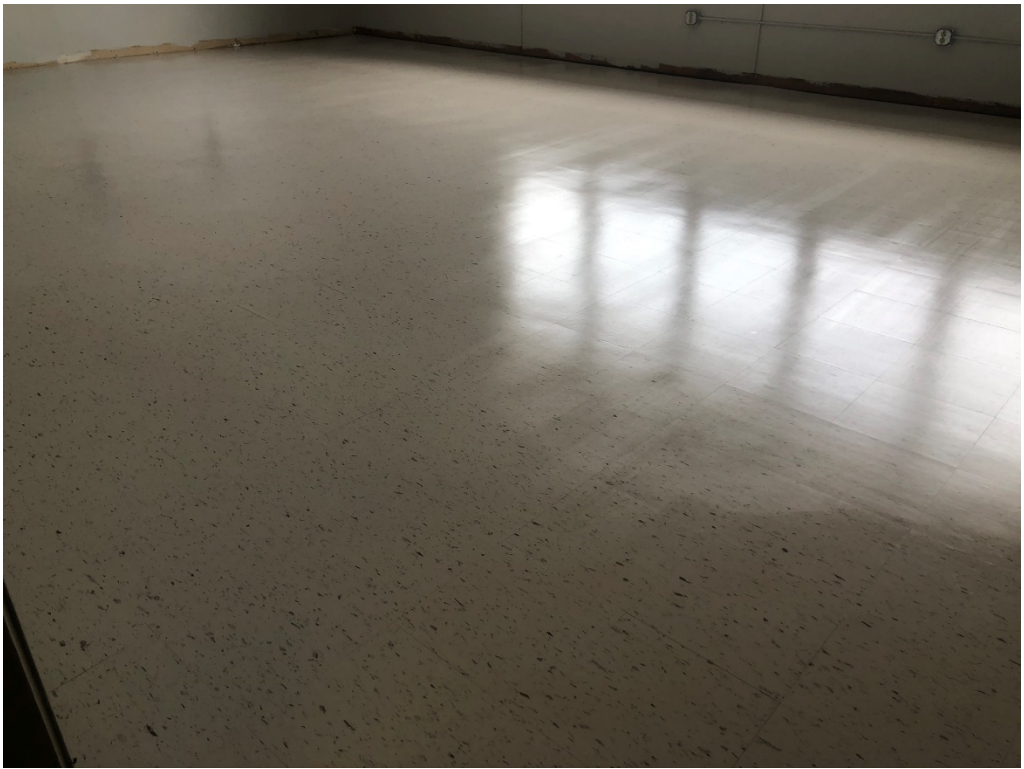
Figure 7 – New VCT Floor in South Hall Classrooms (typical)

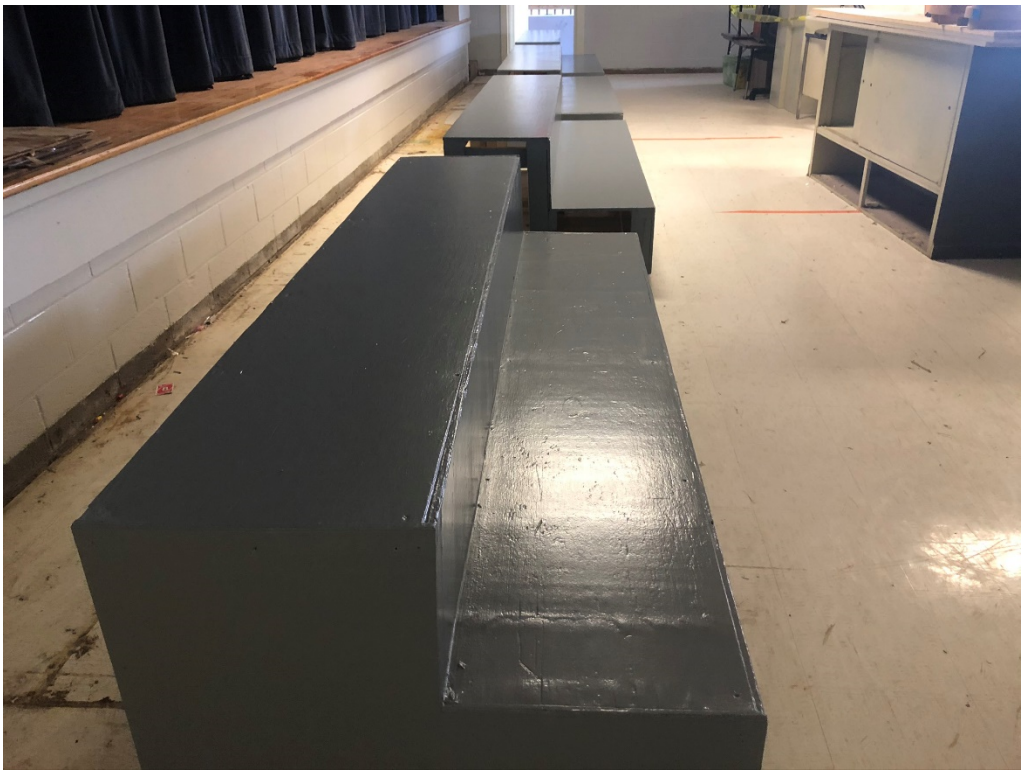
Figure 8 – Painted Steps

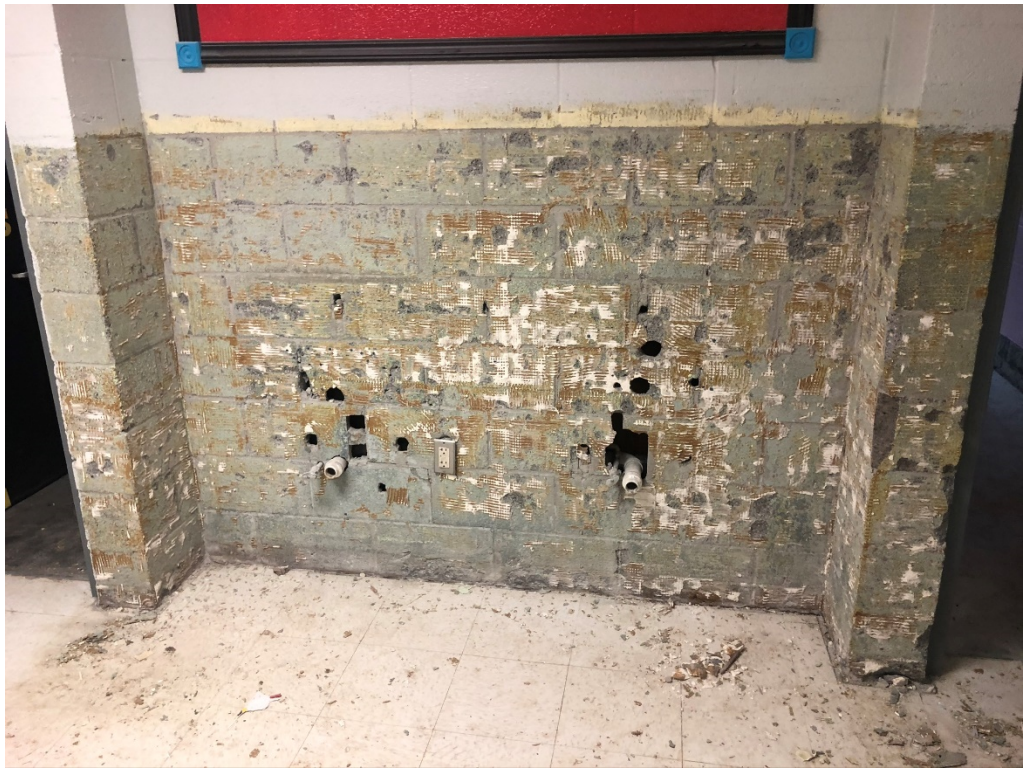
Figure 9 – Demo at EDF's

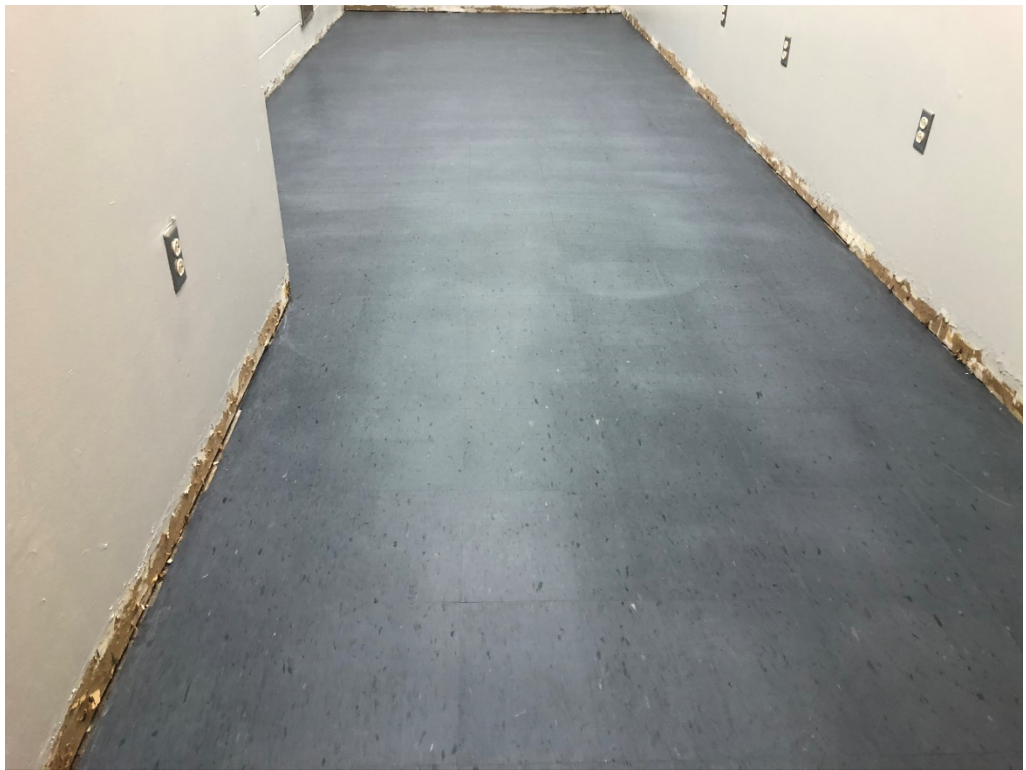
Figure 10 – VCT Install @ Counselor's Office

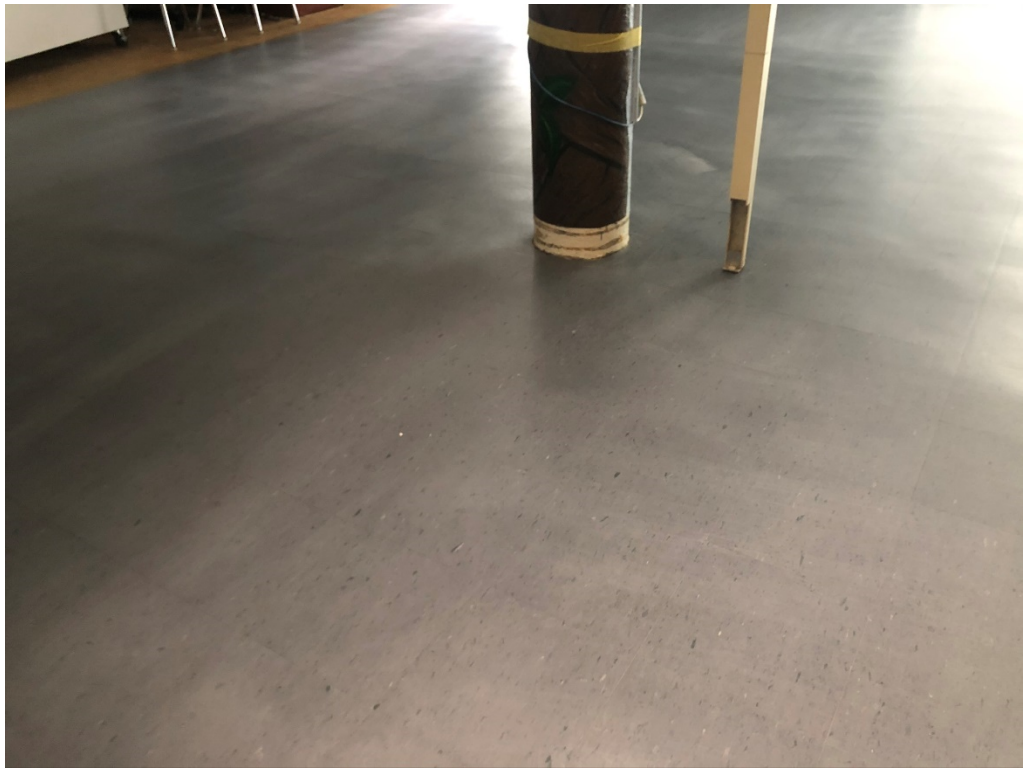
Figure 11 – VCT Install @ Library (Ongoing)

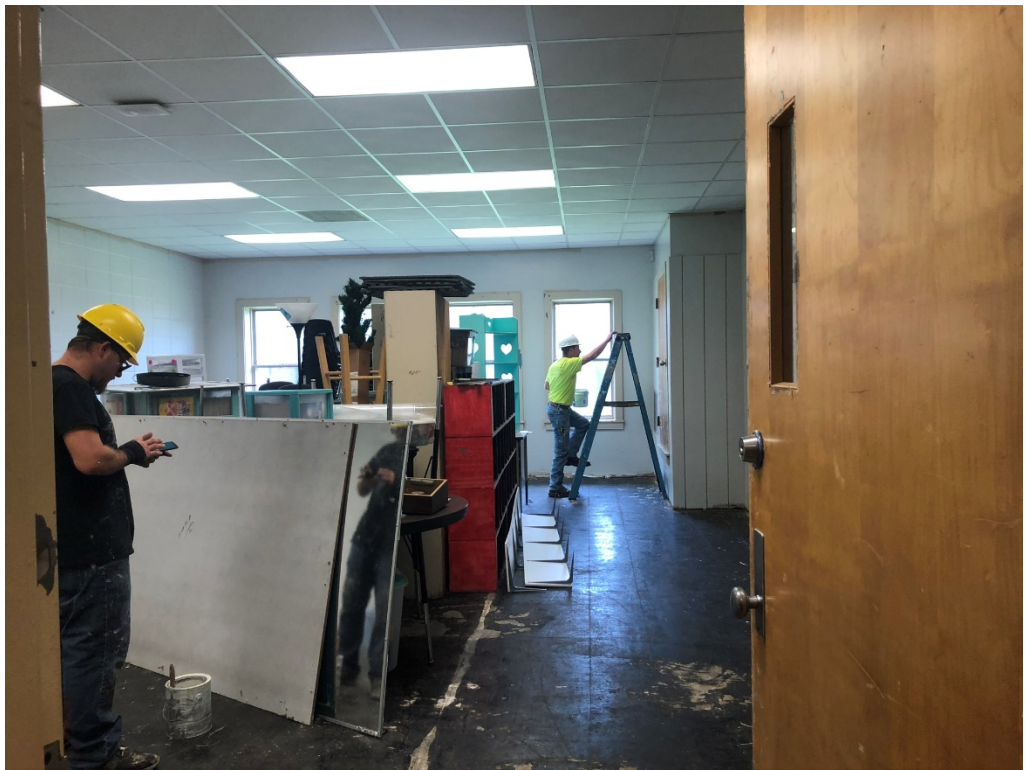
Figure 12 – Paint at North Corridor Classrooms is Ongoing

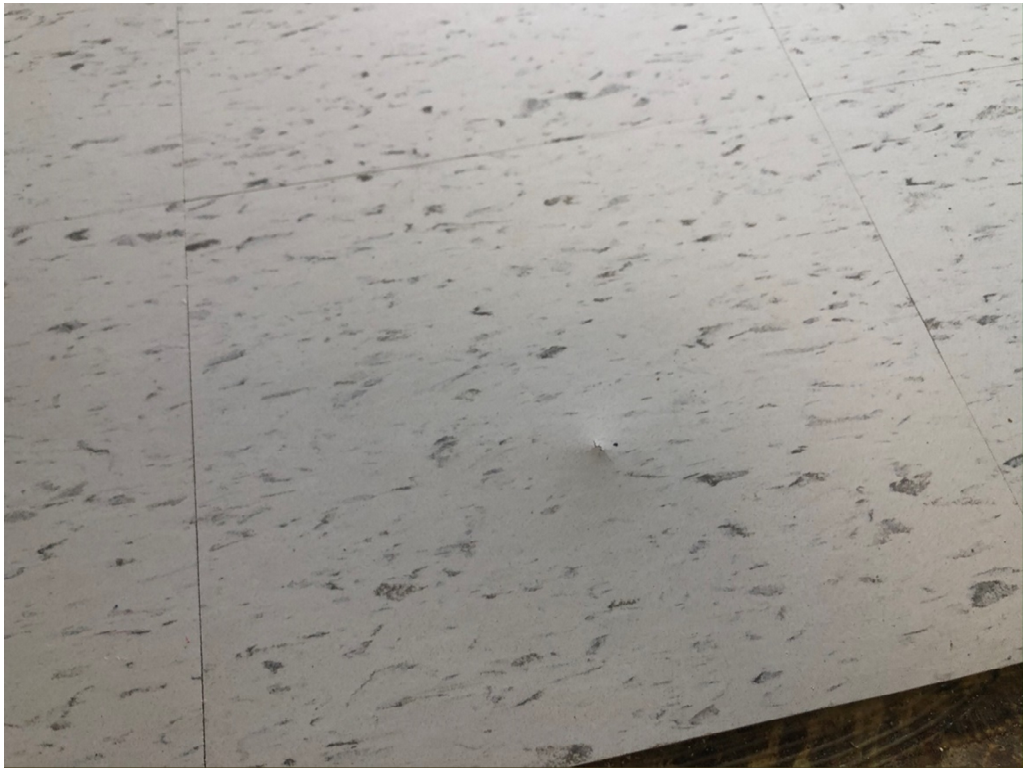
Figure 13 – Some Damage Noted at VCT at Entry to Classroom 5

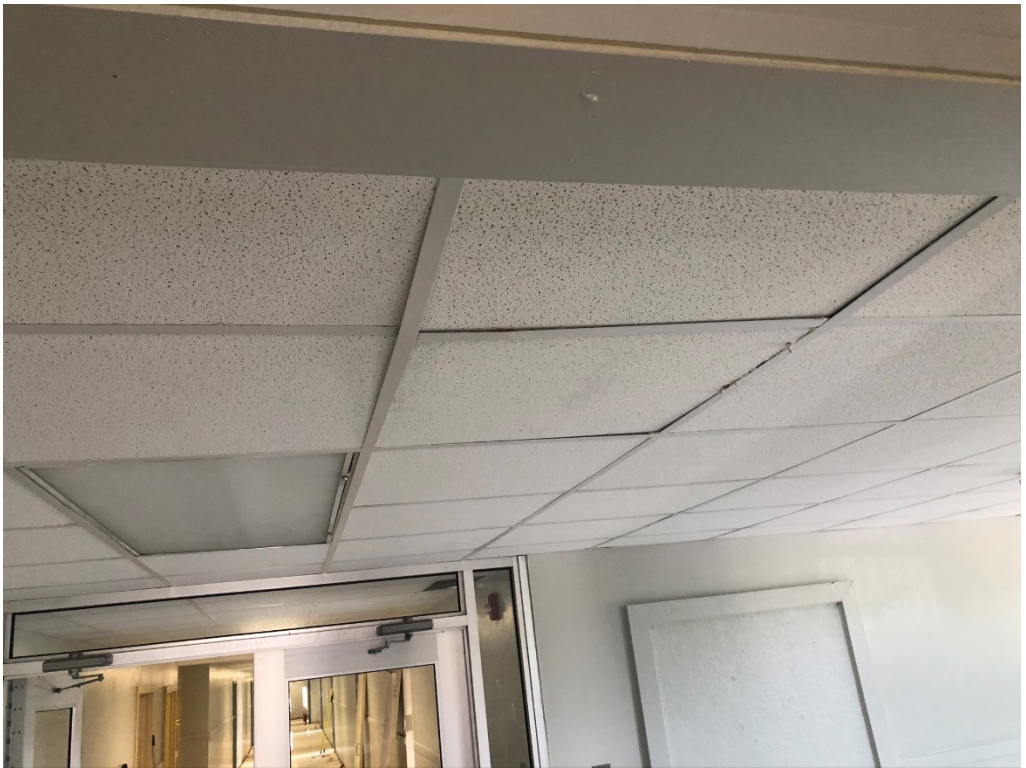
Figure 14 – Damage to Ceilings Noted after School Technical Staff Site Visit
