## Architect's Field Report

18044-Bovina Elementary / Report Number 016

18 June 2020 / 12:30 PM

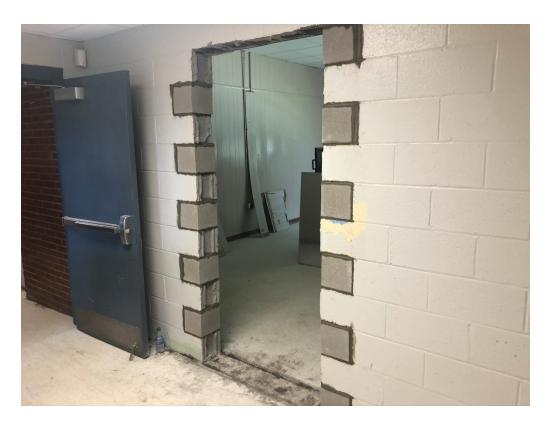
Figure 1 – New Entry @ Workroom 25

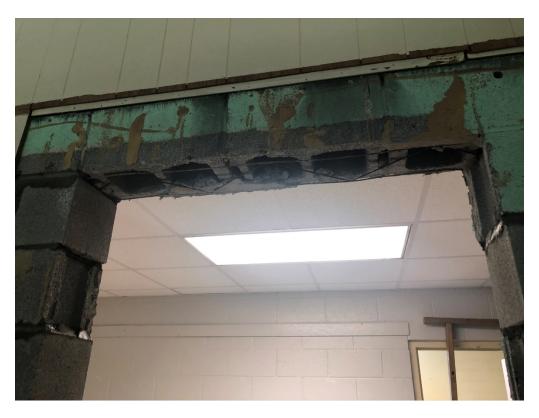
Figure 2 – Interior Header at New Entry @ Workroom 25

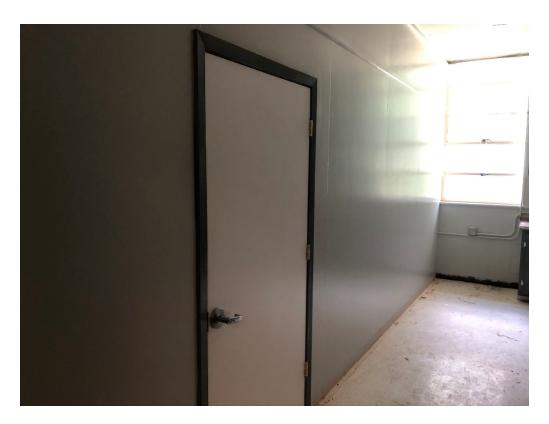
new addition. Paint work is ongoing in the existing hall and flooring

Figure 3 – Paint Work is Ongoing

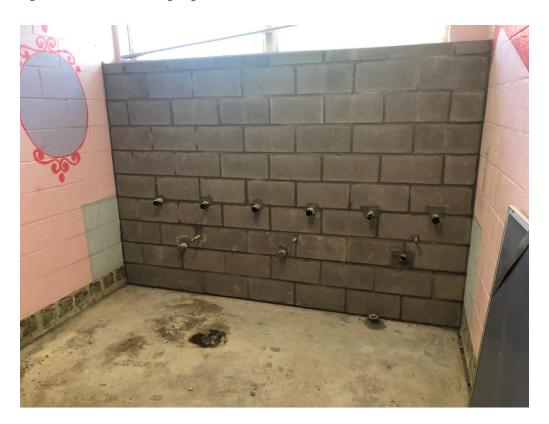
Figure 4 – Block Work at Boys T5

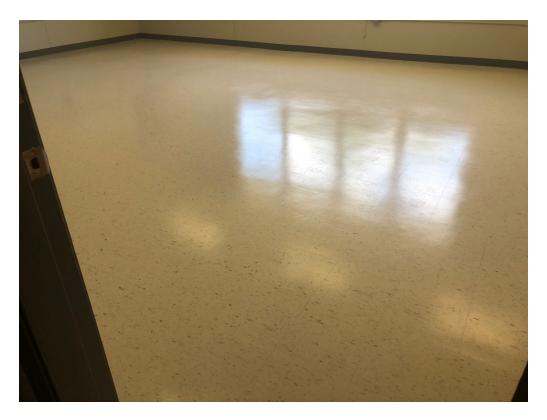
Figure 5 – NEW VCT at North side Classrooms of South Hall

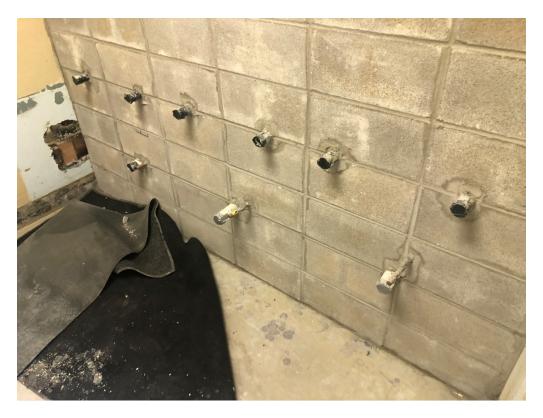
Figure 6 – Block Work at Girls T6

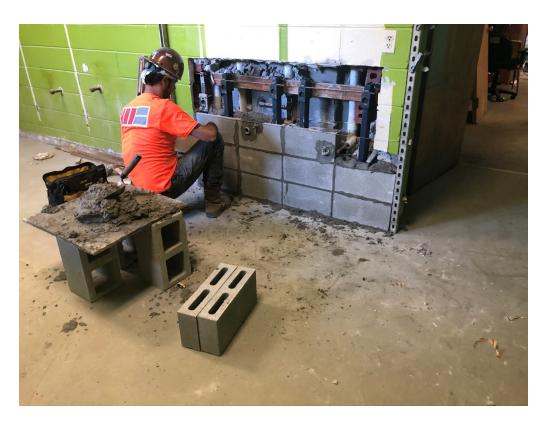
Figure 7 – Block Work at Boys T1

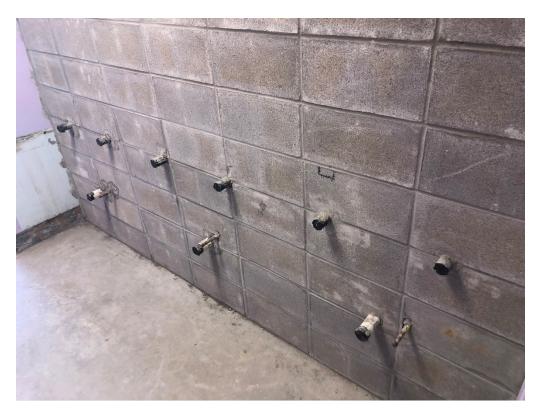
Figure 8 – Block Work at Girls T9

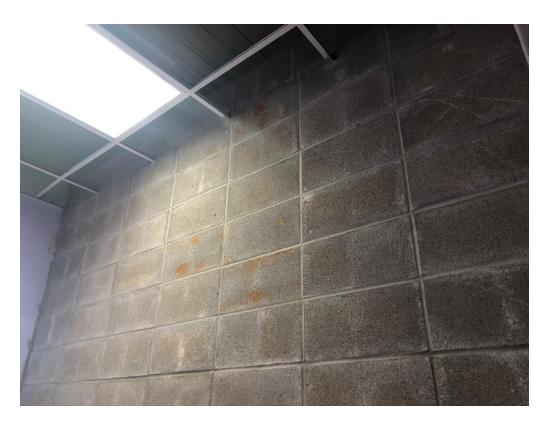
Figure 9 – Block Work at Girls T9 (Ceiling Grid will Require edge Support at Ceiling/Wall)

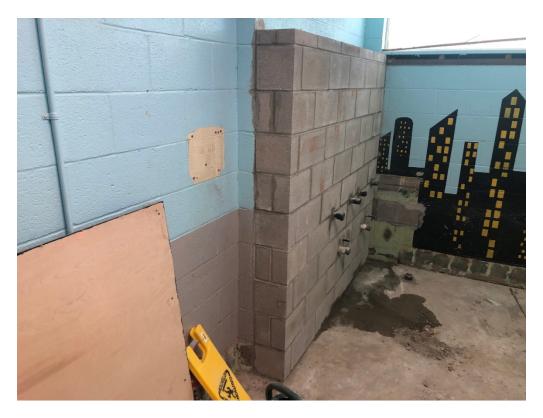
Figure 10 – Block Work at Boys T10
