Architect's Field Report

21 July 2020

18044-Bovina Elementary / Report Number 020

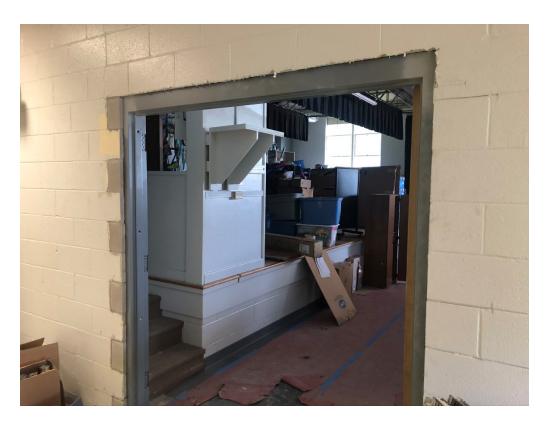
Figure 1 – Steel Frame Installed at Auditorium

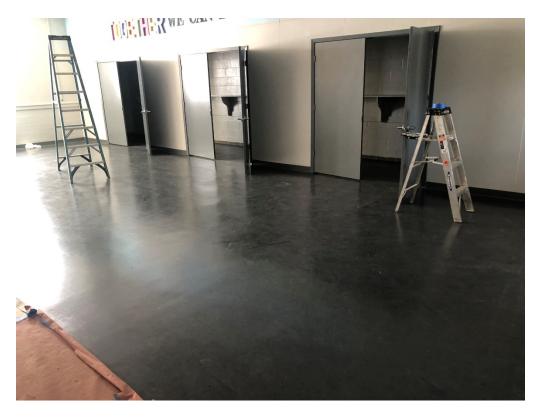
Arriving on site, I entered thru the front. VCT work has been completed in the Auditorium. As I moved along through the corridors, I also saw that VCT work in the North Corridor has been installed but not waxed. Tile in the bathrooms off of this hall is ongoing and about 75% complete.

Figure 2 – VCT installed and Waxed at Auditorium

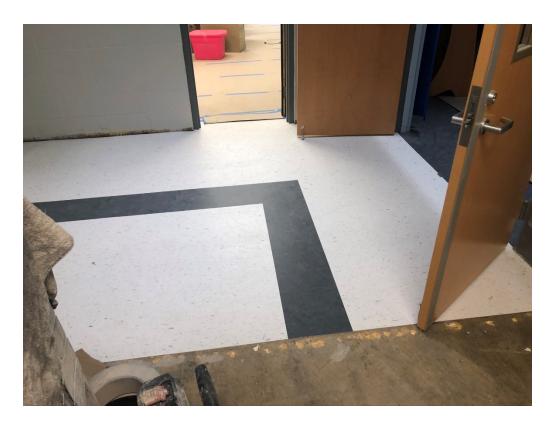
Figure 3 – North Hall VCT

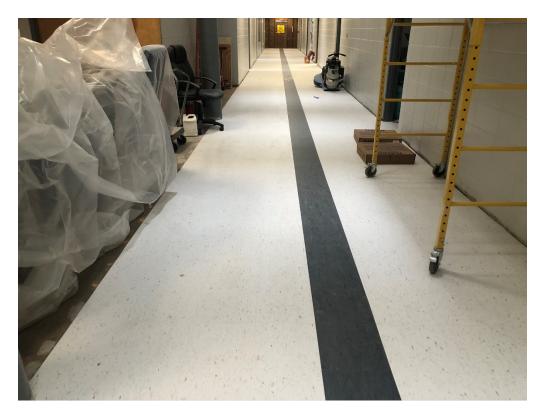
Figure 4 – North Hall VCT

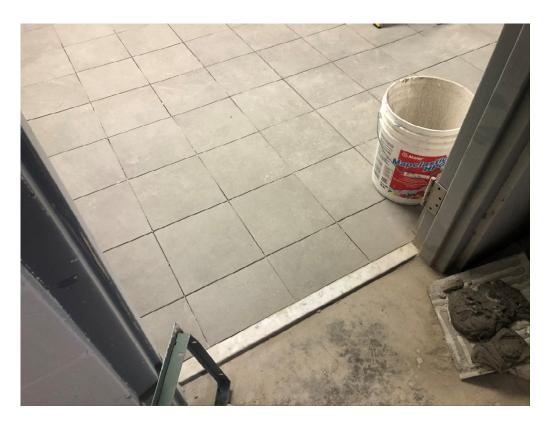
Figure 5 – Marble Threshold Installed

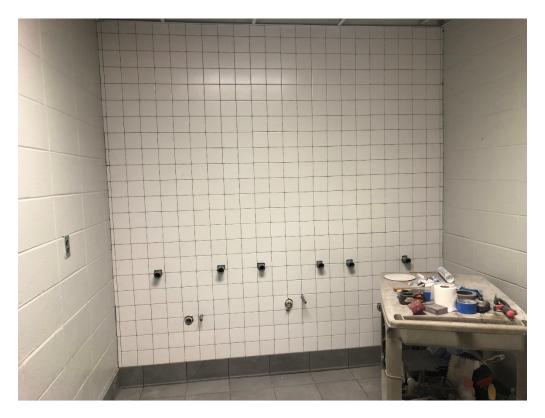
Figure 6 – Tile at Wet Wall

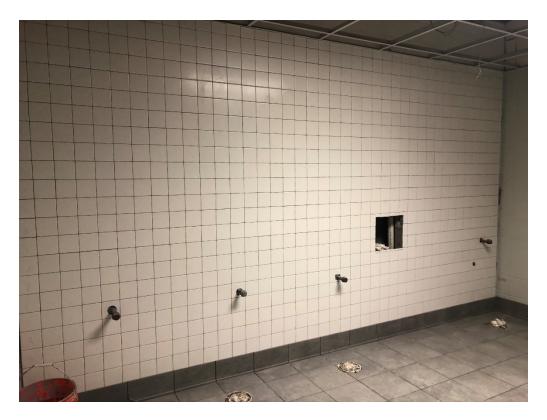
Figure 7 – Tile at Wet Wall

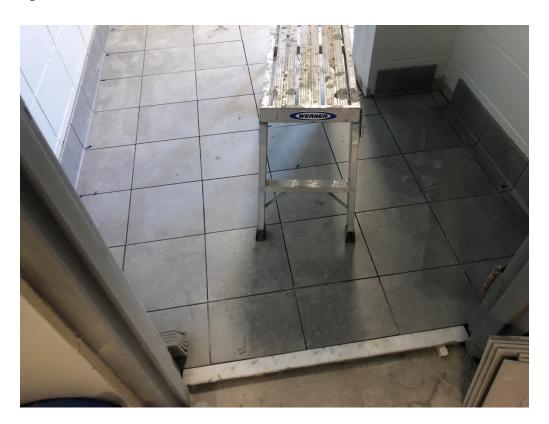
Figure 8 – Tile at Wet Wall

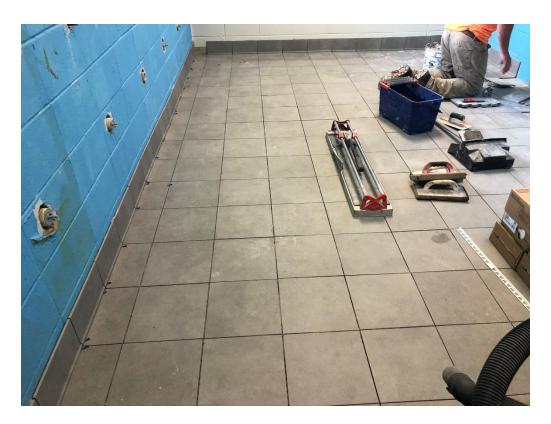
Figure 9 – Tile Set

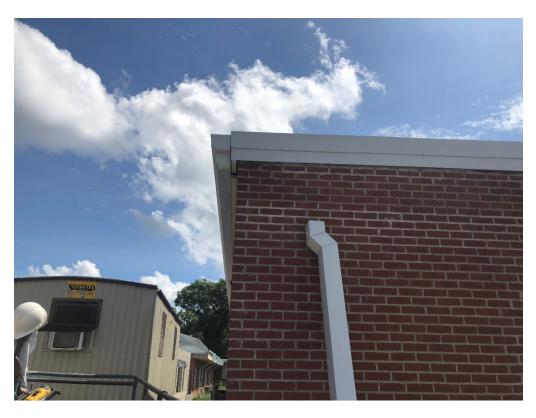
At the exterior, roofers have installed edge trim and gutter work is

beginning.

Figure 10 – New Metal Edge Trim & Downspout ready to install

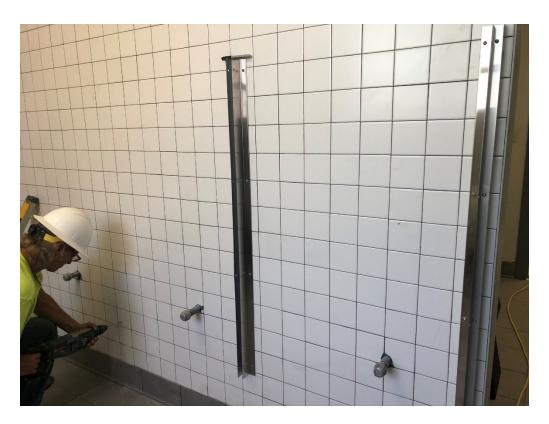
Figure 11 – Toiler Partition Installation

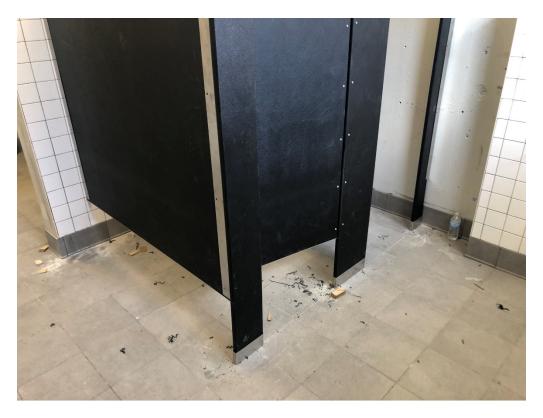
Figure 12 – Toiler Partition Installation

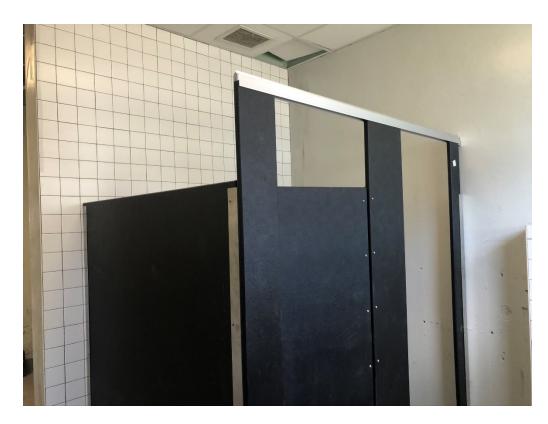
Figure 13 – Toiler Partition Installation

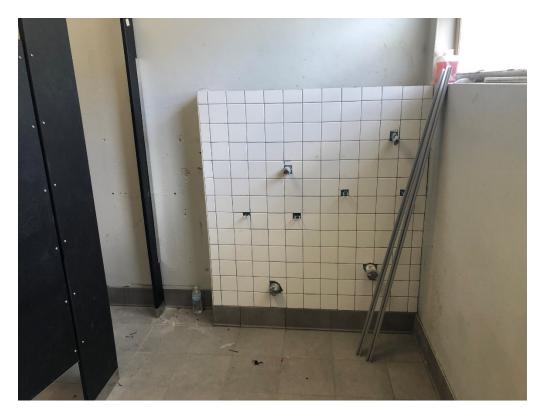
Figure 14 – Tile at Urinal Wall

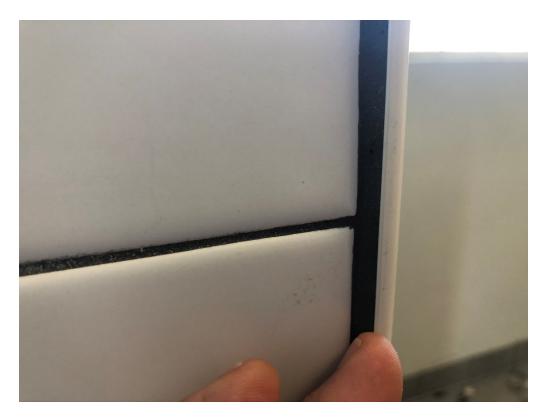
Tile has been completed in these restrooms. Pay attention to figures 15

& 16 in this report as this trim is not correctly seated in the tile.

Figure 15 – Edge Trim Protrudes 1/8" +/-

Reset Metal trim for flush appearance with tile.

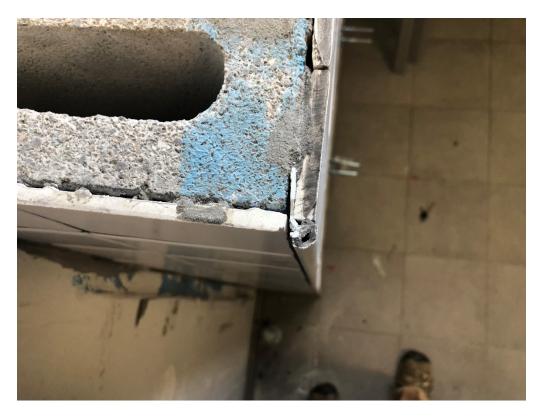
Figure 16 – Edge Trim Protrudes 1/8" +/-
