Architect's Field Report

27 August 2020

18044-Bovina Elementary / Report Number 022

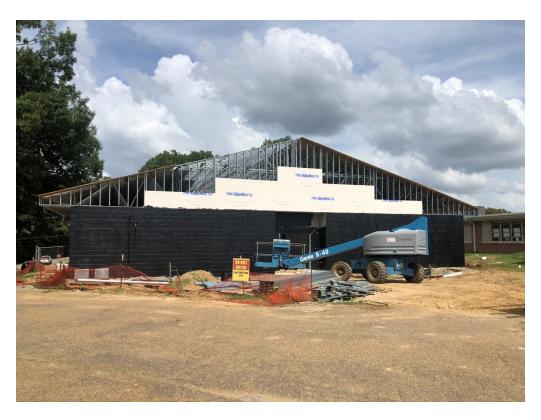
Figure 1 – On-going build at Addition

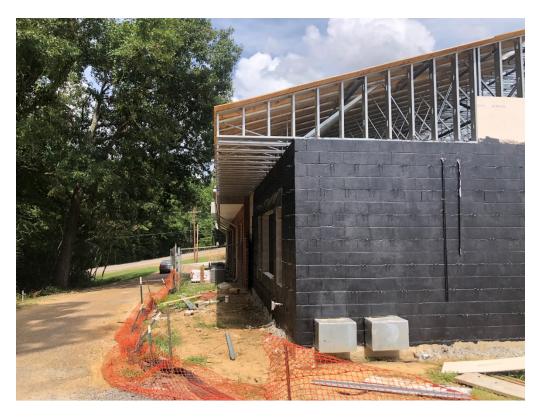
up decking at the roof and pulling off.

Figure 2 – Decking Partially Installed

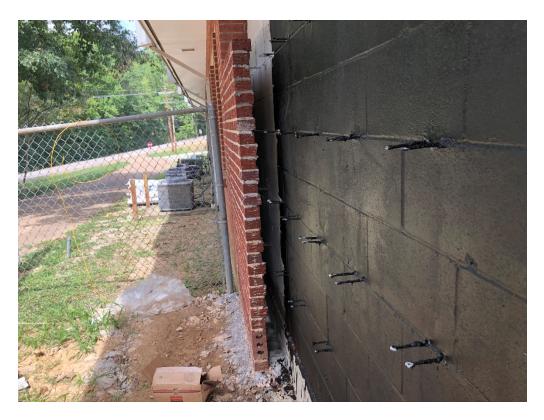
Figure 3 – Brick Mockup and example of Air Gap

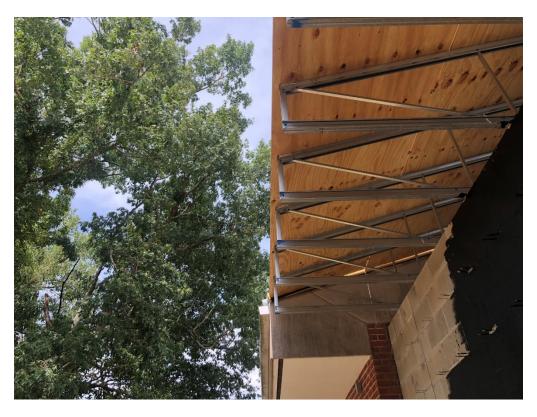
Figure 4 – Roof Edge at North Side of Building

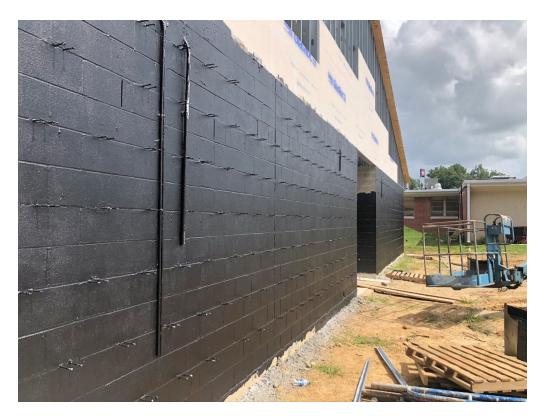
Figure 5 – Exterior Rock Partially Installed

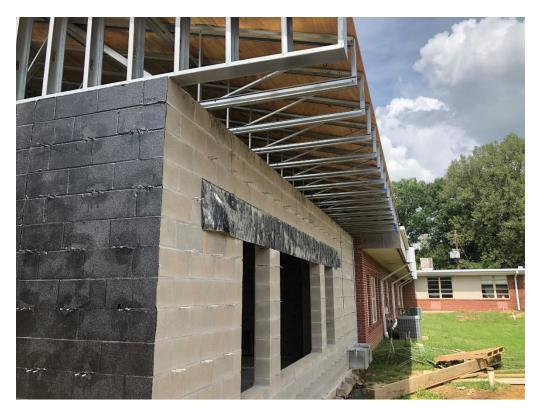
Figure 6 – Water-Proofing Partially Installed

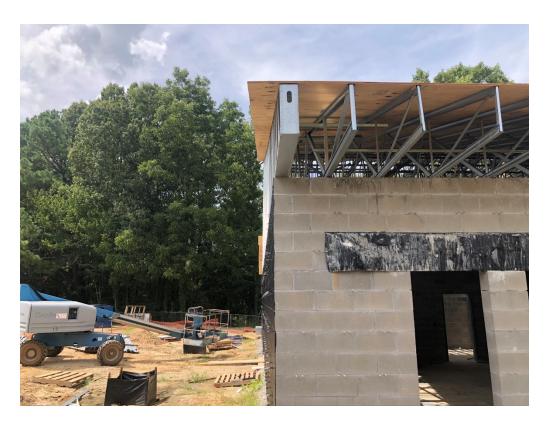
Figure 7 – Roof Edge

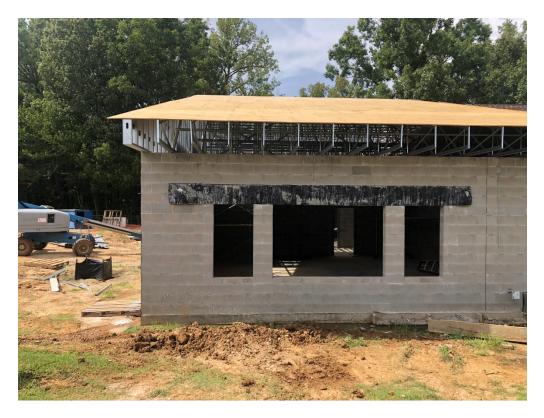
Figure 8 – Decking Partially Installed

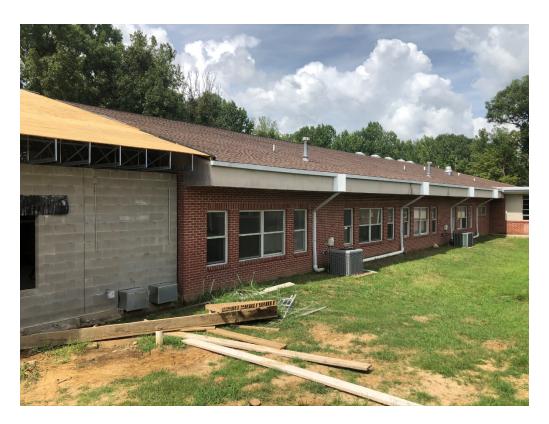
Figure 9 – Roofing Installed

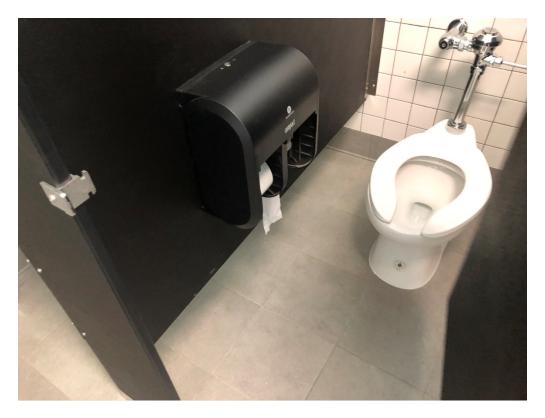
Figure 10 – Toilet Paper Towel Holders Installed

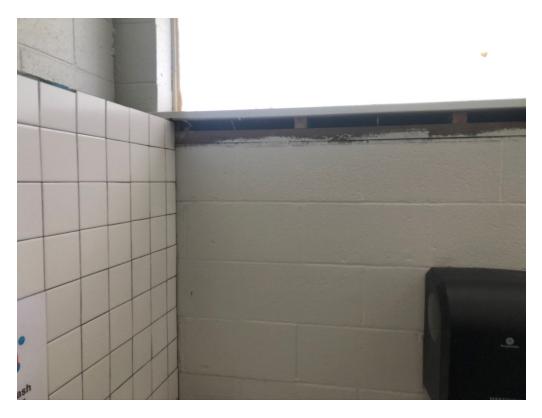
Figure 11 – Finishing Still Needed at top of Walls

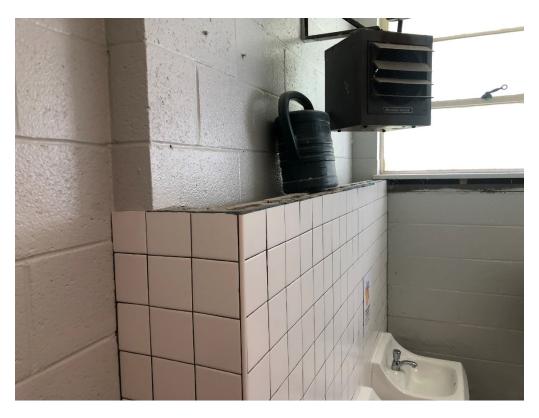
Figure 12 – Caps Required at Wall Tops

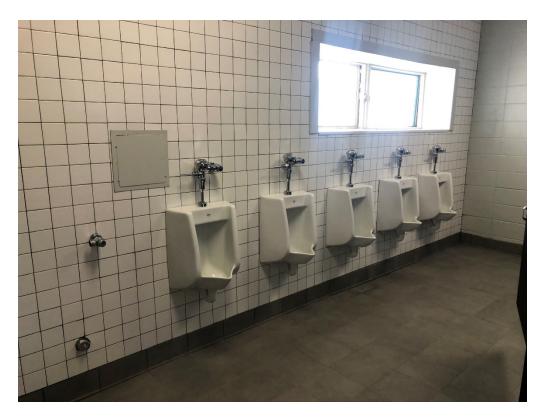
Figure 13 – Missing Urinal Installed

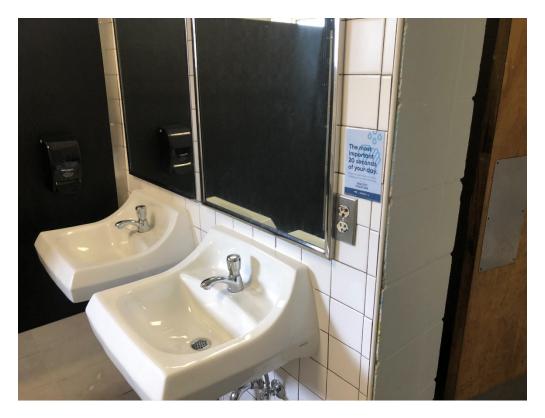
Figure 14 – Outlet Covered

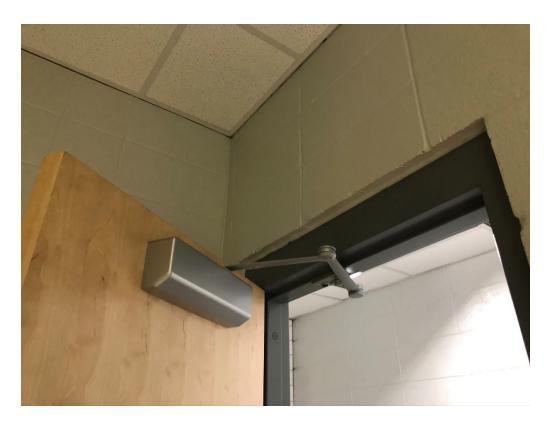
Figure 15 – Closer Opens Approx. 70 degrees

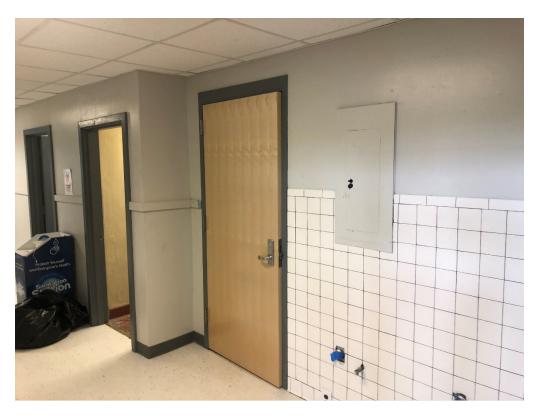
Figure 16 – Door Panels Installed
