Architect's Field Report

201 Park Court, Suite B Ridgeland, MS 39157 P 601.790.9432 F 888.281.0547	18 September 2020
One Jackson Place, Suite 250 188 East Capitol Street Jackson, MS 39201-2100 P 601.352.5411 F 601.352.5362	18044-Bovina Elementary / Report Number 024
161 Lameuse Street, Suite 201 Biloxi, MS 39530 P 228.374.1409 F 228.374.1414	Contract Paul Jackson & Son Date / Time 16 September 2020 / 2:00 PM Weather / Temp Partly cloudy / 85 ° F Est % Complete 74% Sched Conformance + 00 days Work in Progress Storefront Install Firewall Installation Present at Site Richard Creel, Paul Jackson & Son Paul Purser, DBA Observations I arrived on site when school was letting out. Workers at the rear addition were operating within the project bounds without disturbing school dismissal. Storefront installers were finishing up installing the final window unit, carefully fitting the aluminum frame into the existing brick opening. Brick masons still have to come and complete brick sills. Inside, framers were completing light gauge stud framing and drywall installation for the fire wall to be installed between the existing structure and the new addition. Items to Verify None Action Required no

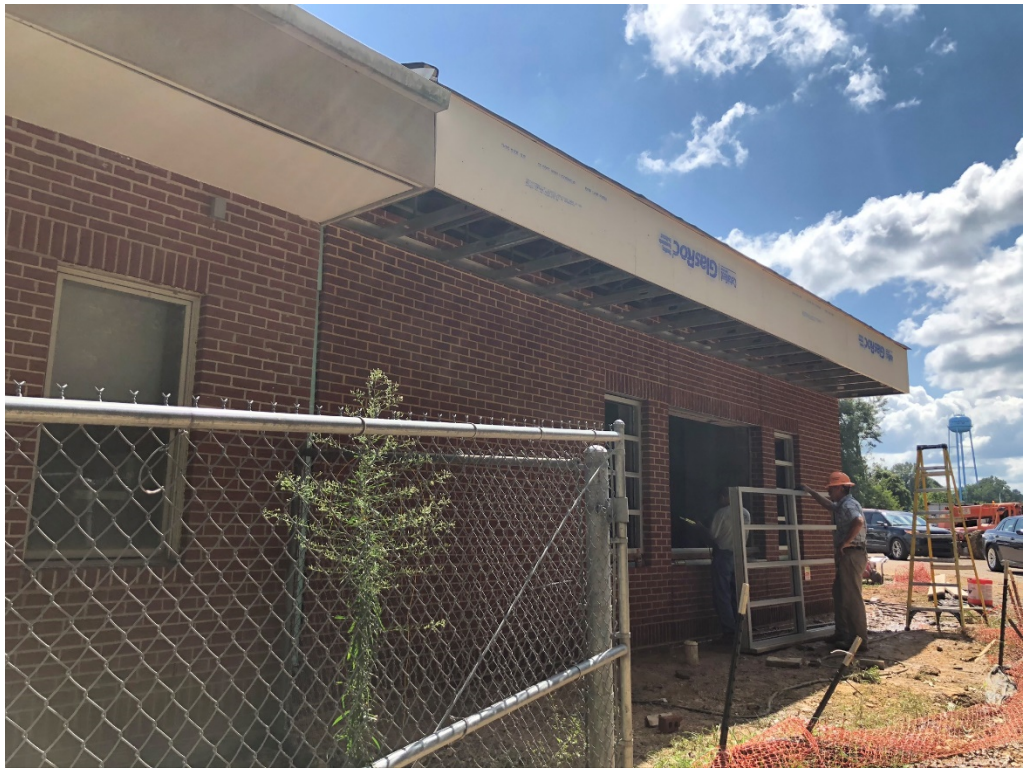
Figure 1 – Soffit Framing and Sheathing is Complete

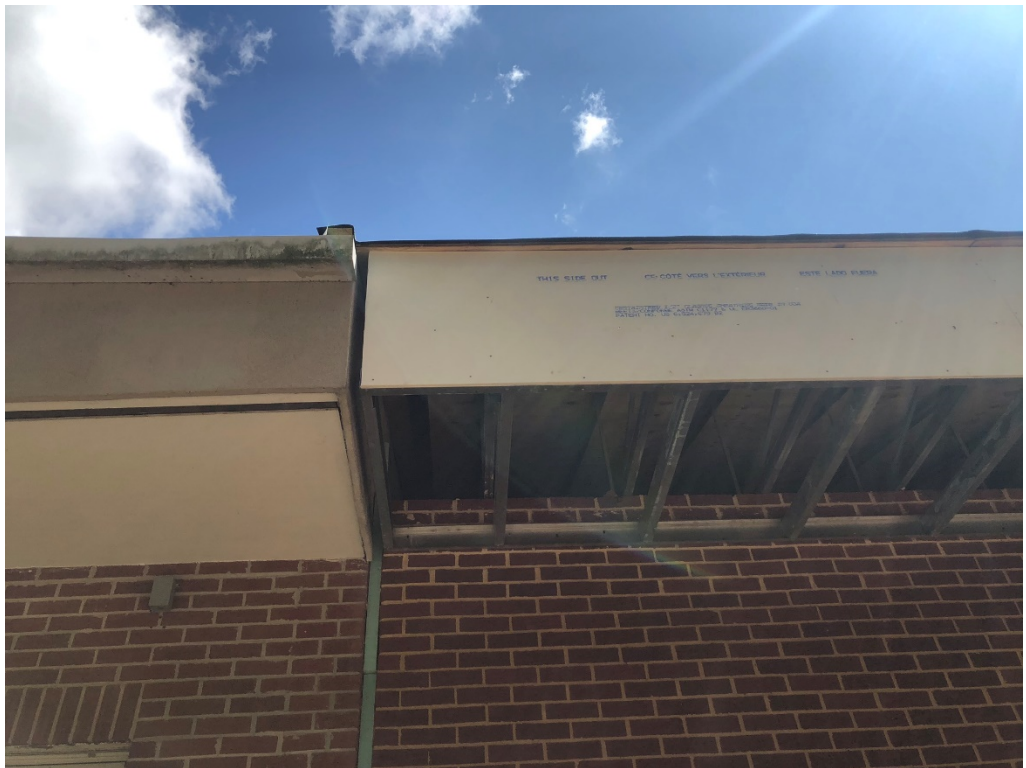
Figure 2 – Soffit Framing and Sheathing is Complete

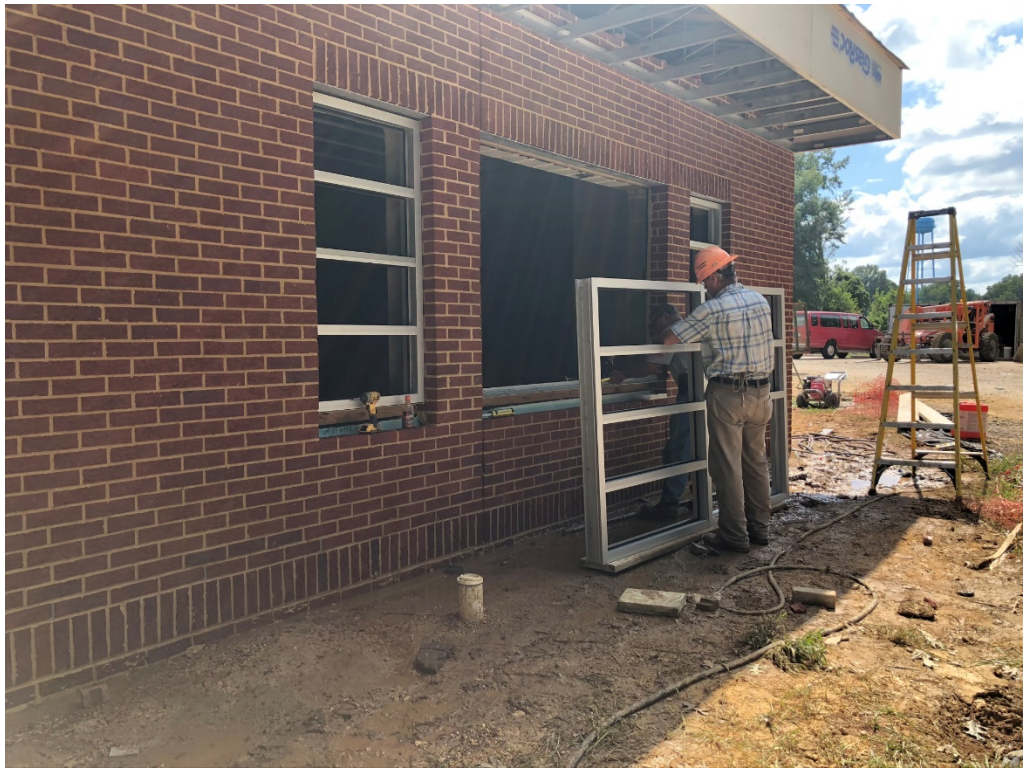
Figure 3 – Storefront Install Ongoing

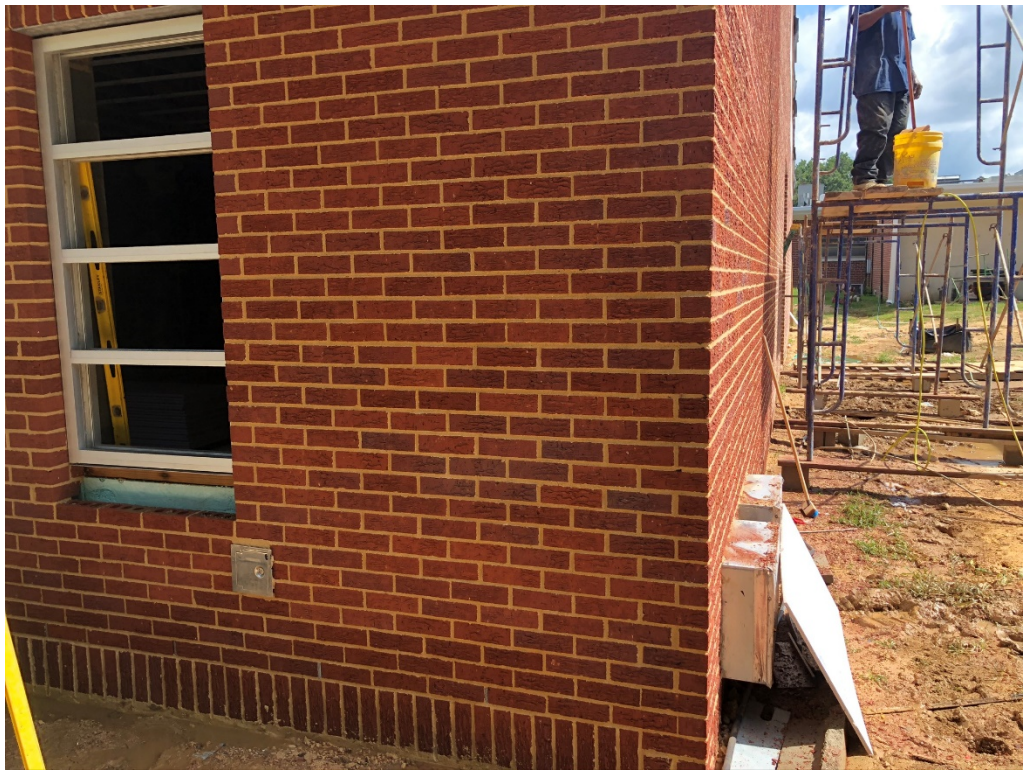
Figure 4 – Most Windows are Complete

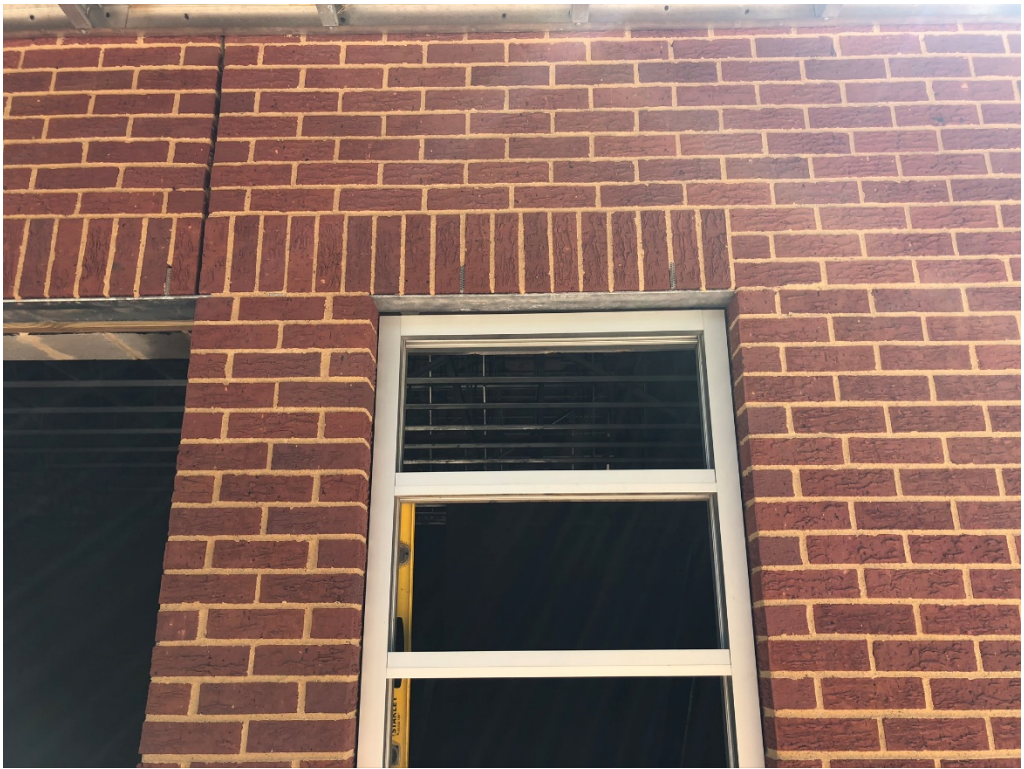
Figure 5 – Storefront Window Installed

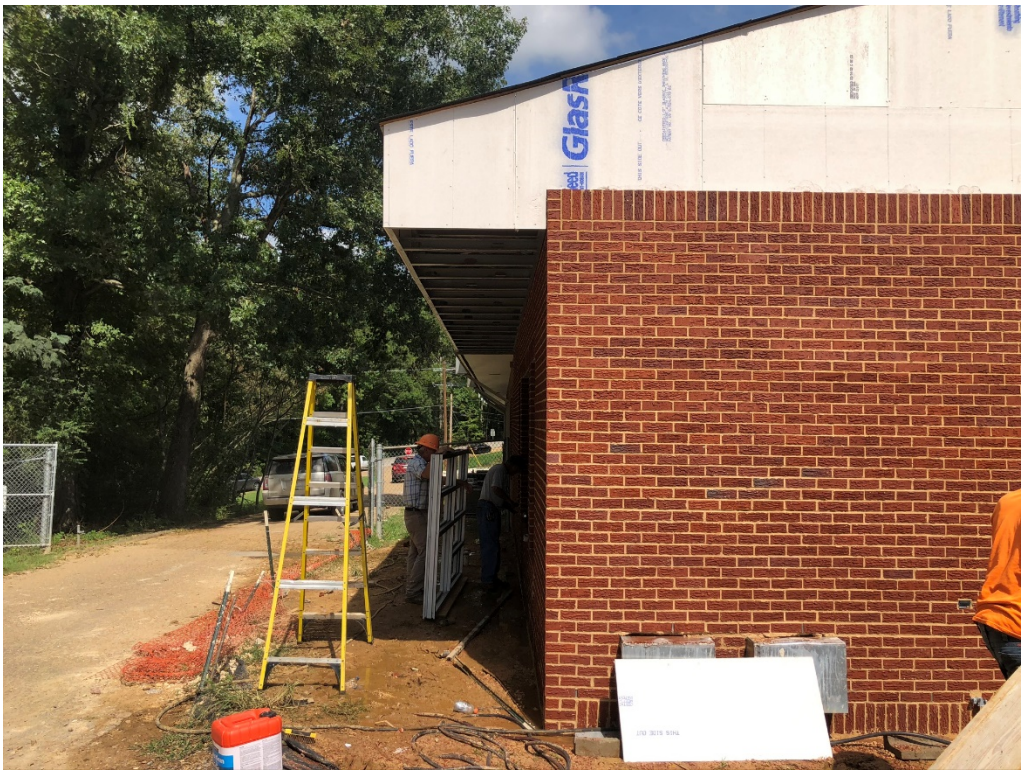
Figure 6 – Soffit Work

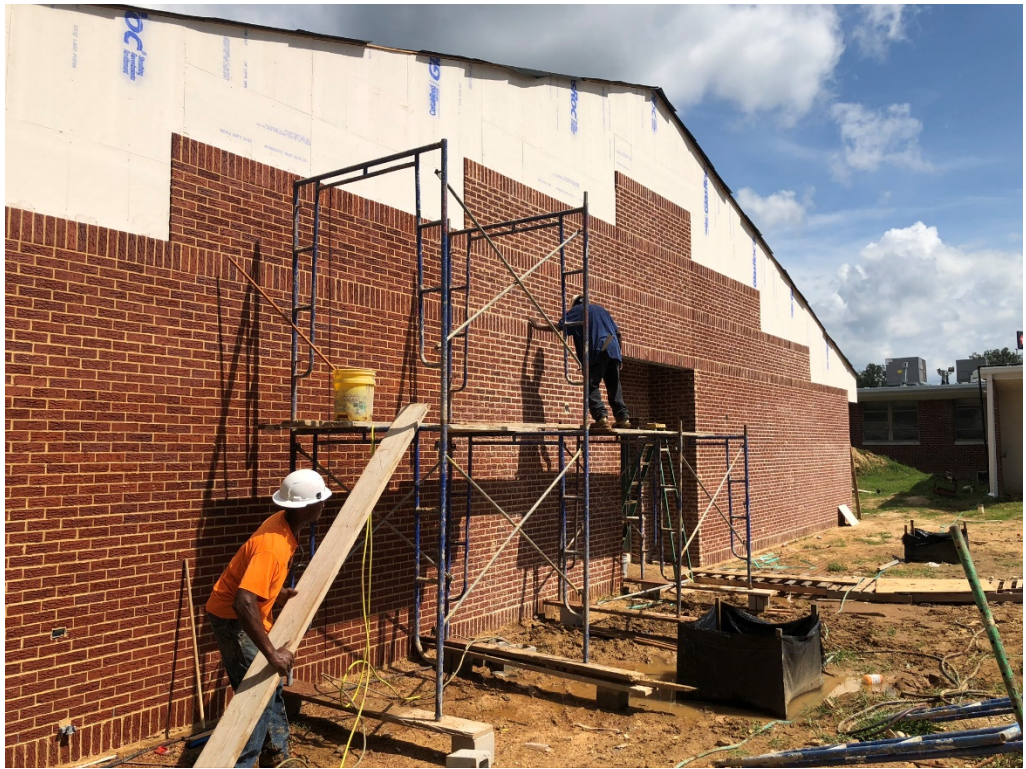
Figure 7 – Workers Setting Scaffold for Exterior Finish Work

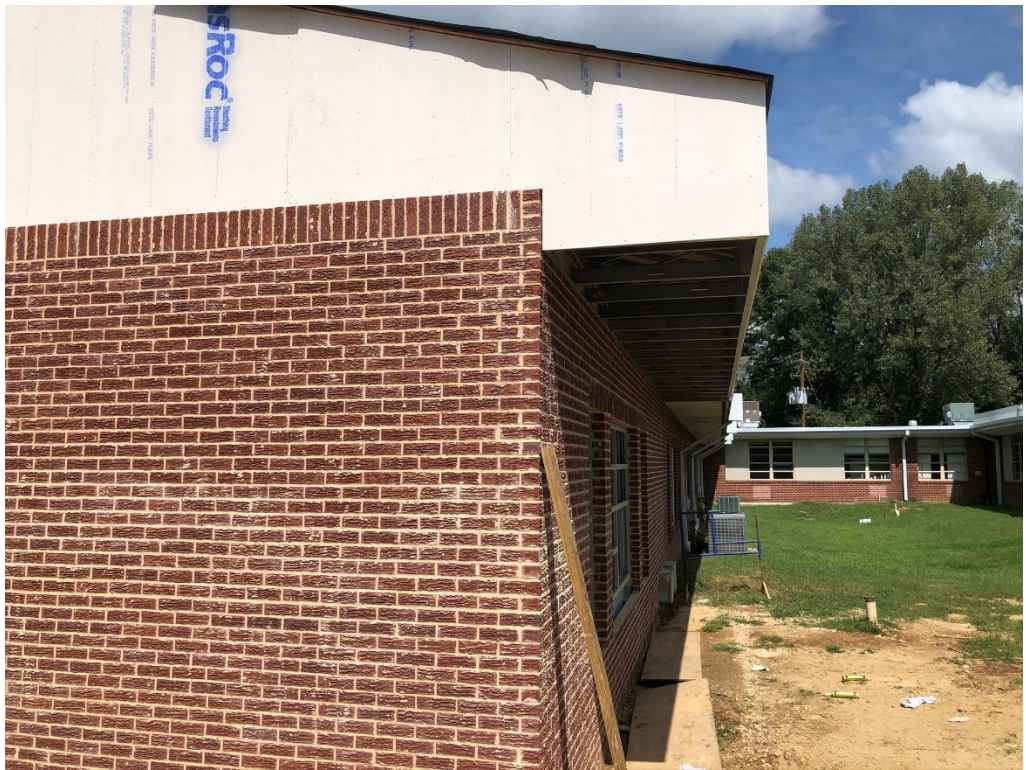
Figure 8 – Soffit Framing and Sheathing Installed

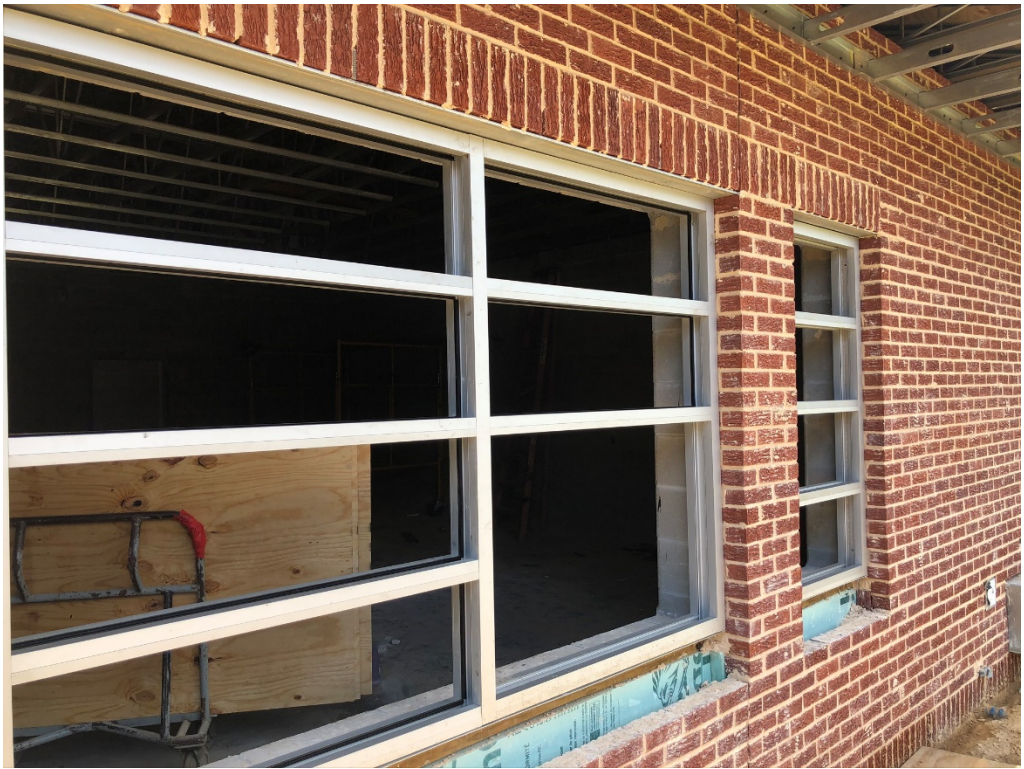
Figure 9 – Storefront Installed

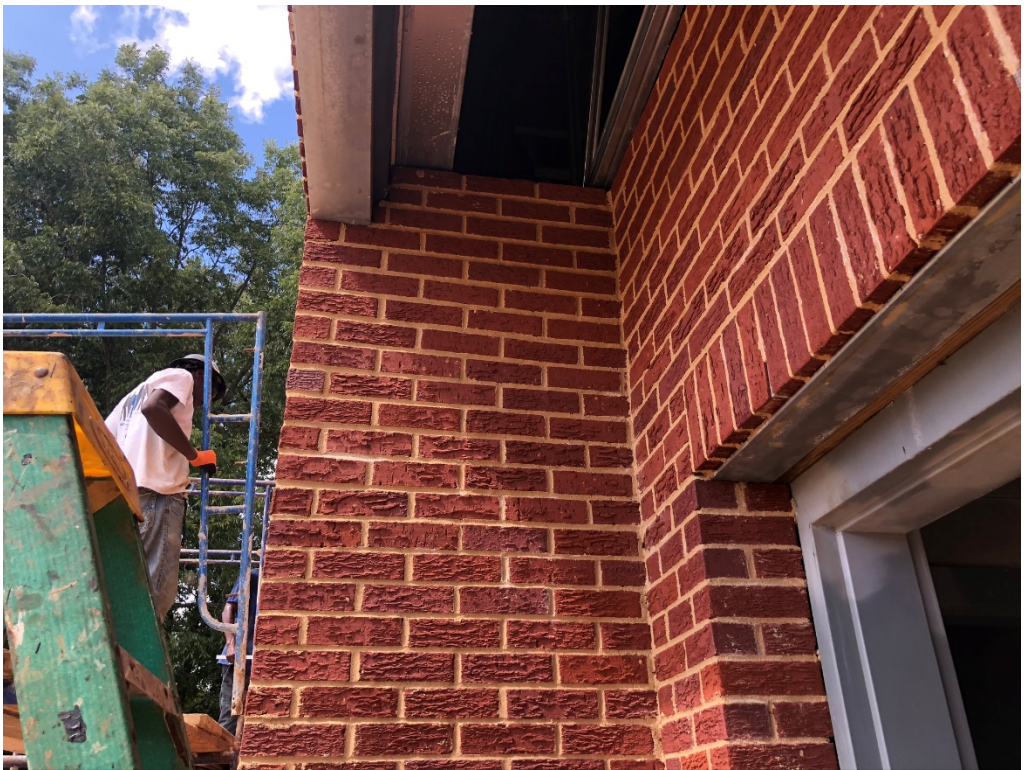
Figure 10 – Brick Work at Entry Setback

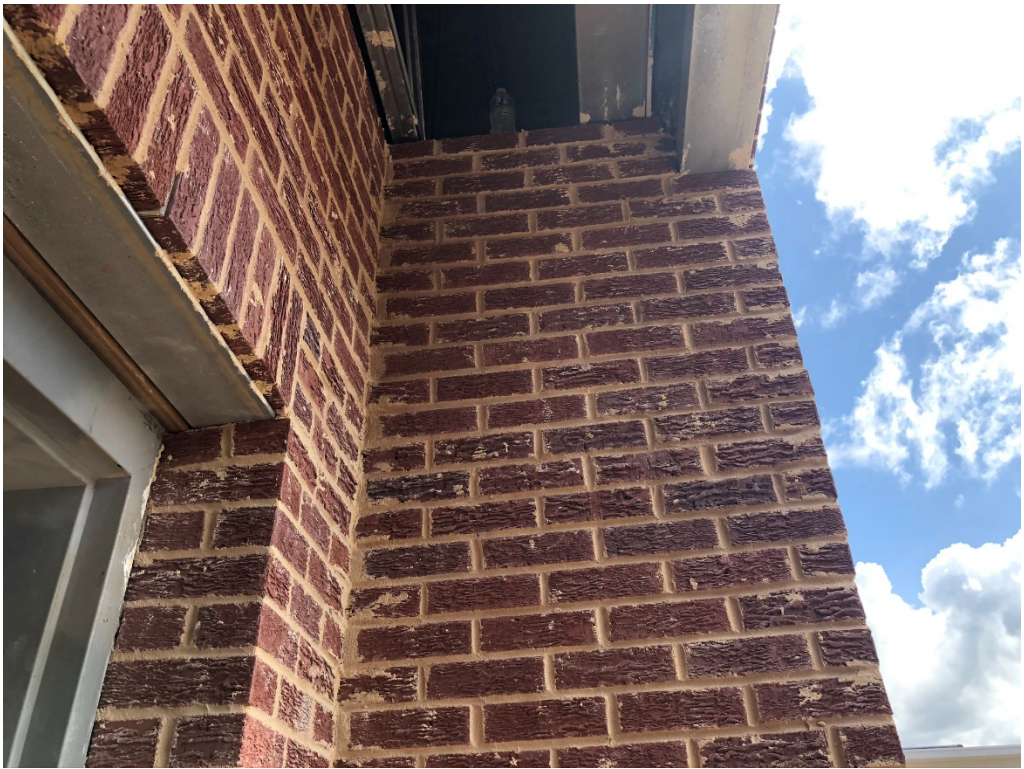
Figure 11 – Brick Work at Entry Setback

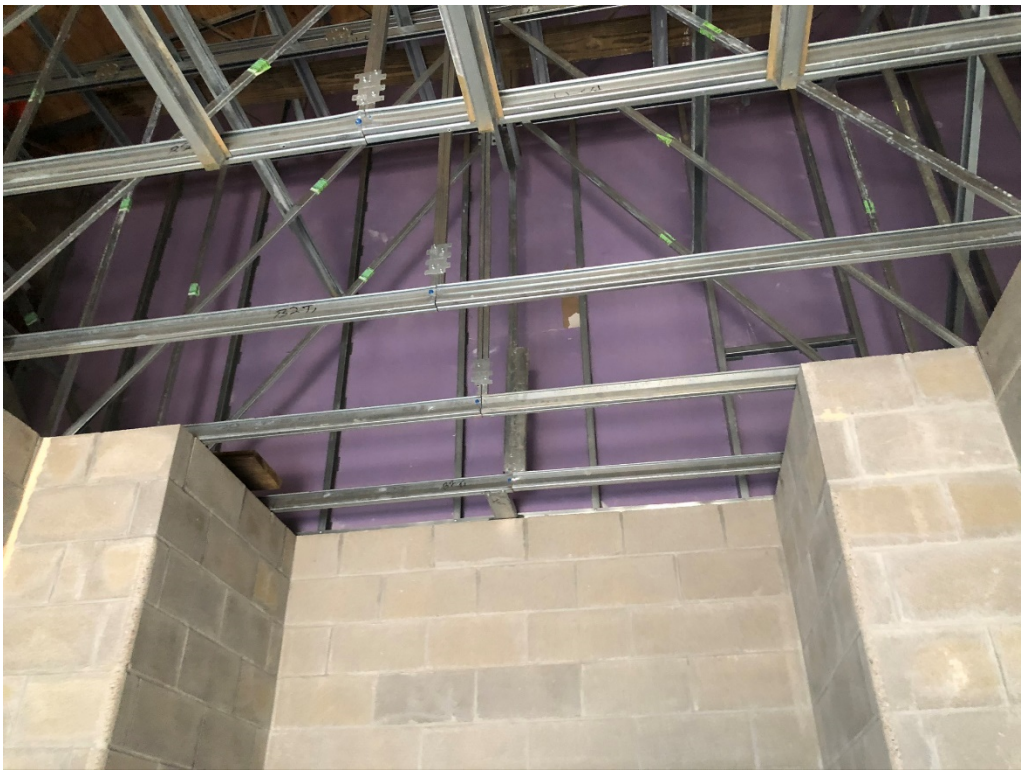
Figure 12 – Interior Firewall Installed

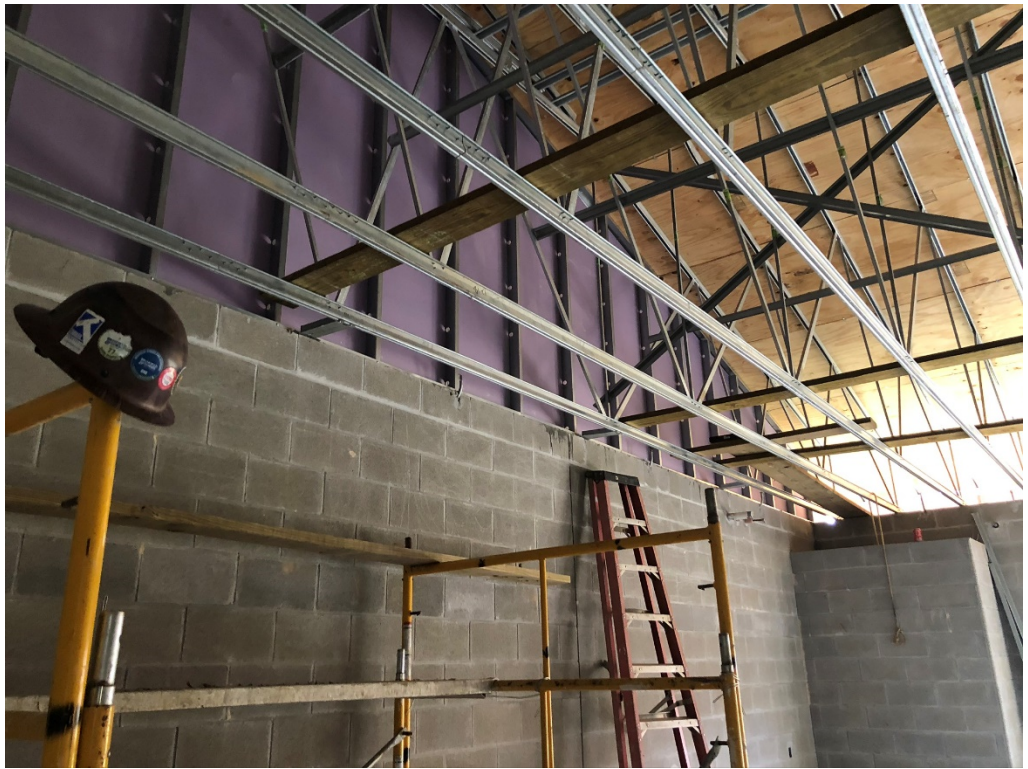
Figure 13 – Interior Firewall Installed

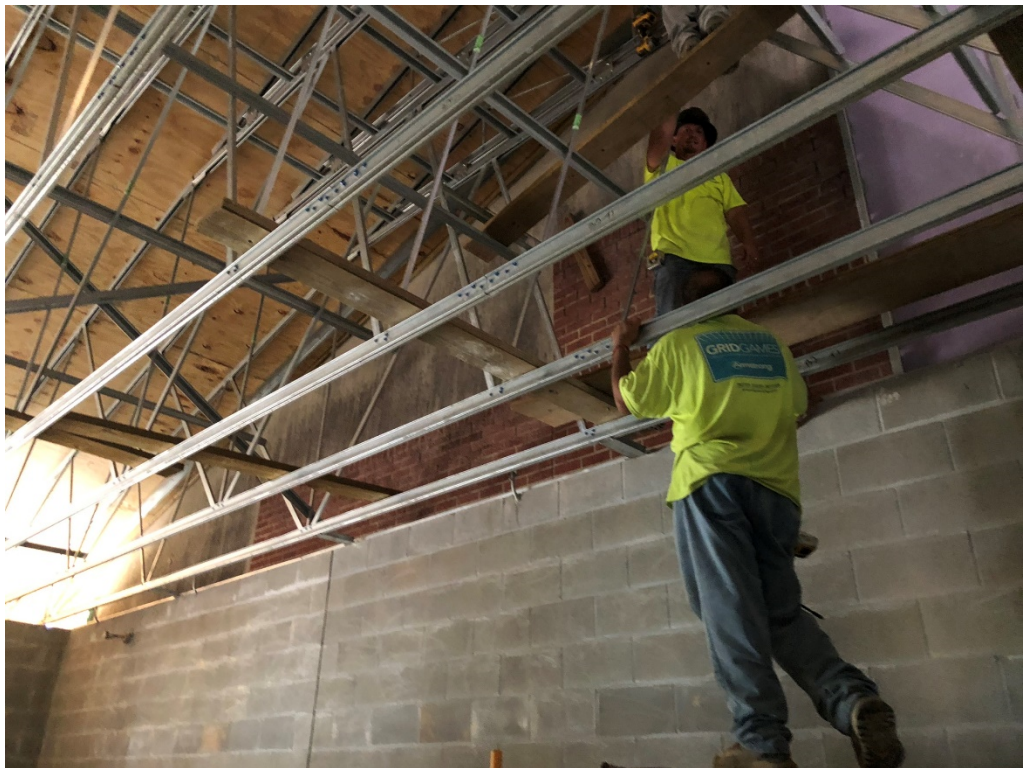
Figure 14 – Interior Firewall Installation
