Architect's Field Report

201 Park Court, Suite B Ridgeland, MS 39157 P 601.790.9432 F 888.281.0547	31 October 2020 18044-Bovina Elementary / Report Number 028
One Jackson Place, Suite 250 188 East Capitol Street Jackson, MS 39201-2100 P 601.352.5411 F 601.352.5362	Contract Paul Jackson & Son Date / Time 28 October 2020 / 11:30 AM Weather / Temp Clear / 76 ° F Est % Complete 85% Sched Conformance + 00 days Work in Progress Painting ACT Installation
161 Lameuse Street, Suite 201 Biloxi, MS 39530 P 228.374.1409 F 228.374.1414	Present at Site Richard Creel, Paul Jackson & Son Paul Purser, DBA Observations I arrived on site and noted work being performed mostly at the interior of the addition. Sidewalks have been formed up at the rear of the addition. At the interior. Painters were at work in the main corridor and classrooms appear to be complete. Workers were also installing ACT at classrooms. At our new double egress doors between the addition and the existing hall, it appears some augmenting of the door panels has been performed. This Cutting is uneven and unsightly and needs to be repaired straight or replaced.

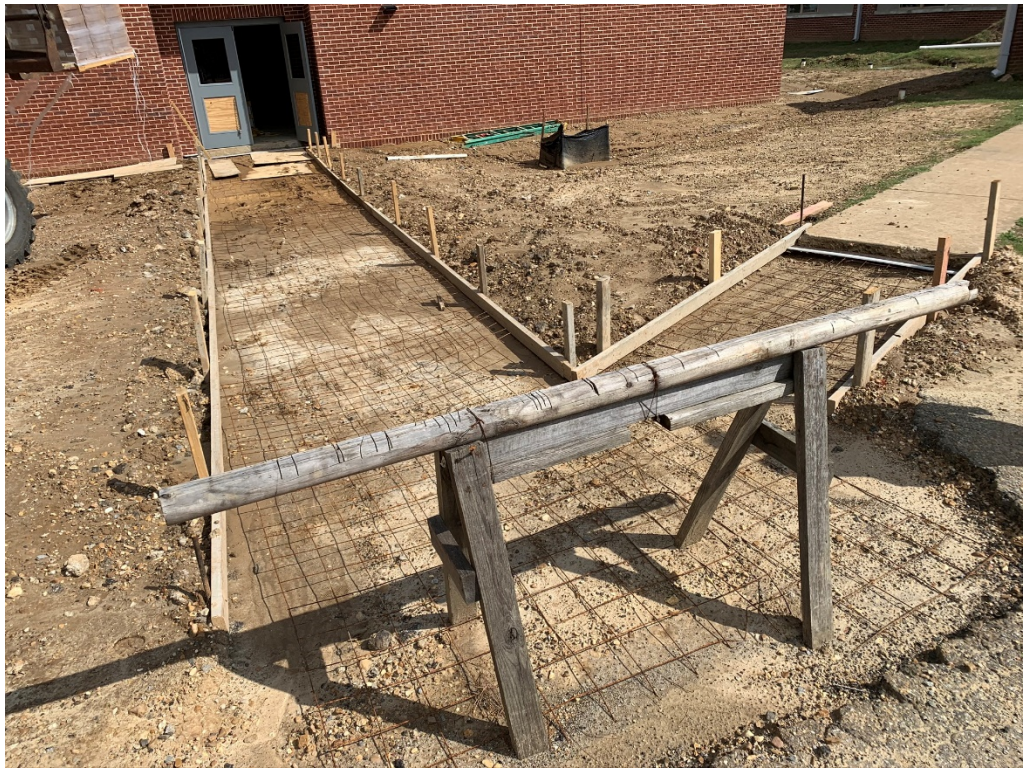
Figure 1 – Sidewalk Formed

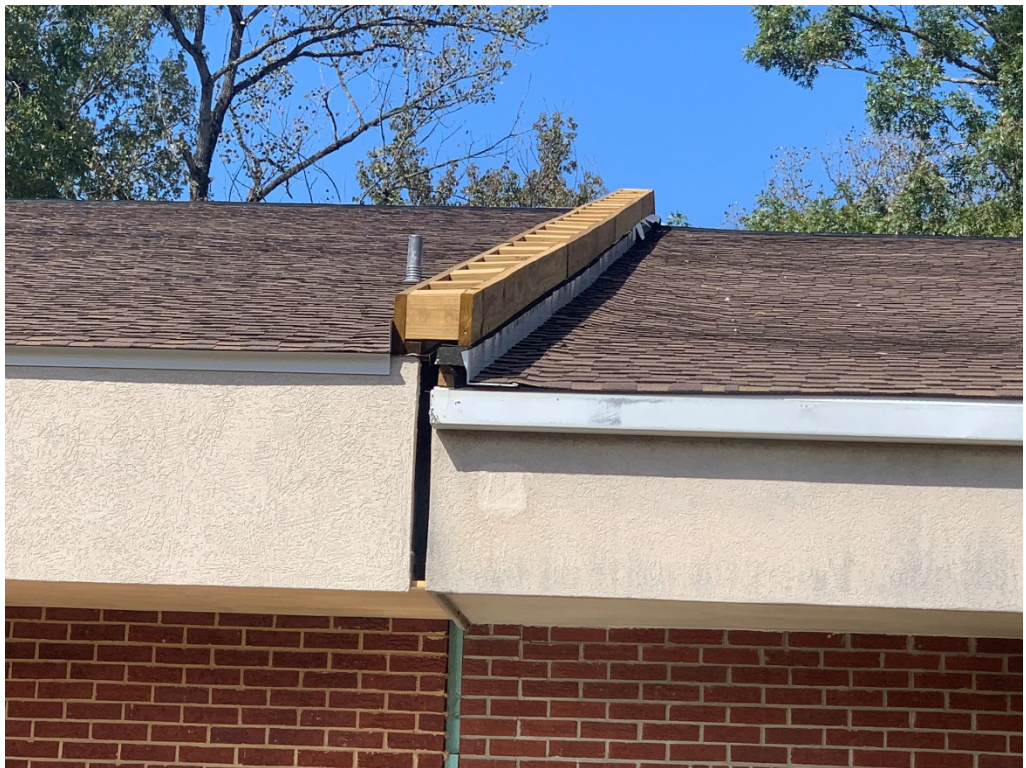
Figure 2 – Framing @ Roofing Connection

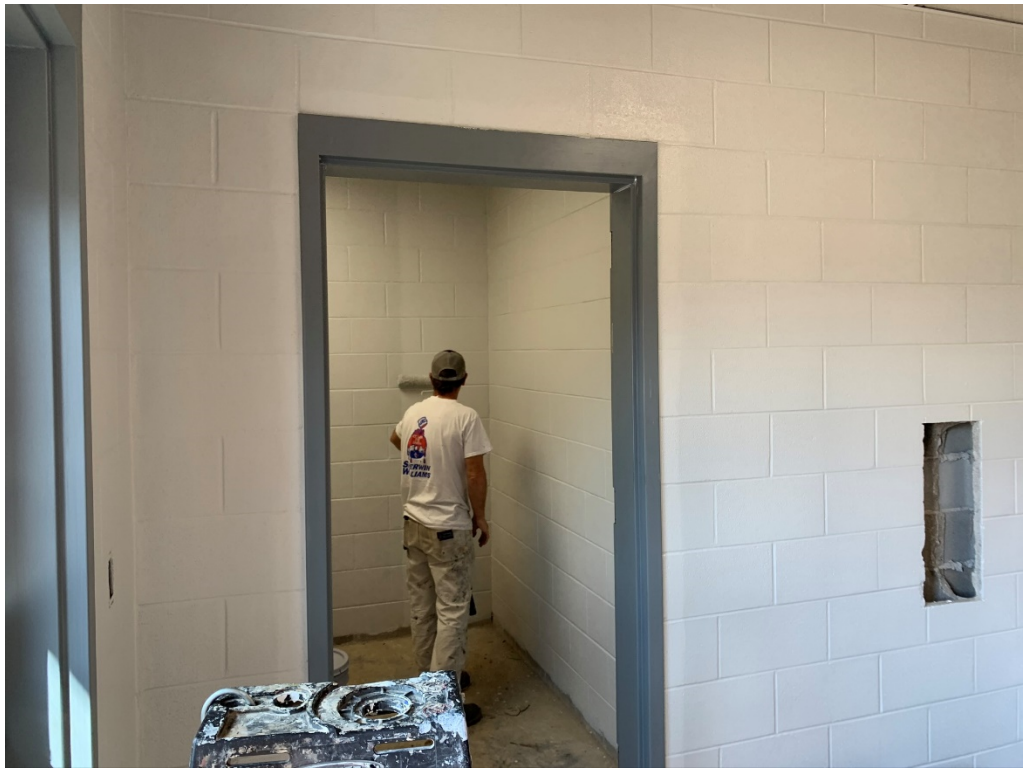
Figure 3 – Paint is ongoing at interior

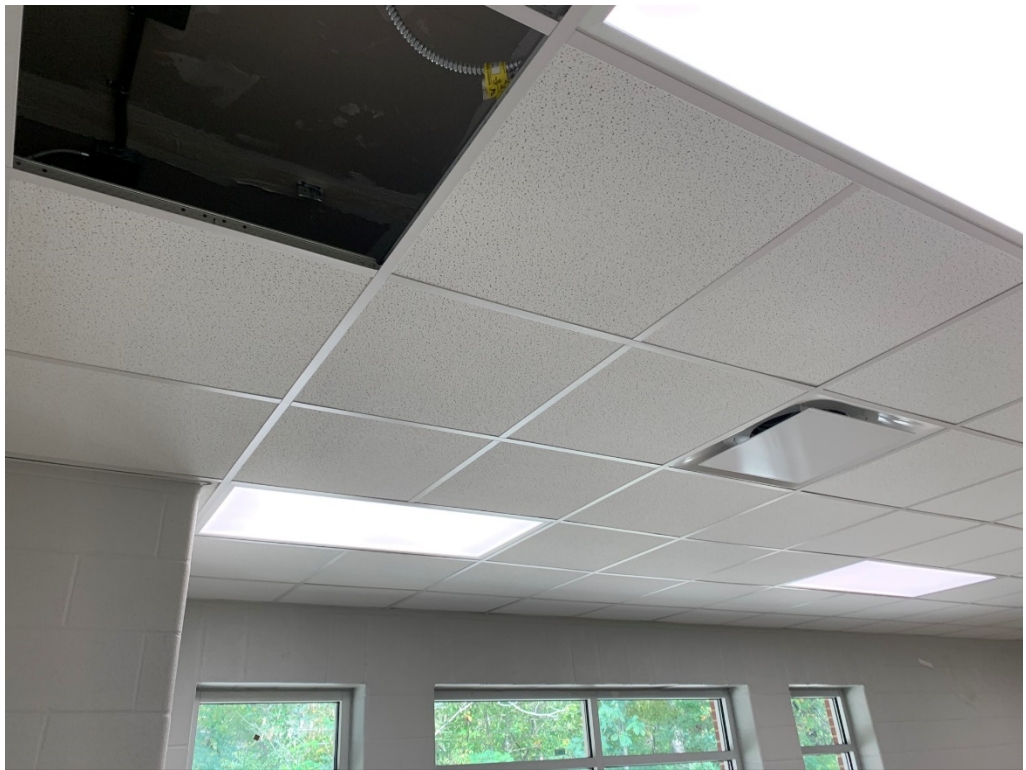
Figure 4 – ACT Installation

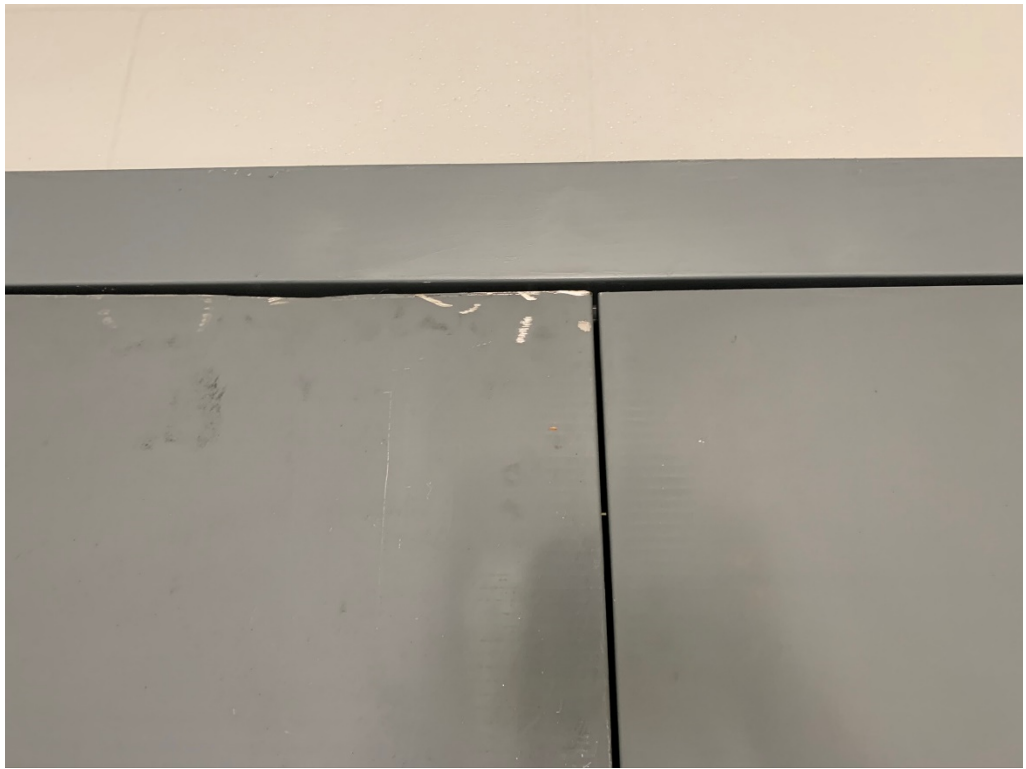
Figure 5 – Top of Door Edge has Been Cut and Is Uneven; This Edge Should be Straight

Items to Verify None Action Required Repair Field Cut at door panel or replace door panel Report By:

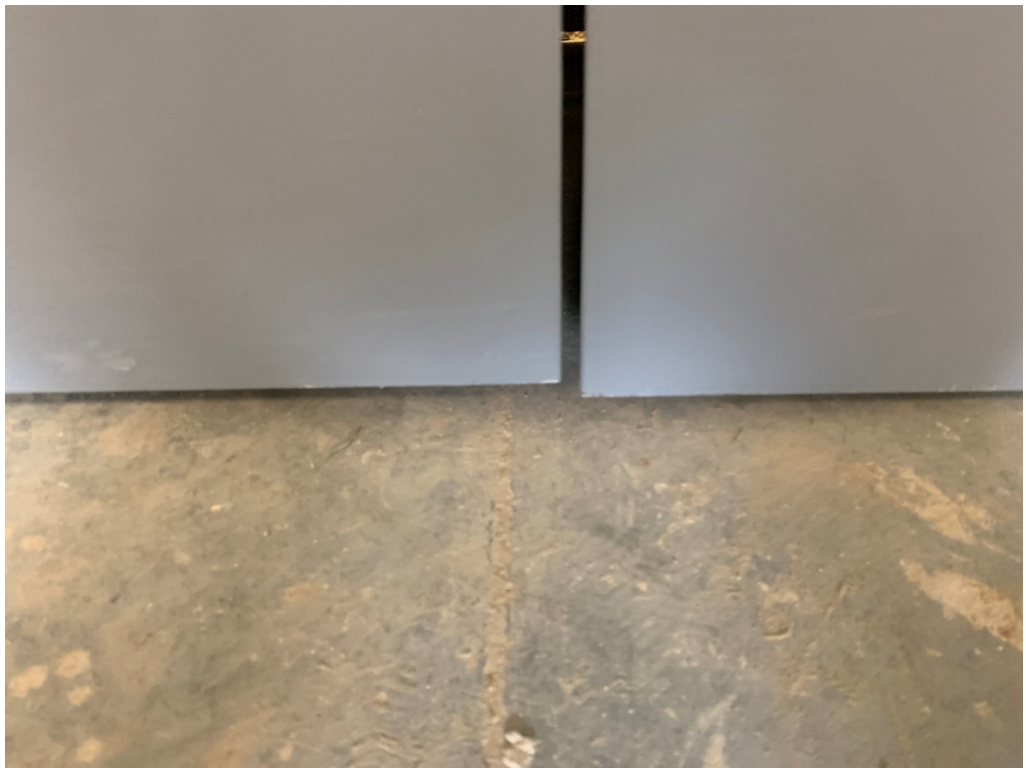
Figure 6 – Doors are out of Square at Entry Into new Addition

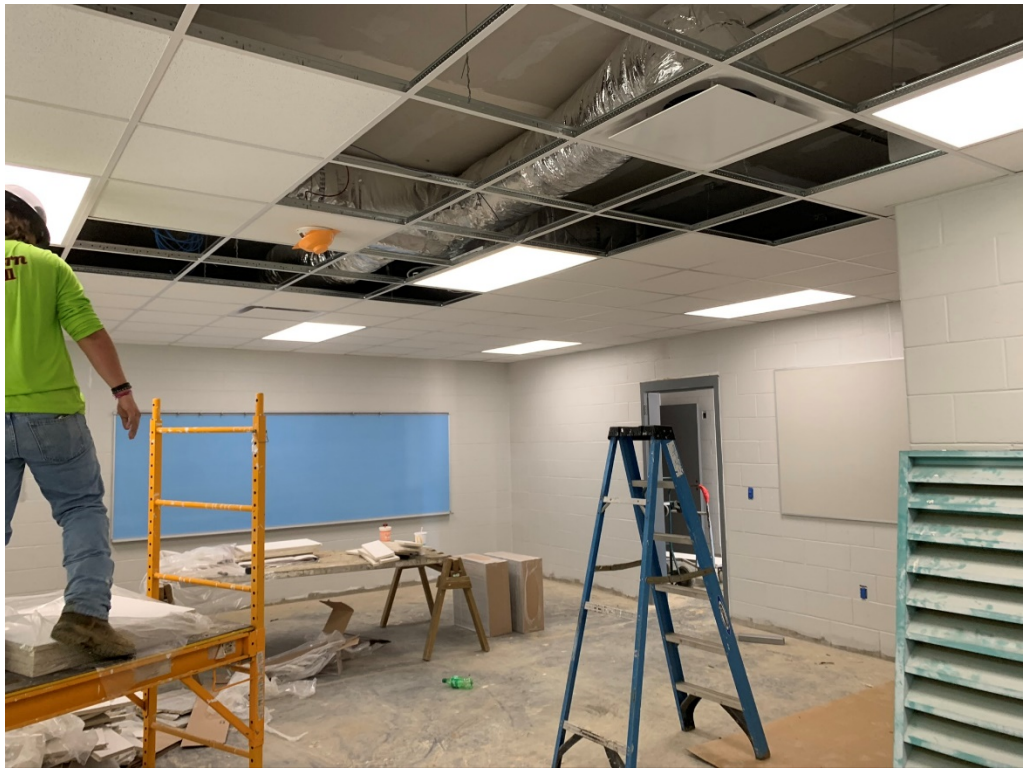
Figure 7 – ACT Installation

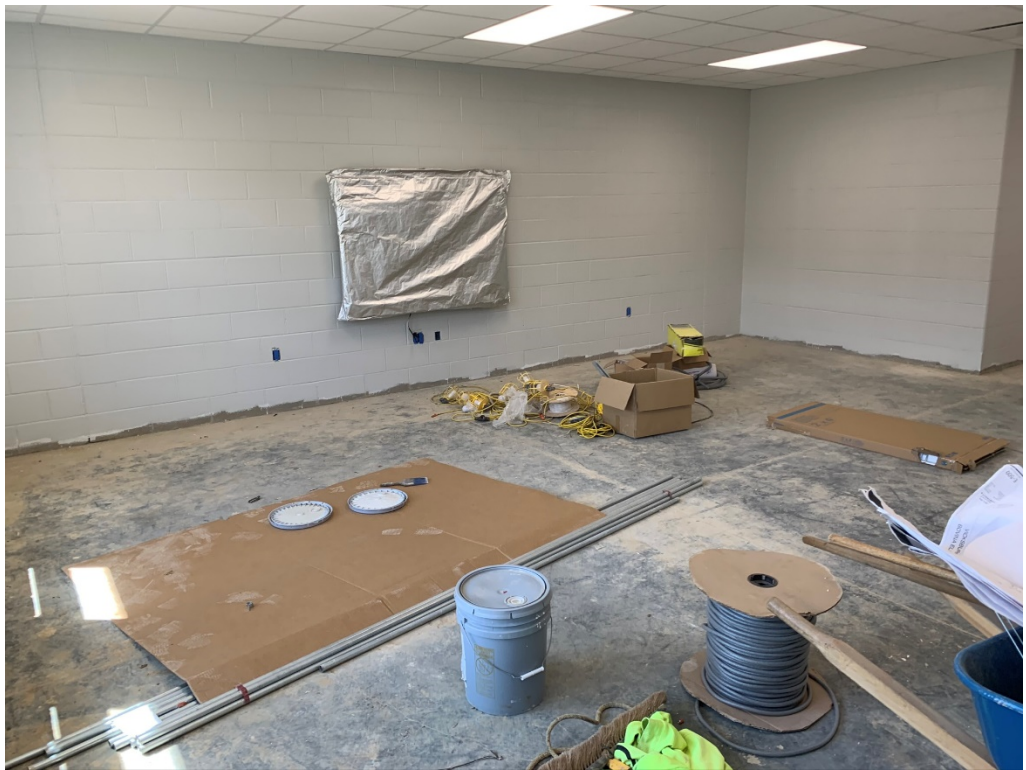
Figure 8 – Equipment Installed

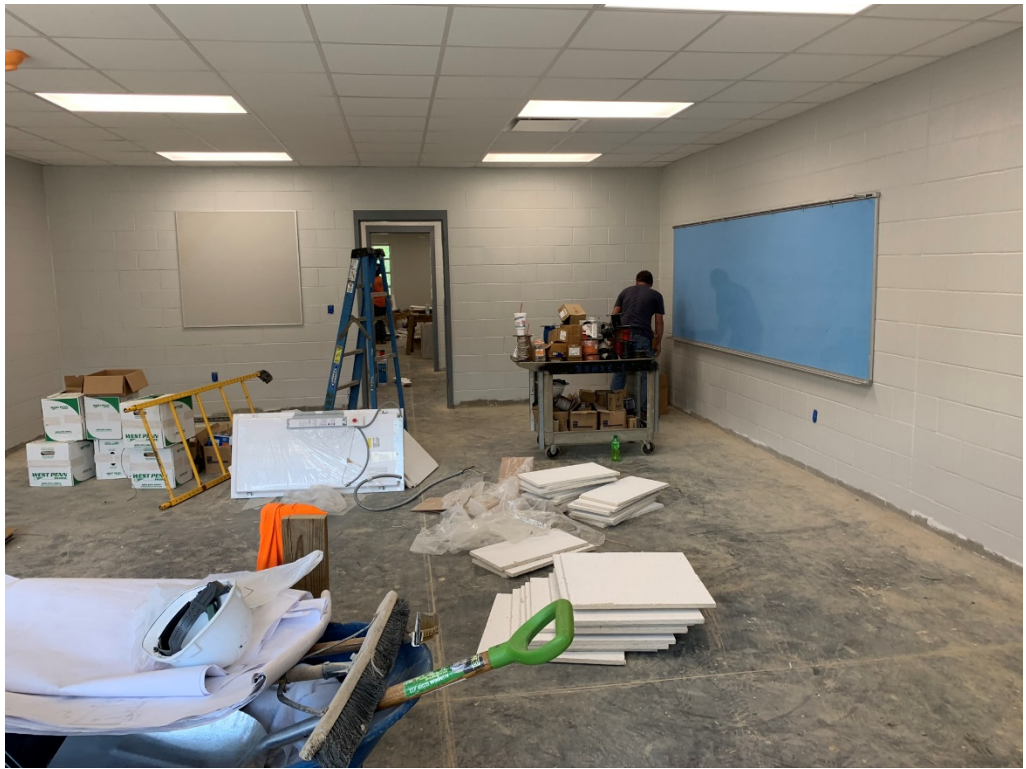
Figure 9 – Boards Installed and Painted

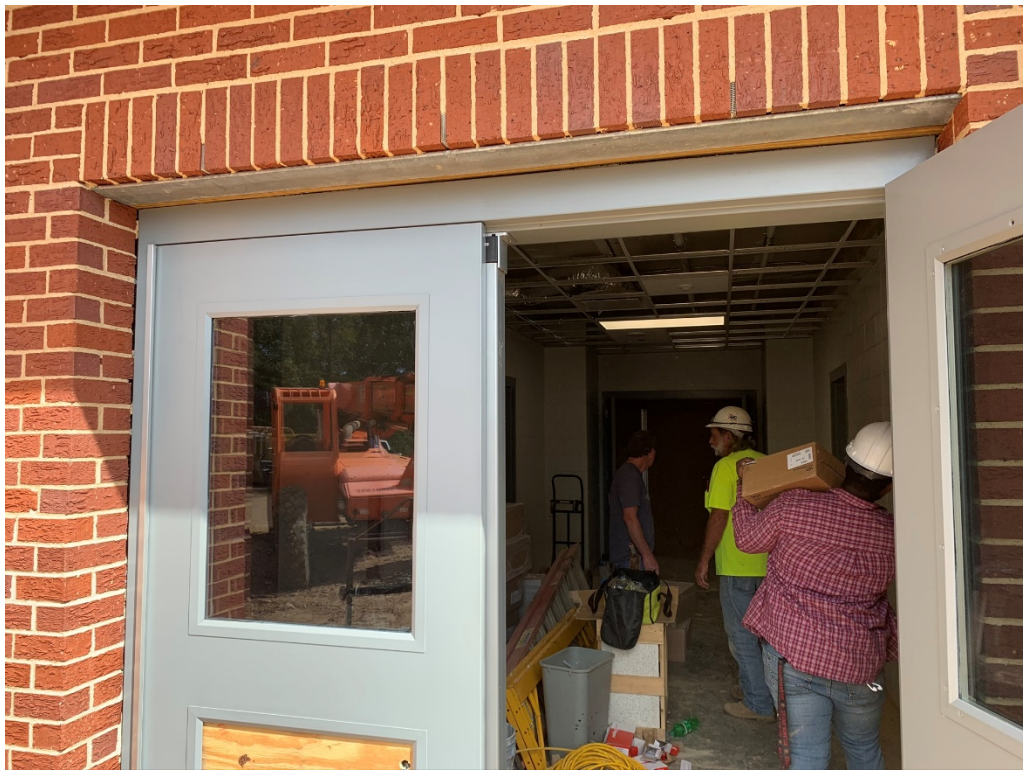
Figure 10 – Glass Installed at Door Panels
