06 May 2020

18045-BOW Bowmar Elementary / Report Number 004

Date / Time 05 May 2020 / 12:00 PM

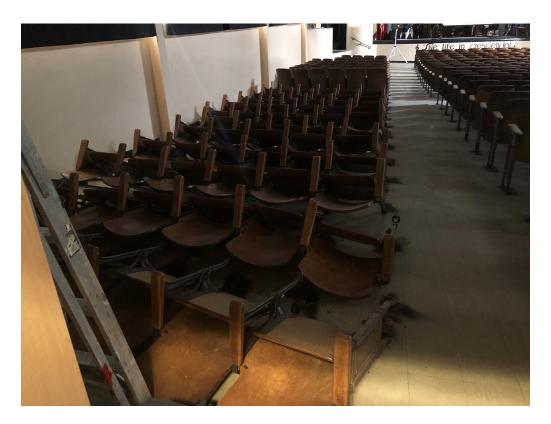
Observations I entered the site from the Main front entry. Noting work performed in

Figure 1 – Chairs in Auditorium have been unfastened at floor

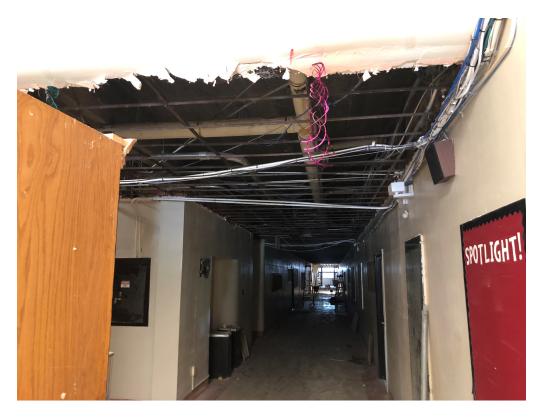
Figure 2 – Demo work at Hallway

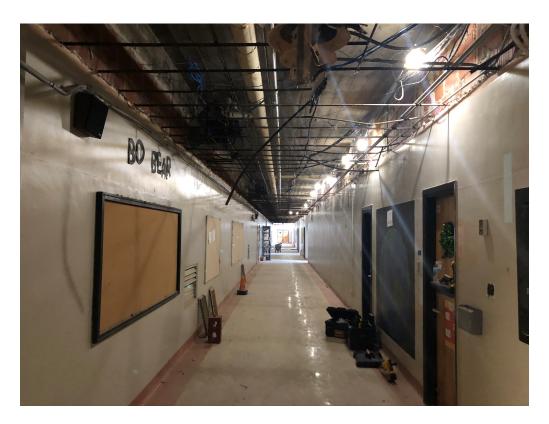
Figure 3 – Demo work at Hallway

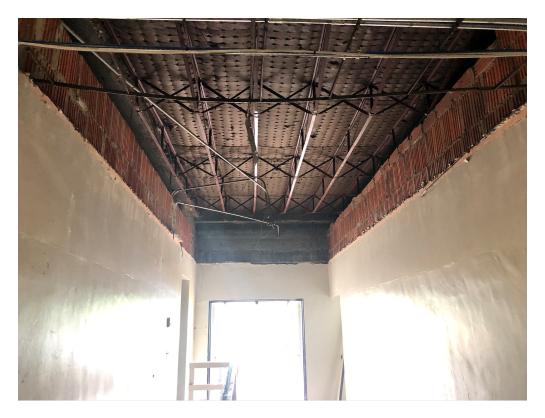
Figure 4 – Demo work at Hallway

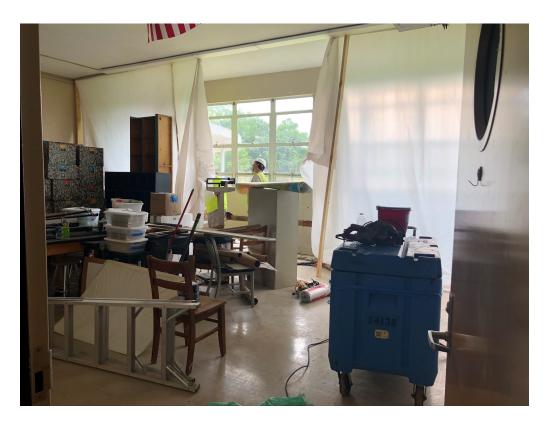
> the auditorium, I reviewed further demo work in the hall areas. I met James Brock as he was refinishing interior steel frames of windows in Classroom 15. We discussed work in this area already performed.

Figure 5 – Classroom 15 plastic protection & window refinishing

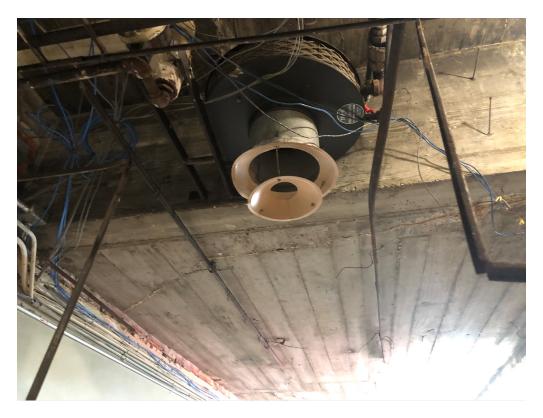
> Mr. Brock and I also walked Corridor 115 and reviewed issues with step down in roof that may prevent ducting from being run down the hallway

as per plans.

Figure 6 – Step down at Roof

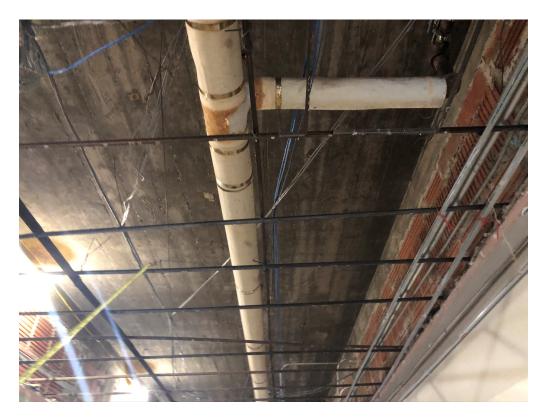
Figure 7 – Pipe prevent duct runs from crossing each other

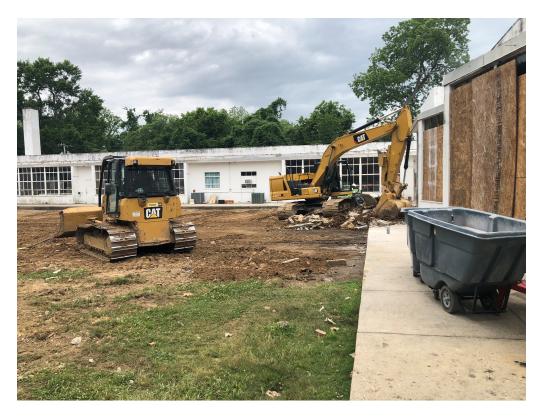
We walked to the exterior and noted demo work on trailers is complete

aside from cleanup. Concrete demo is being performed in this area at

the North Section of courtyard.

Figure 8 – Courtyard Demo

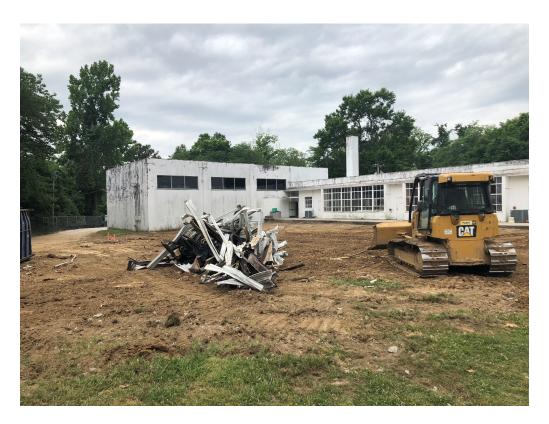
Figure 9 – Courtyard Demo

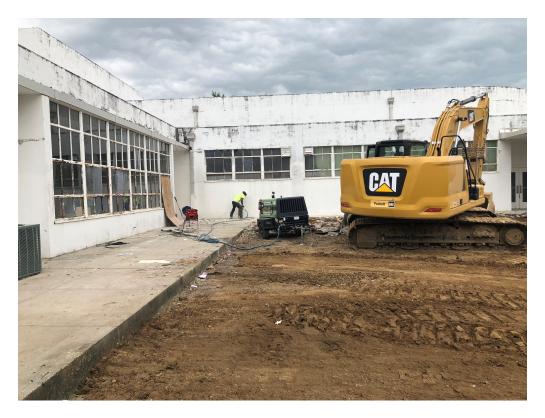
Figure 10 – Concrete Demo Ongoing

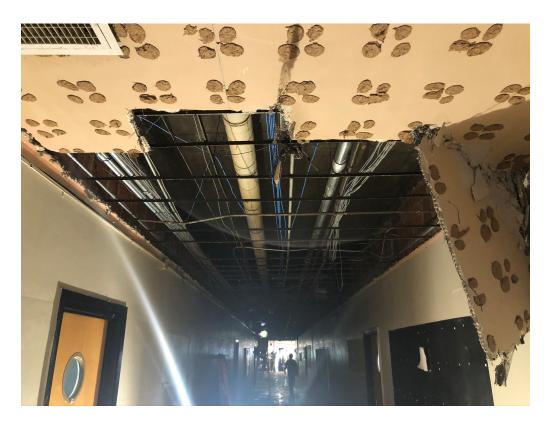
Figure 11 – Corridor 100 Demo Ongoing

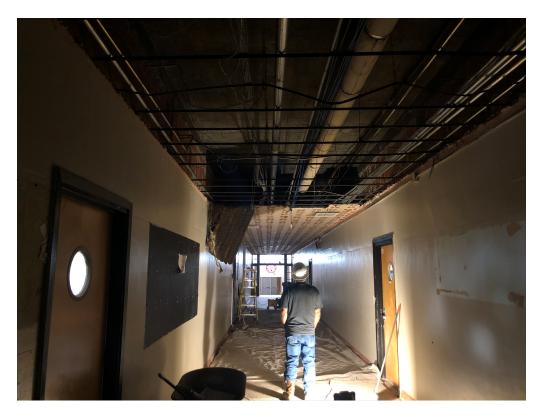
Figure 12 – Corridor 100 Demo Ongoing
