22 May 2020

18045-BOW Bowmar Elementary / Report Number 006

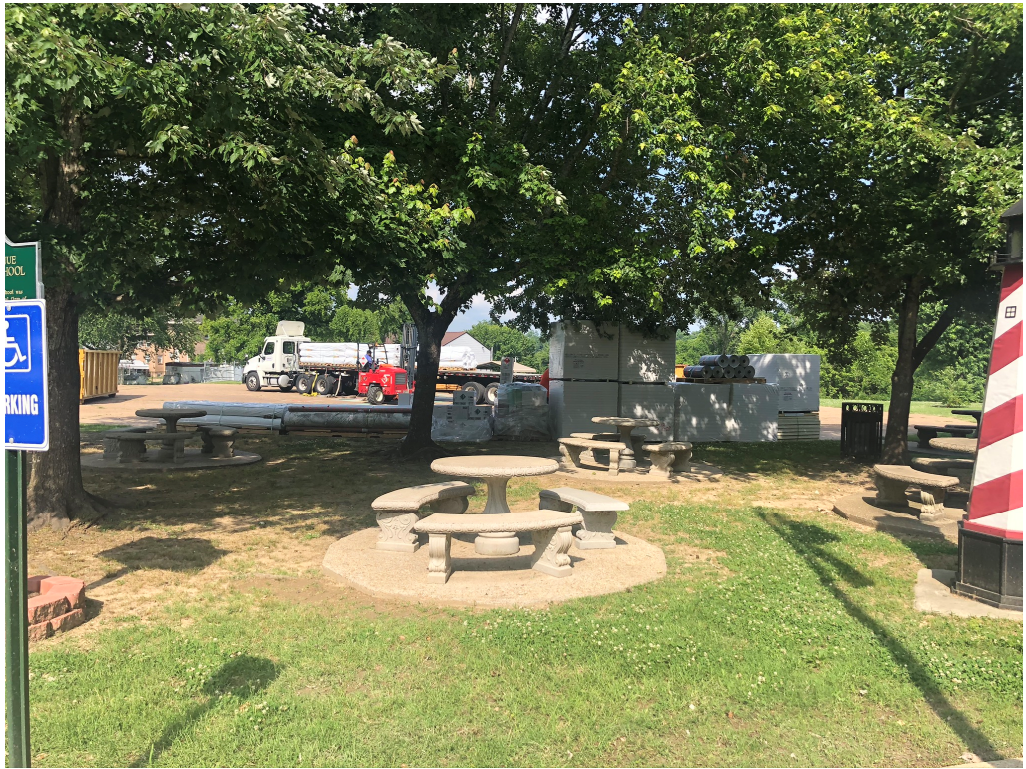
Figure 1 – Roofing Material Has Started to Arrive on Site

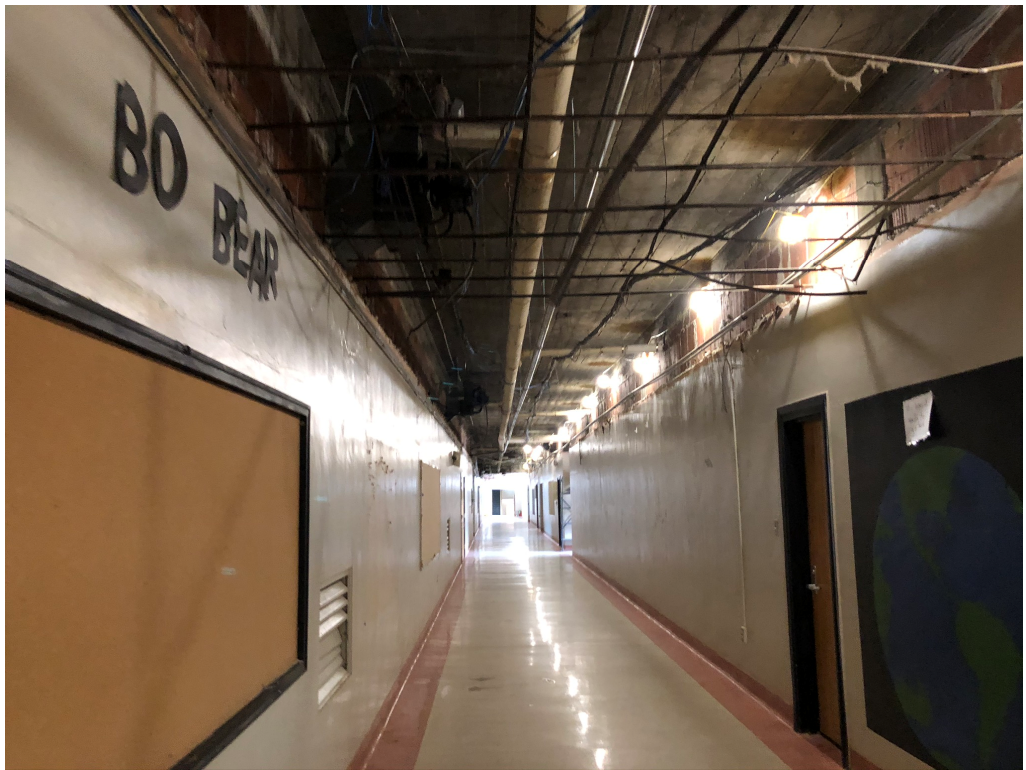
Figure 2 – North Hall Progress

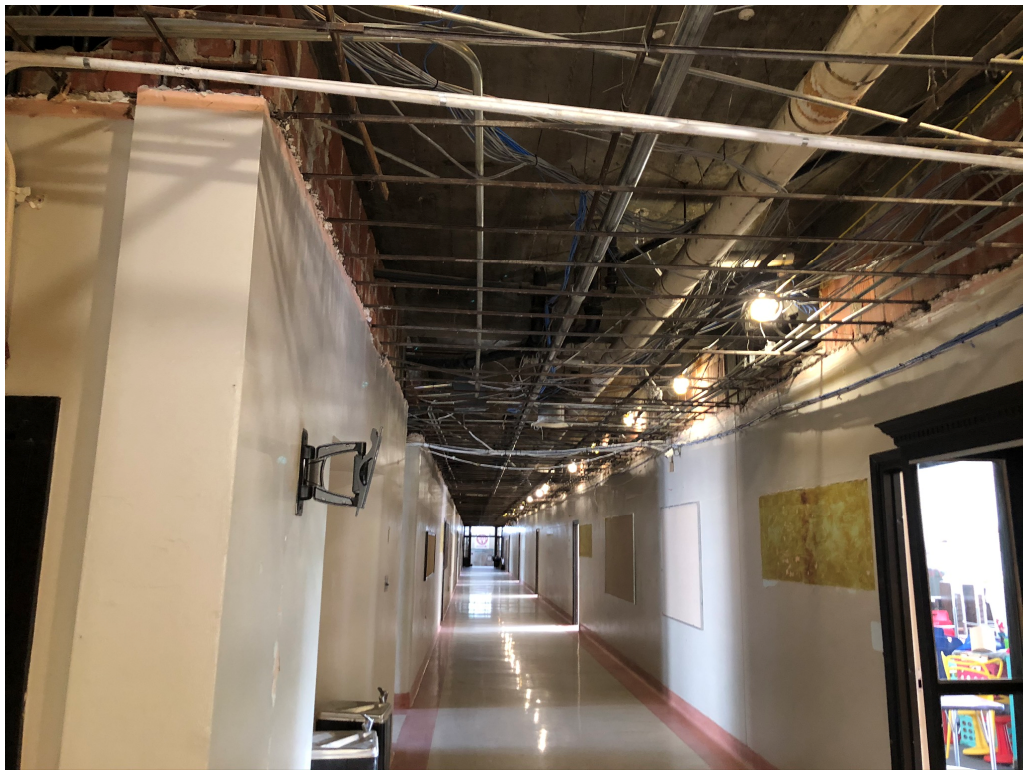
Figure 3 – West Hall Progress

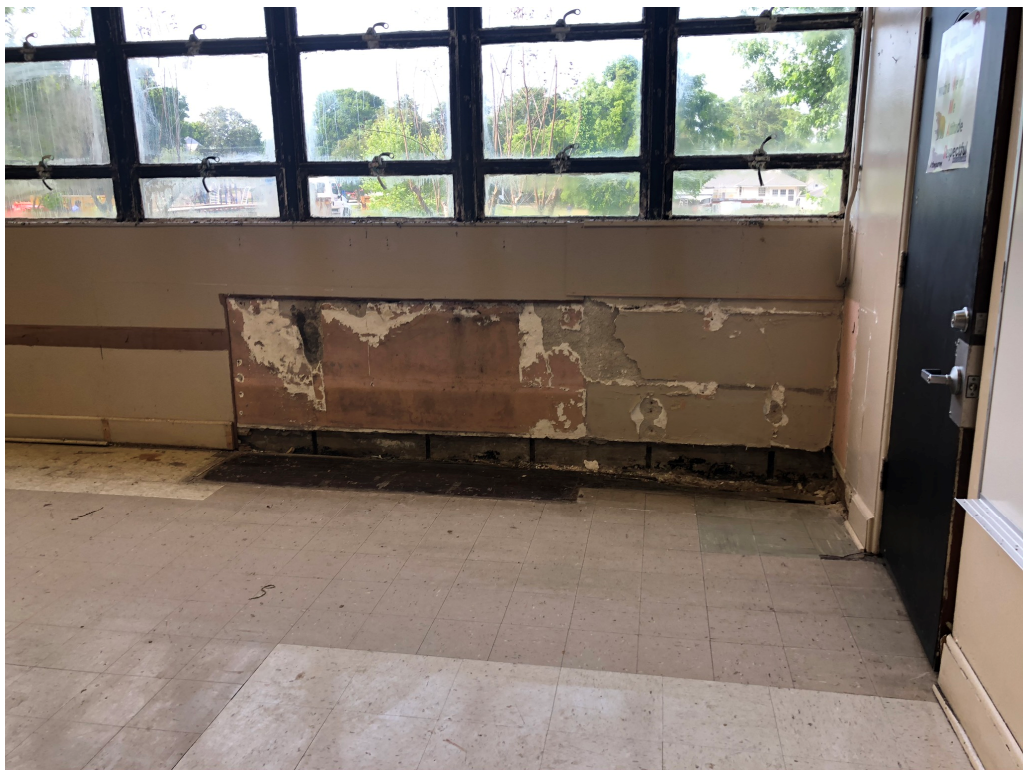
Figure 4 – Science Room 16 Cubby Removal

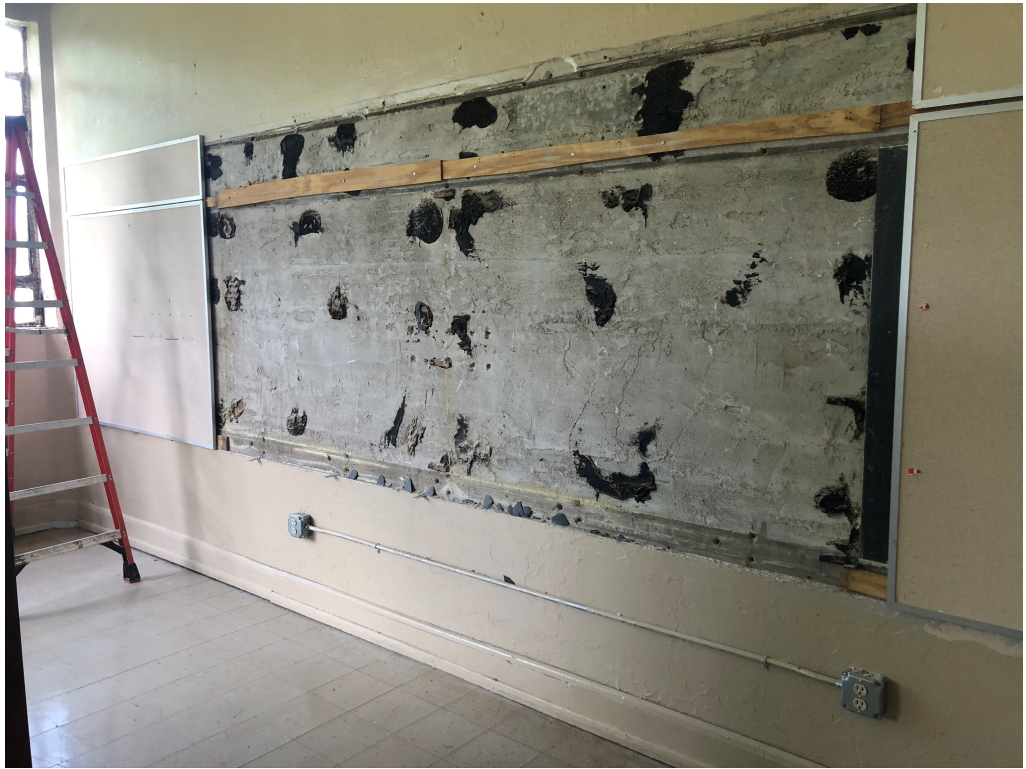
Figure 5 – Science Room 17 Blackboard Removal

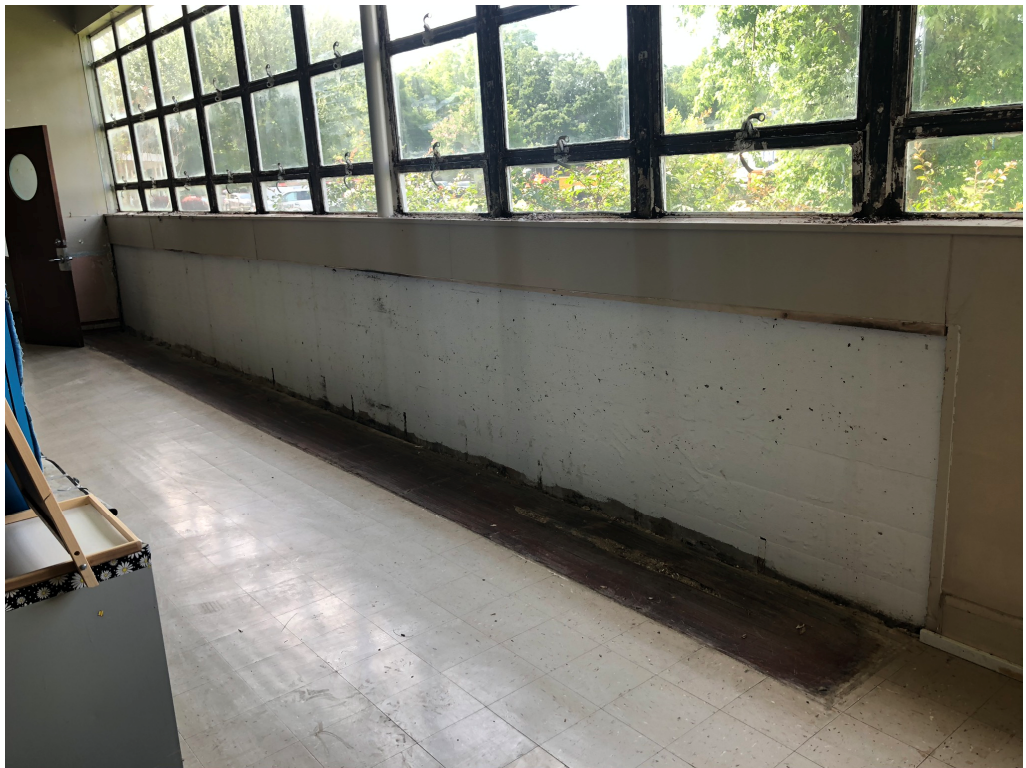
Figure 6 – Science Room 17 Cubby Removal

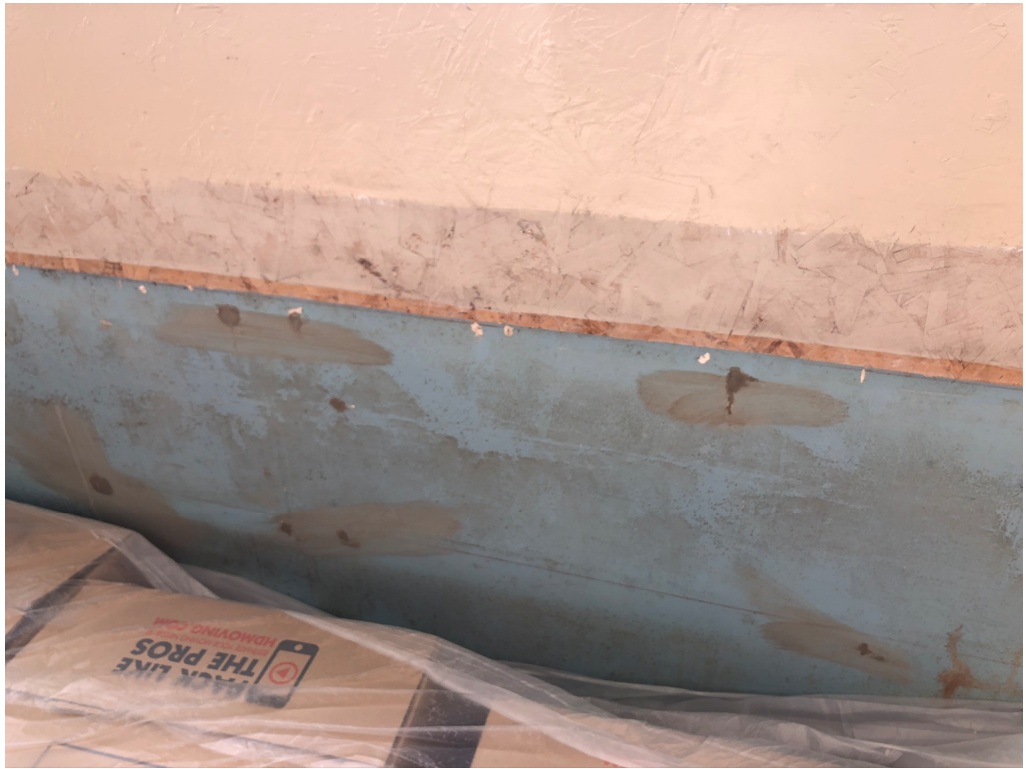
Figure 7 – OSB/Plywood Atop Plaster as Existing Repair to Plaster Sills (typical)

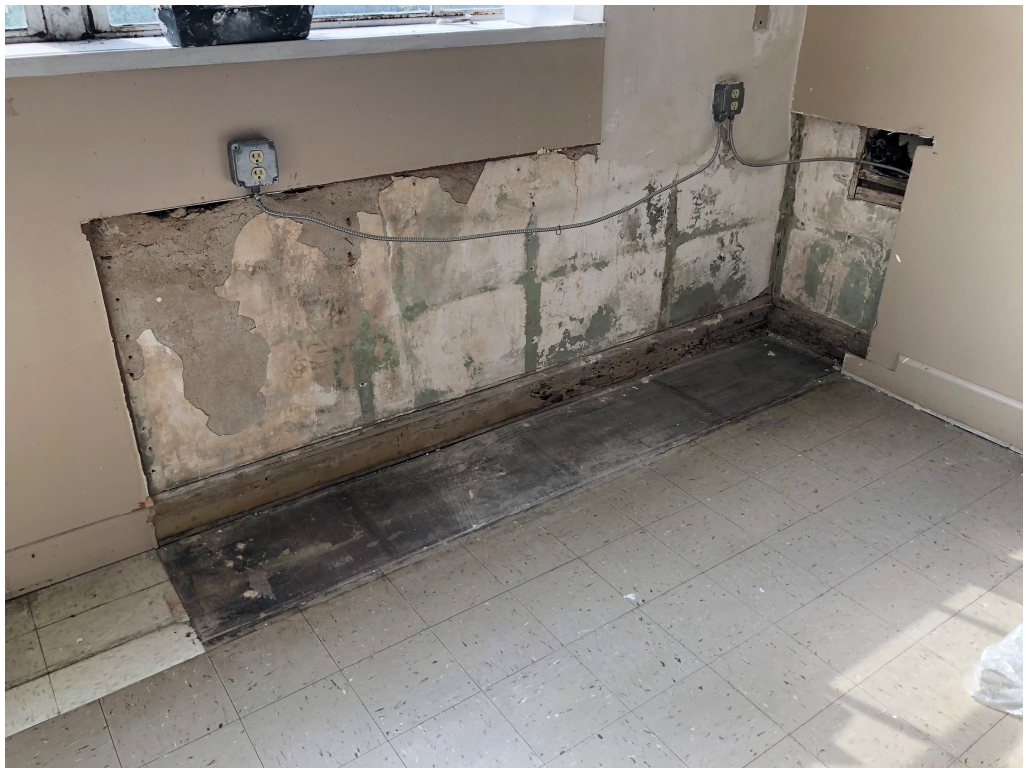
Figure 8 – Classroom 1 Cubby Removal

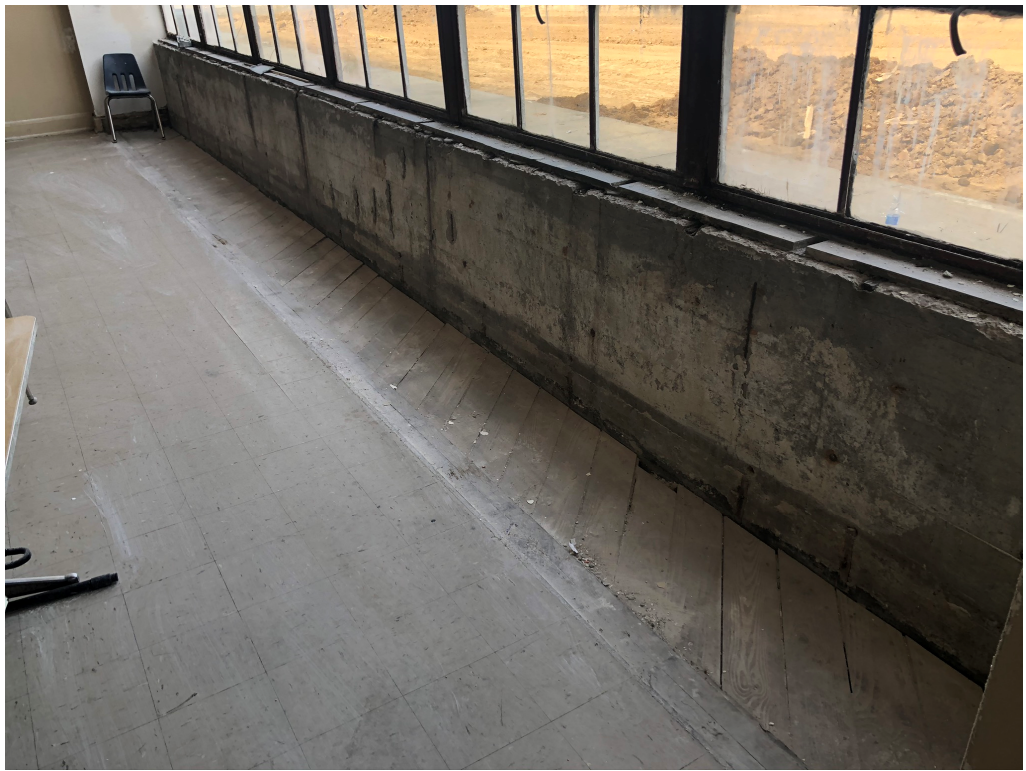
Figure 9 – Sped 2 Cubby Removal

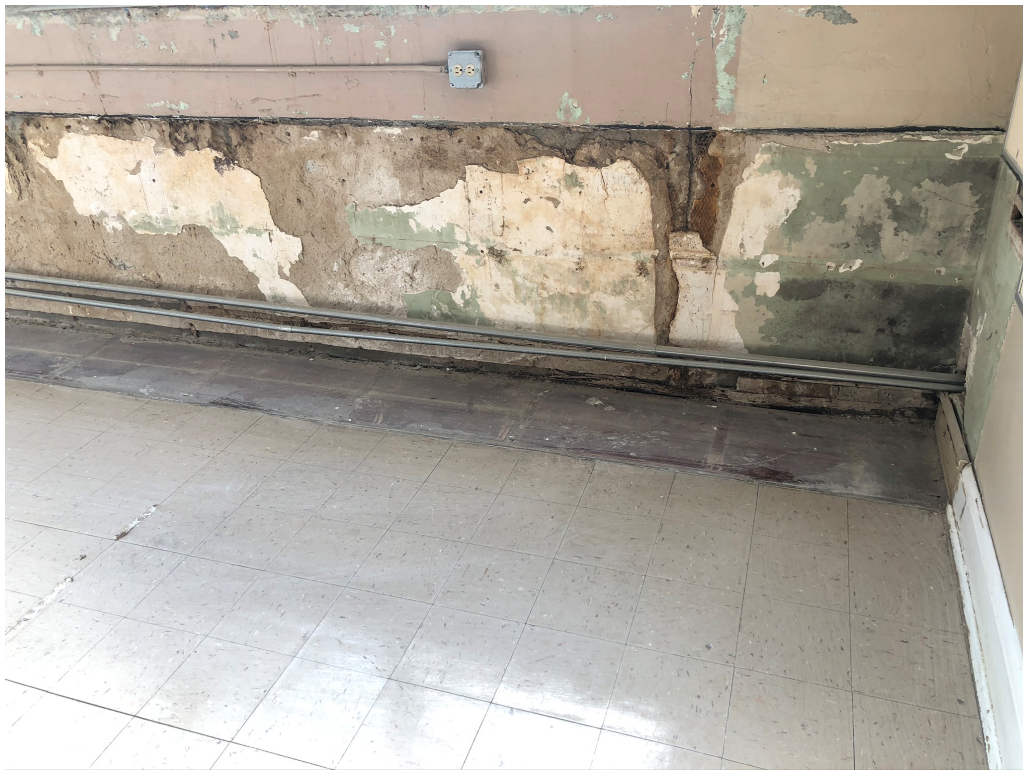
Figure 10 – Classroom 6 Cubby Removal

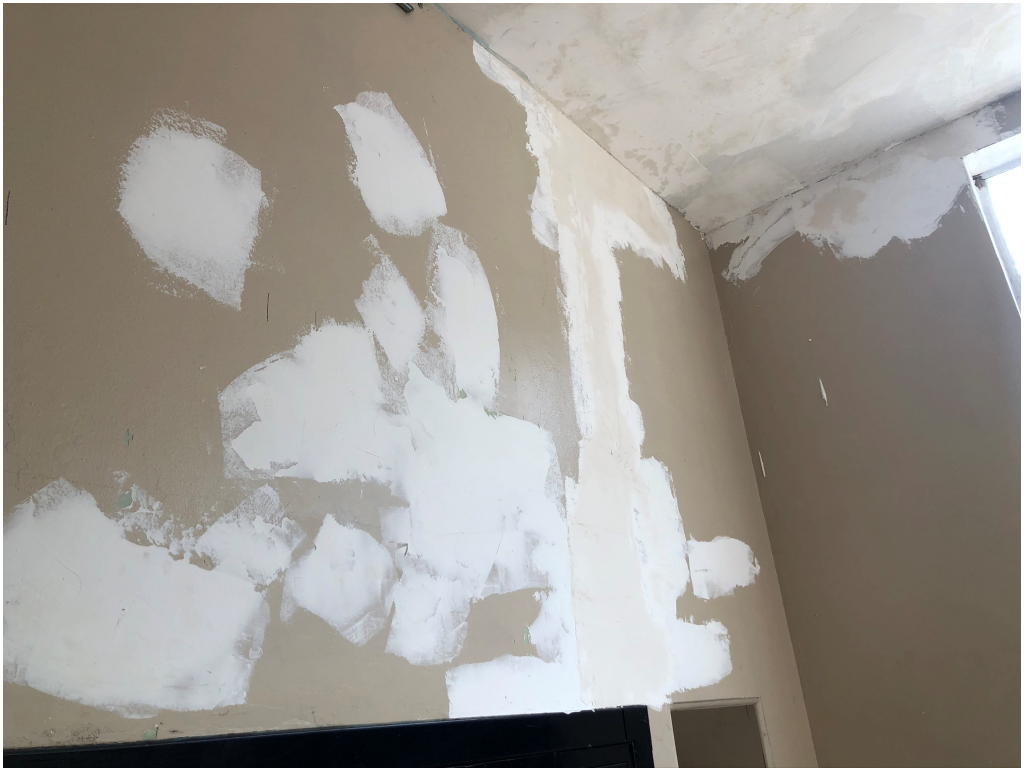
Figure 11 – Plaster Repair at Classroom 3

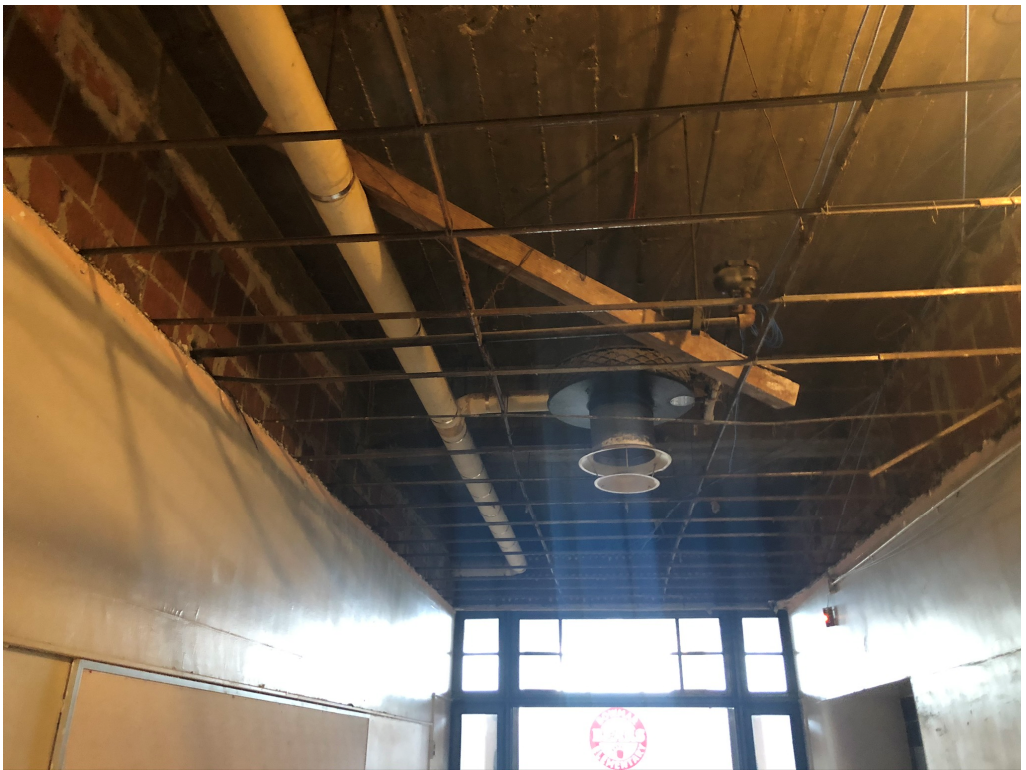
Figure 12 – Existing 4x4 Atop Boiler Pipe to Support Ceiling
