28 May 2020

18045-BOW Bowmar Elementary / Report Number 007

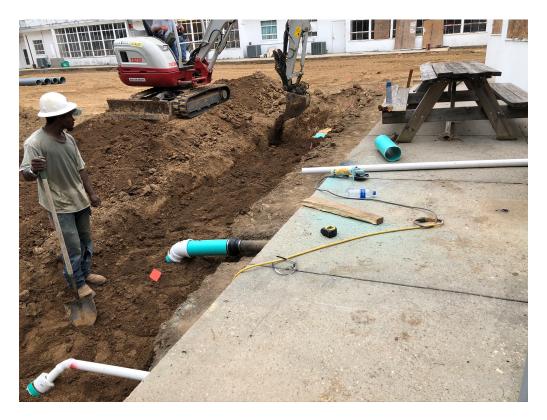
Figure 1 – Rough In Plumbing

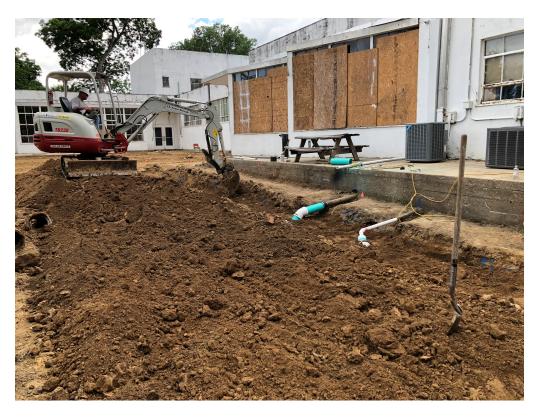
Figure 2 – Rough In Plumbing

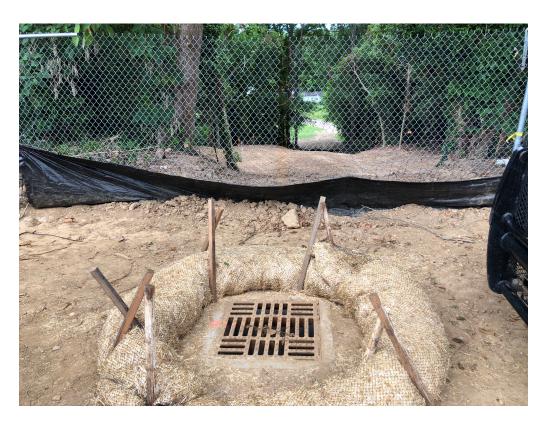
Figure 3 – Grate Surrounded by Sediment Protection

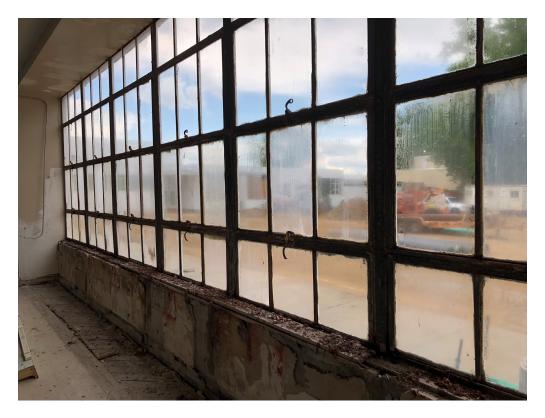
I arrived on site and walked through the entry at the passage 117. The building had a very strong chemical smell which I can assume was from the stripper being used to remove paint at the windows. Only 2 workers

were in the building applying the stripper and removing paint.

Figure 4 – Chemical Stripper Used to Remove Paint
