04 June 2020

18045-BOW Bowmar Elementary / Report Number 008

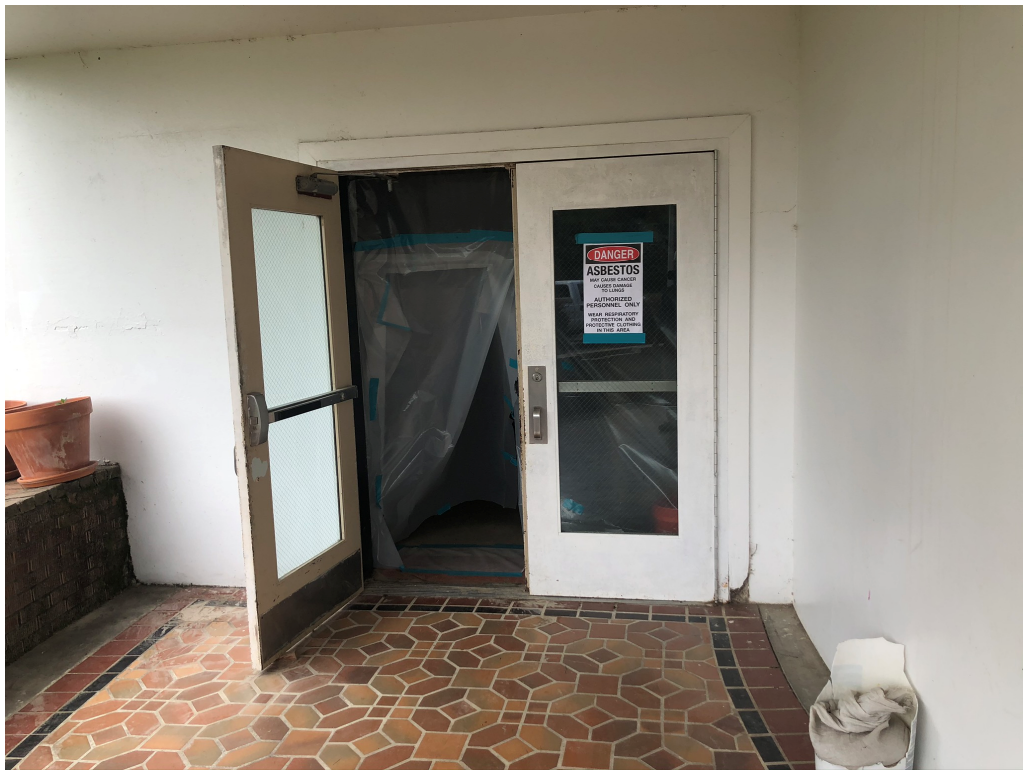
Figure 1 – Asbestos Protection Installed with Signage

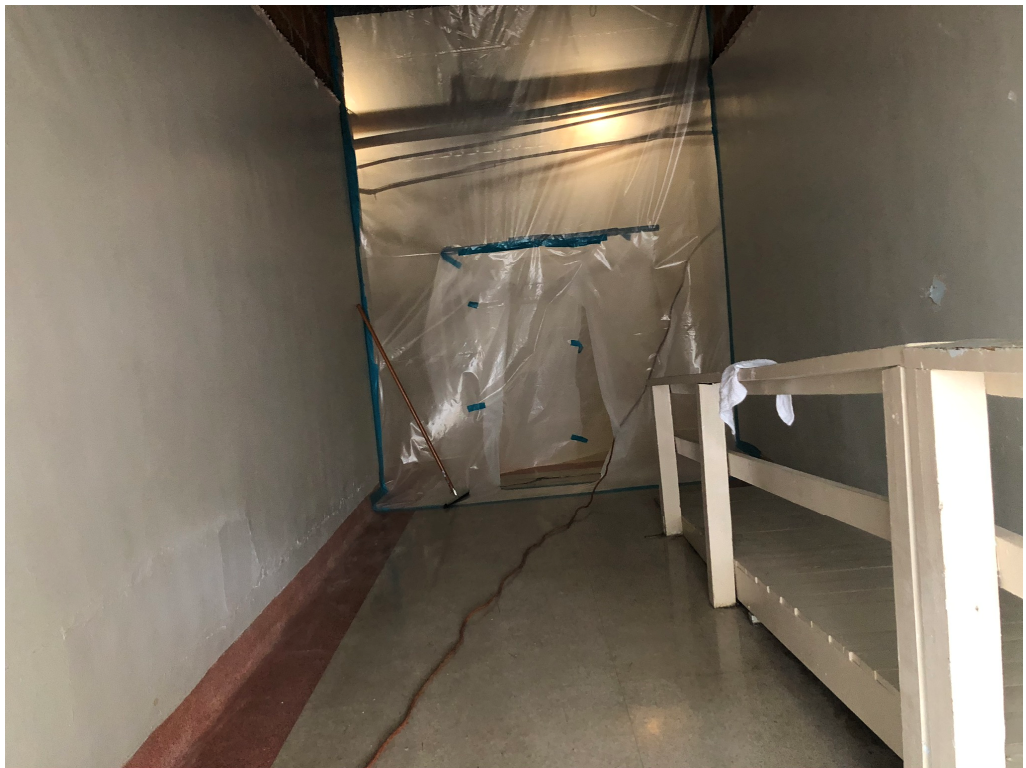
Figure 2 – Secondary Asbestos Plastic Protection

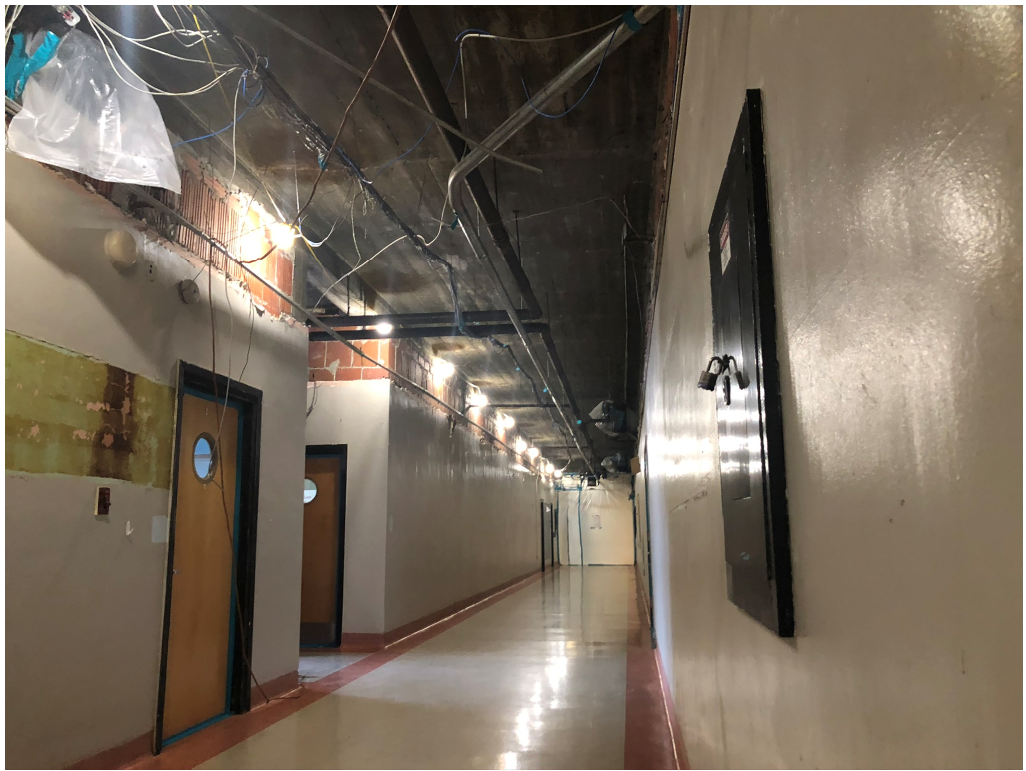
Figure 3 – Asbestos Insulation Removal @ Pipe

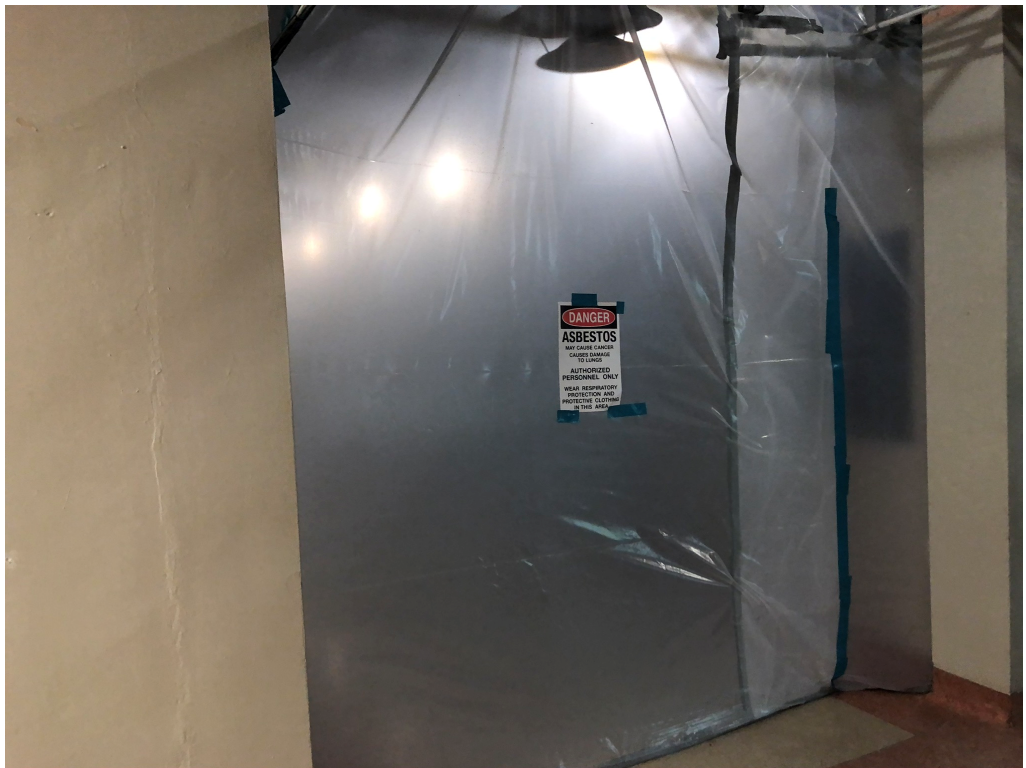
Figure 4 – Asbestos Protection between Halls

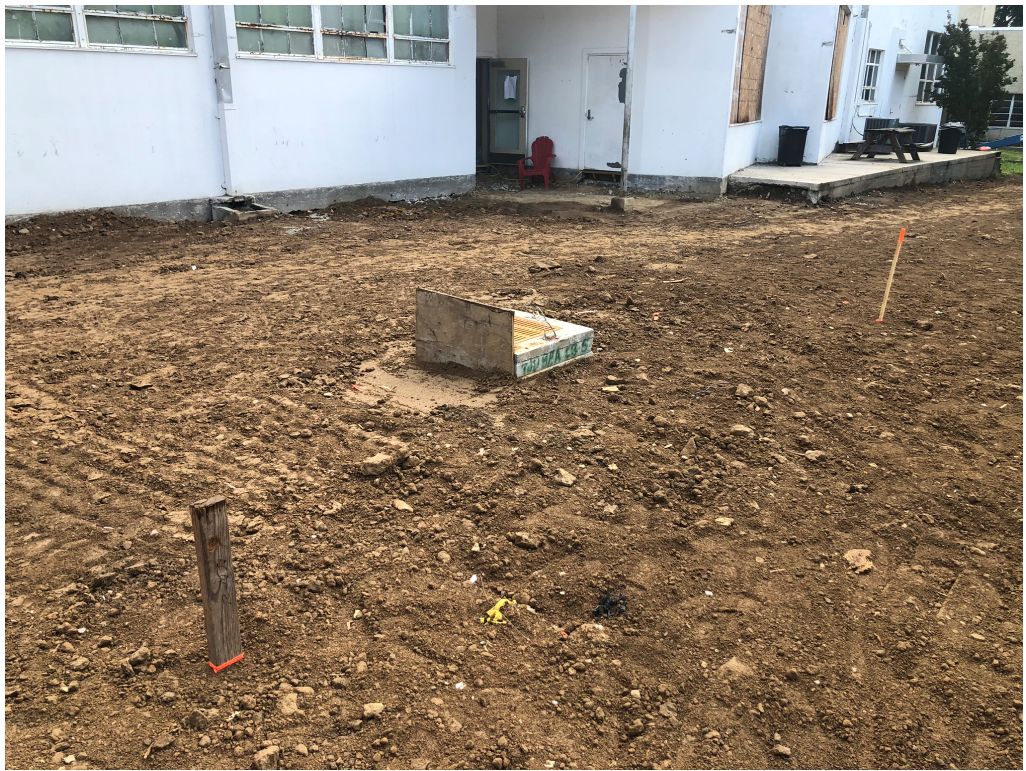
Figure 5 – Inlet Installed with Storm Drainage

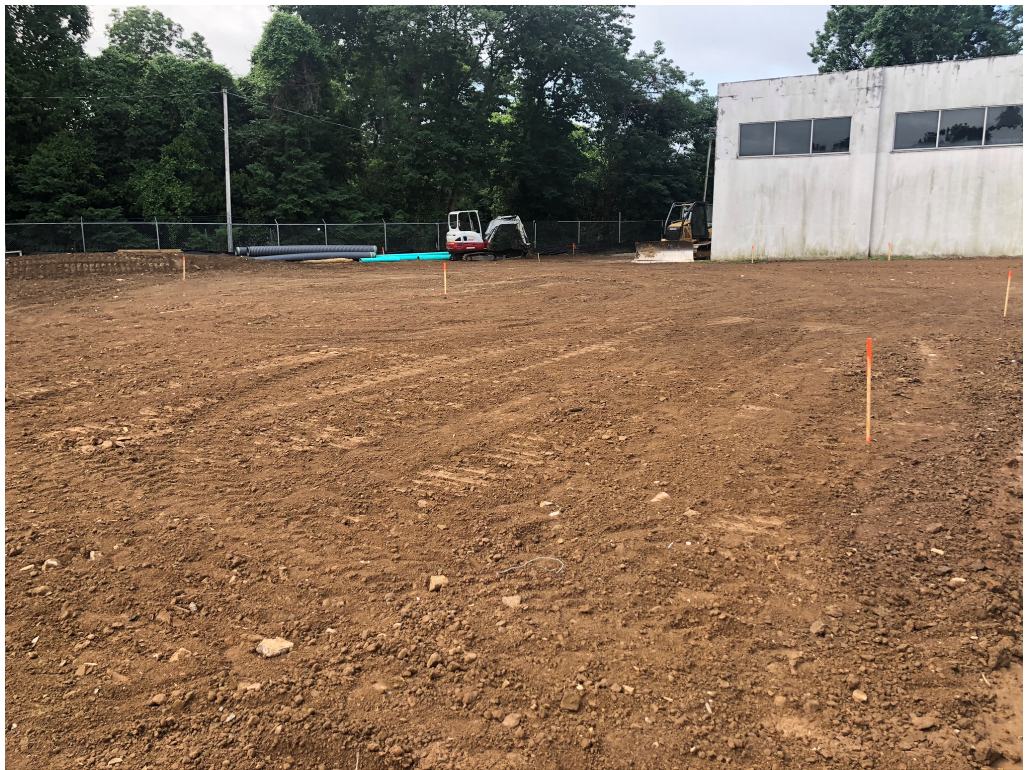
Figure 6 – Grading Stakes Set

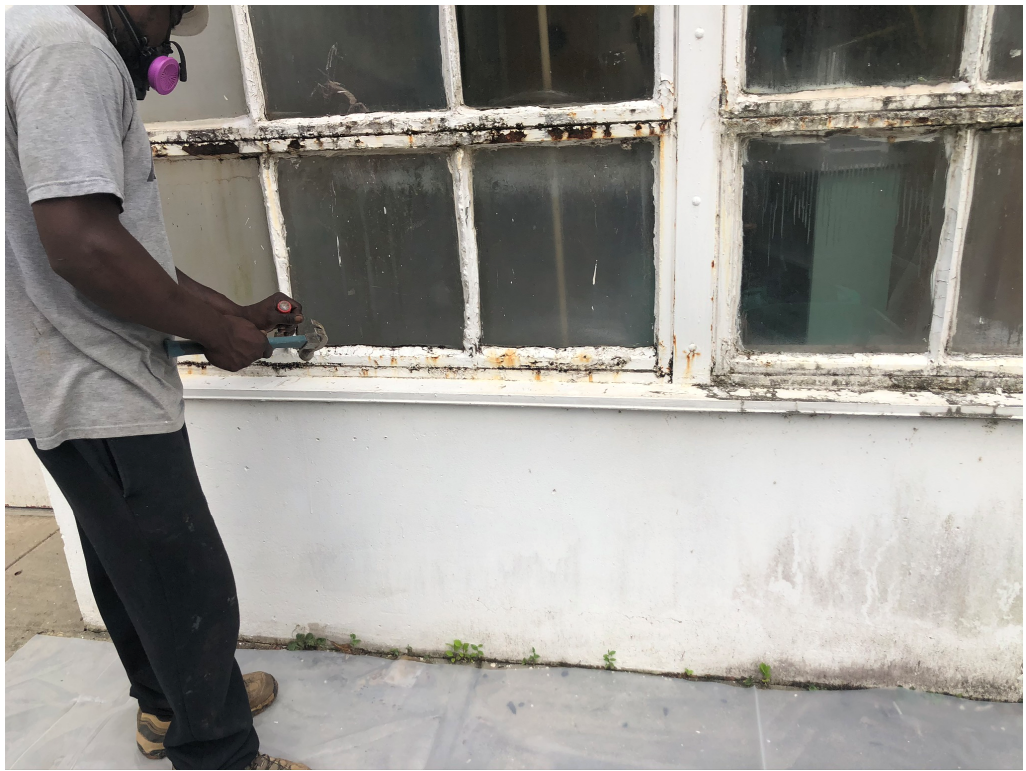
Figure 7 – Window Glazing Removal

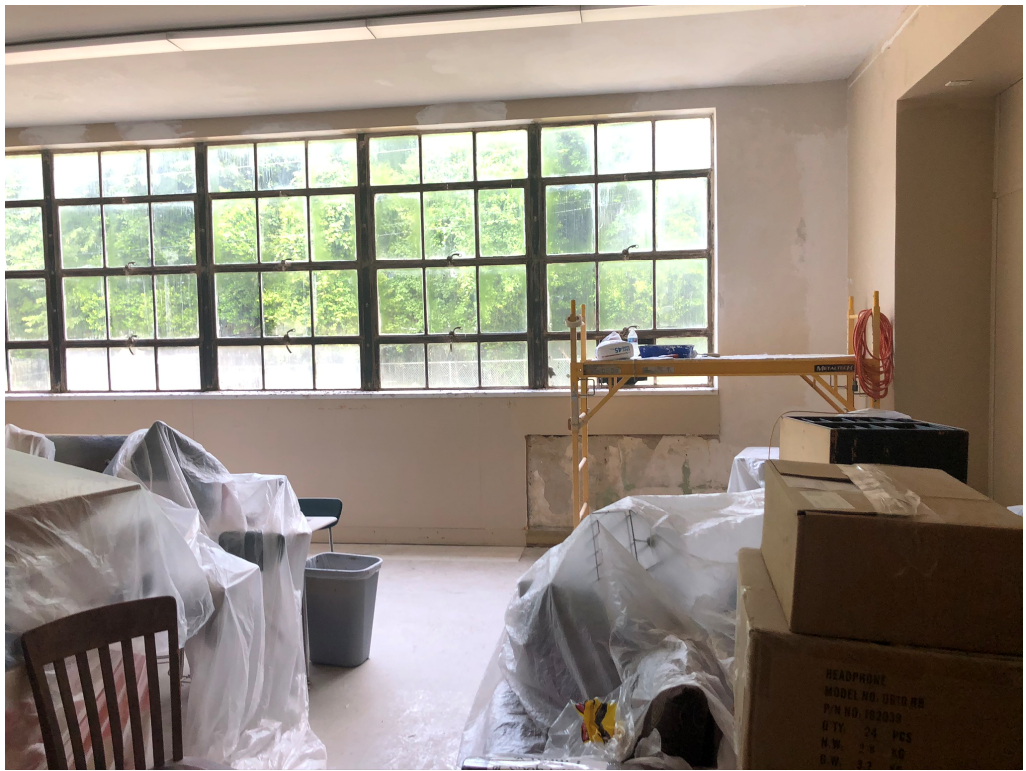
Figure 9 – Paint and Prep Ongoing

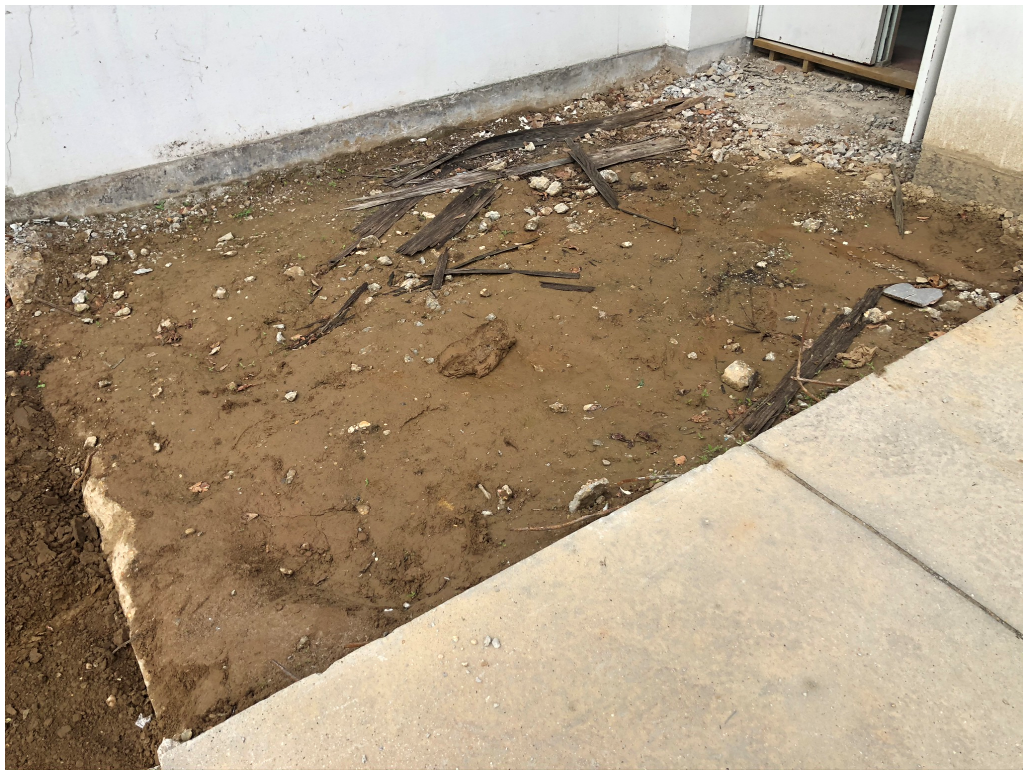
Figure 10 – Demoad Concrete in South Corner of Rear Yard
