18045-BOW Bowmar Elementary / Report Number 009

Work in Progress

Duct Install Window Rehabilitation

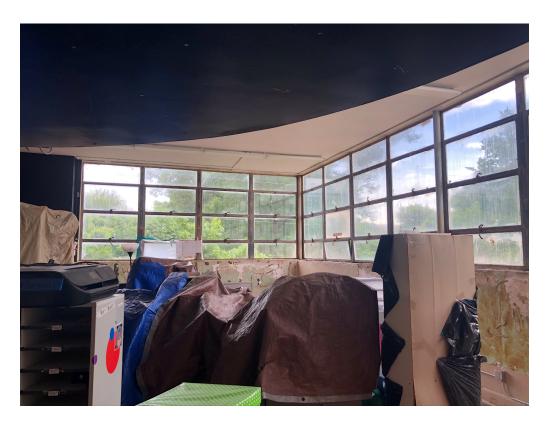
Figure 1 – Library 43 Window Uncovered

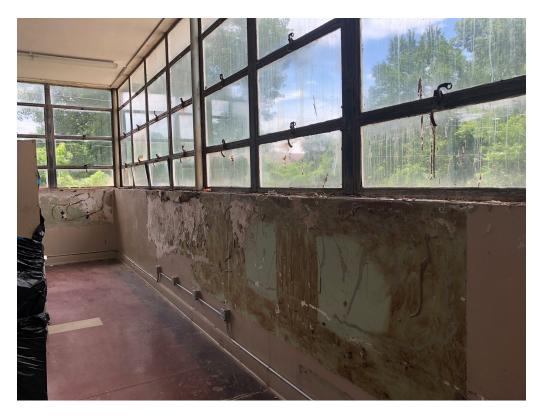
Figure 2 – Window Sill at Library 43

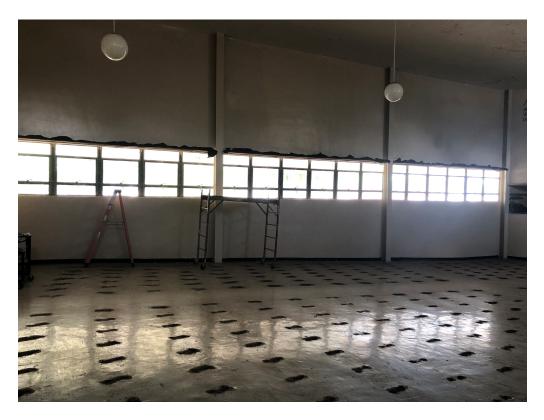
Upon arrival, I entered through the Main entry. Asbestos remediation is ongoing in the Main Hall running North and South. Chairs have been removed in auditorium and window rehab was ongoing in this area.

Figure 3 – Window Rehabilitation in Auditorium

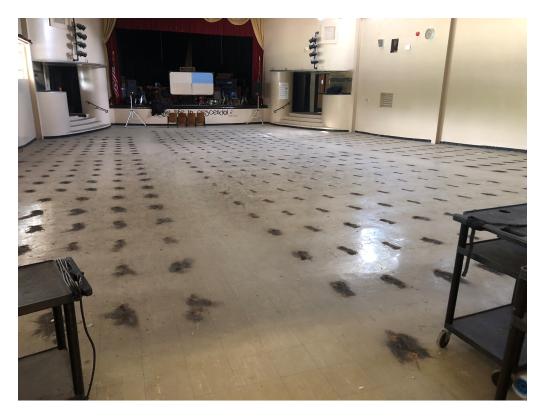
Figure 4 – Chairs in Auditorium Removed

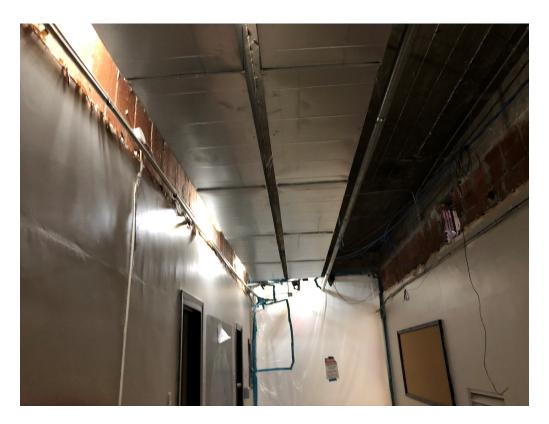
Mechanical ducting has been installed in this area as well.

Figure 5 – New Ducting in Passage 116

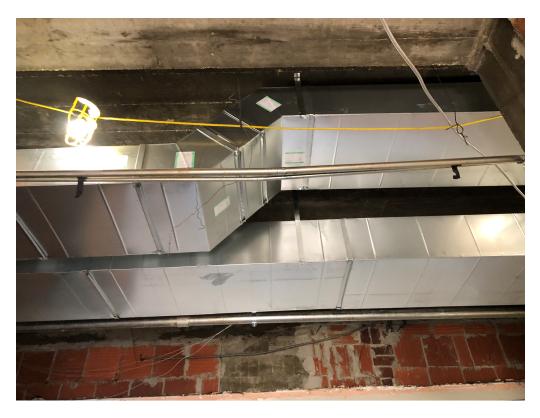
Figure 6 – New Ducting in Passage 116

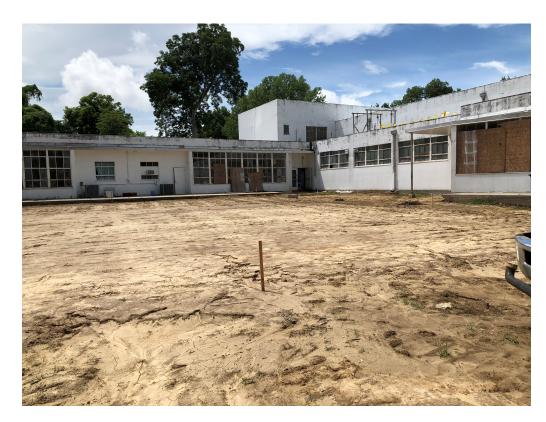
Figure 7 – Pad in Rear Yard

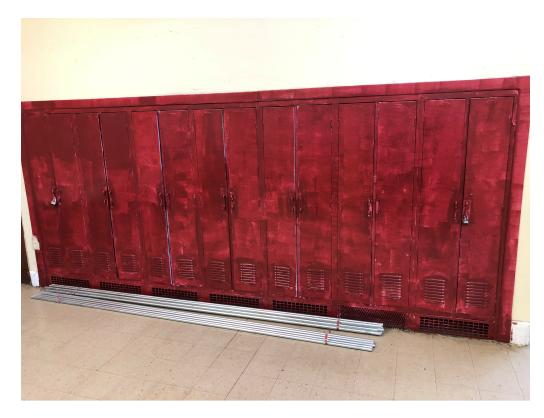
Figure 8 – Primed Lockers
