27 August 2020

18045-BOW Bowmar Elementary / Report Number 013

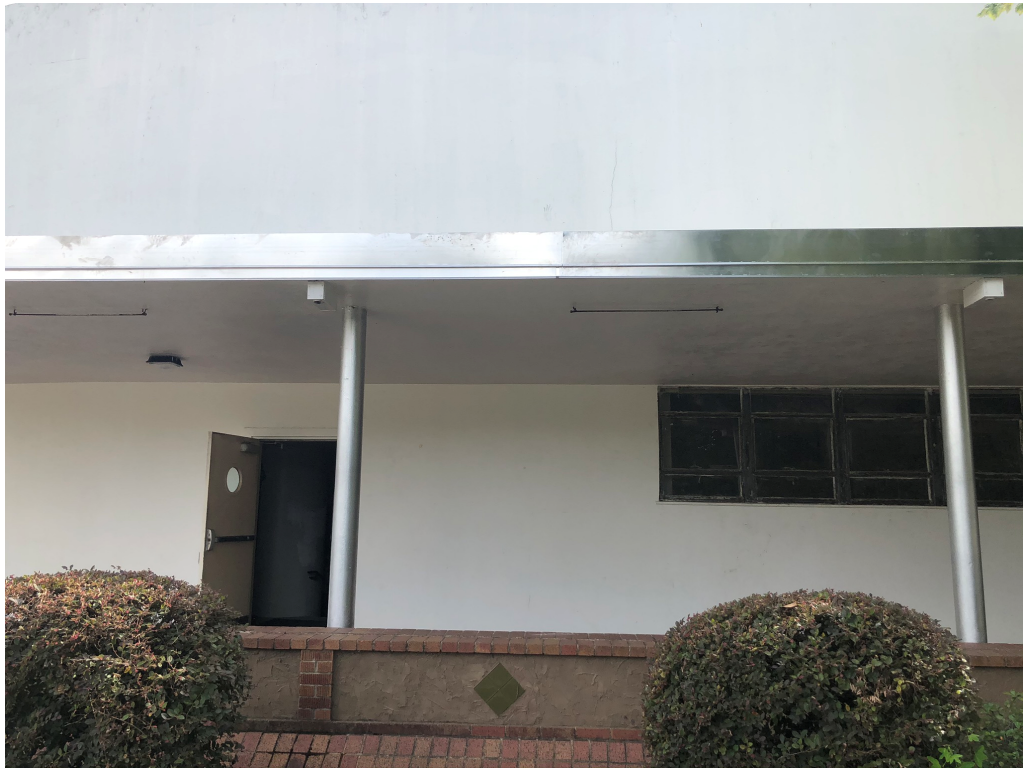
Figure 1 – Roof Edge Installed at Front Covering

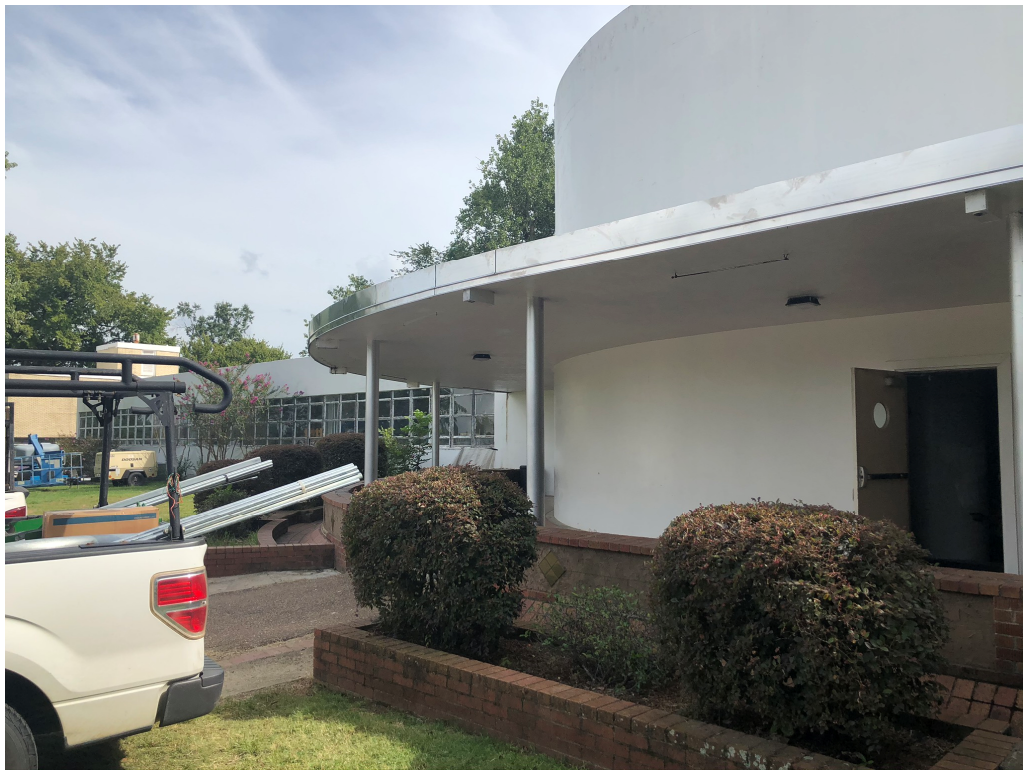
Figure 2 – Roof Edge Installed at Front Covering

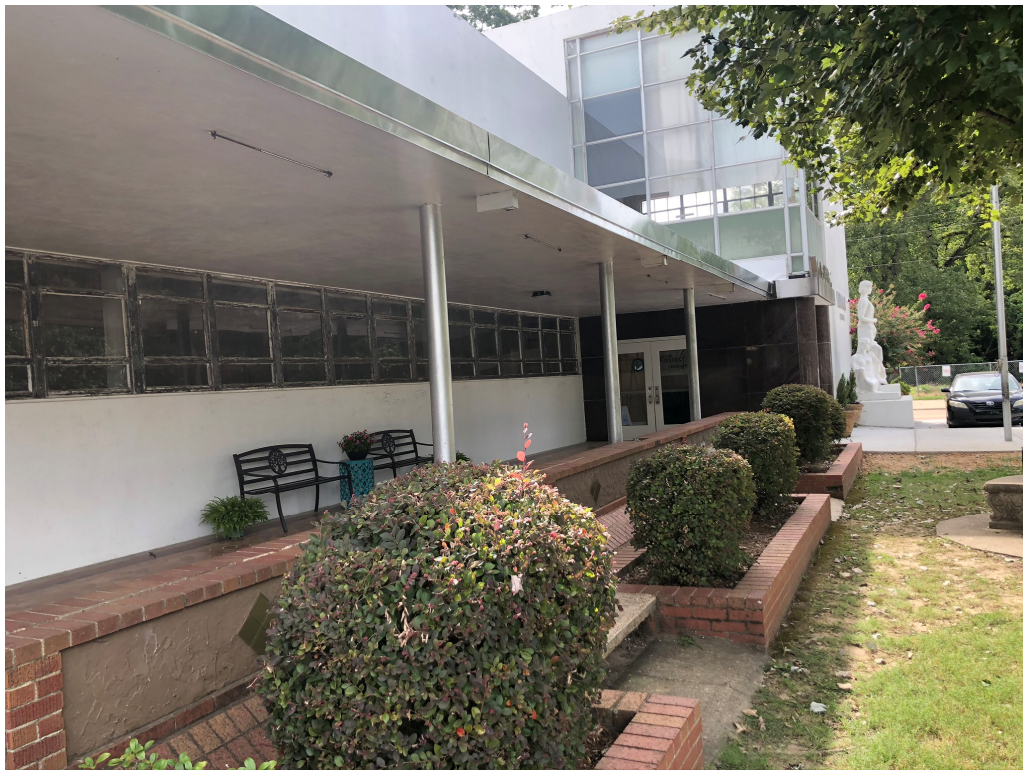
Figure 3 – Roof Edge Installed at Front Covering

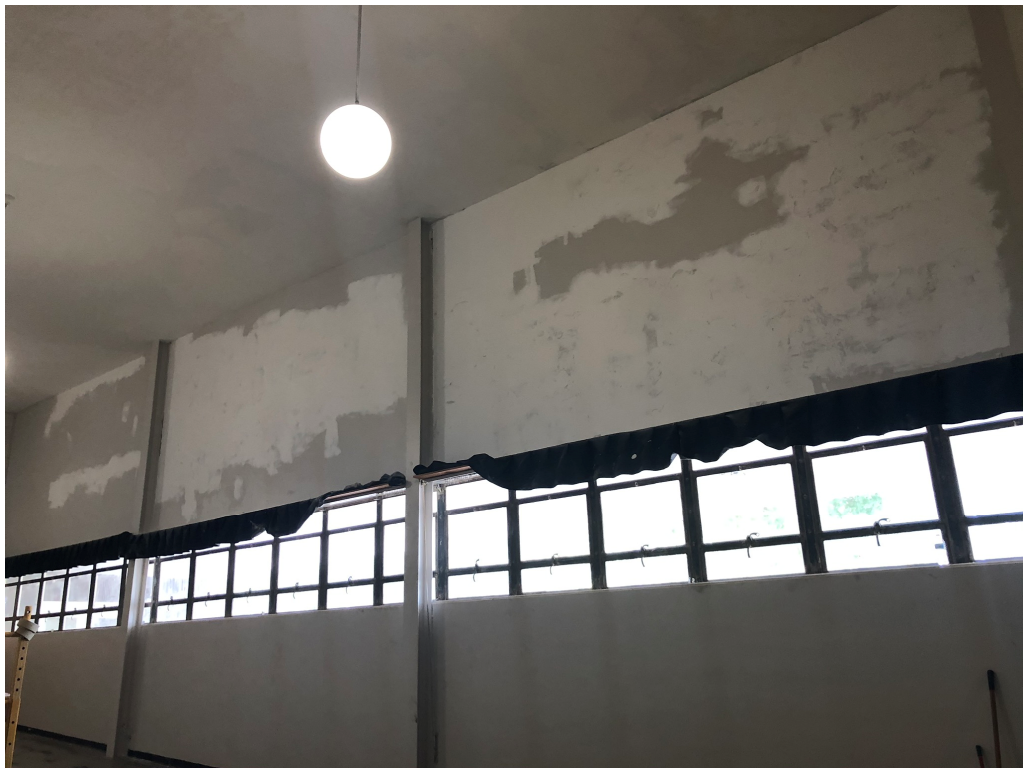
Figure 4 – Wall Prep at Auditorium

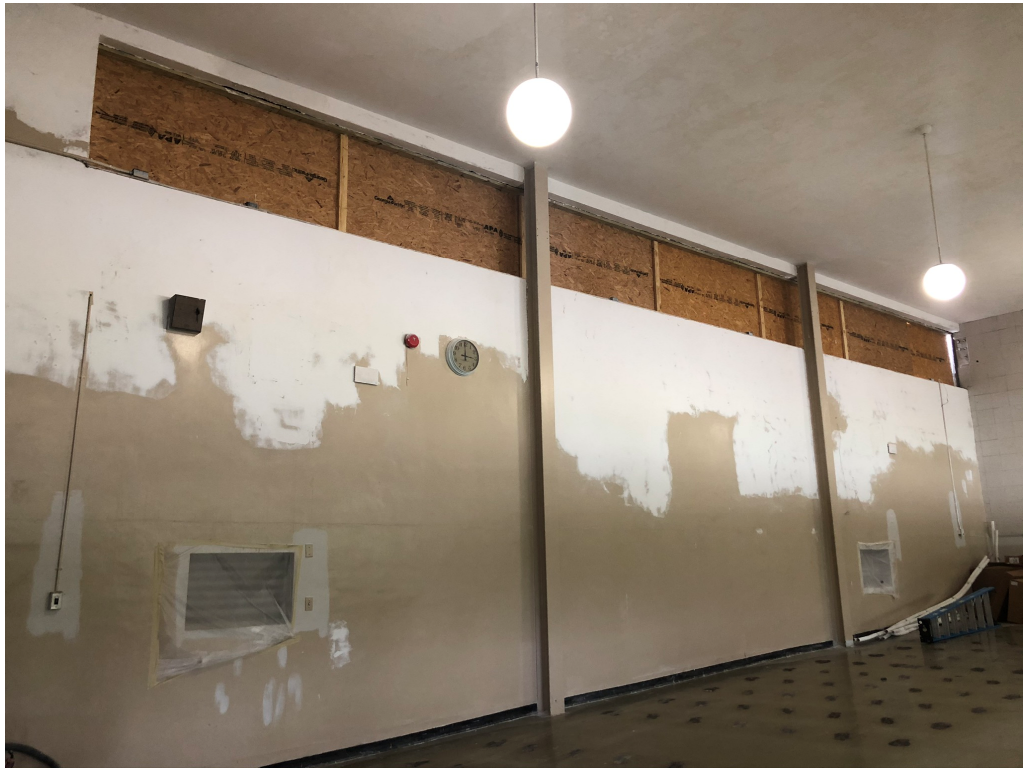
Figure 5 – Wall Prep at Auditorium

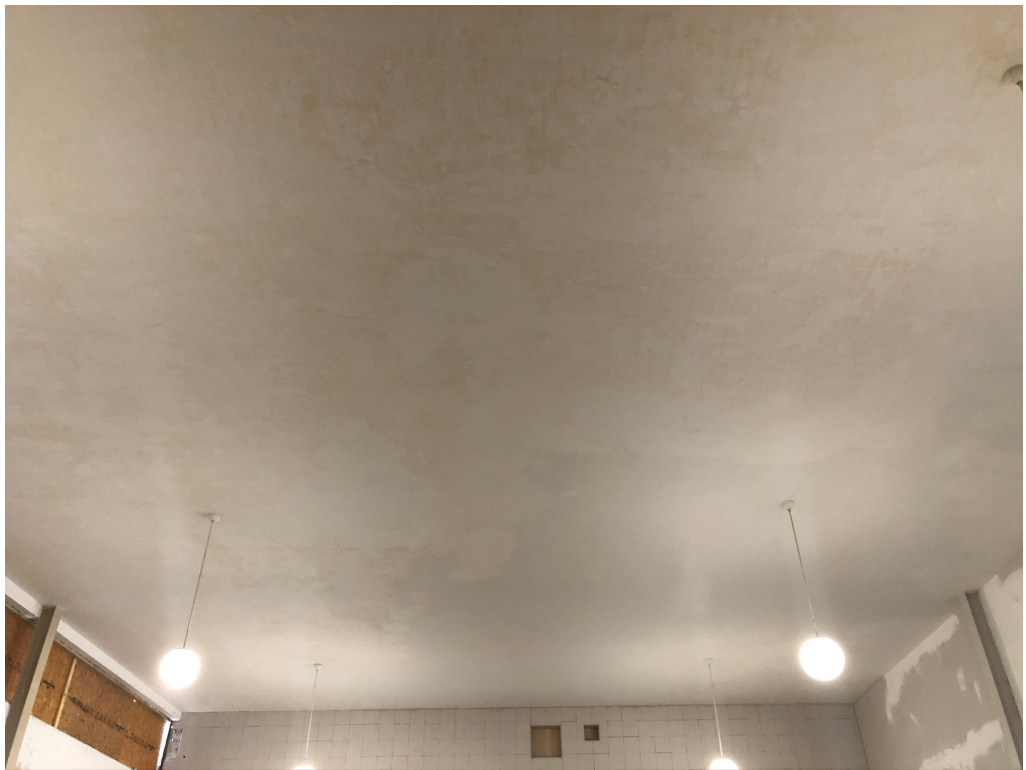
Figure 6 – Ceiling Prep at Auditorium

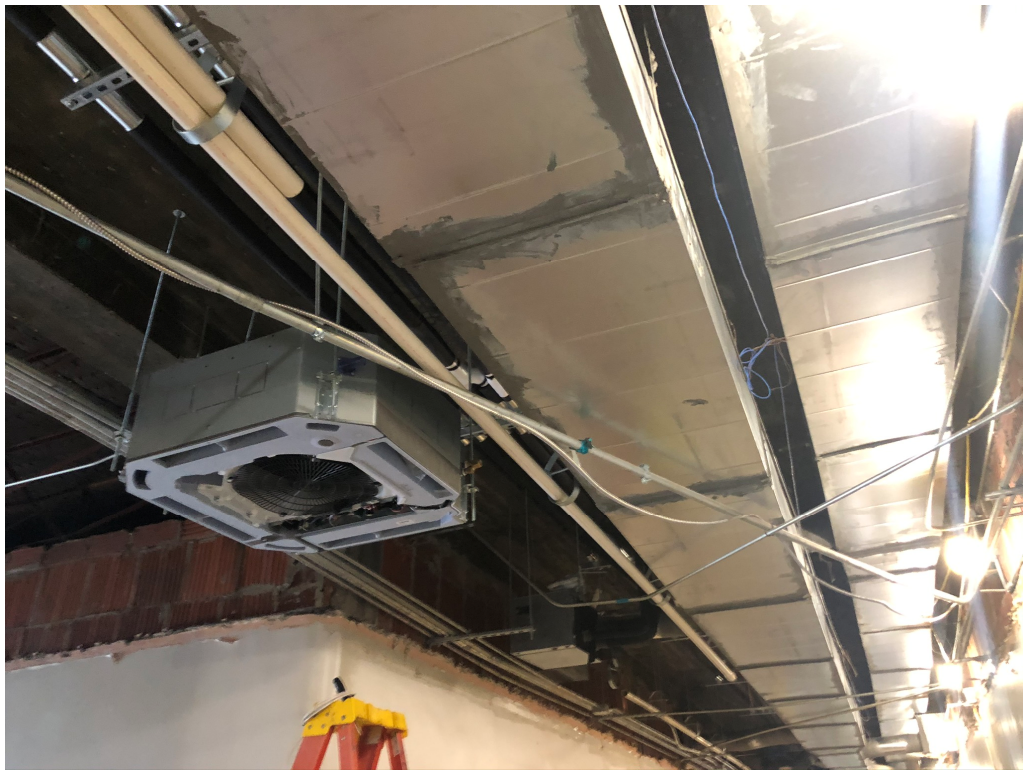
Figure 7 – HVAC Equipment

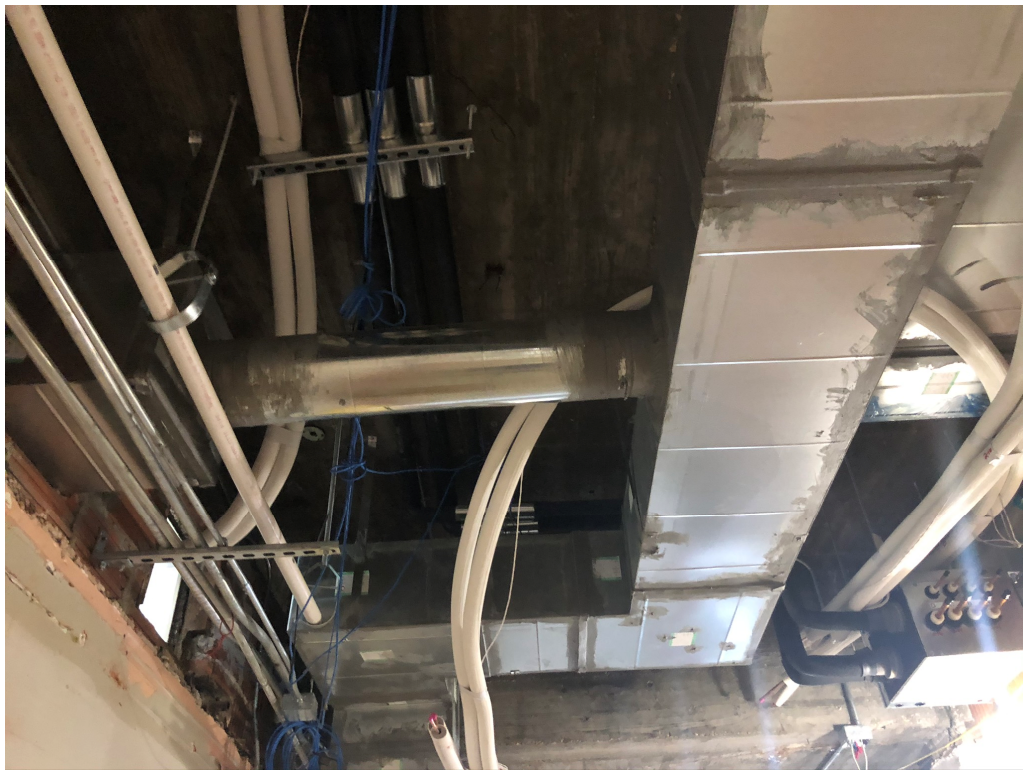
Figure 8 – Sealed Ducting

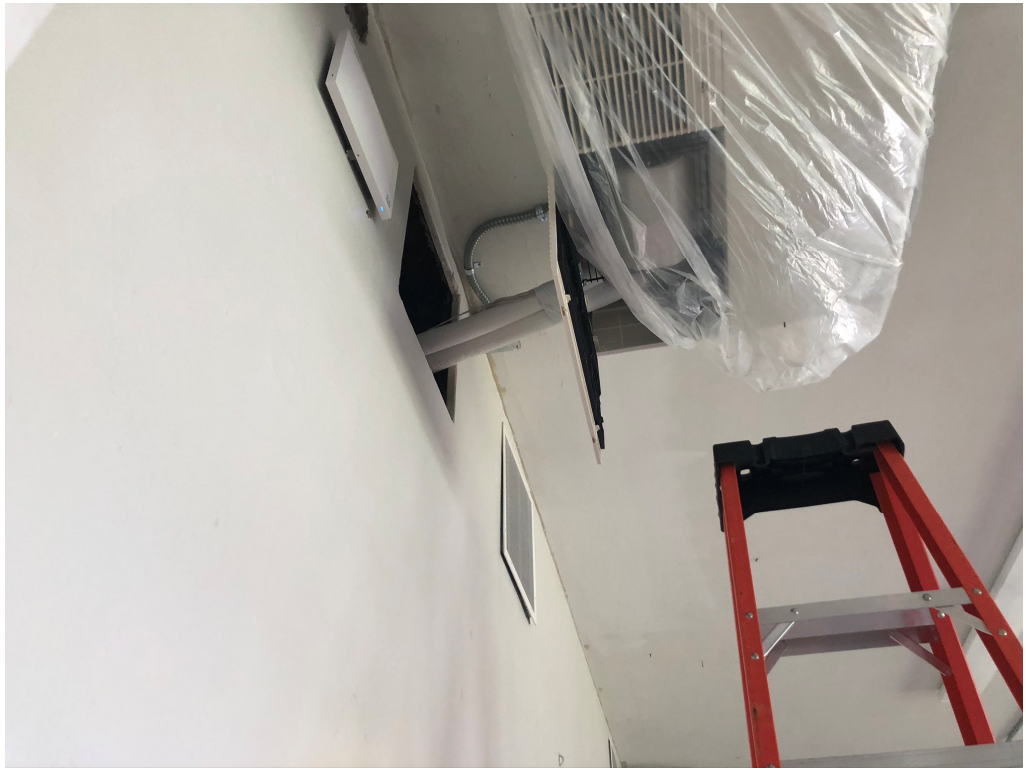
Figure 9 – HVAC Equipment Install Ongoing

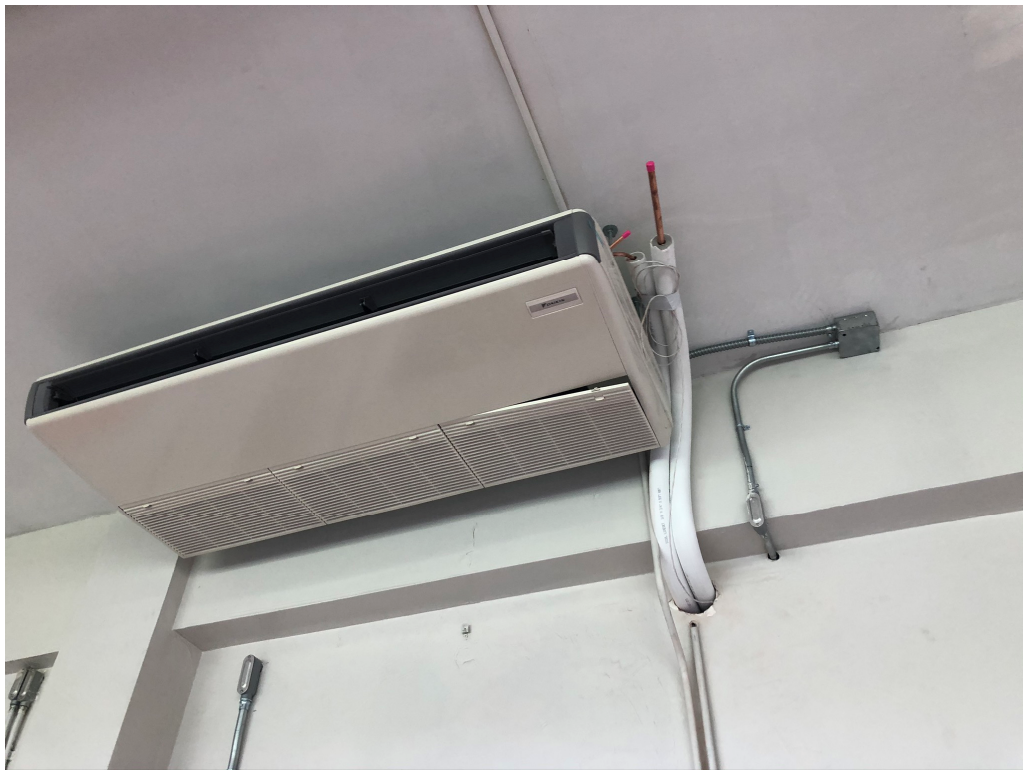
Figure 10 – HVAC Equipment Install Ongoing

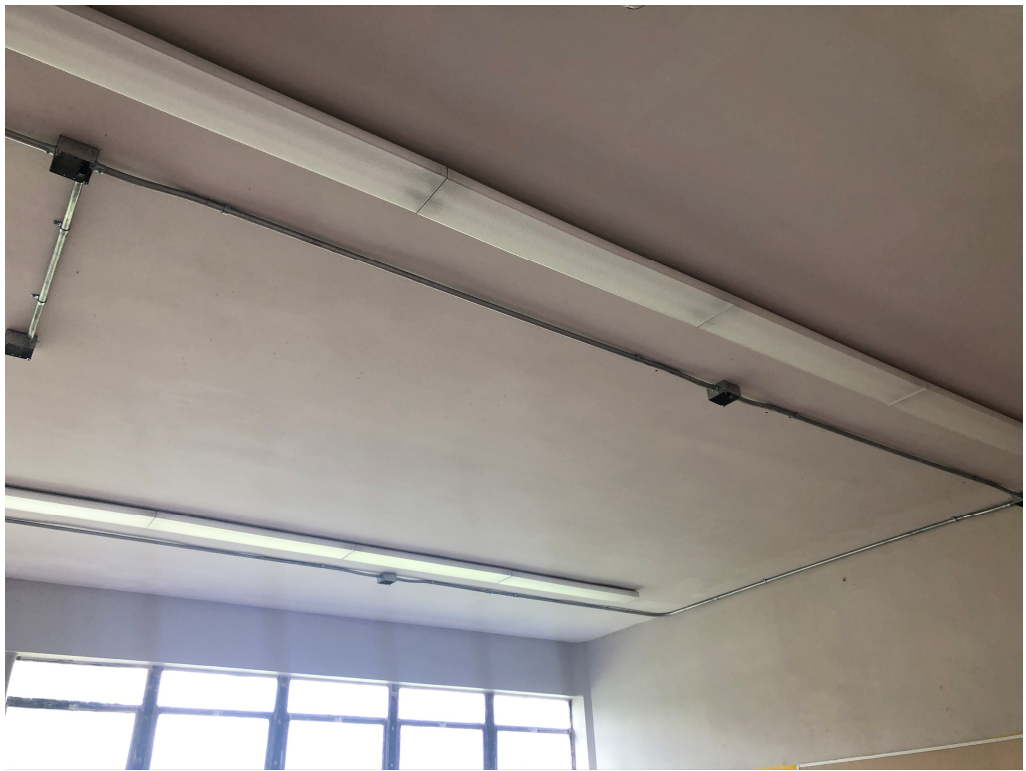
Figure 11 – Conduit Install at Ceiling in Some Rooms

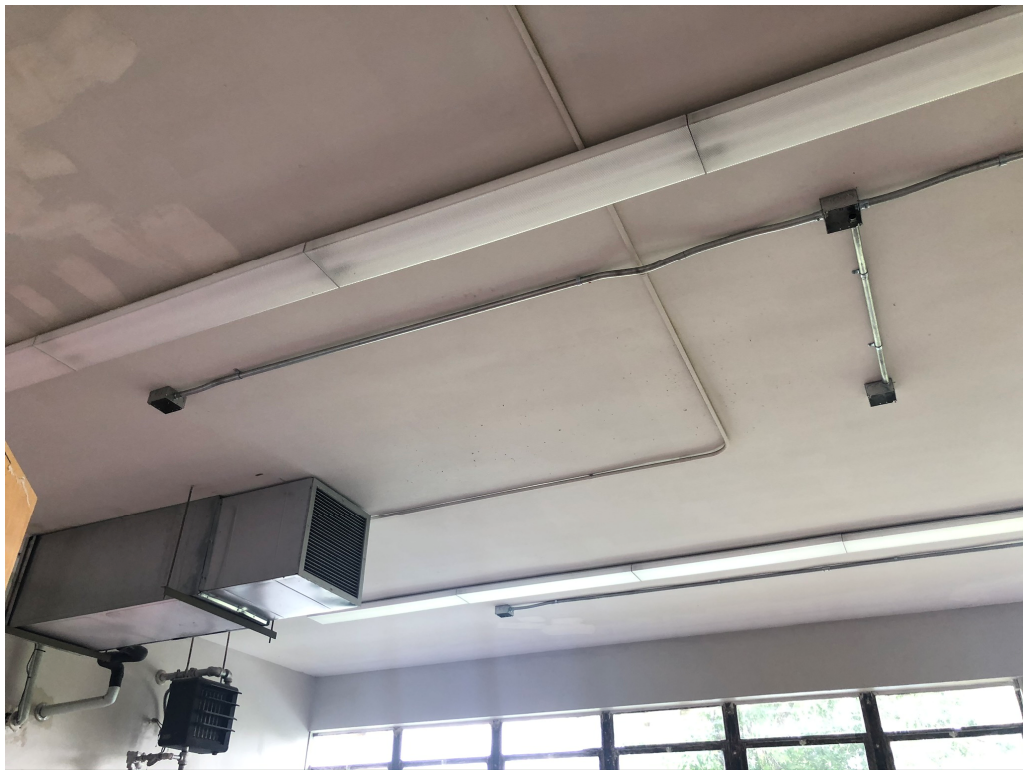
Figure 12 – Conduit Install at Ceiling in Some Rooms

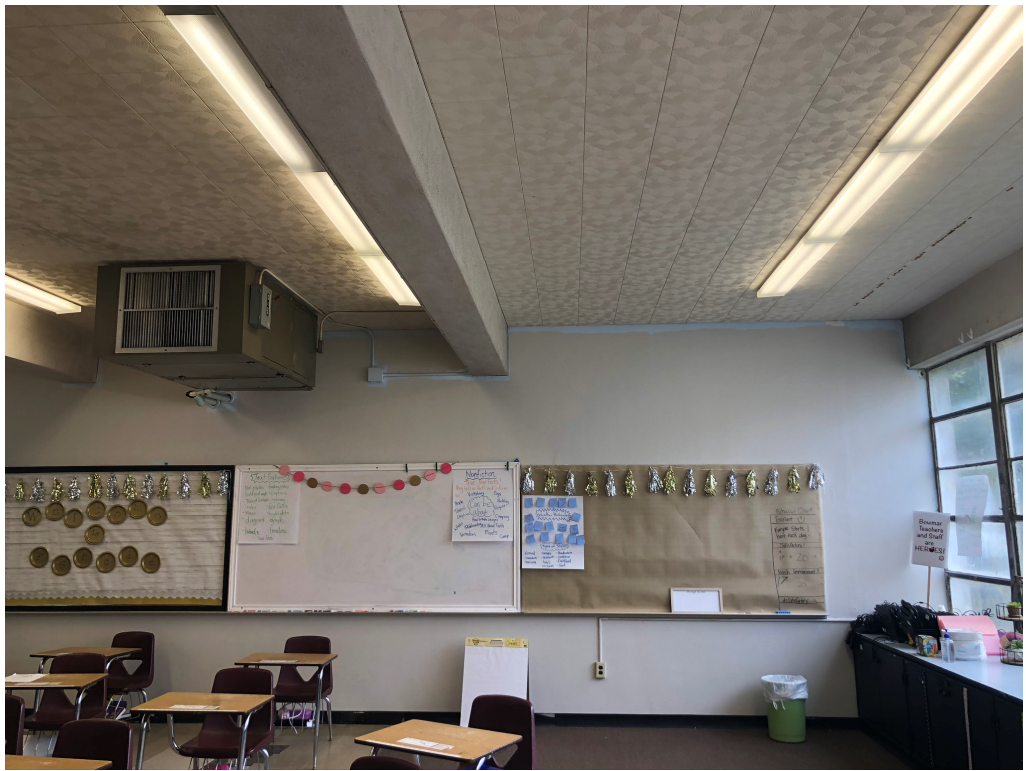
Figure 13 – Field Paint Applied; Awaiting Trim Out

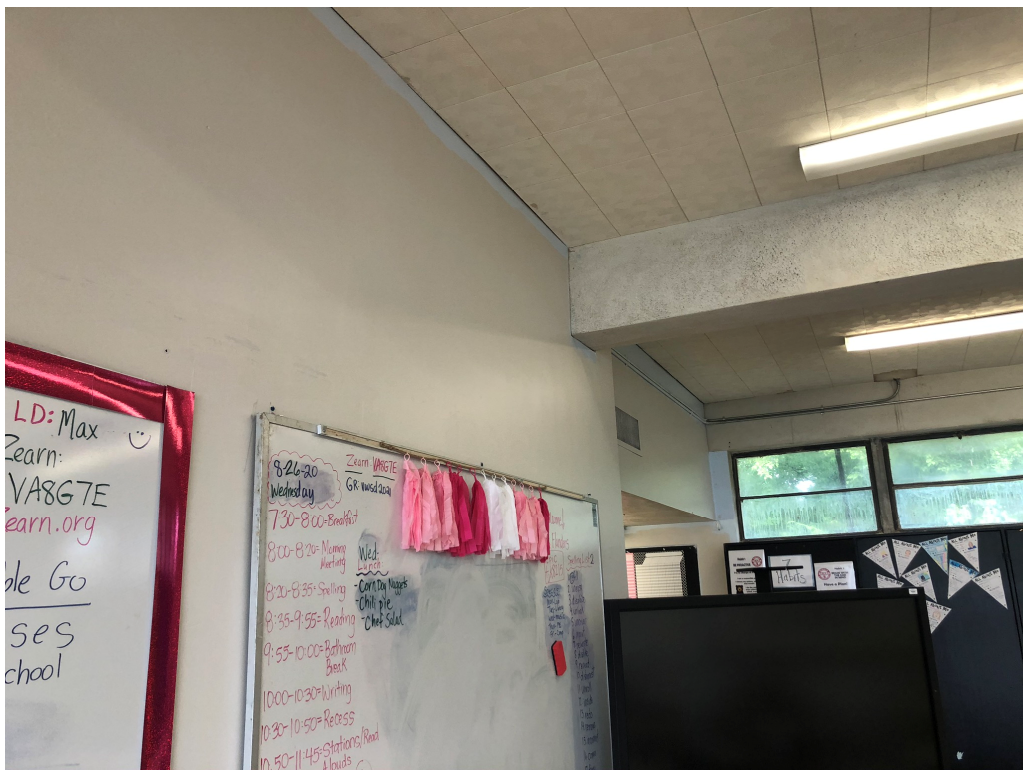
Figure 14 – Field Paint Applied; Awaiting Trim Out

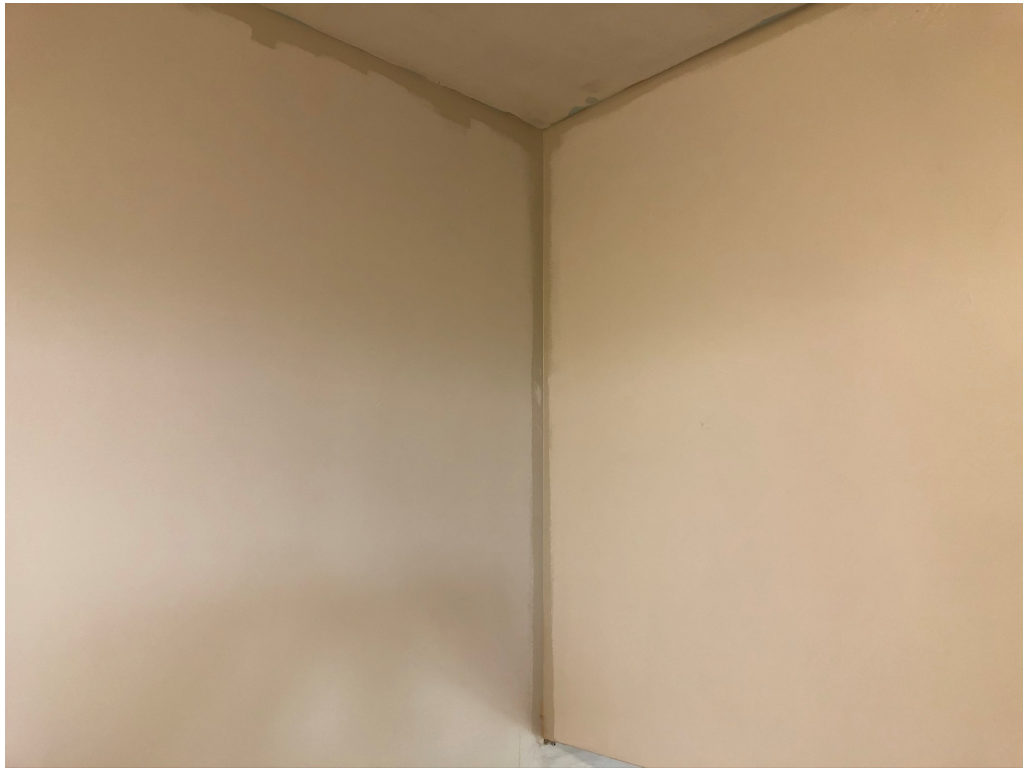
Figure 15 – Field Paint Applied; Awaiting Trim Out

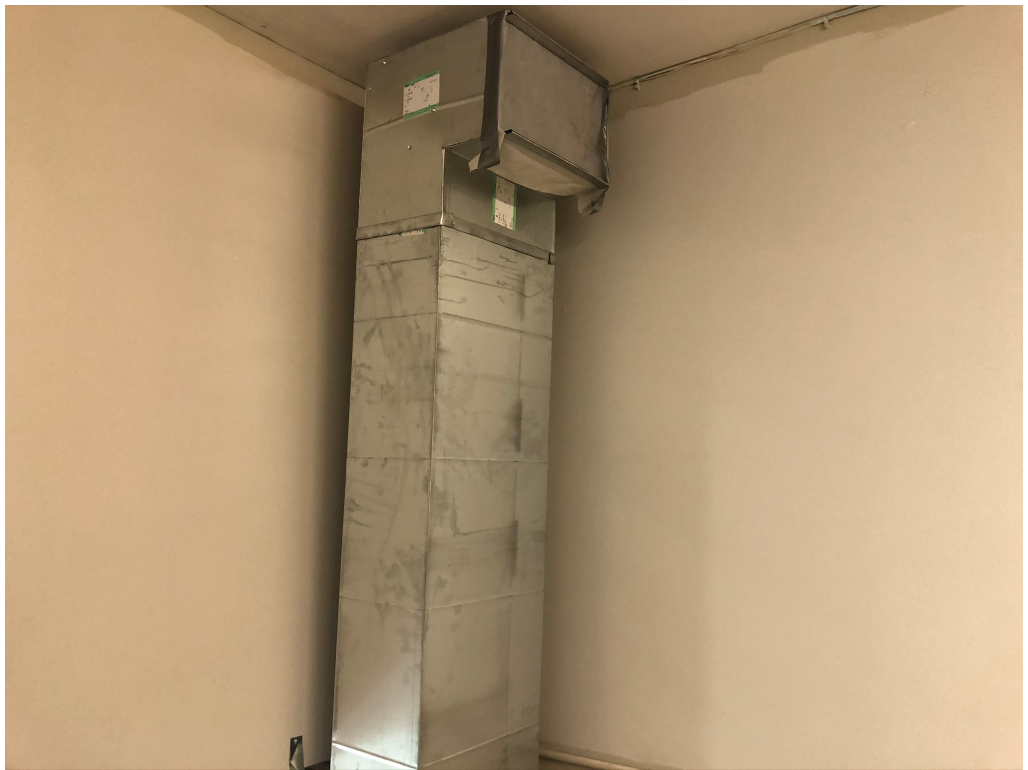
Figure 16 – HVAC Ducting Partially Installed

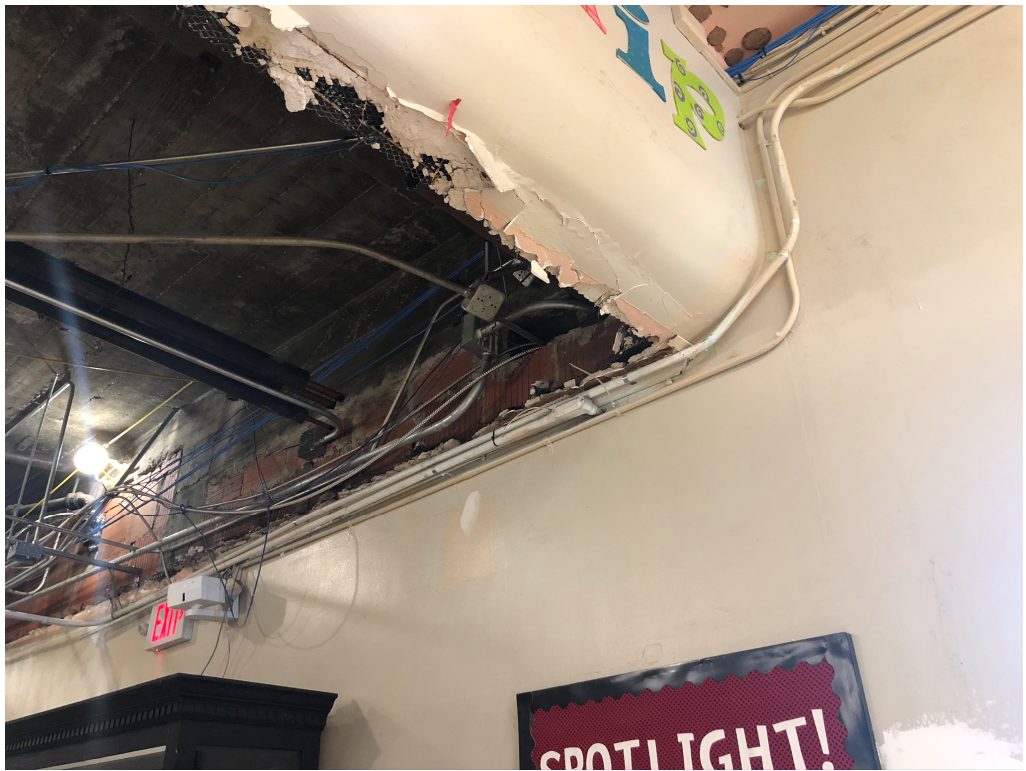
Figure 17 – Camera Connected Through Conduit to be Removed (Camera Needs to be disconnected by School Staff for Contractor to move forward)

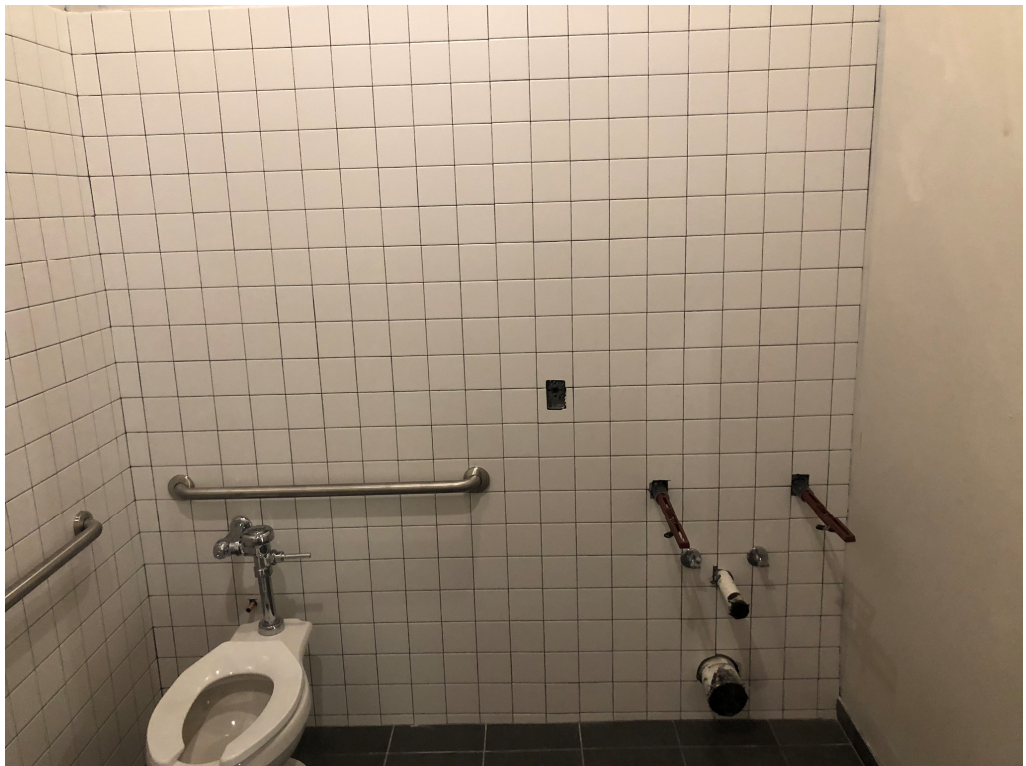
Figure 18 – Fixtures Partially Installed at ADA Bathroom

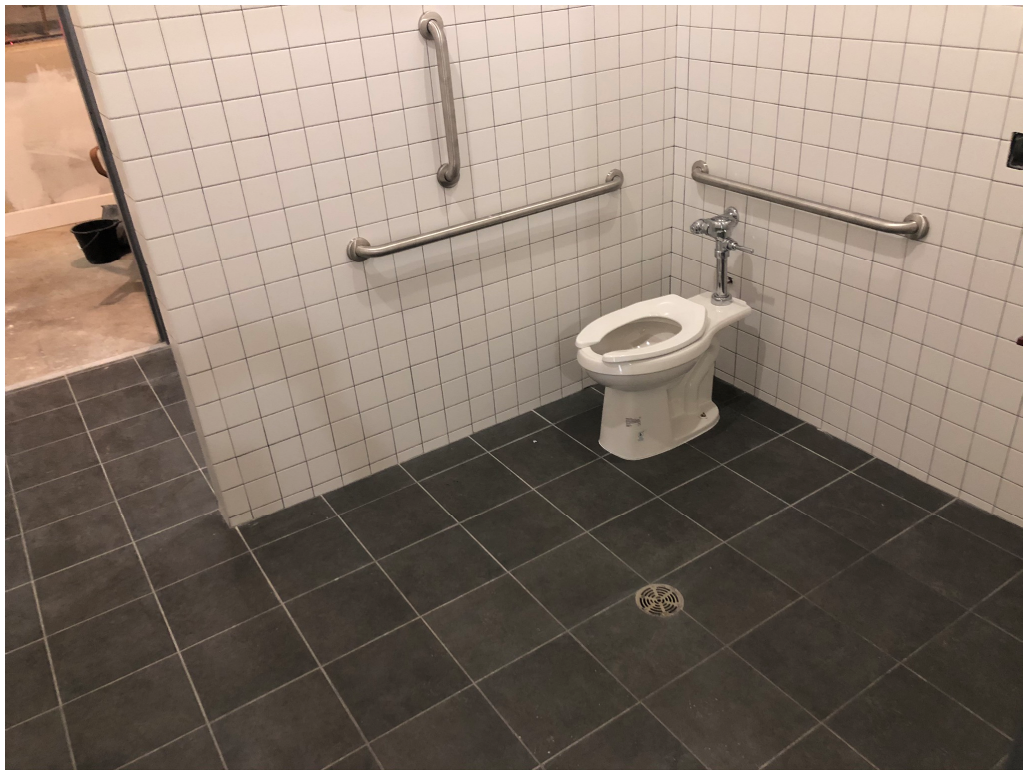
Figure 19 – Fixtures Partially Installed at ADA Bathroom

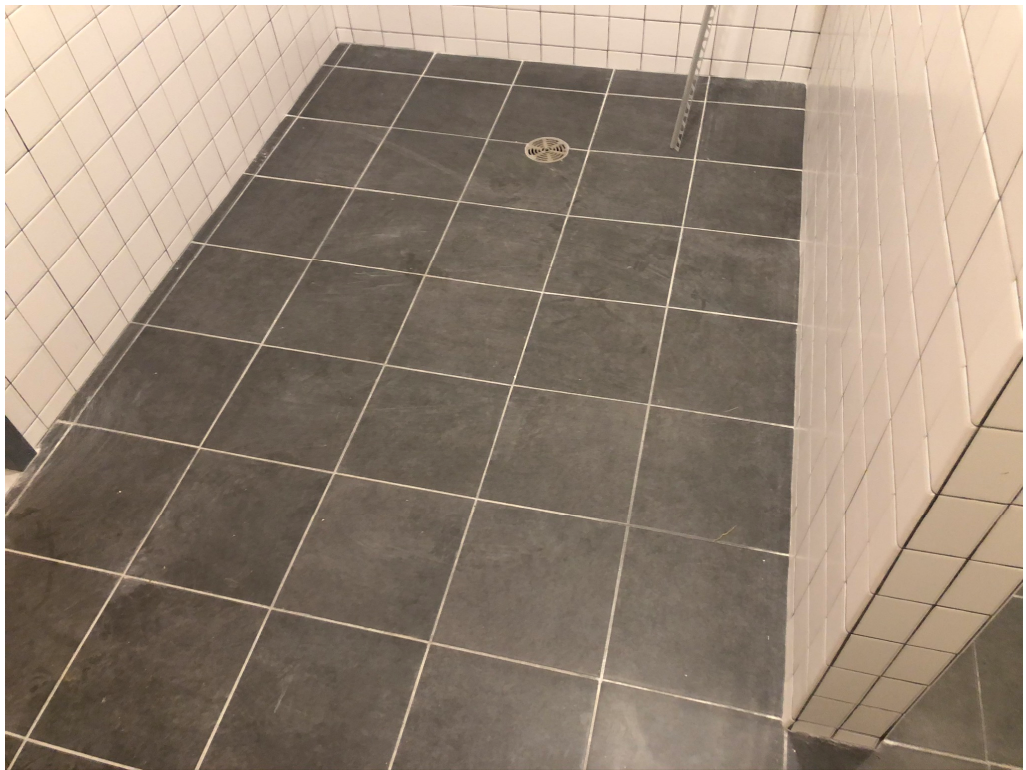
Figure 20 – Tile Grouted at ADA Bathroom

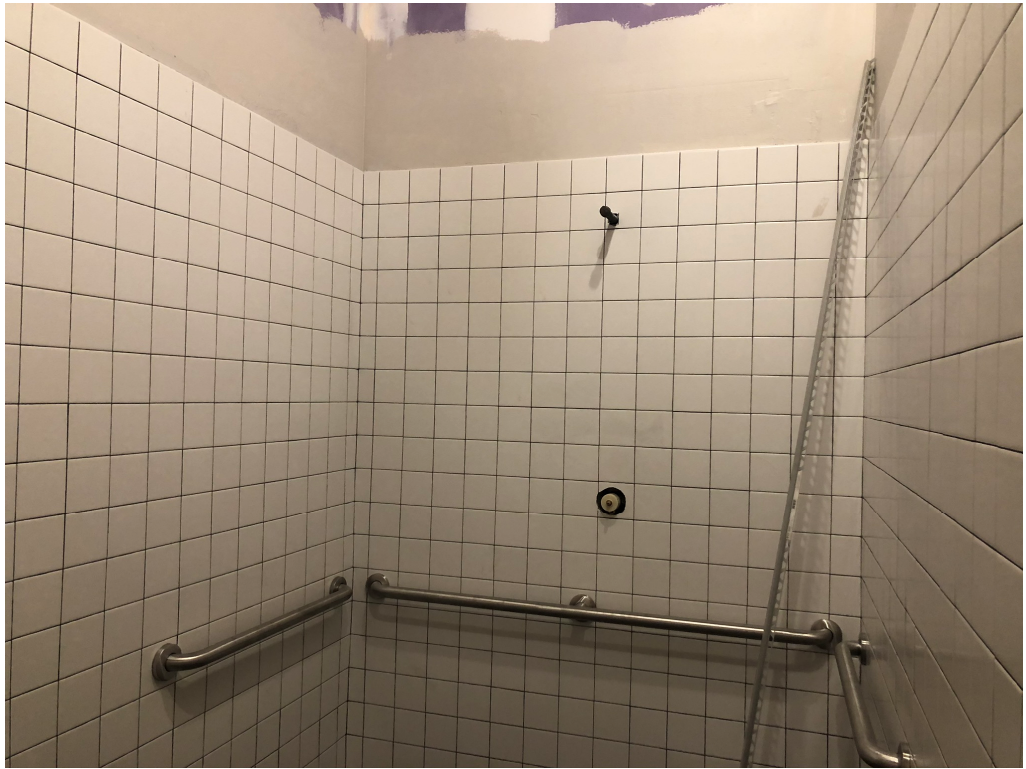
Figure 21 – ADA Shower

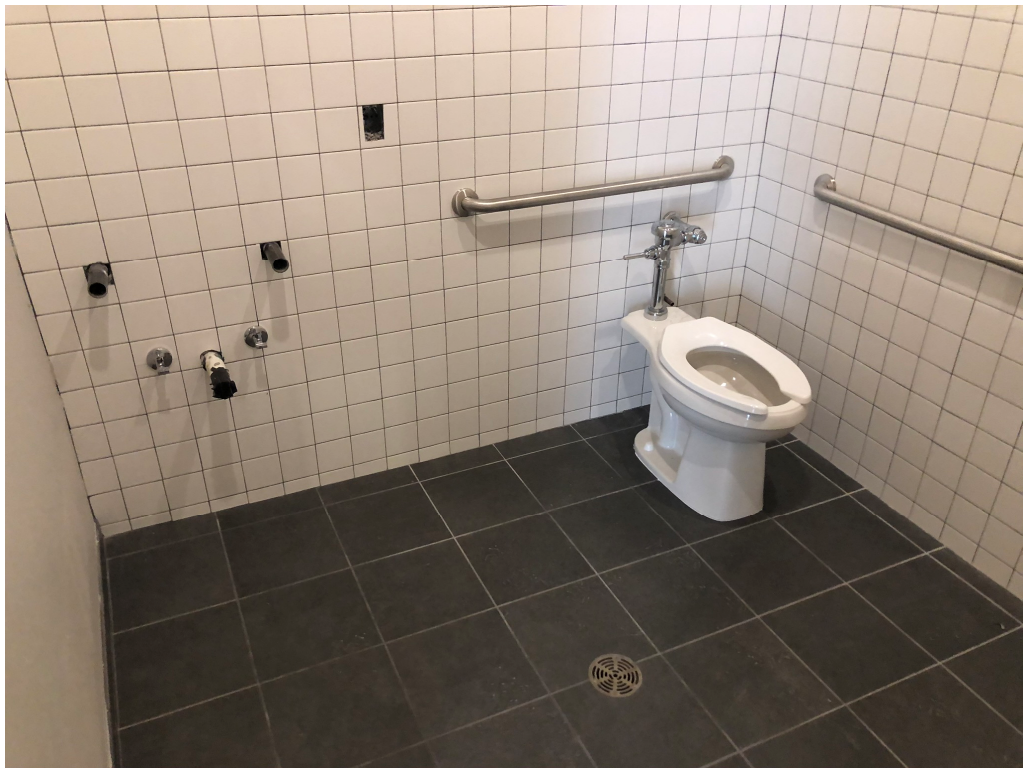
Figure 22 – ADA Bathroom Fixtures Partially Installed

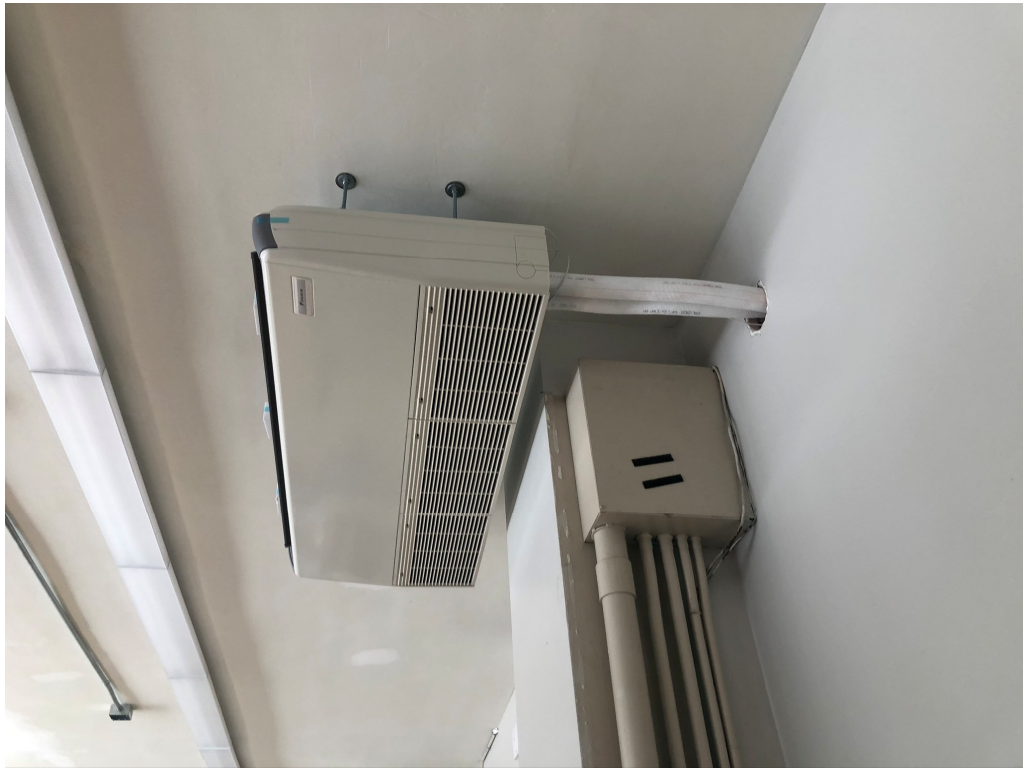
Figure 23 – HVAC Equipment Install Complete in Some Rooms

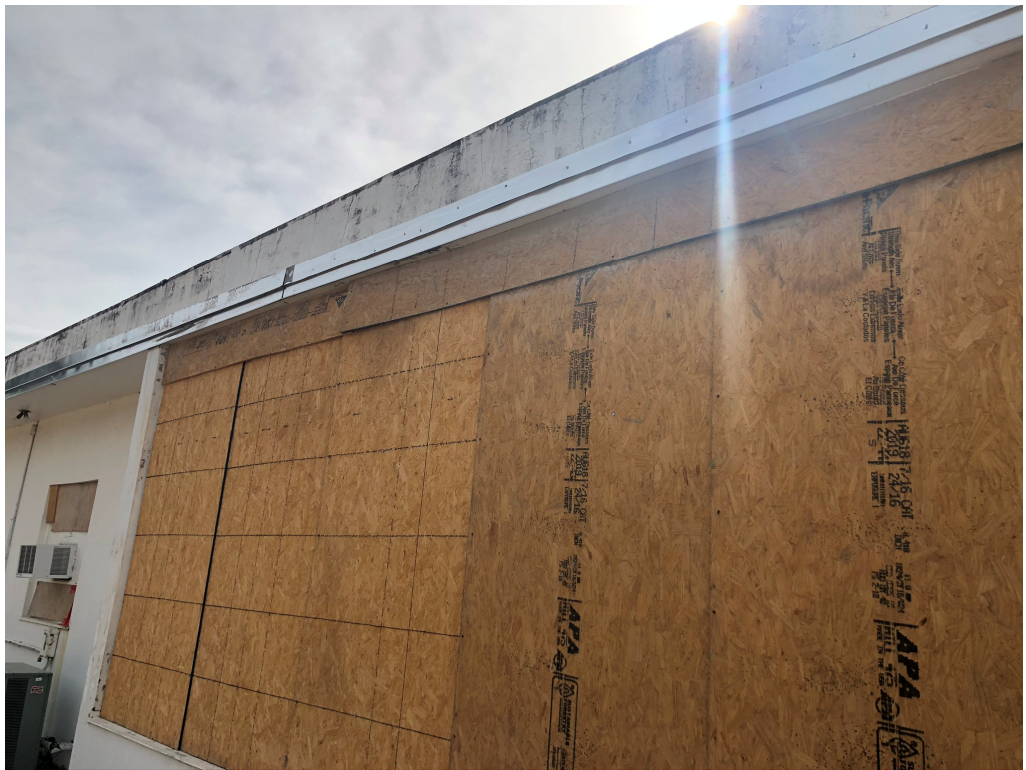
Figure 24 – Base Trim Installed Awaiting Cover Trim
