02 December 2020

18045-BOW Bowmar Elementary / Report Number 020

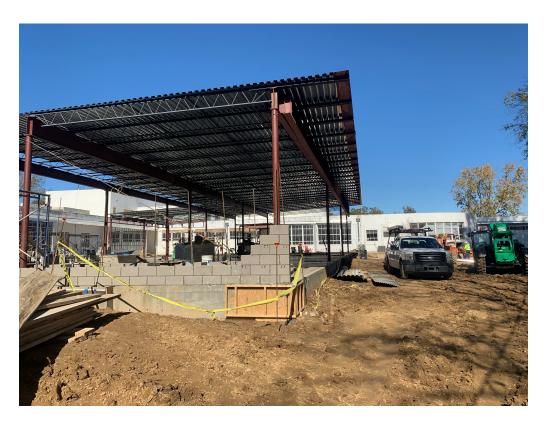
Figure 1 – South Corner of Addition

I met Jimmy White on the slab and we discussed work progress. He intends to pour concrete at sidewalks within the next few weeks. We looked at some potential issues with leaving the sidewalks un-poured at this stage of the progress, including wash out that has already begun at

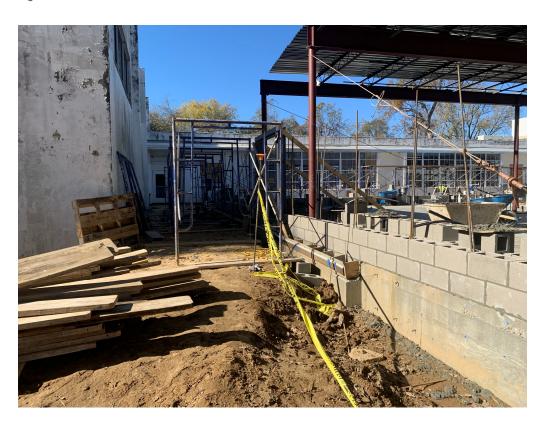
Mason, electricians, and welders were all on site working. Block was being installed and has been installed up to 2 courses at the time of my

Figure 2 – CMU installation is ongoing

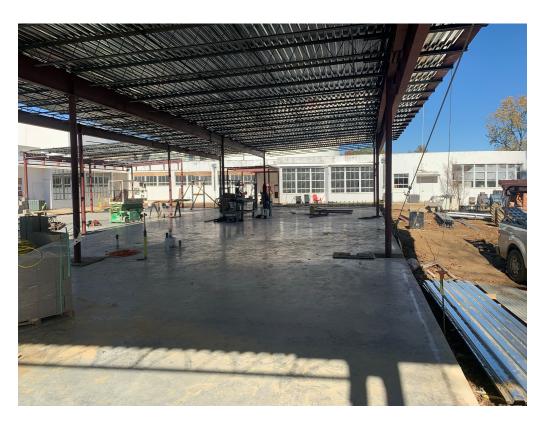
Steel has been installed as well as roof joists and decking for the front 2/3 of the addition. The remainder of steel awaits full installation of the

Figure 3 – Roof Decking installed over ceiling joists

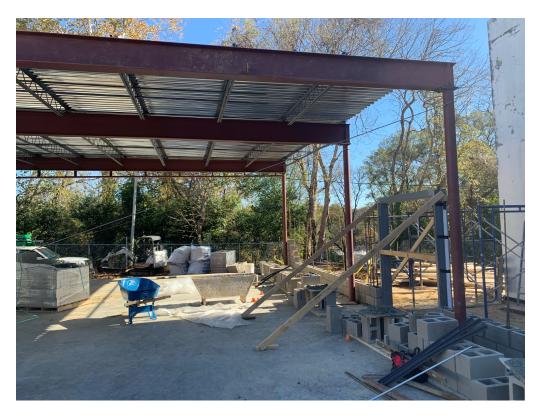
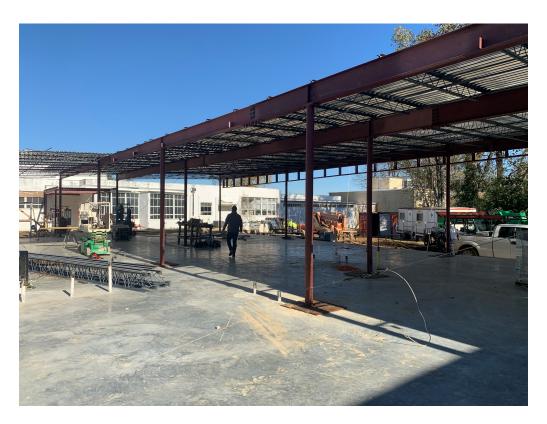
back CMU structural wall.

Figure 4 – Remainder of Steel work is awaiting CMU block installation

Figure 5 – Remainder of Steel work is awaiting CMU block installation

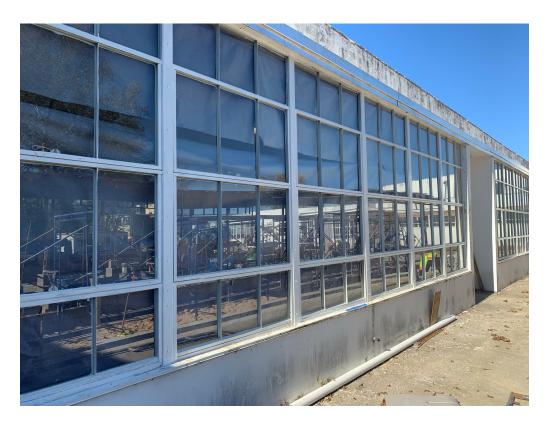
Figure 7 – SE side of Existing Glazing Installed

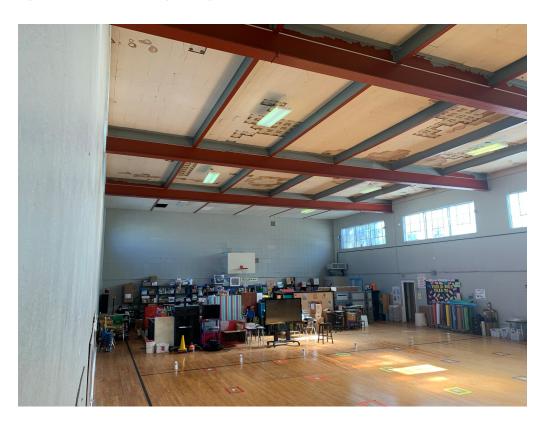
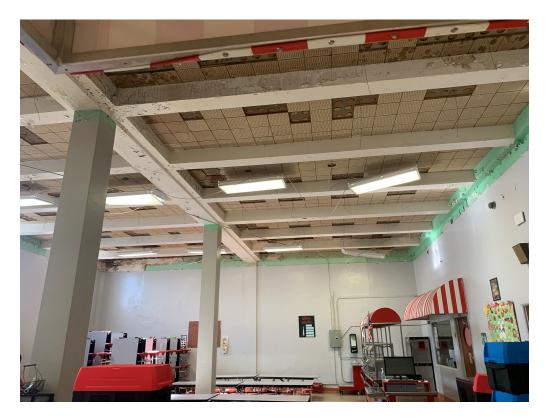
We also walked the interior of the existing building and reviewed ceiling demo that has been performed in the gym and cafeteria areas. Making our way to the boiler room, Jimmy pointed out a plumbing and electrical conflict at the new panel location. He mentioned that Travis Altsman is

Figure 8 – Gymnasium Ceiling Removed

Figure 9 – Cafeteria Ceiling Removed

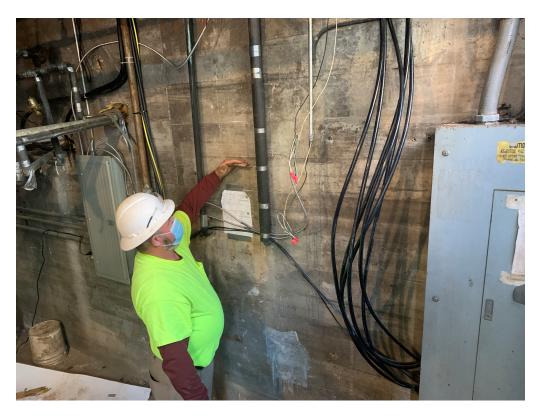
aware of the conflict and working towards a solution.

Figure 10 – Plumbing/Electrical Conflict (awaiting resolution)
