15 January 2021

18045-BOW Bowmar Elementary / Report Number 022

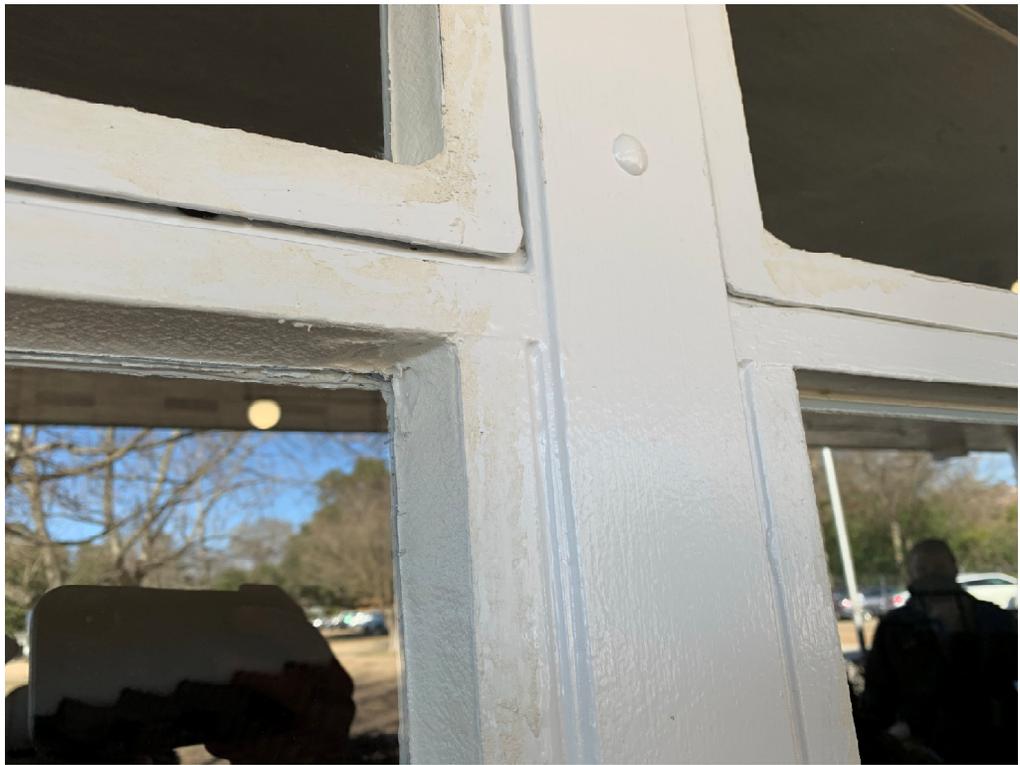
Figure 1 – Window Glazing is On-Going; Ensure that full coverage at all 4 side of each pane is applied (ie the right pane in this image only has the sides and bottom glazed but the left pane has all 4)

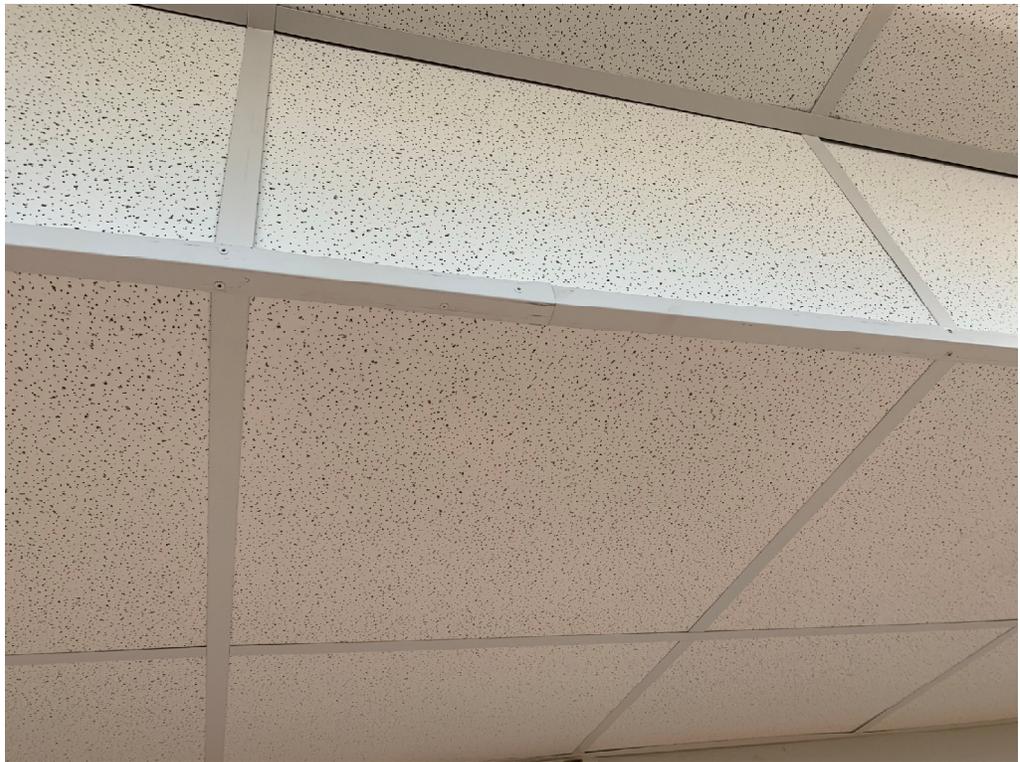
Figure 2 – Touch Up required at ceiling grid here and throughout

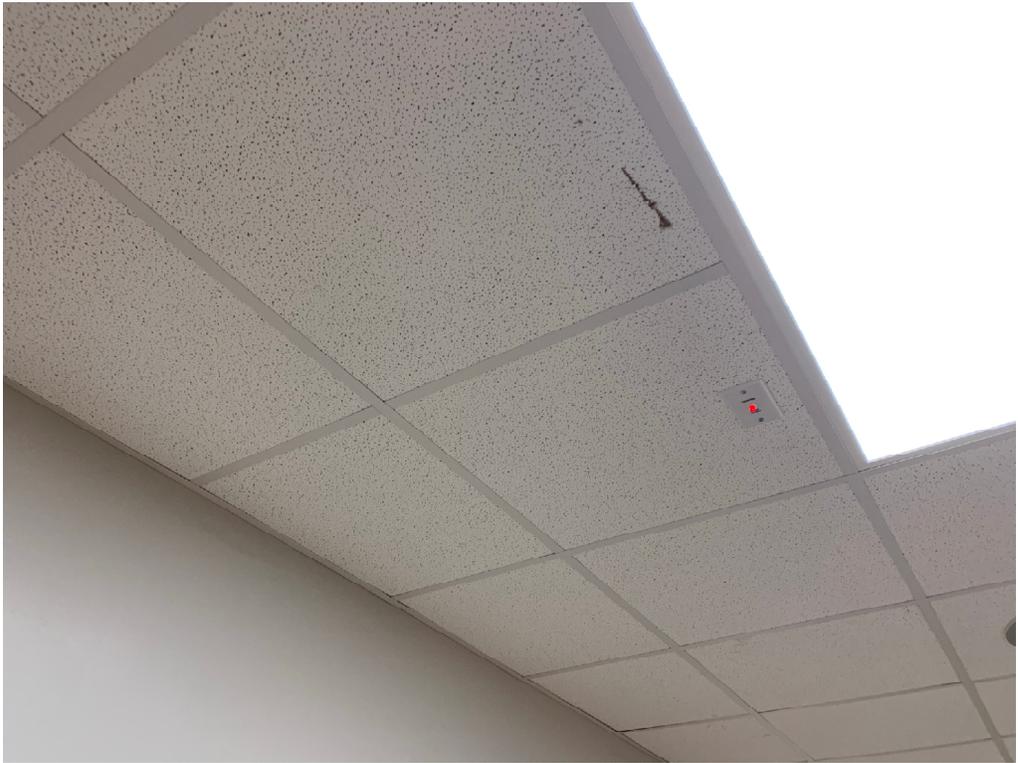
Figure 3 – Some Damage Noted at ceiling tiles throughout

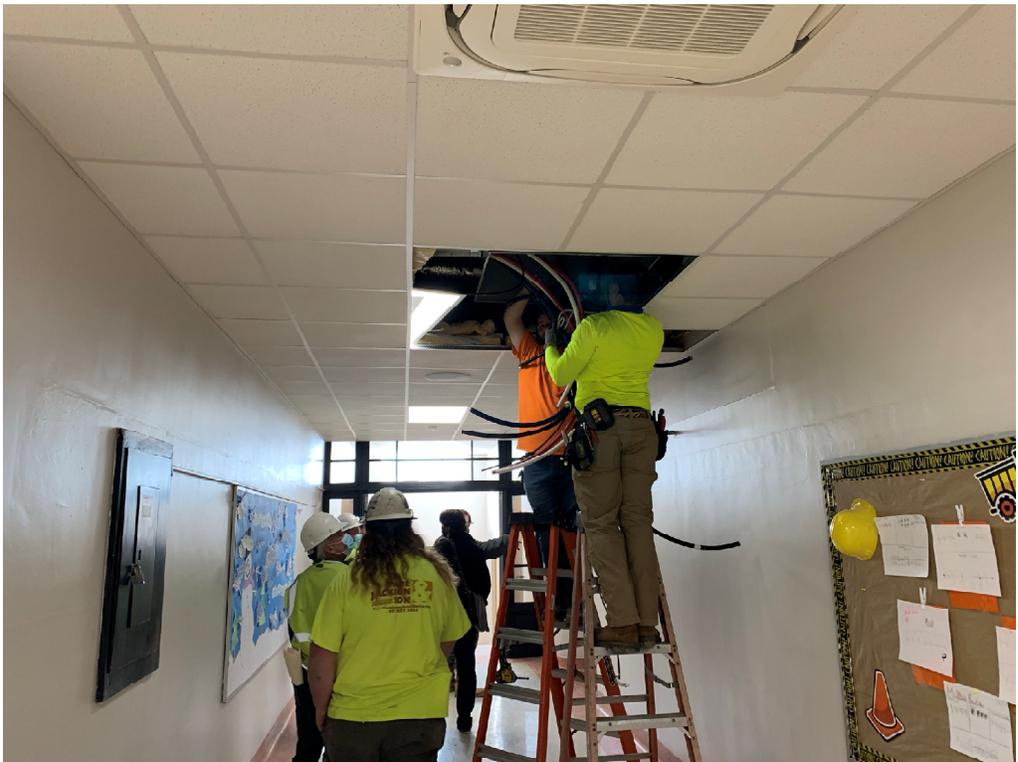
Figure 4 – Work above ceilings is Ongoing

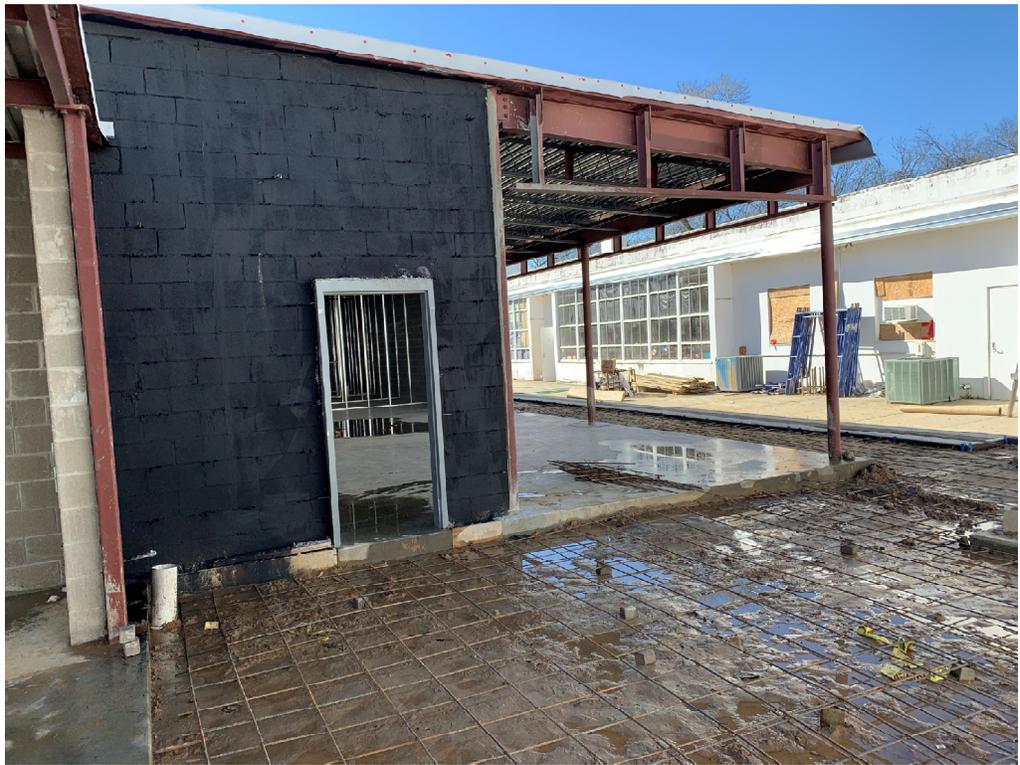
Figure 5 – Wet Site days are preventing concrete in these areas that do not dry out quickly

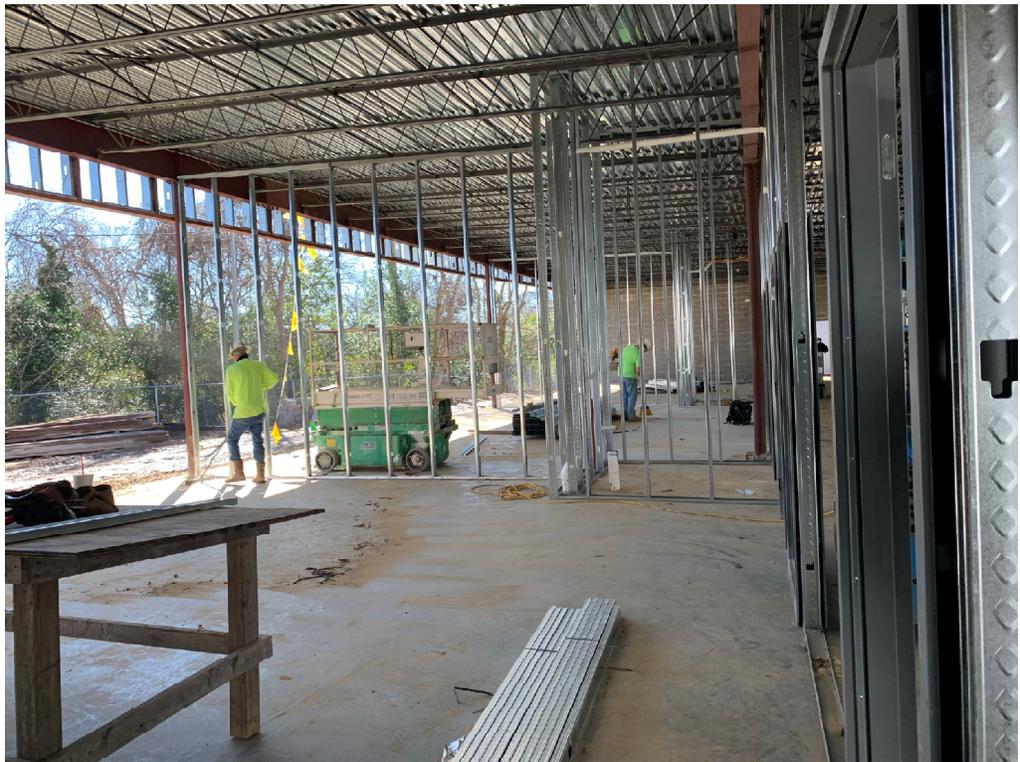
Figure 6 – Interior Metal Stud Framing at Addition

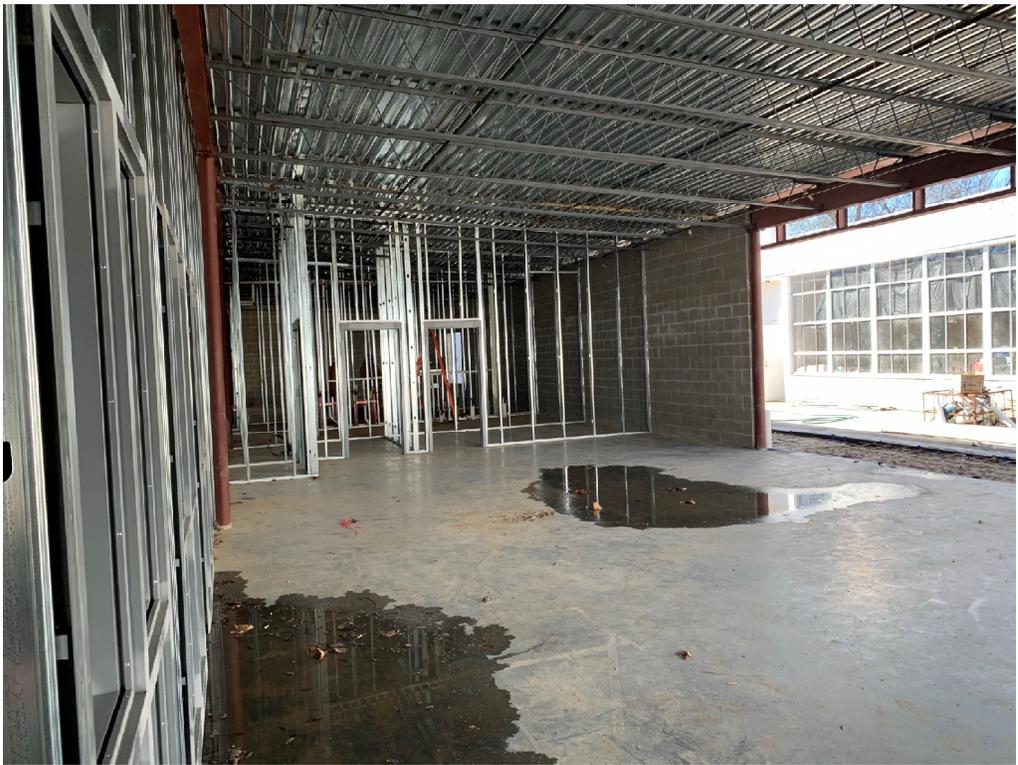
Figure 7 – Interior Metal Stud Framing at Addition

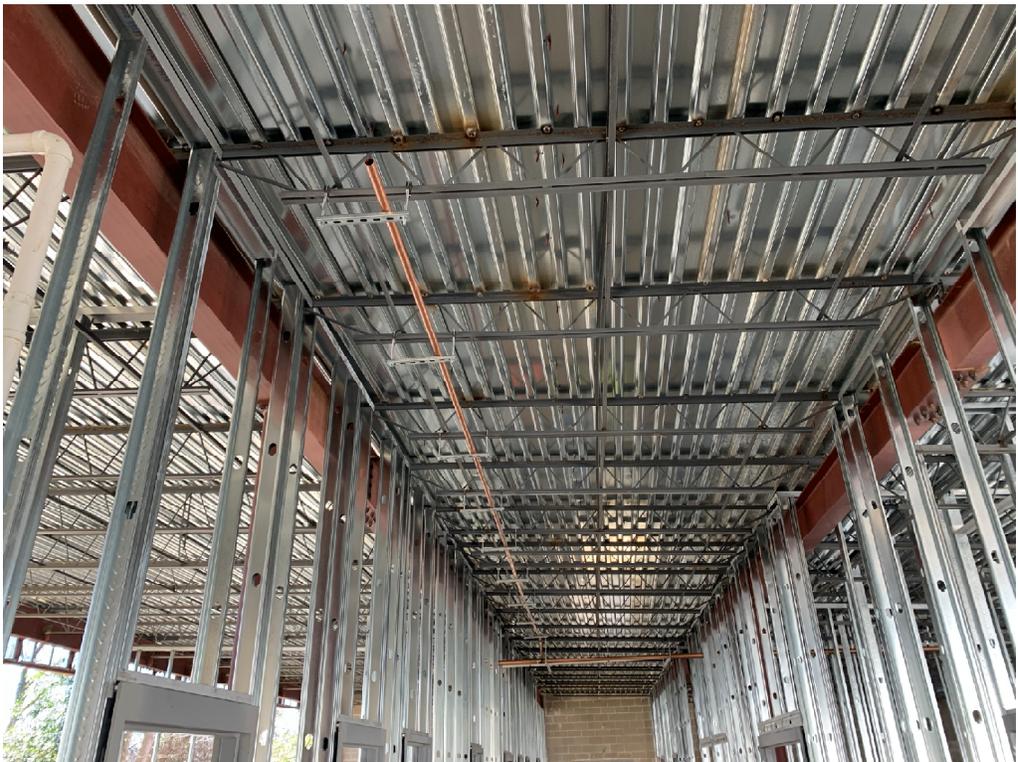
Figure 8 – Plumbing @ Addition

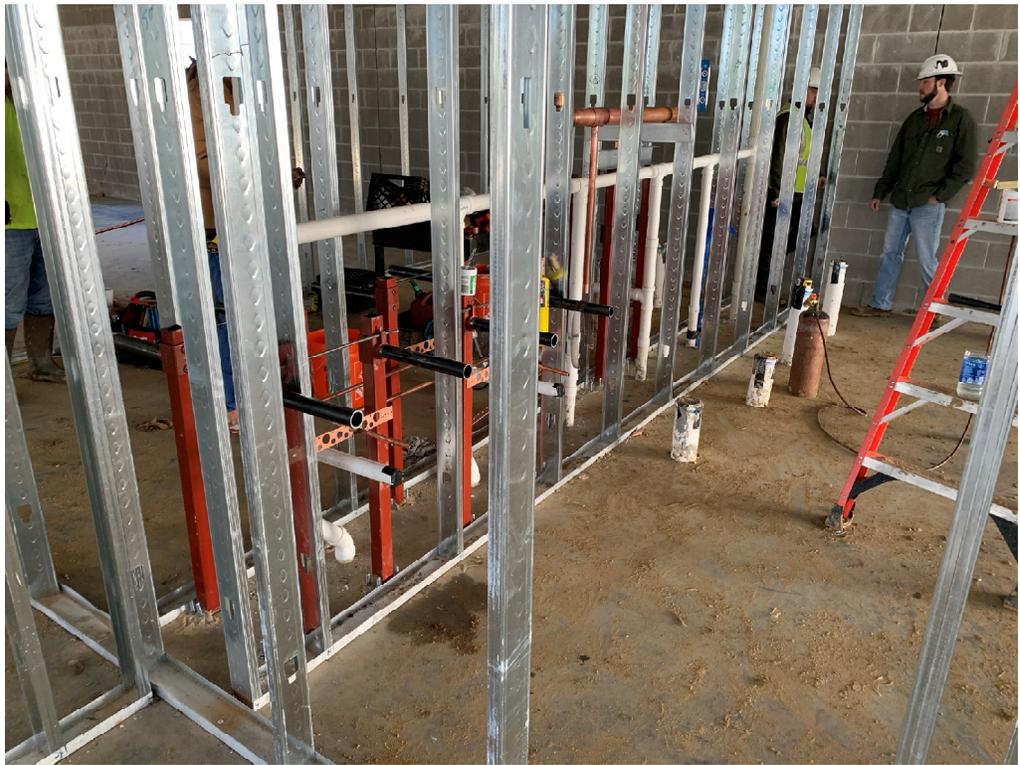
Figure 9 – Plumbing @ Addition

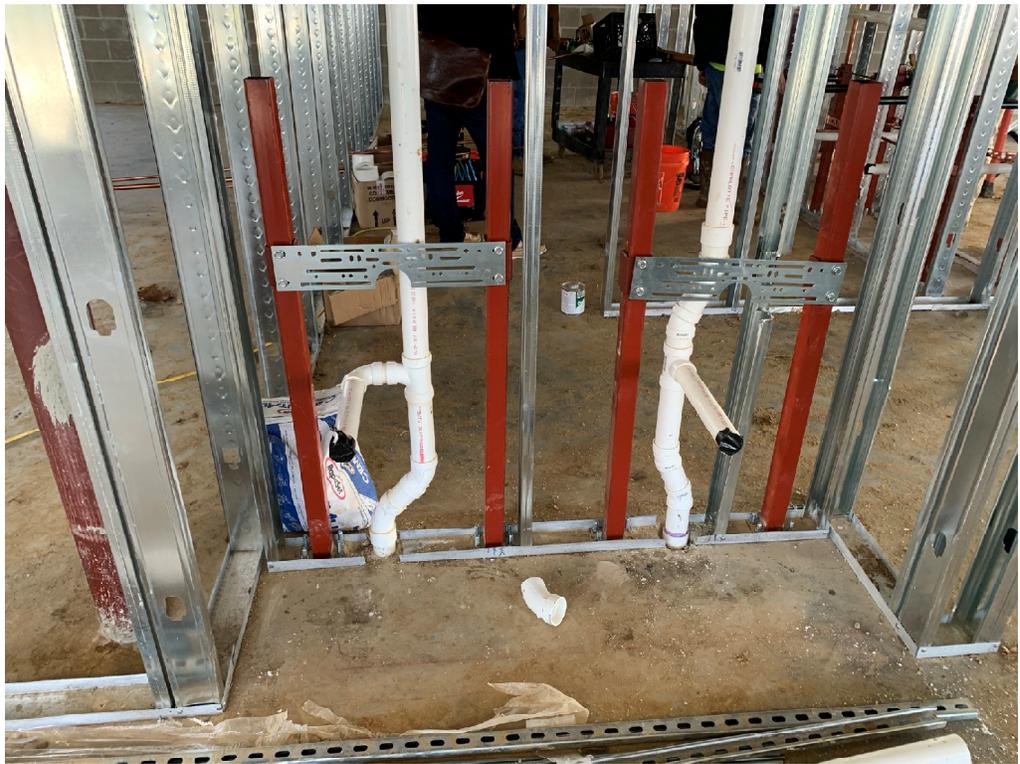
Figure 10 – Plumbing @ Addition

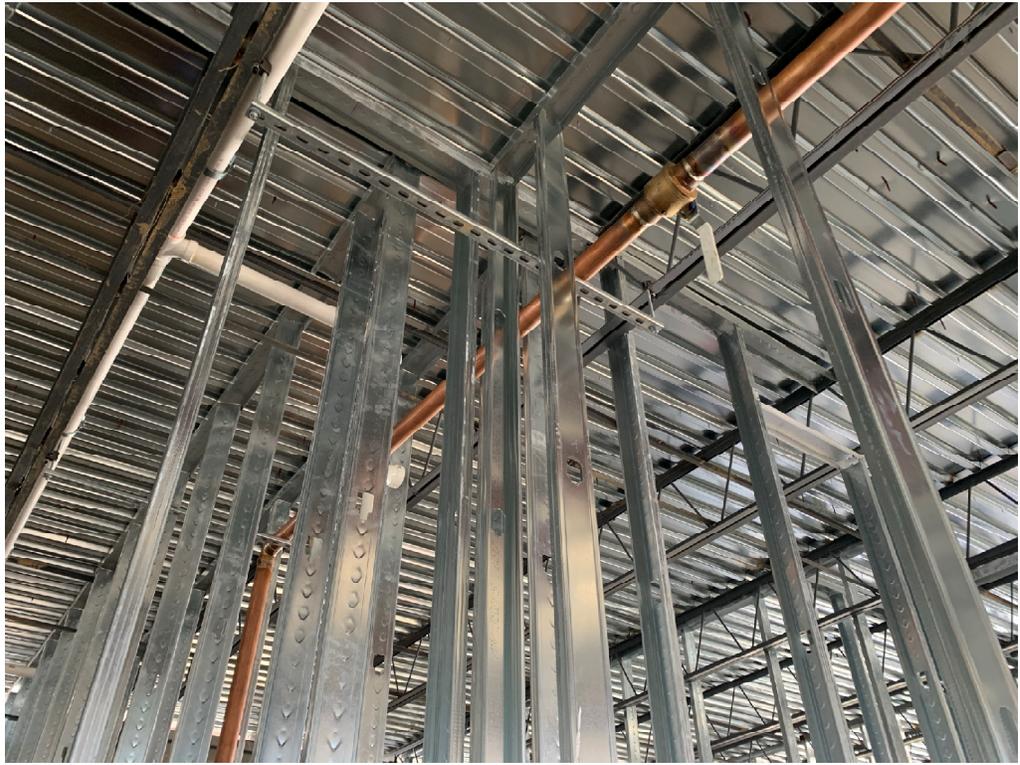
Figure 11 – Plumbing @ Addition

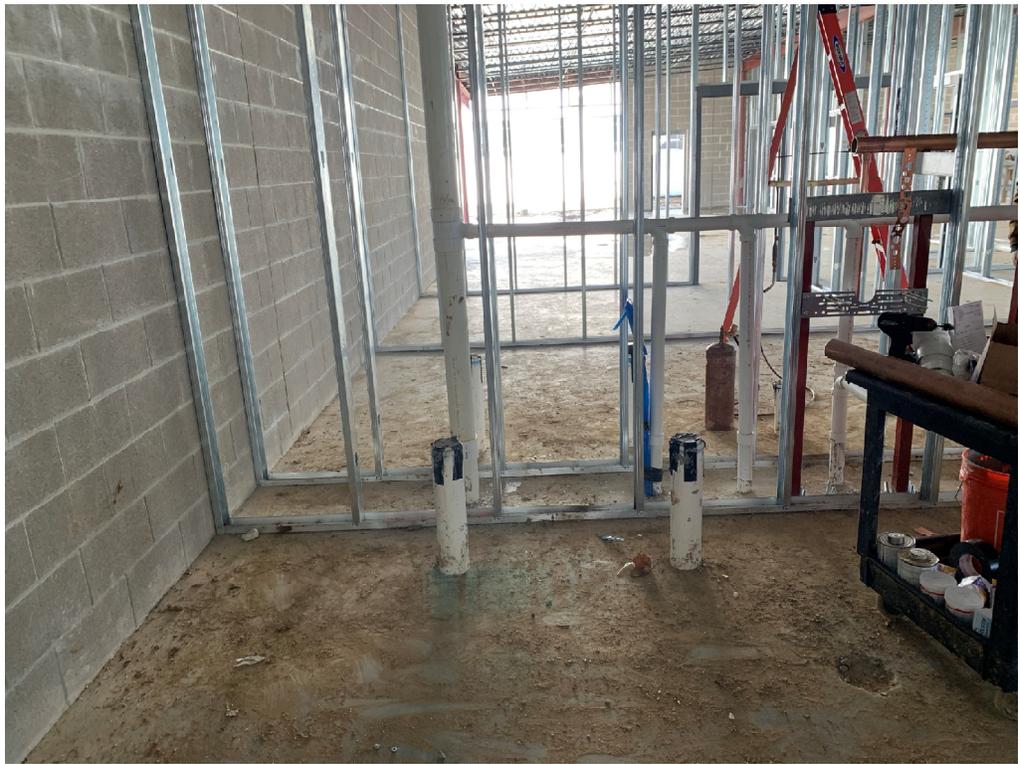
Figure 12 – Plumbing @ Addition
