18045-BOW Bowmar Elementary / Report Number 023

Observations

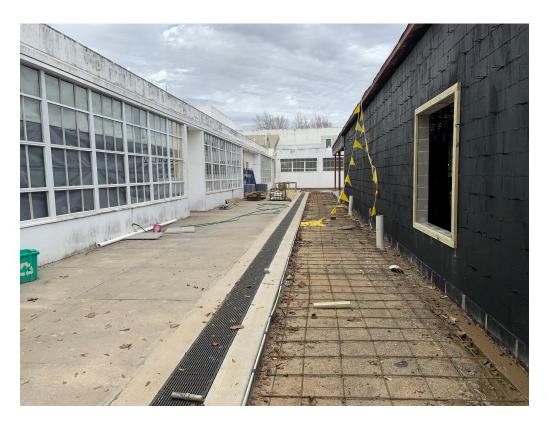
Figure 1 – Exterior Progress

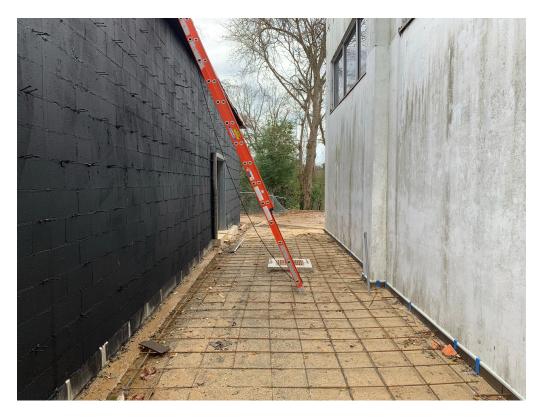
Figure 2 – Exterior Progress

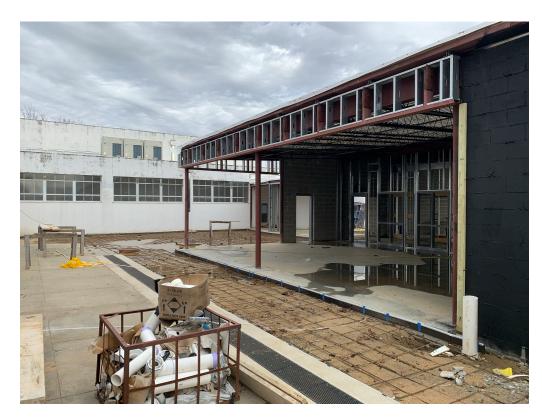
Figure 3 – Exterior Progress

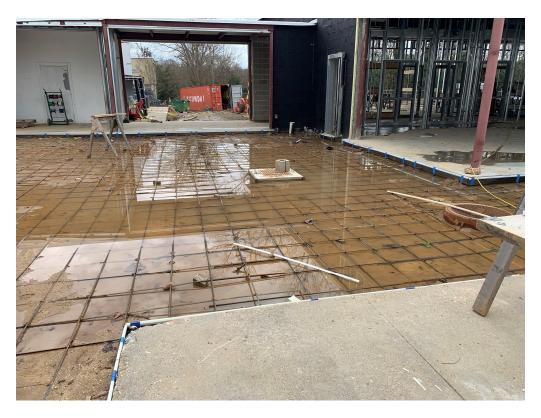
Figure 4 – Drainage Issues at Courtyard

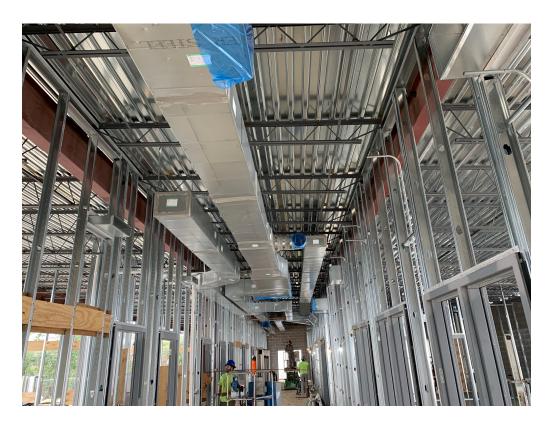
Figure 5 – HVAC Ducting is Ongoing

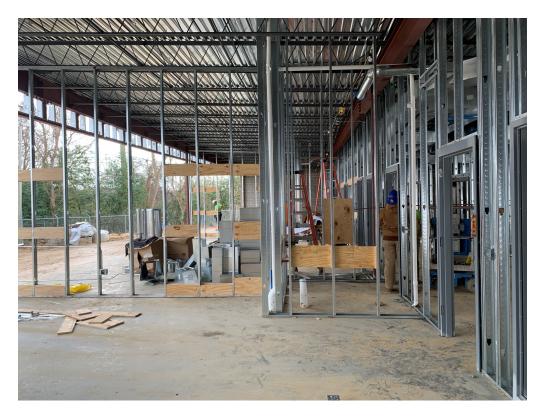
Figure 6 – Plywood Blocking Installed

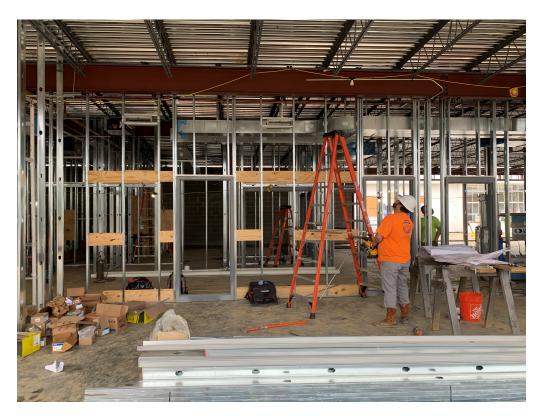
Figure 7 – Plywood Blocking Installed

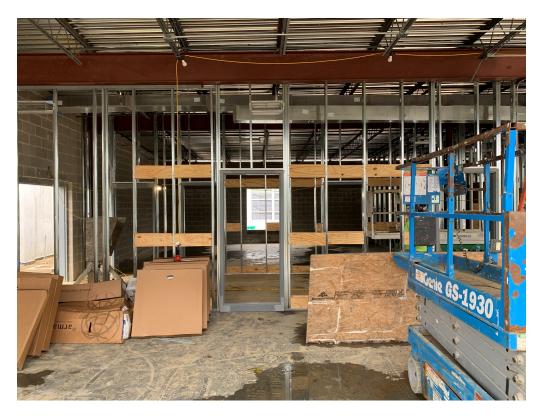
Figure 8 – Plywood Blocking Installed

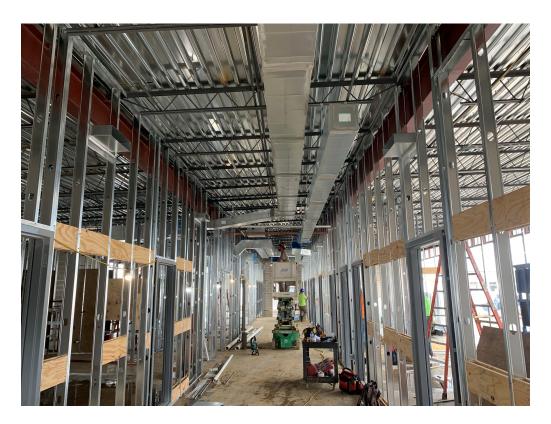
Figure 9 – HVAC Ducting is Ongoing

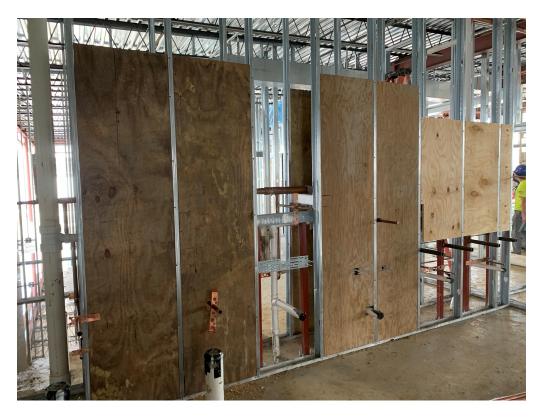
Figure 10 – Plywood Blocking Installed
