12 March 2021

18045-BOW Bowmar Elementary / Report Number 026

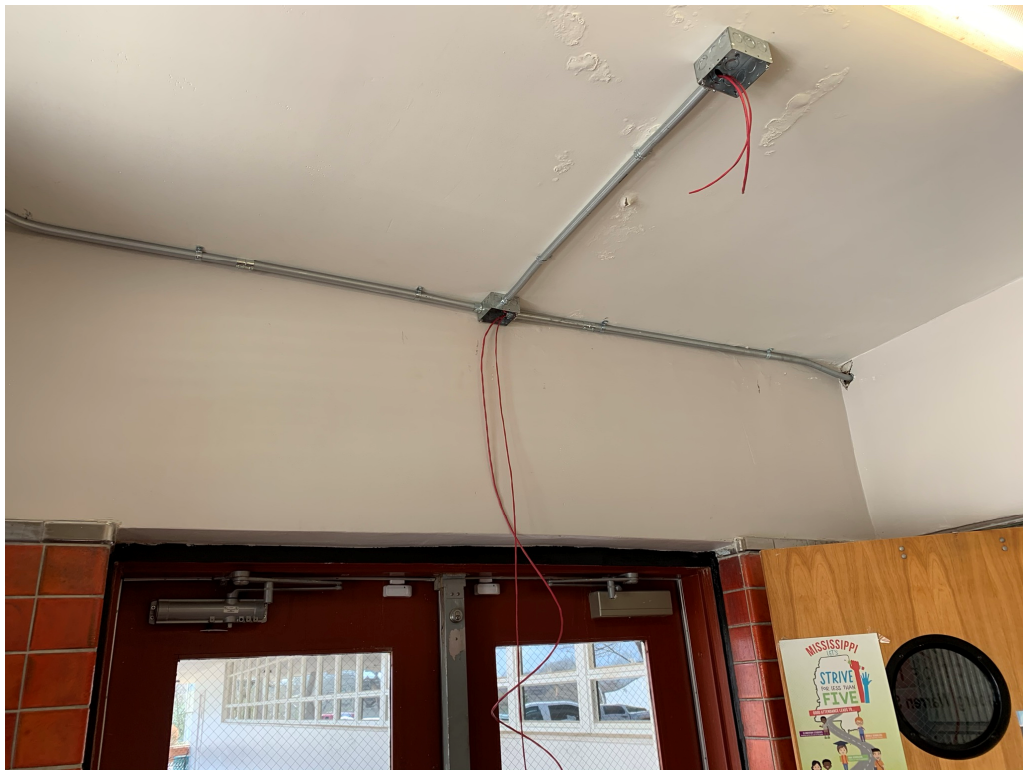
Figure 1 – Alarm Installation wire pulls at Entry Foyer

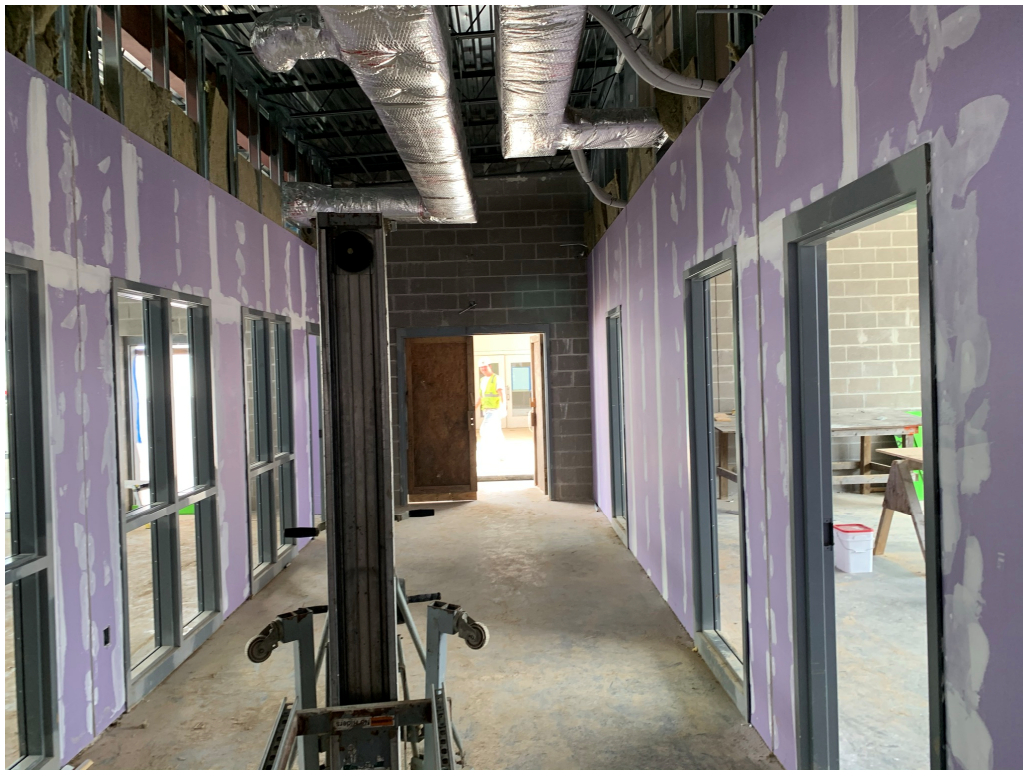
Figure 2 – Hall Looking toward front of School

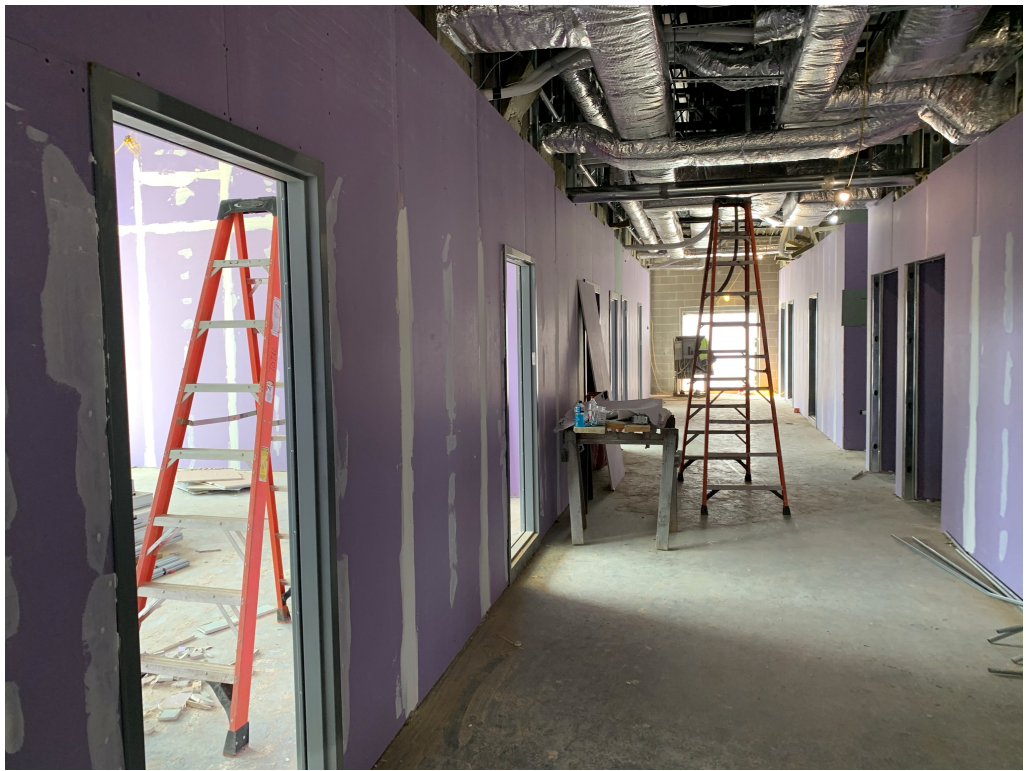
Figure 3 – Hall Looking toward Gym

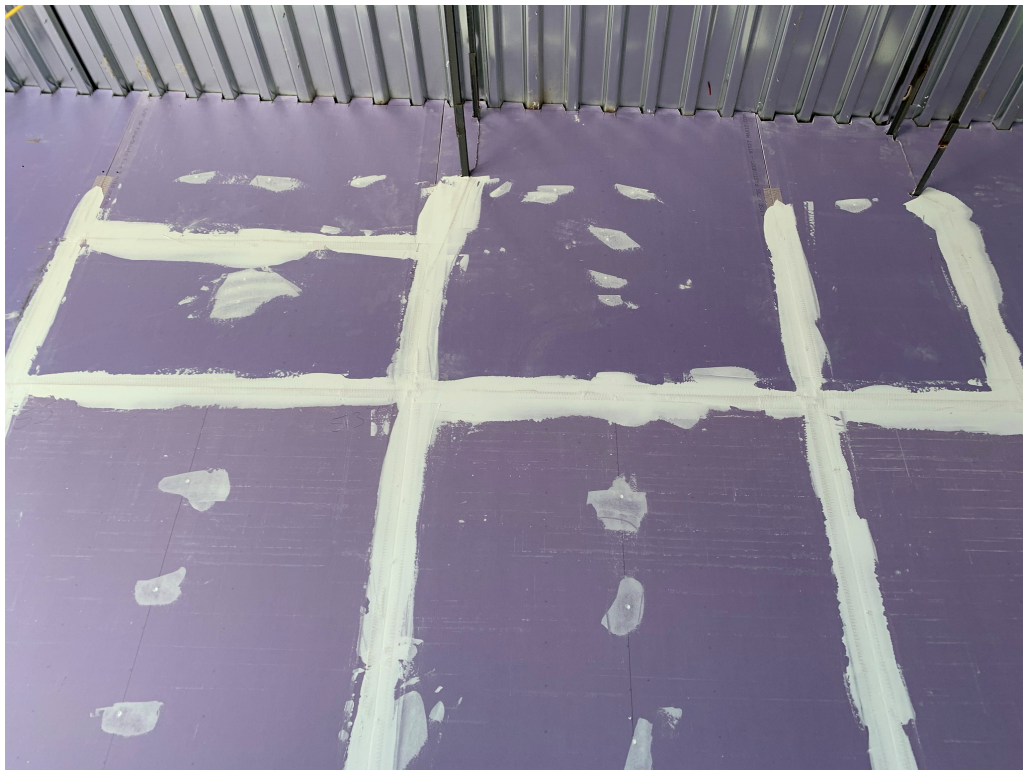
Figure 4 – Some flex noted in walls; contractor to complete drywall installation including perimeter screw pattern at all sheets as well as add kickers in hall as needed

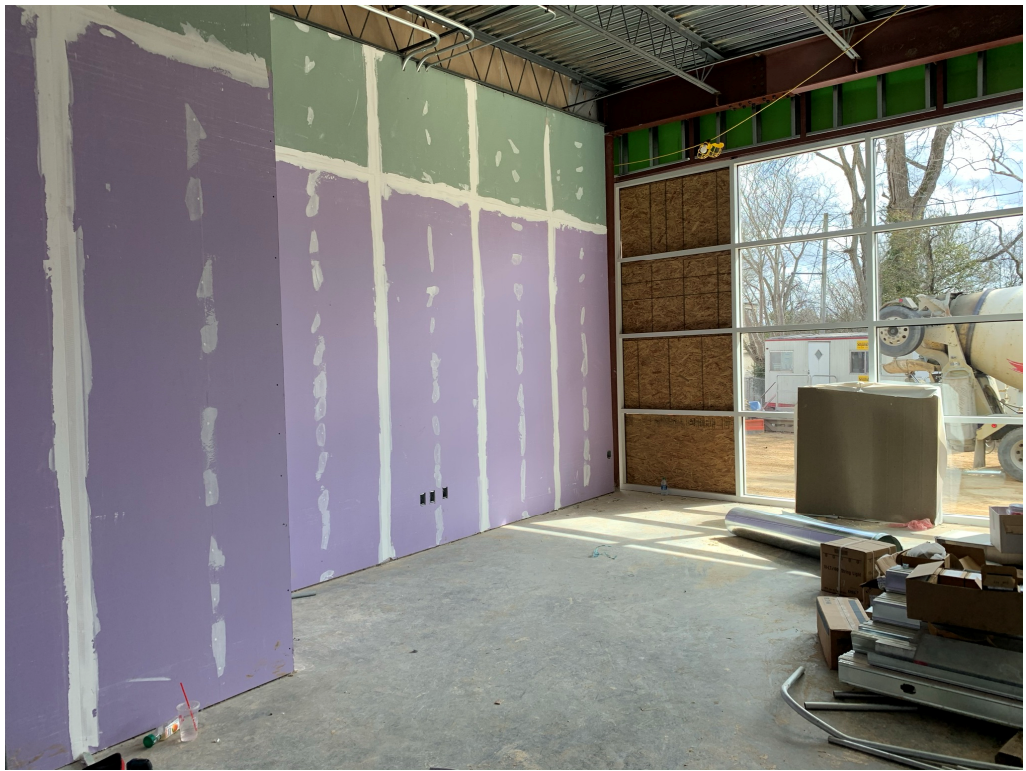
Figure 5 – Top of wall where joist conflict to be boxed in with drywall

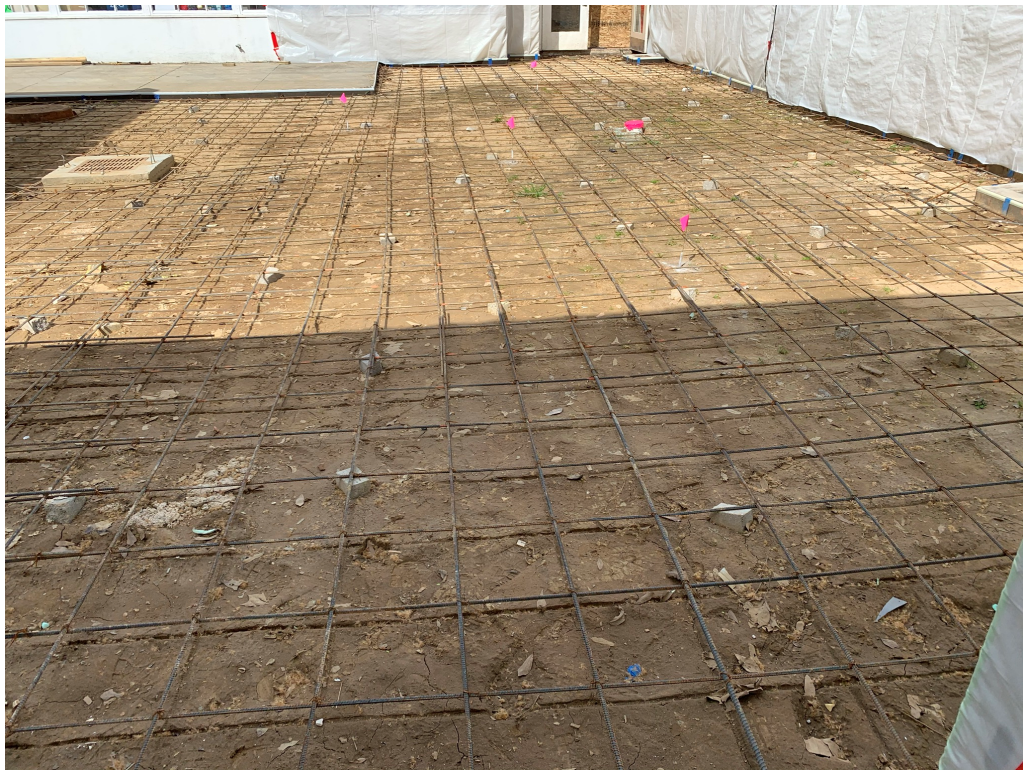
Figure 6 – Rebar lifted in place ready for concrete

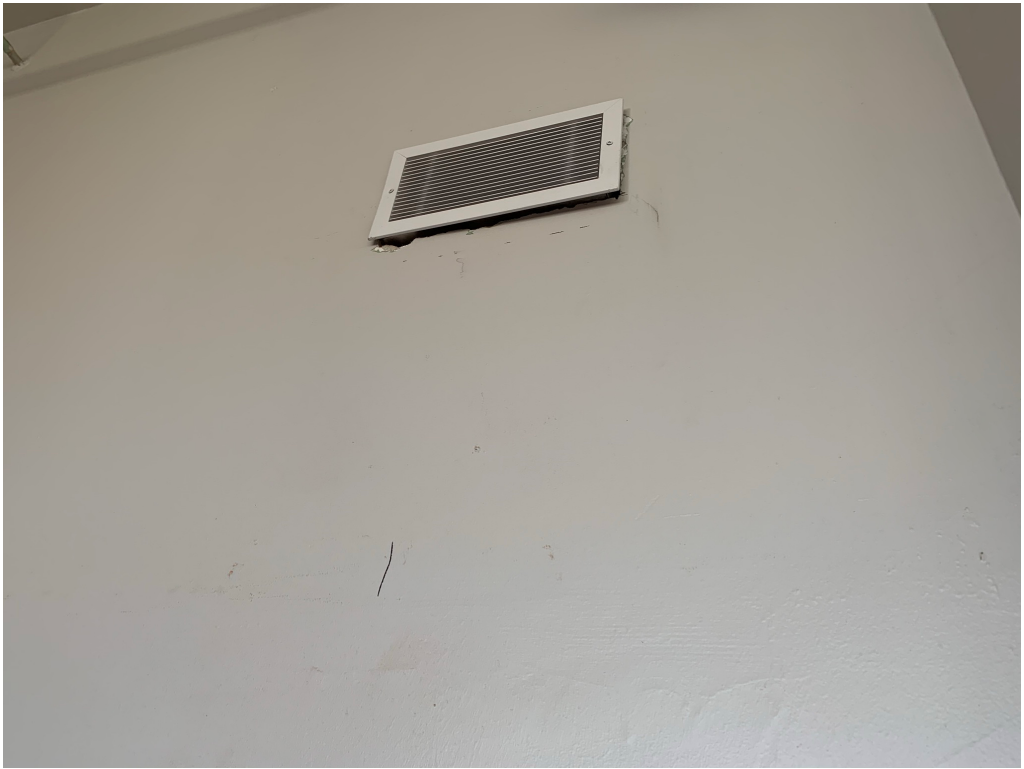
Figure 7 – New HVAC vents shall be flush to wall at installations

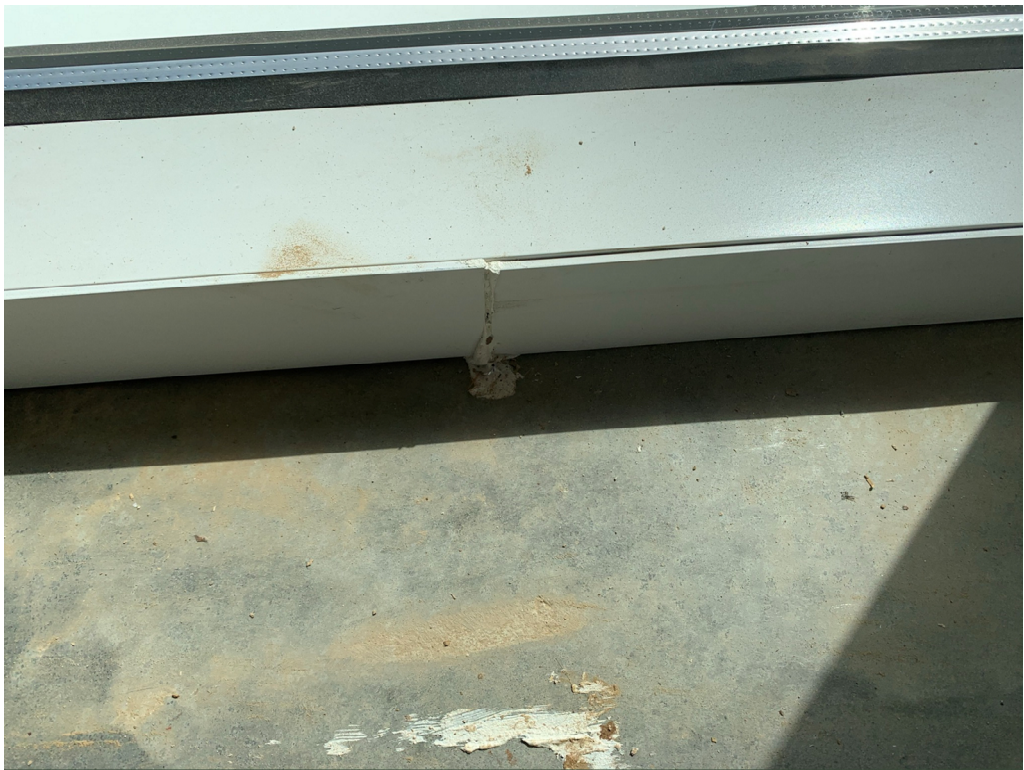
Figure 8 – Caulking & Storefront will need to be corrected any place where not smooth or flush or gaps found between metal trims
