18045-BOW Bowmar Elementary / Report Number 027

18 March 2021 / 10:30 AM Date / Time

Architects Who Know Education

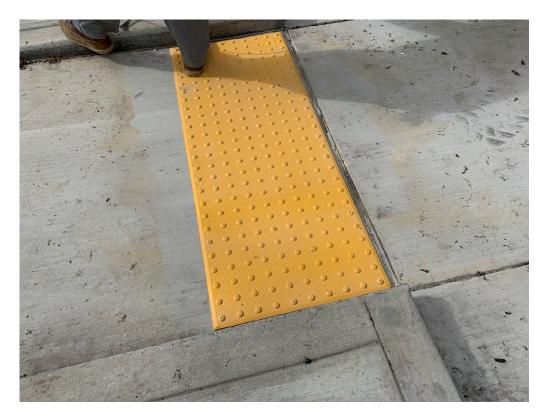
finishing up the installation of a rumble strip at the ADA Parking Pad. We

Figure 1 – Rumble Strip Installed at ADA Parking Pad

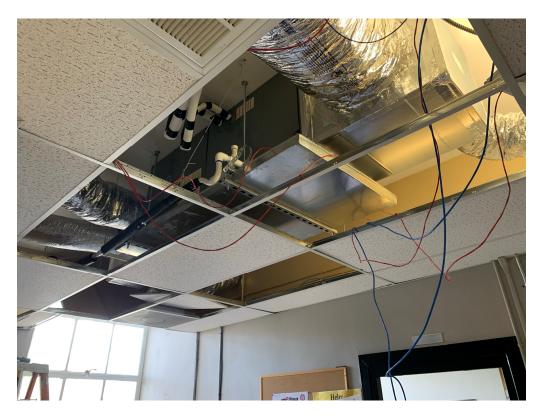
Figure 2 – HVAC Unit Installed at Office

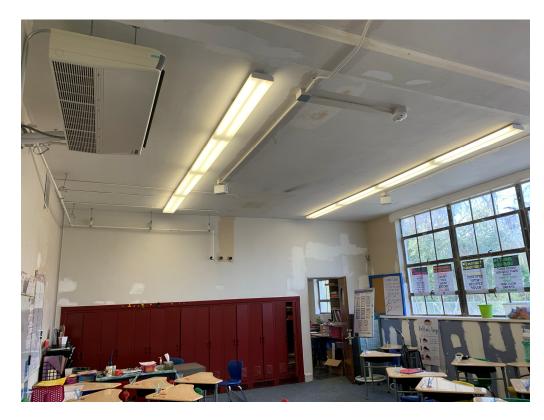
Most interior HVAC units have been demoed, but pipes and hangers still

require removal and walls still need patching. Most new interior units

Figure 3 – HVAC Unit Removal at Classroom nearly complete

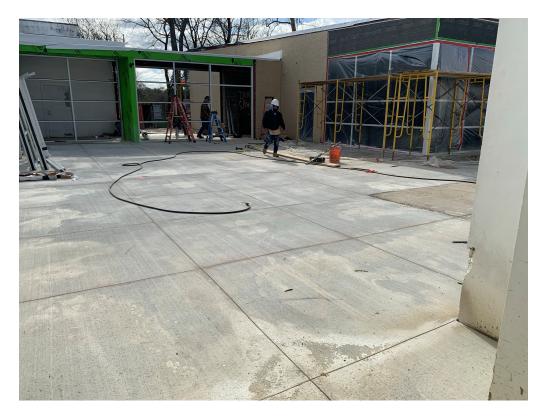
Figure 4 – Installed Concrete

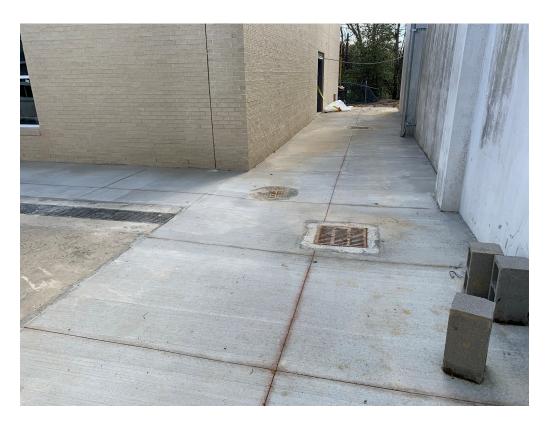
Figure 5 – Installed Concrete

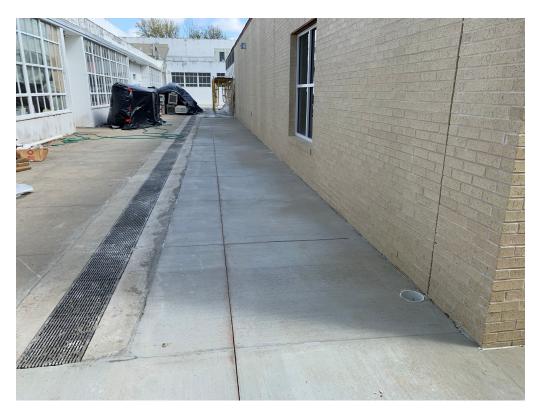
Figure 6 – Installed Concrete

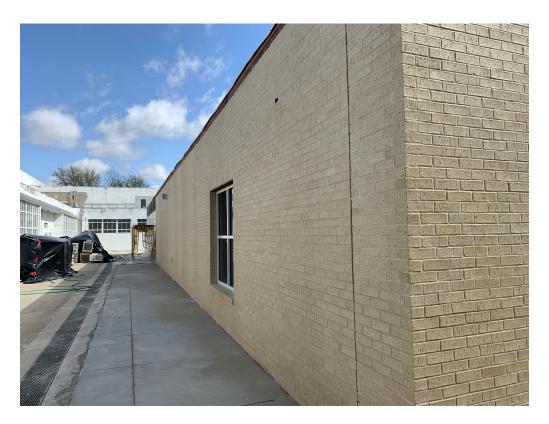
Figure 7 – Brick Washed

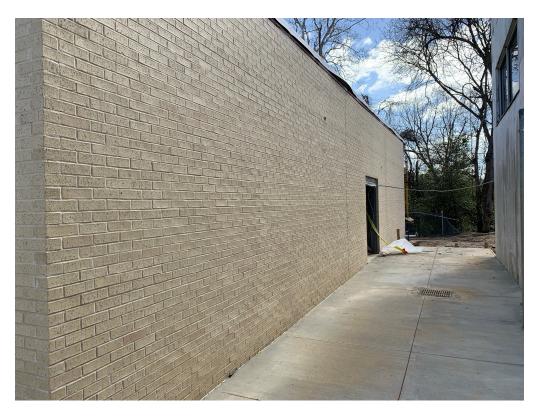
Figure 8 – Brick Washed

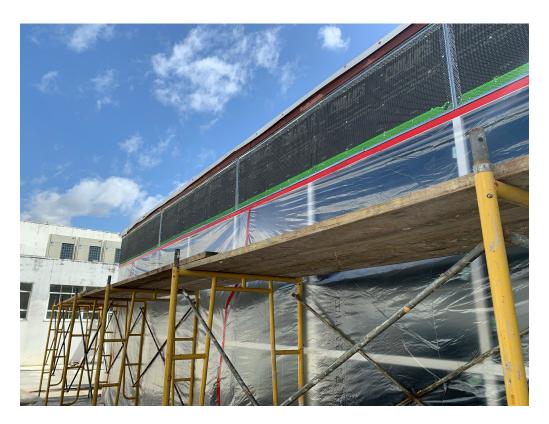
Figure 9 – Stucco Lathe Installed

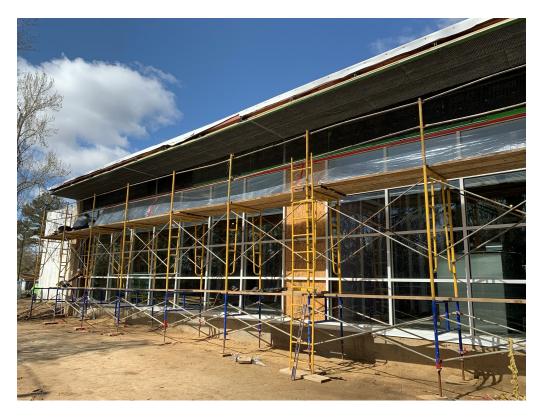
Figure 10 – Stucco Lathe Installed

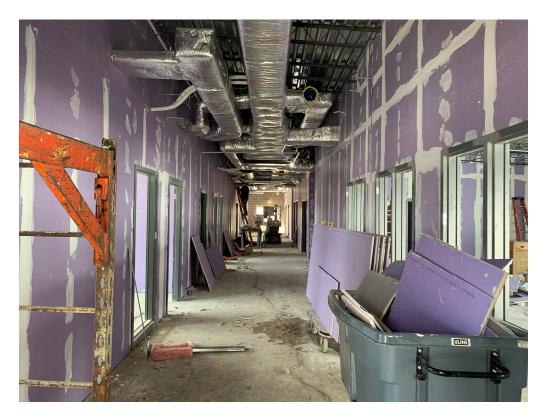
Figure 11 – Drywall Finishing in Progress

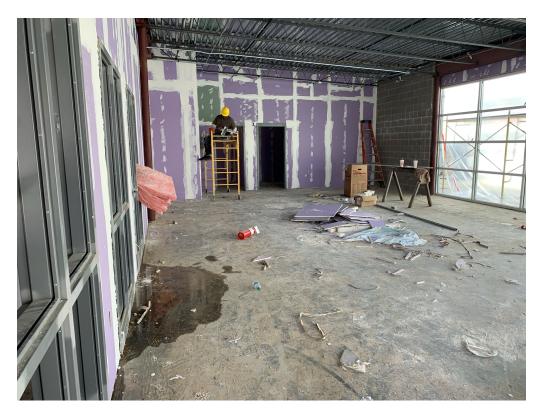
Figure 12 – Drywall Finishing in Progress

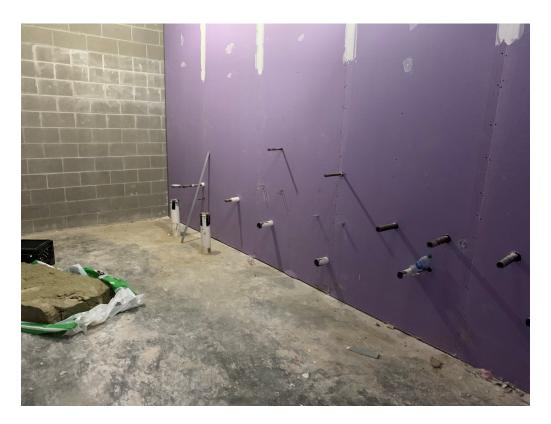
Figure 13 – Bathroom Drywall Installed

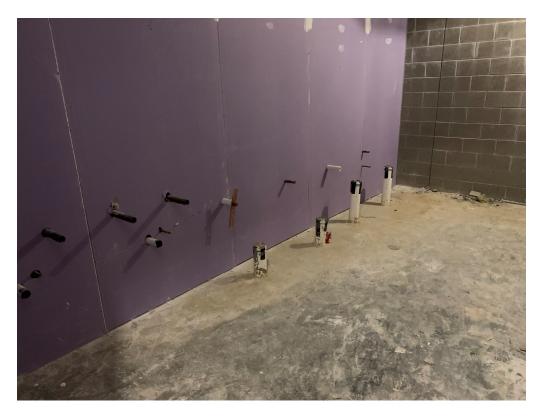
Figure 14 – Bathroom Drywall Installed

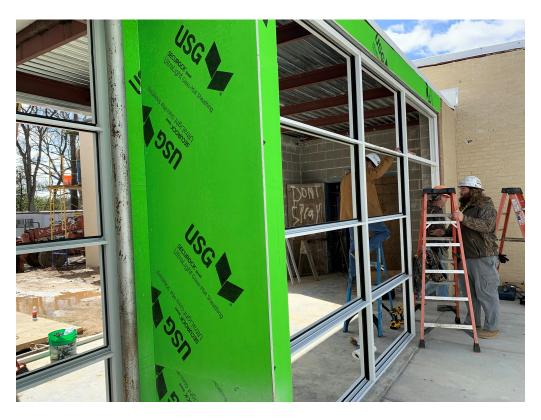
Figure 15 – Storefront at Connector Hall

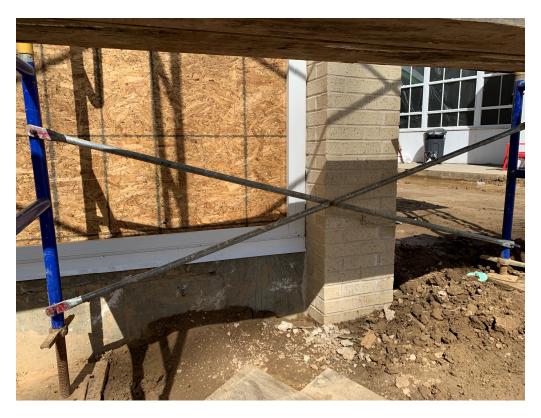
Figure 16 – Storefront at Brick Corner

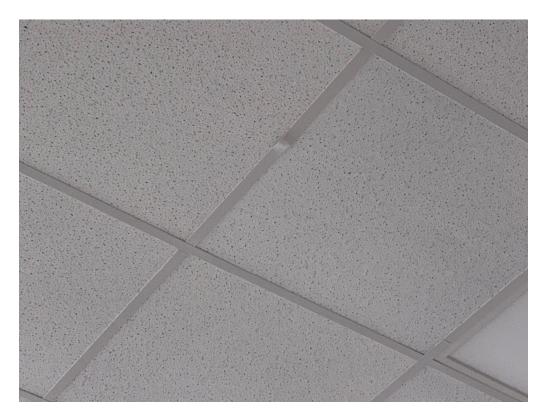
Figure 17 – Damaged Ceiling Grid IN cafeteria Requires Replacement

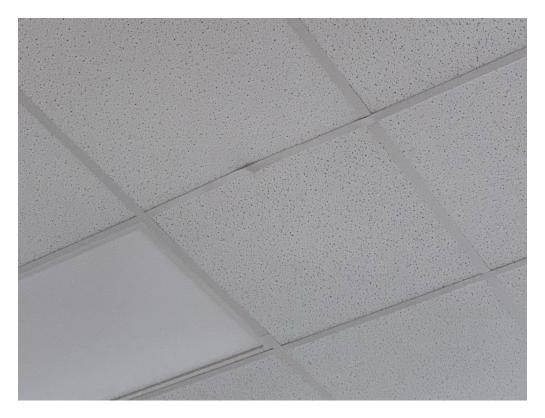
Figure 18 – Damaged Ceiling Grid IN cafeteria Requires Replacement
