24 March 2021

18045-BOW Bowmar Elementary / Report Number 028

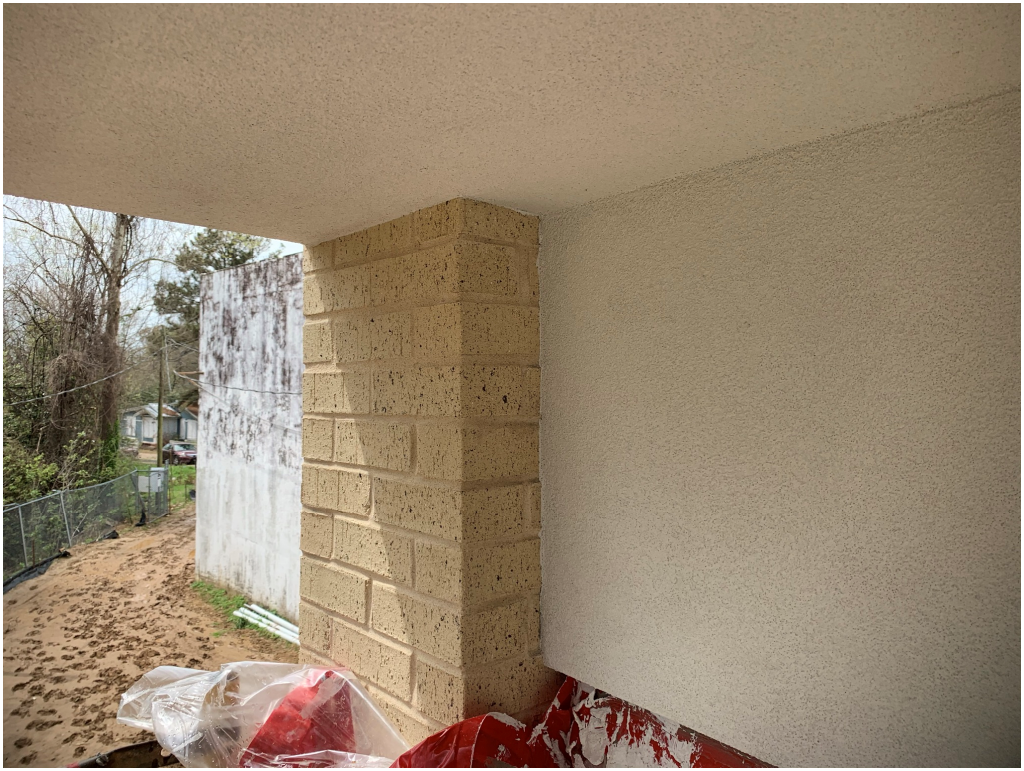
Figure 1 – Finished Stucco Mockup Section

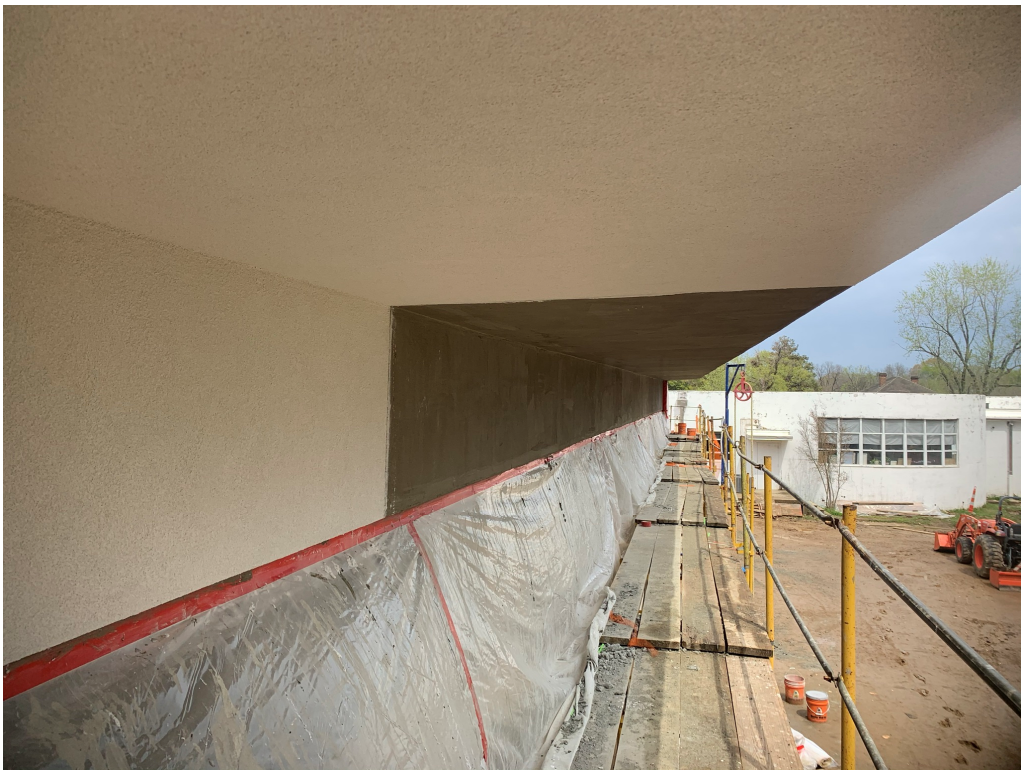
Figure 2 – Finished Stucco Mockup Section

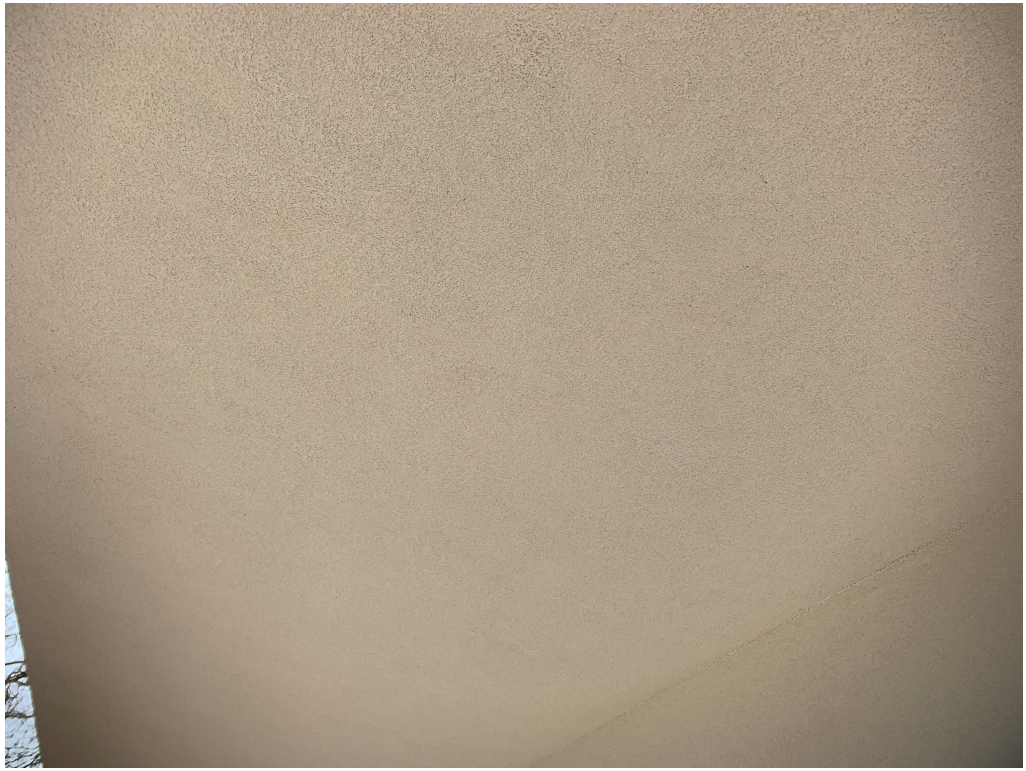
Figure 3 – Finished Stucco Mockup Section

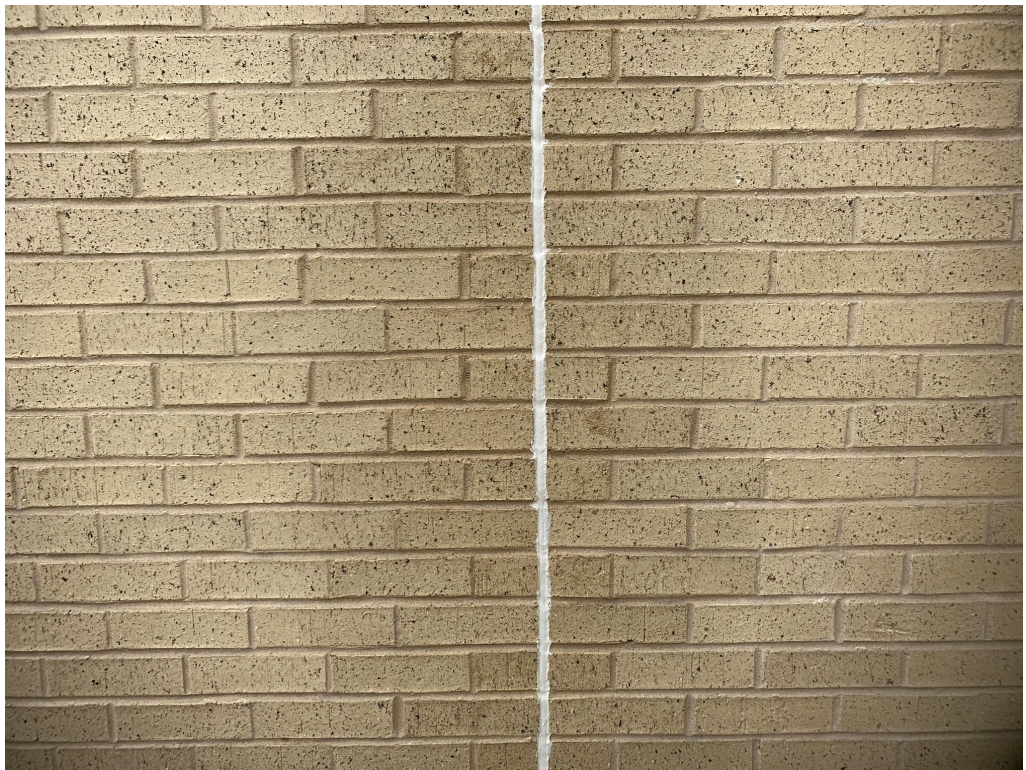
Figure 4 – Sealant Installed

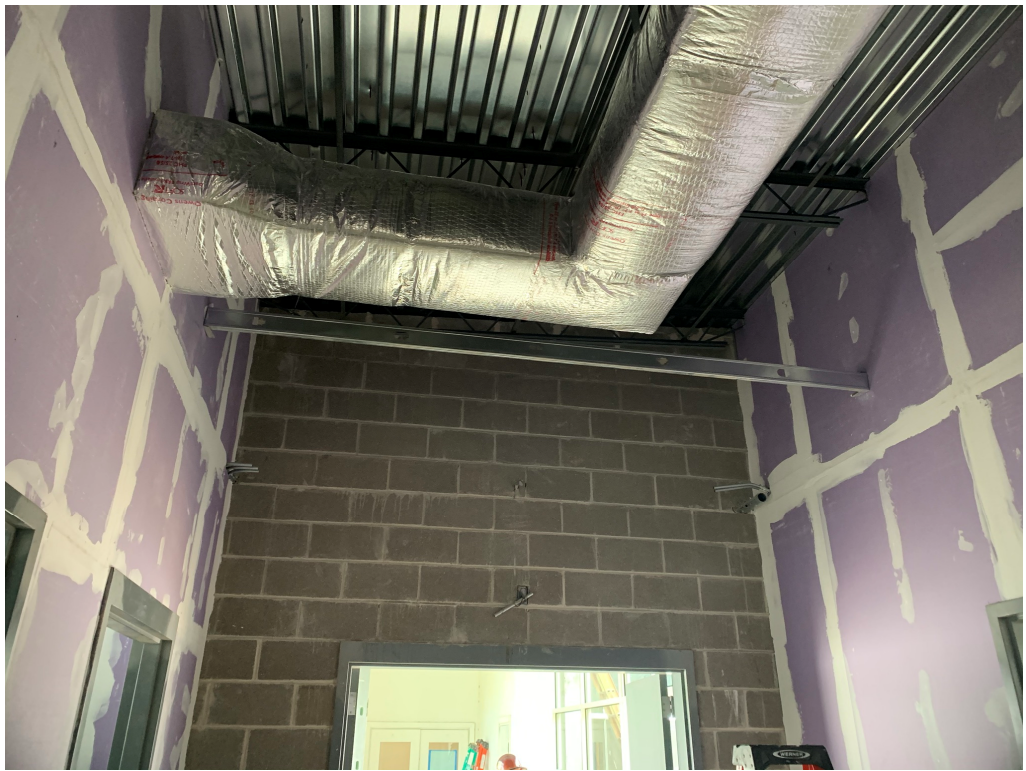
201 Park Court, Suite B Ridgeland, MS 39157 P 601.790.9432 F 888.281.0547	Contract	Paul Jackson & Son
	Date / Time	23 March 2021 / 12:30 PM
	Weather / Temp	Cloudy / 62 ° F
	Est % Complete	70%
One Jackson Place, Suite 250 188 East Capitol Street Jackson, MS 39201-2100 P 601.352.5411 F 601.352.5362	Sched Conformance	+/- 00 days
	Work in Progress	Mechanical Installers Electrical Installers Drywall Finishing
	Present at Site	Jimmy White, PJS Paul Purser, DBA
161 Lameuse Street, Suite 201 Biloxi, MS 39530 P 228.374.1409 F 228.374.1414	Observations	<p>On site, I met Jimmy White, Paul Jackson &amp; Son, at the rear addition. I reviewed the stucco work performed in a ten-foot section with him. The finish looks good, clean, and without defects.</p> <p>Finish work was also in progress at the interior. Drywall finishers were at work in several areas there. Also, mechanical and electrical workers were busy installing their corresponding trade items.</p> <p>A bracing style has been suggested by the contractor, noted in figure 5. This suggestion is being made due to conflicts between ducting and other above ceiling items and new bracing that was agreed upon 2 weeks ago. Mr. White says that they are unable to get a diagonal stud every 4' due to the conflicts so they are suggesting going all the way across, from wall to wall with a supporting stud.</p>

Figure 5 – Bracing Suggested by Contractor

Items to Verify	Acceptability of new stud arrangement in accordance with design intentions.
	Action Required	None
	Report By:

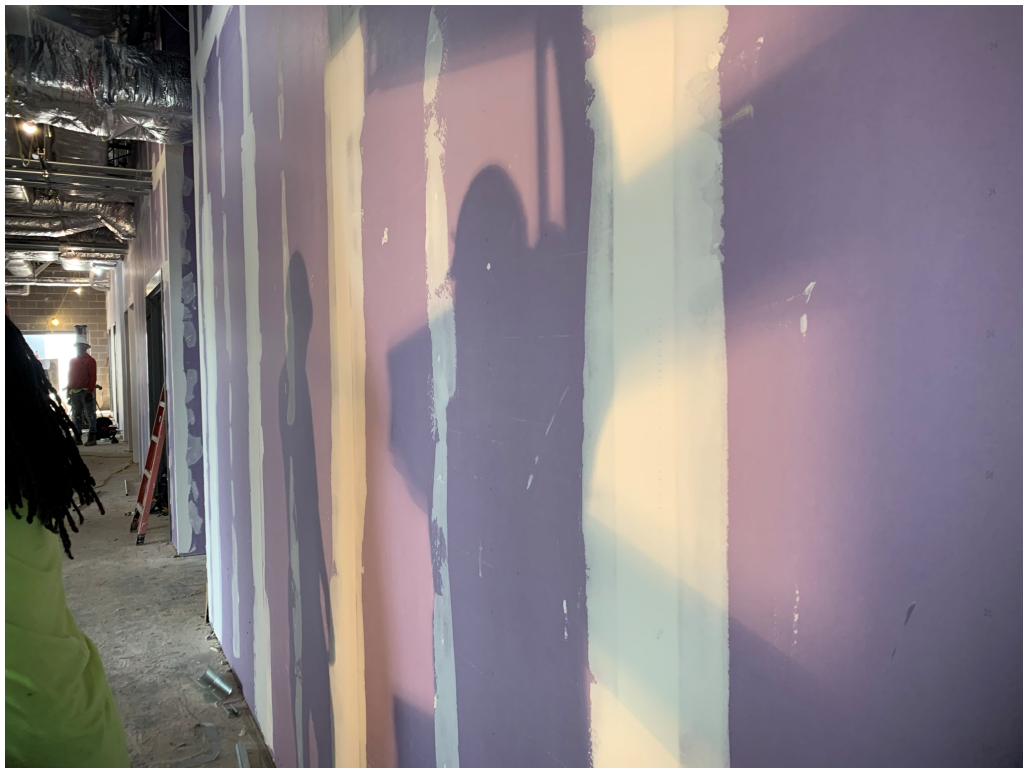
Figure 6 – Finish Work is Ongoing
