23 April 2021

18045-BOW Bowmar Elementary / Report Number 029

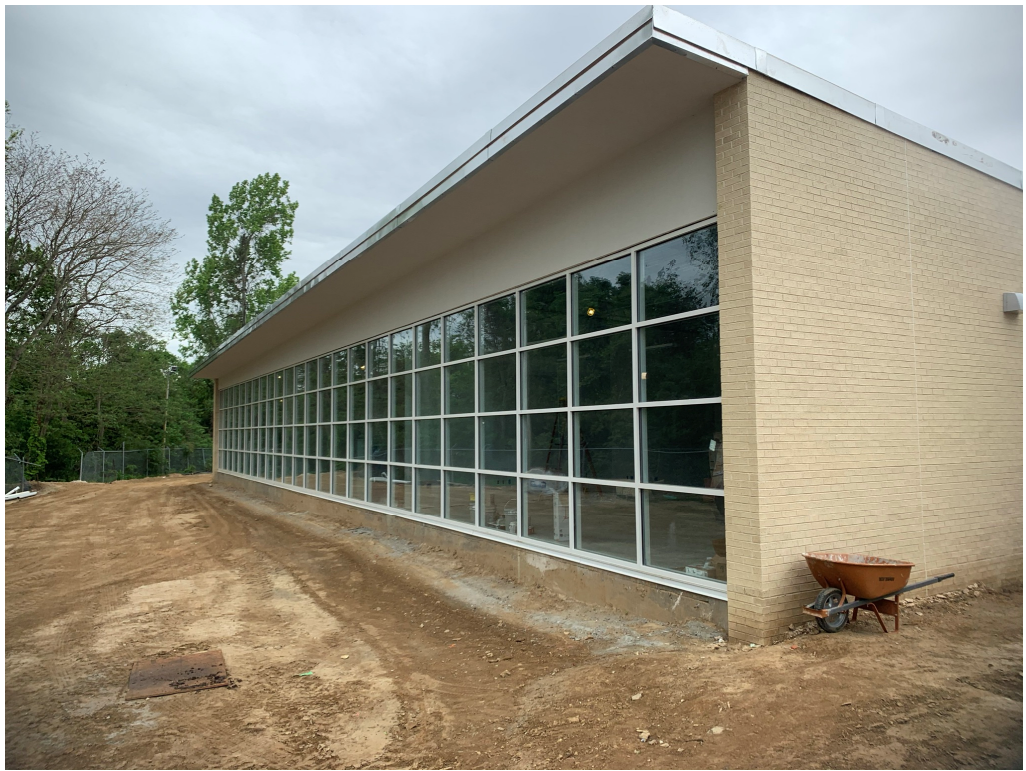
Figure 1 – East facing Facade

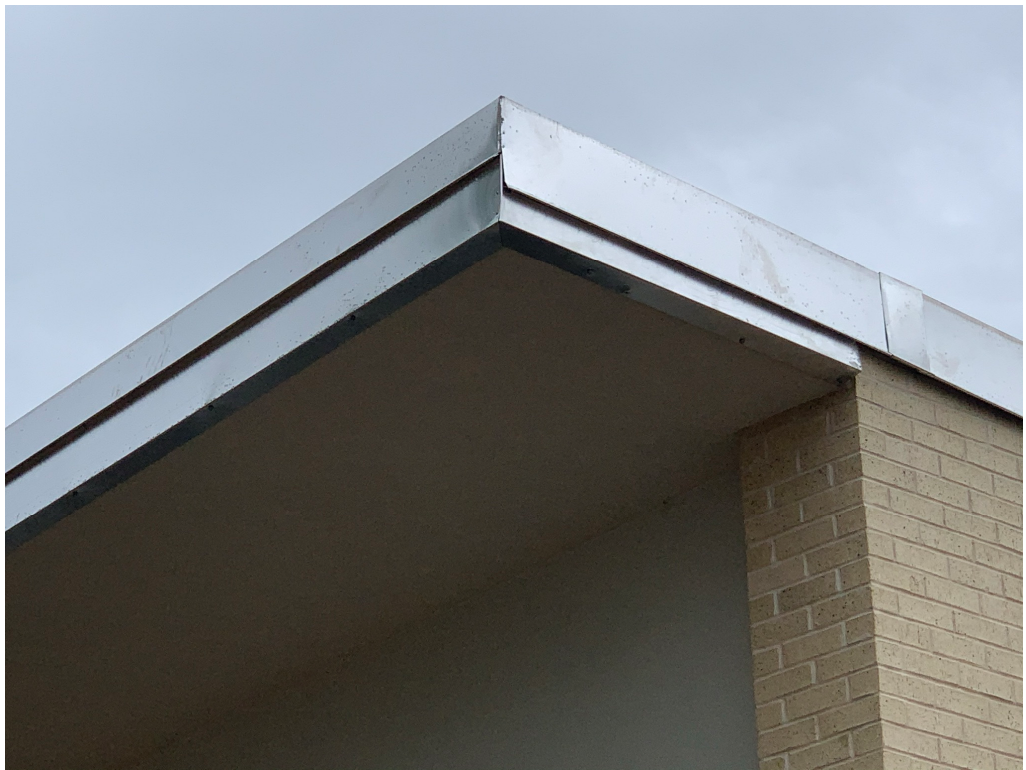
Figure 2 – Why are our trims not aligned?

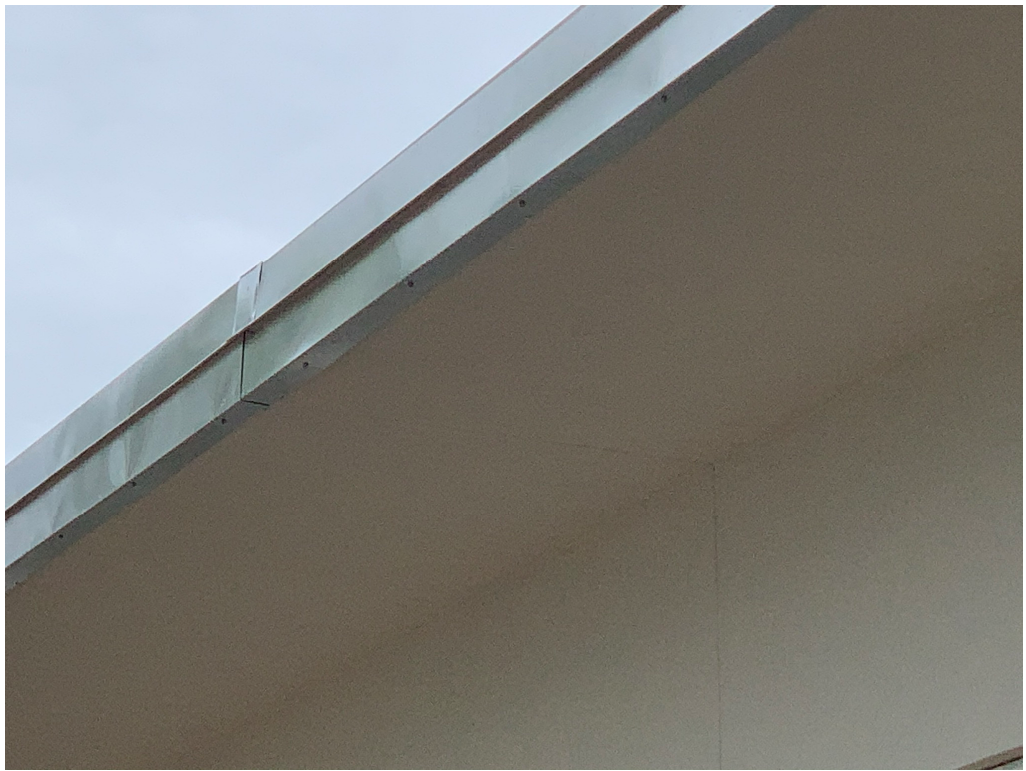
Figure 3 – Is there a finish piece of trim to hide these fasteners and wavy flashing?

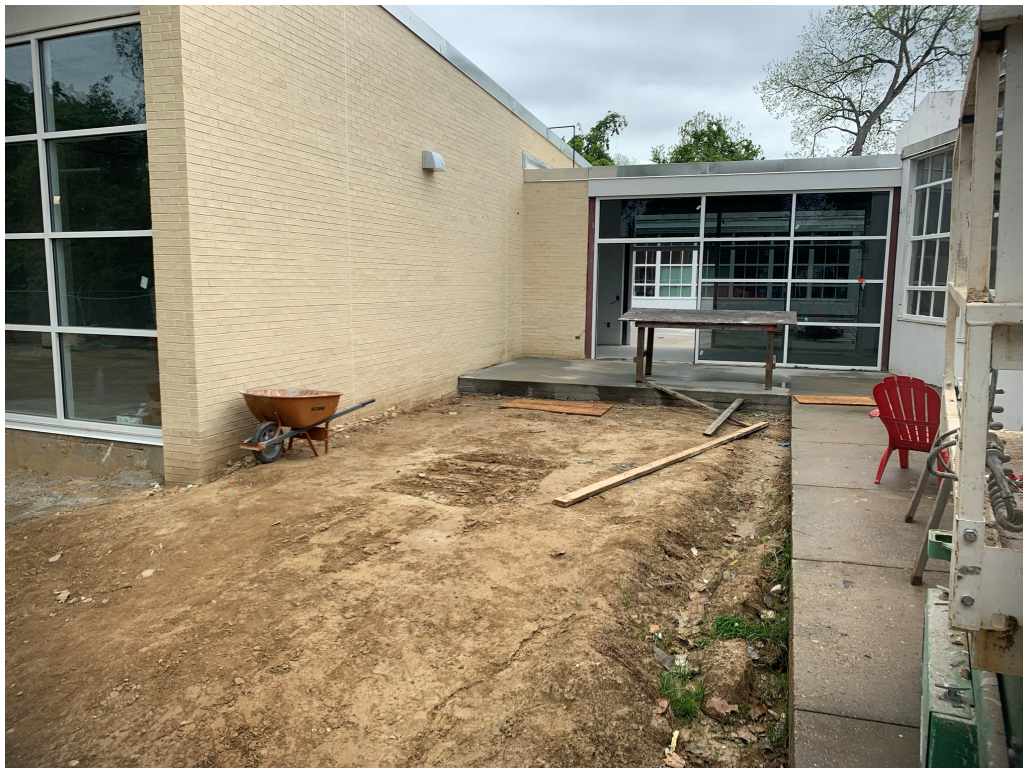
Figure 4 – Courtyard progress

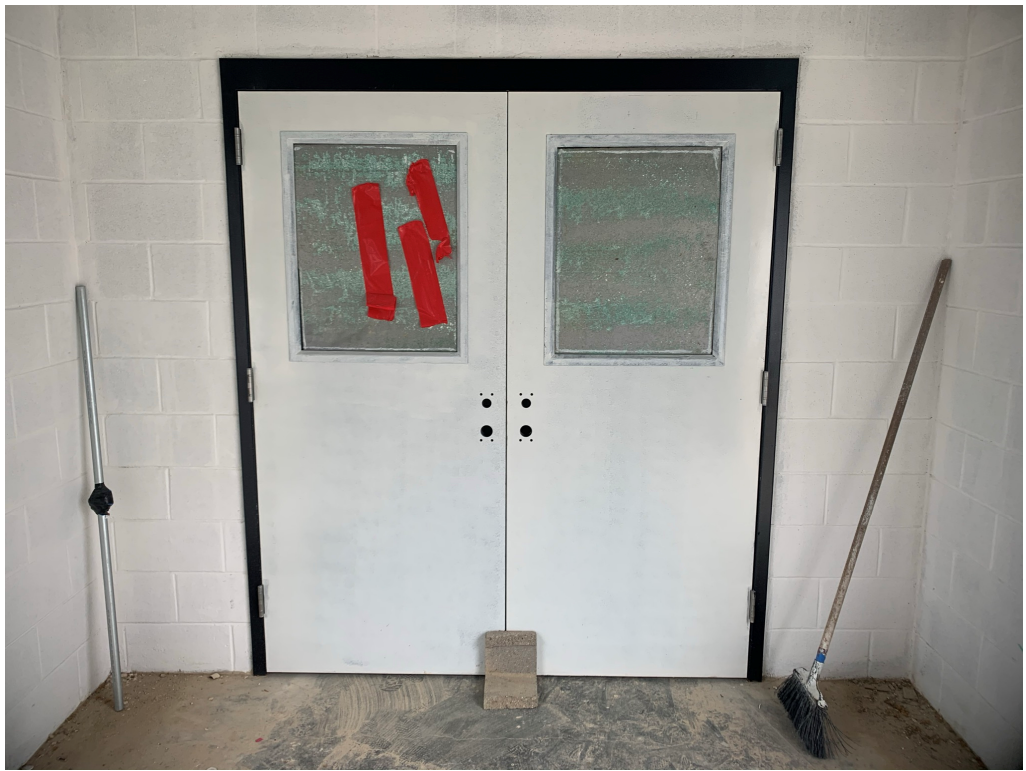
Figure 5 – Windows cut into doors

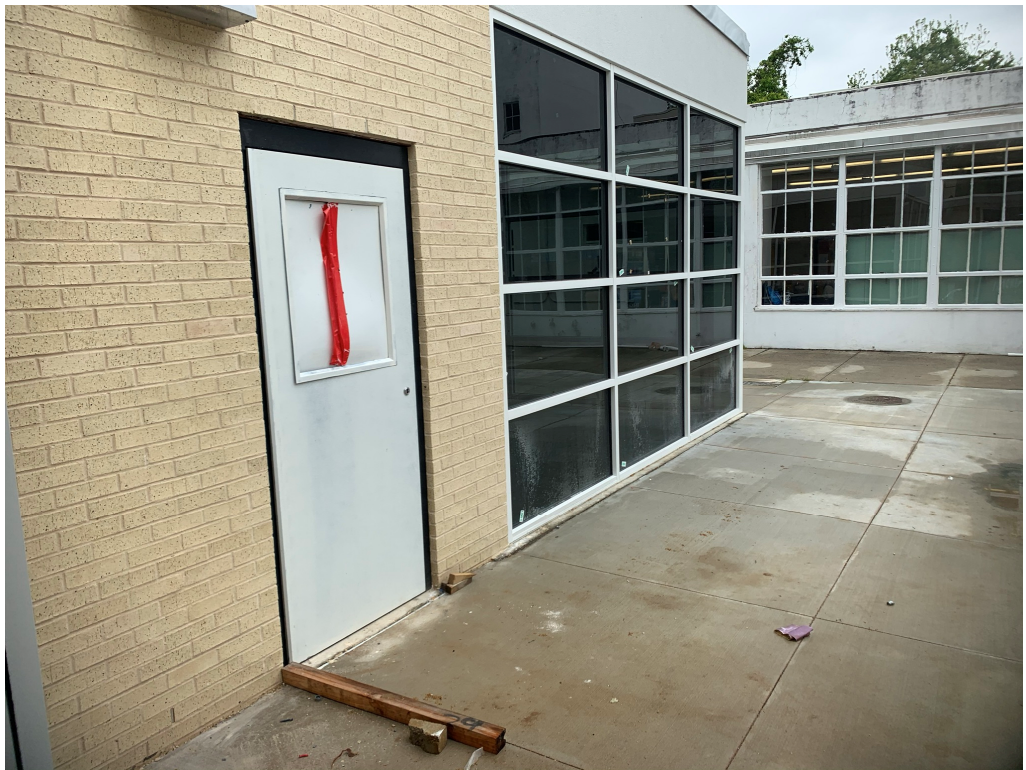
Figure 6 – Windows cut into doors

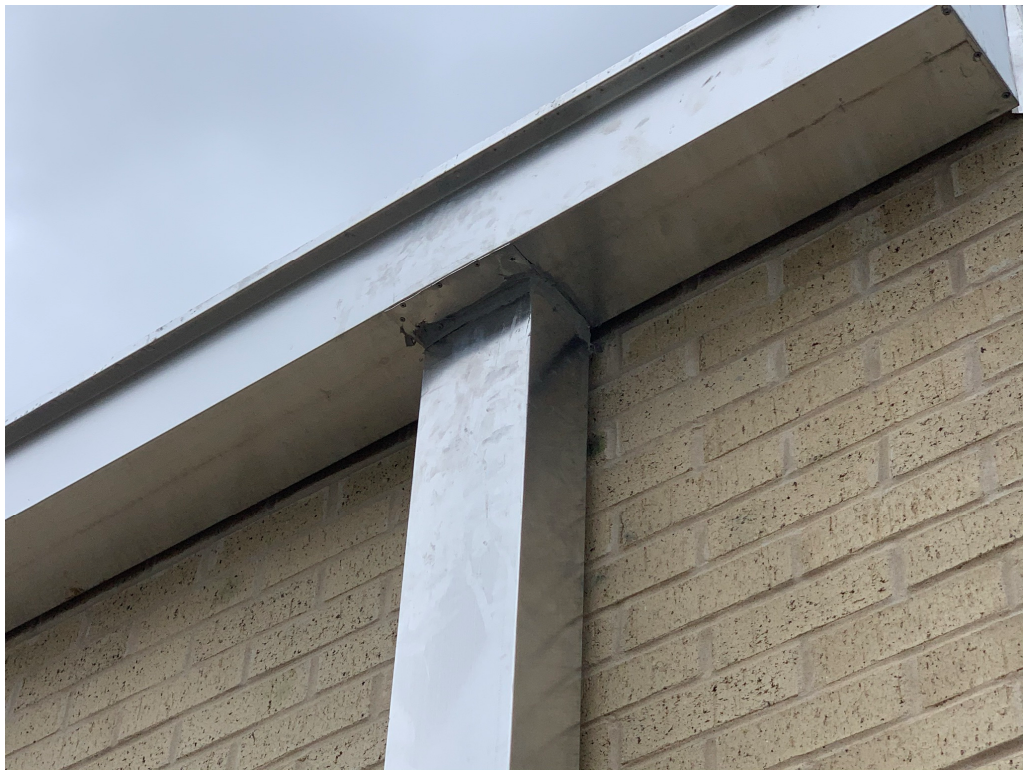
201 Park Court, Suite B Ridgeland, MS 39157 P 601.790.9432 F 888.281.0547	Contract	Paul Jackson & Son
	Date / Time	23 April 2021 / 1:15 PM
	Weather / Temp	Cloudy / 61 ° F
	Est % Complete	70%
One Jackson Place, Suite 250 188 East Capitol Street Jackson, MS 39201-2100 P 601.352.5411 F 601.352.5362	Sched Conformance	+/- 00 days
	Work in Progress	None
	Present at Site	Paul Purser, DBA
161 Lameuse Street, Suite 201 Biloxi, MS 39530 P 228.374.1409 F 228.374.1414	Observations	<p>Arriving on site, I entered at the front entry. I made my way towards the addition. Here progress has been made on a few fronts. Windows have been installed at egress doors. Lights have been hung in classrooms. Mud and paint appear to be ongoing. Glazing has been installed at our metal frames at the interior.</p> <p>At the East façade, work is nearing completion. I have some concerns about the appearance of the trim work but work may still be ongoing with these. Namely, at the corner, the upper trims do not align. Is there a reason for this? Also, the return part of the trim that turns under the soffit appears to be about twice as large as it is drawn in our documents and has exposed fasteners. Will there be a finish piece of trim to cover these fasteners per spec? A similar issue is at the downspout connections at the rear gutter; will these exposed fasteners and sloppy sealant be covered?</p>

Figure 7 – Sloppy Sealant at Downspouts; are these to be covered with cover plate so that fasteners do not show?

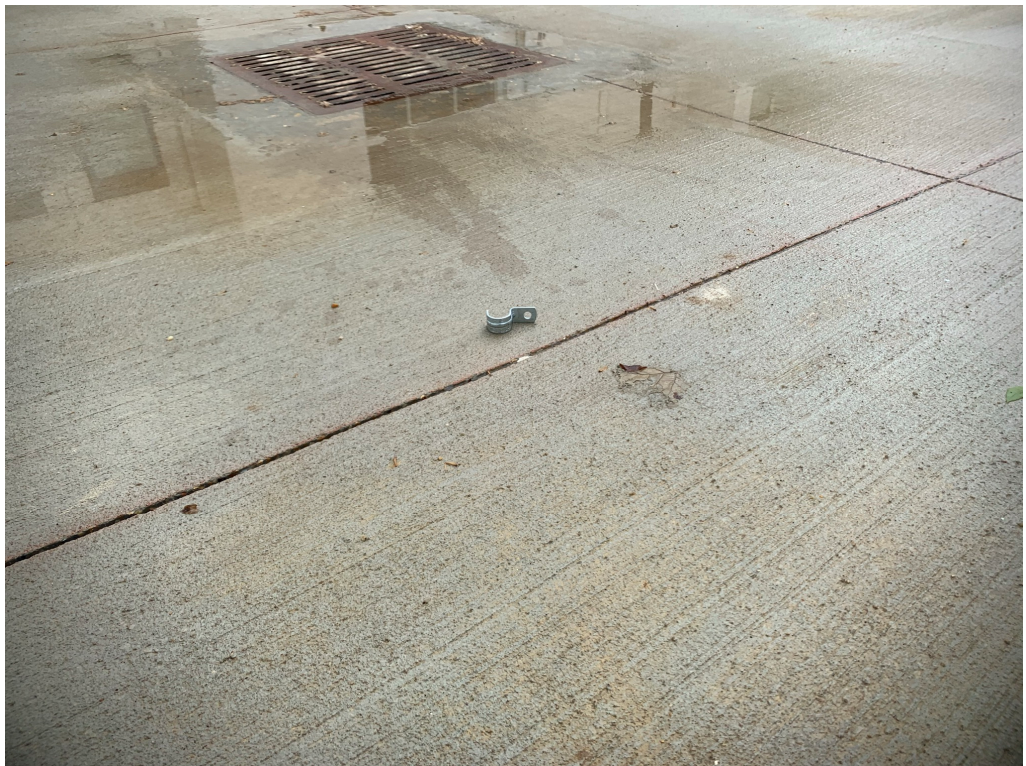
Figure 8 – Standing water around inlet needs correction

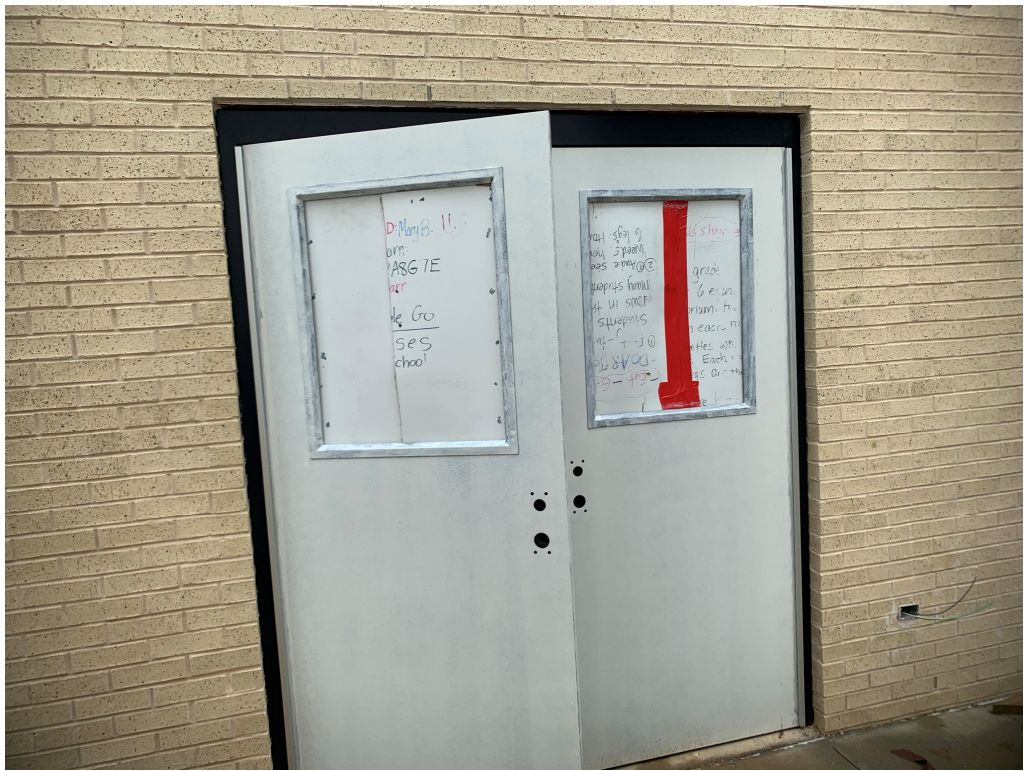
Figure 9 – Windows cut into doors

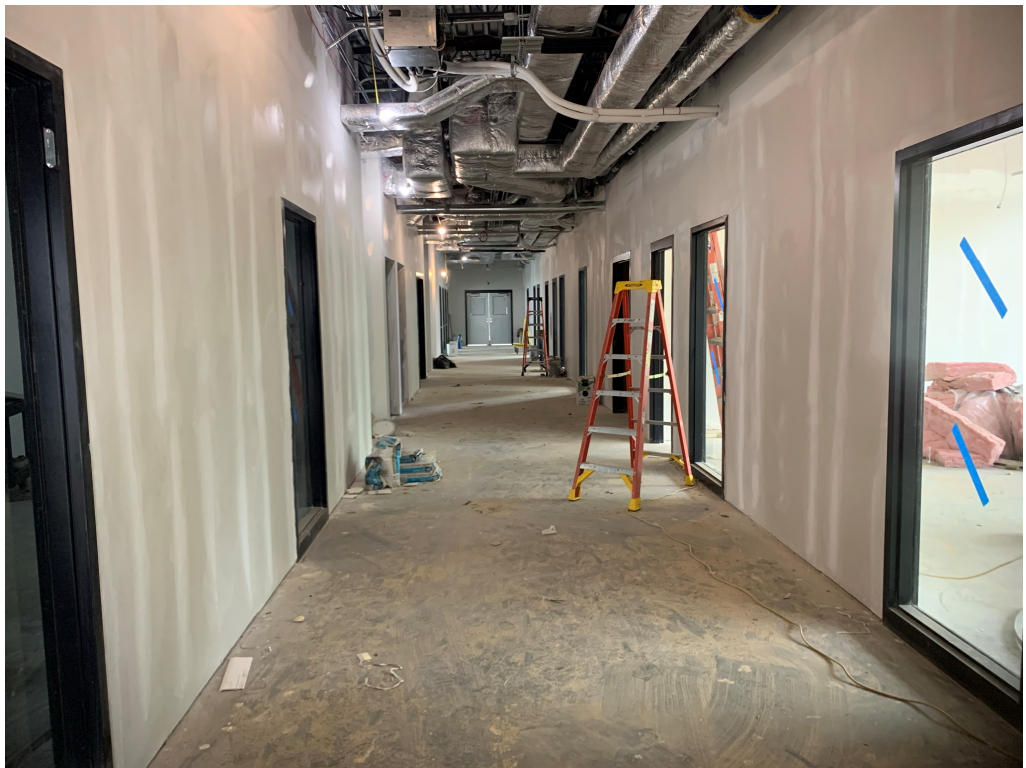
Figure 10 – Mud/Paint is ongoing

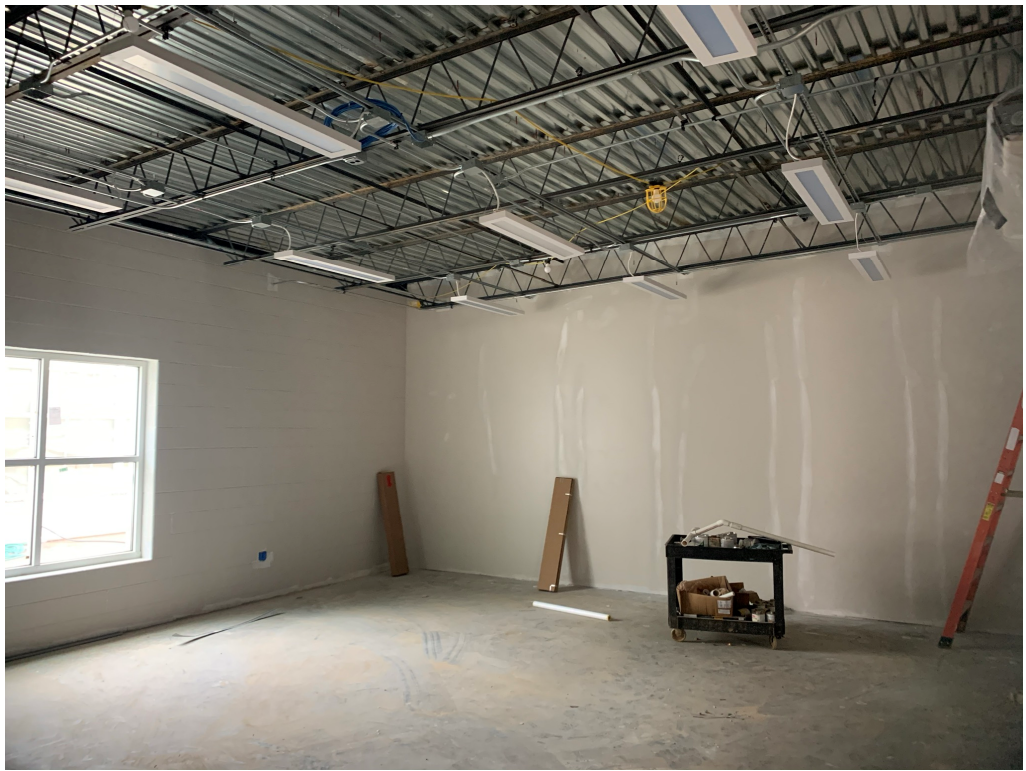
Figure 11 – Lighting Hung in Space

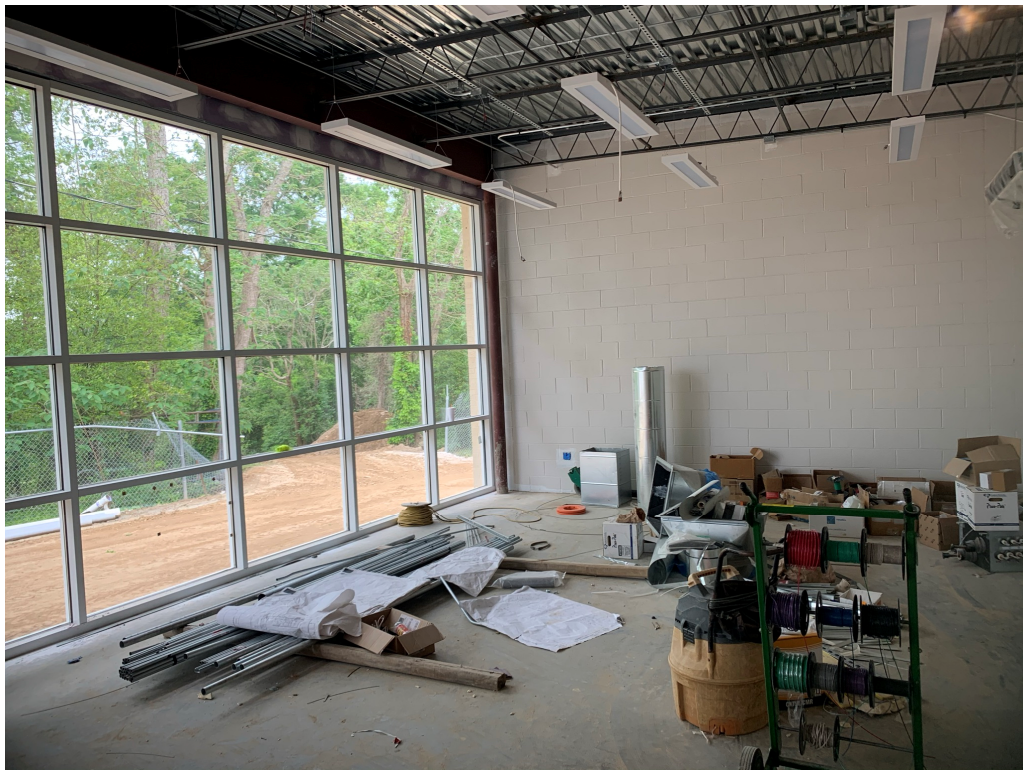
Figure 12 – Lighting Hung in Space

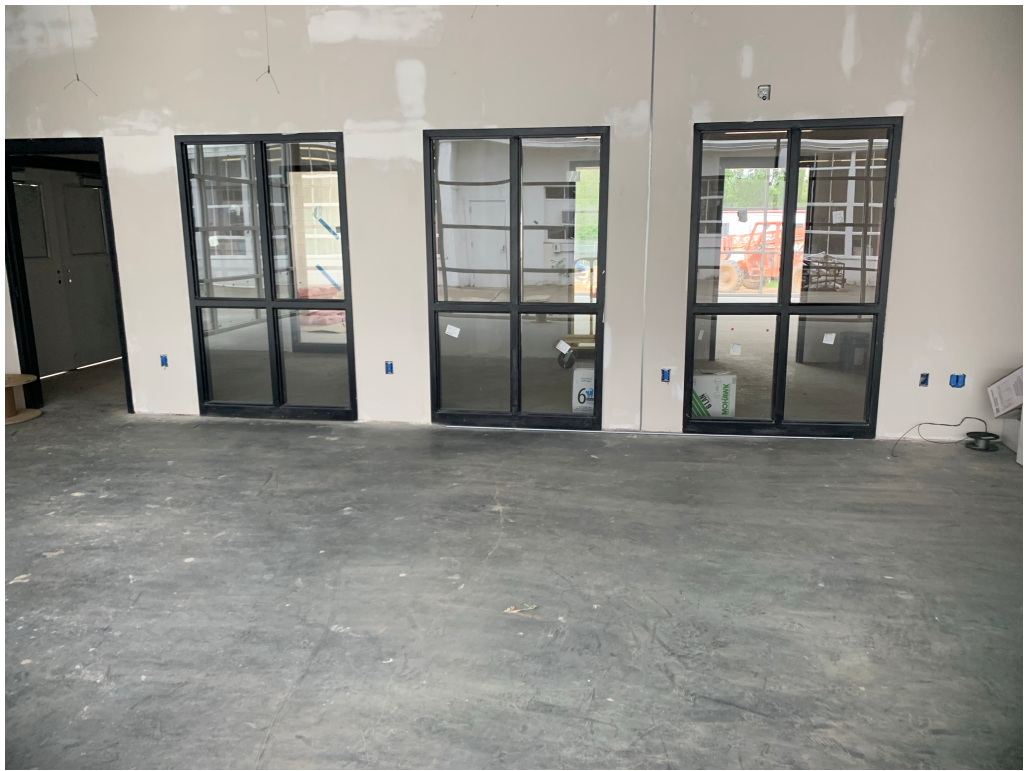
Figure 13 – Glazing Installed at Steel Interior Frames

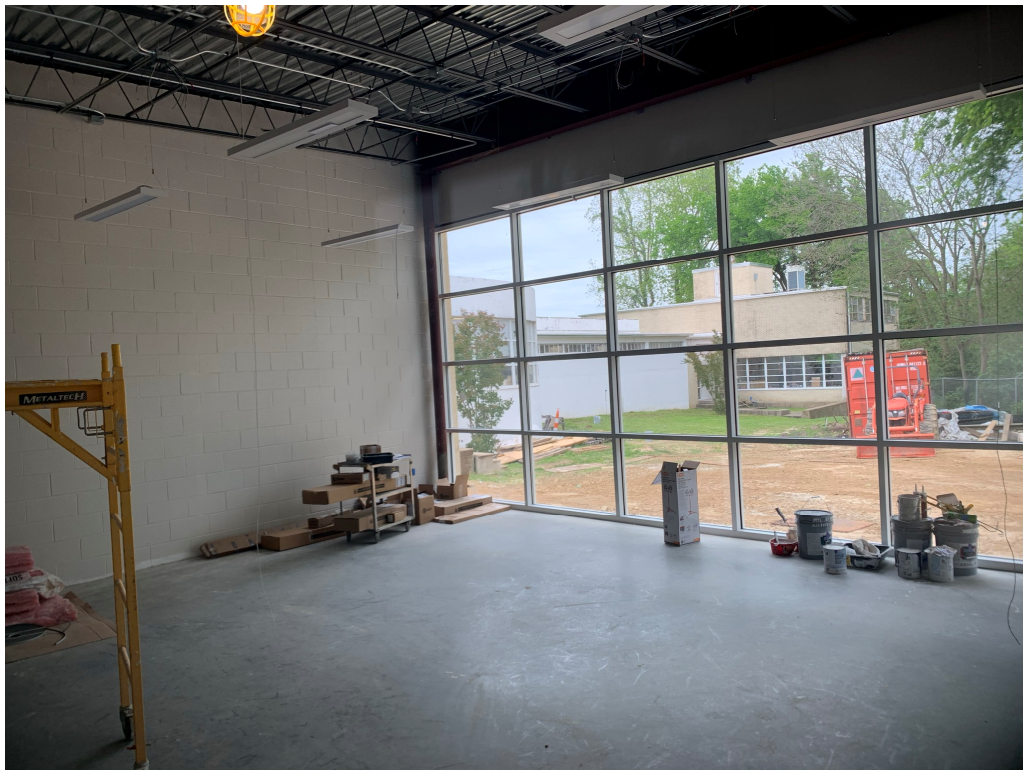
Figure 14 – Lighting Hung in Space
