28 May 2021

18045-BOW Bowmar Elementary / Report Number 030

26 May 2021 / 2:00 PM

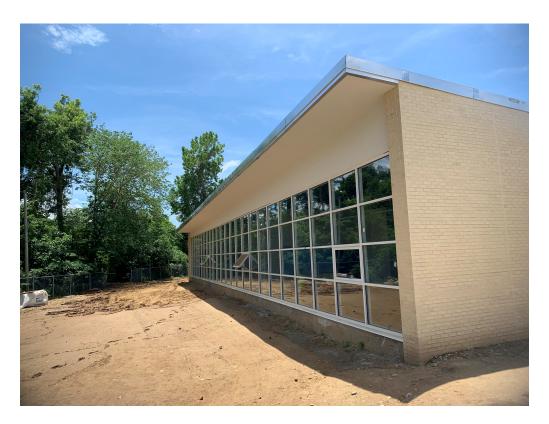
Figure 1 – Roof Trim Replaced to Match

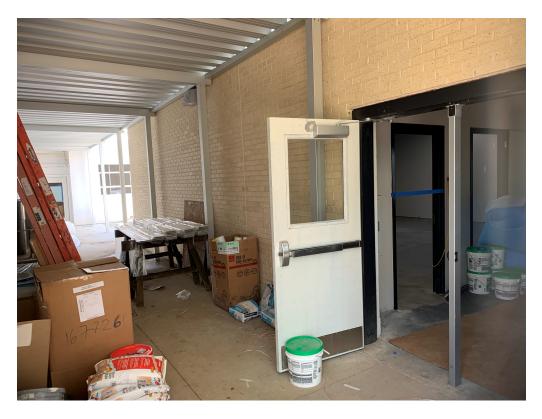
Figure 2 – Rear Exit Corridor; this area needs to be kept clean for egress from main building in case of an evacuation event.

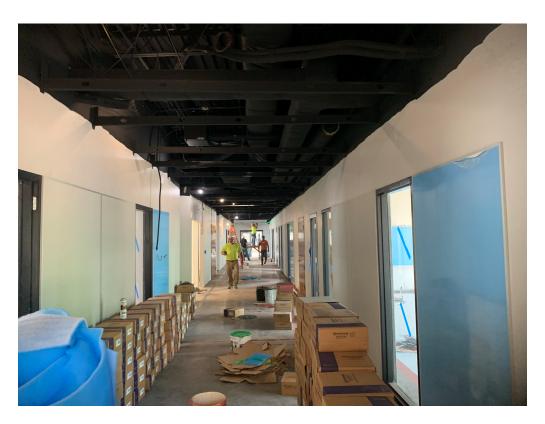
Figure 3 – Above Ceiling Painted

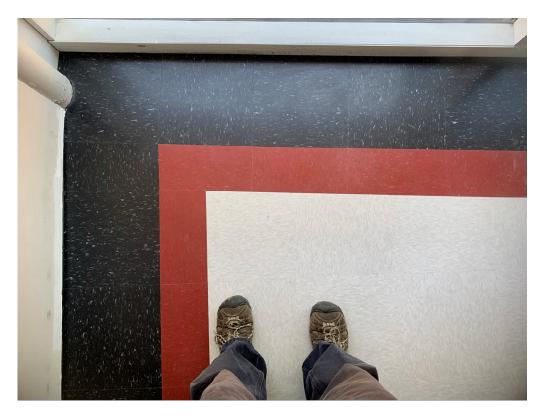
Figure 4 – New VCT Installed

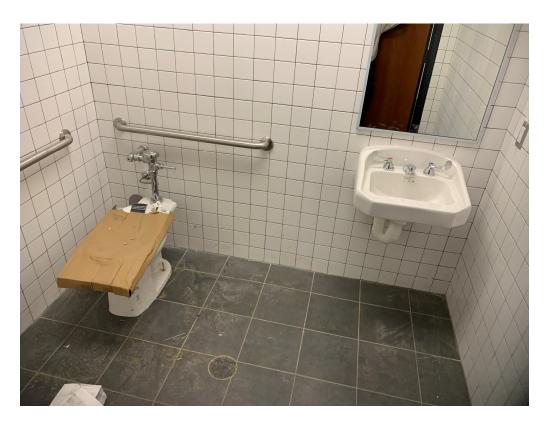
Figure 5 – ADA Bathroom Installed

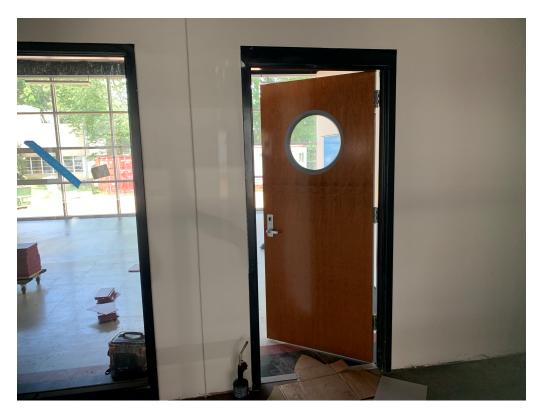
Figure 6 – Door Panels Installed

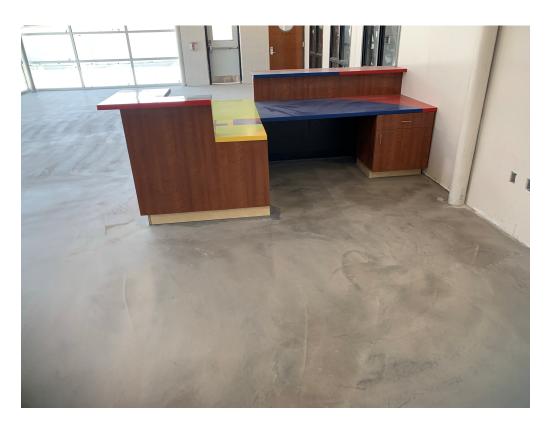
Figure 7 – Millwork Installed

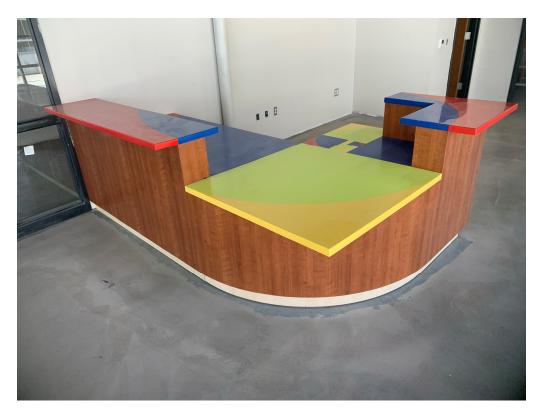
Figure 8 – Millwork Installed

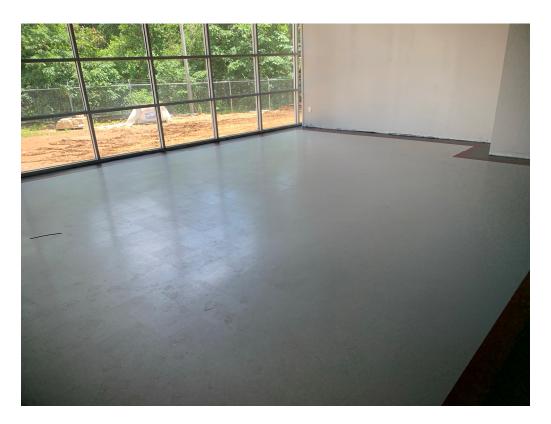
Figure 9 – New VCT Installed

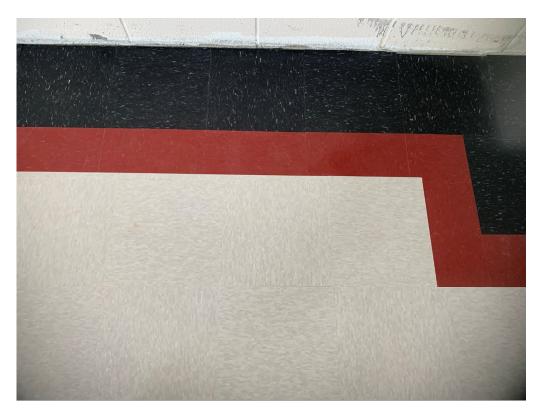
Figure 10 – New VCT Installed
