09 June 2021

18045-BOW Bowmar Elementary / Report Number 031

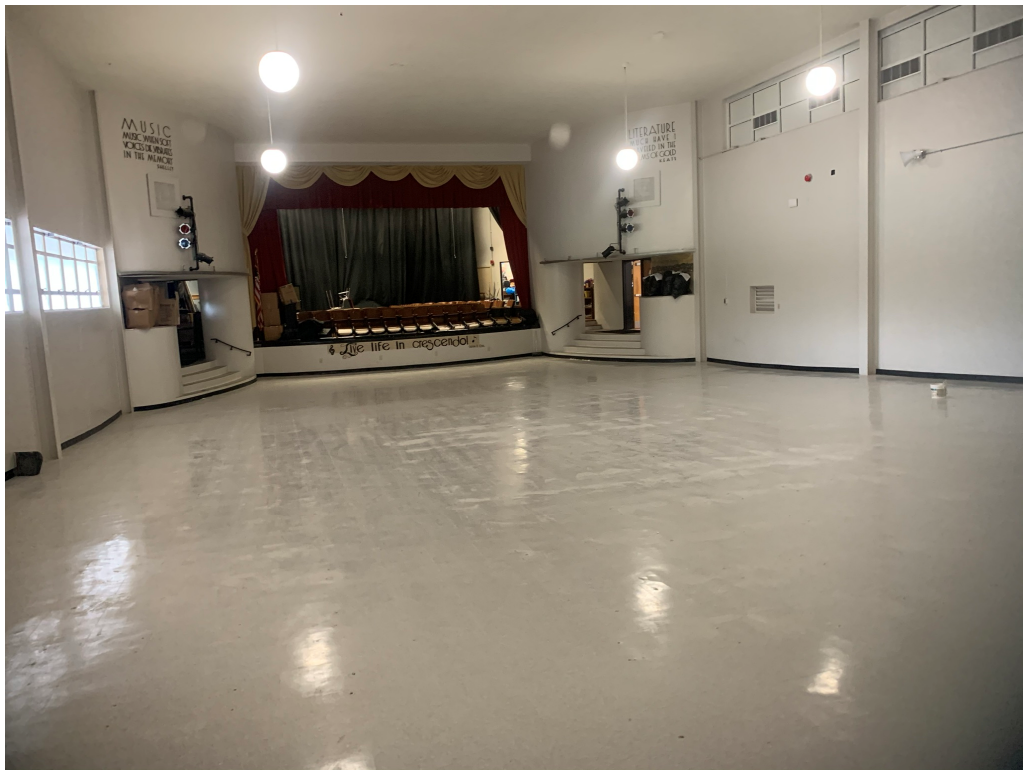
Figure 1 – Auditorium Clear of Chairs

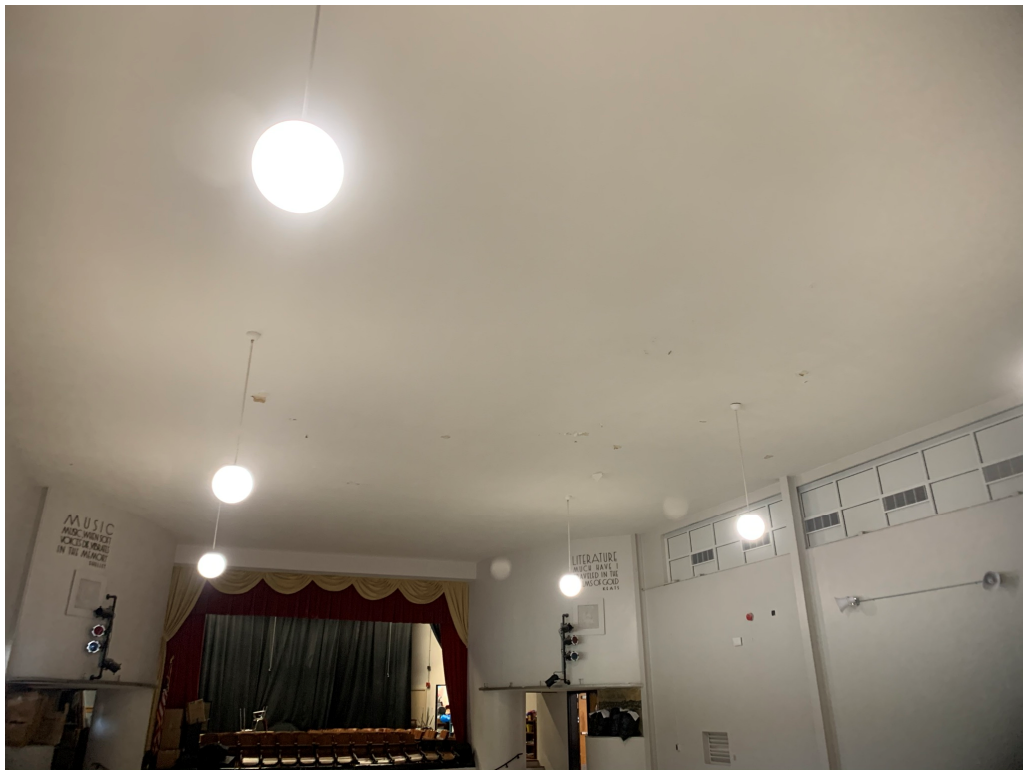
Figure 2 – Moisture up to 22%, per contractor's reading, causing paint to peel

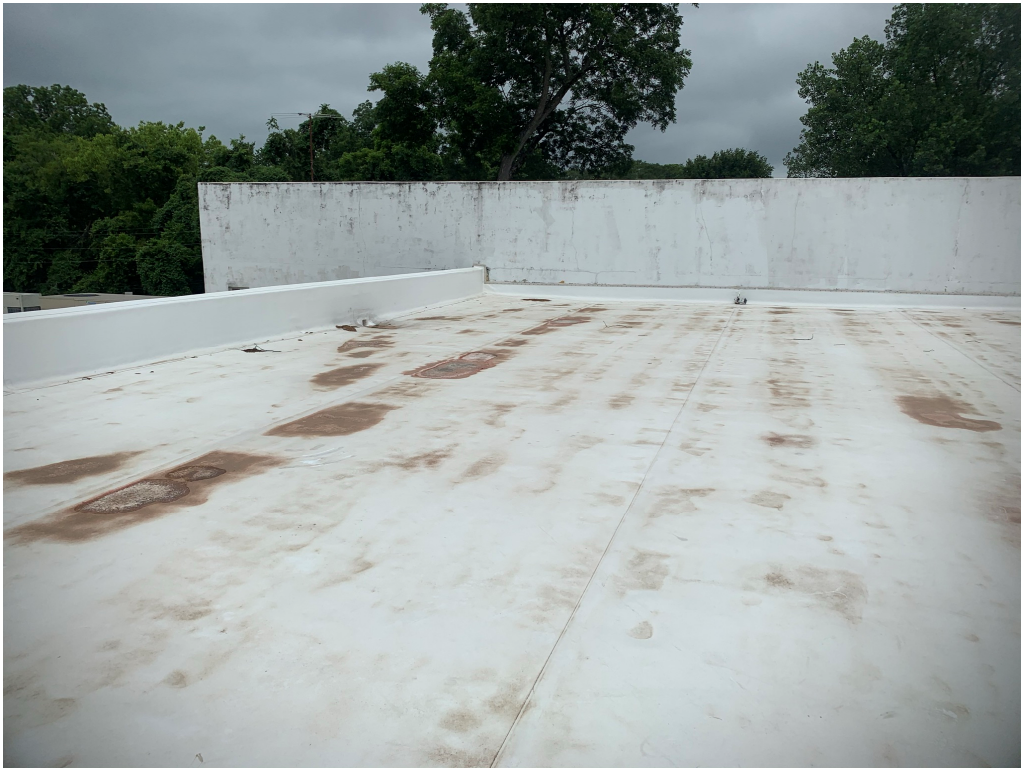
Figure 3 – Roofing Membrane appears in good condition

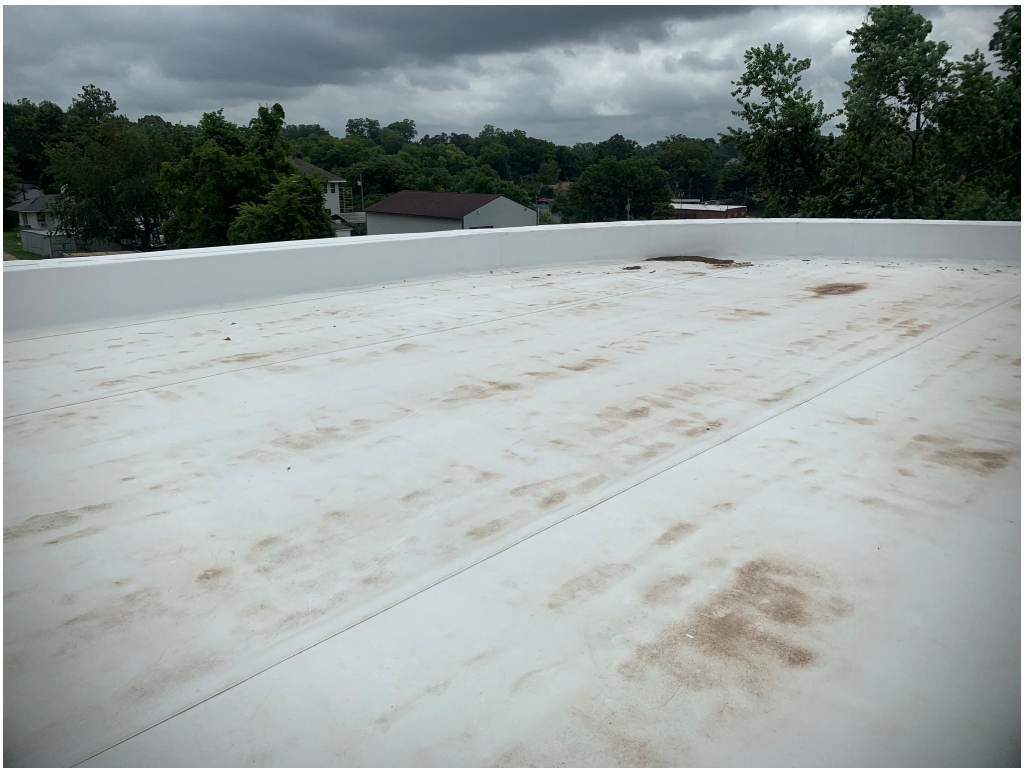
Figure 4 – Roofing Membrane appears in good condition

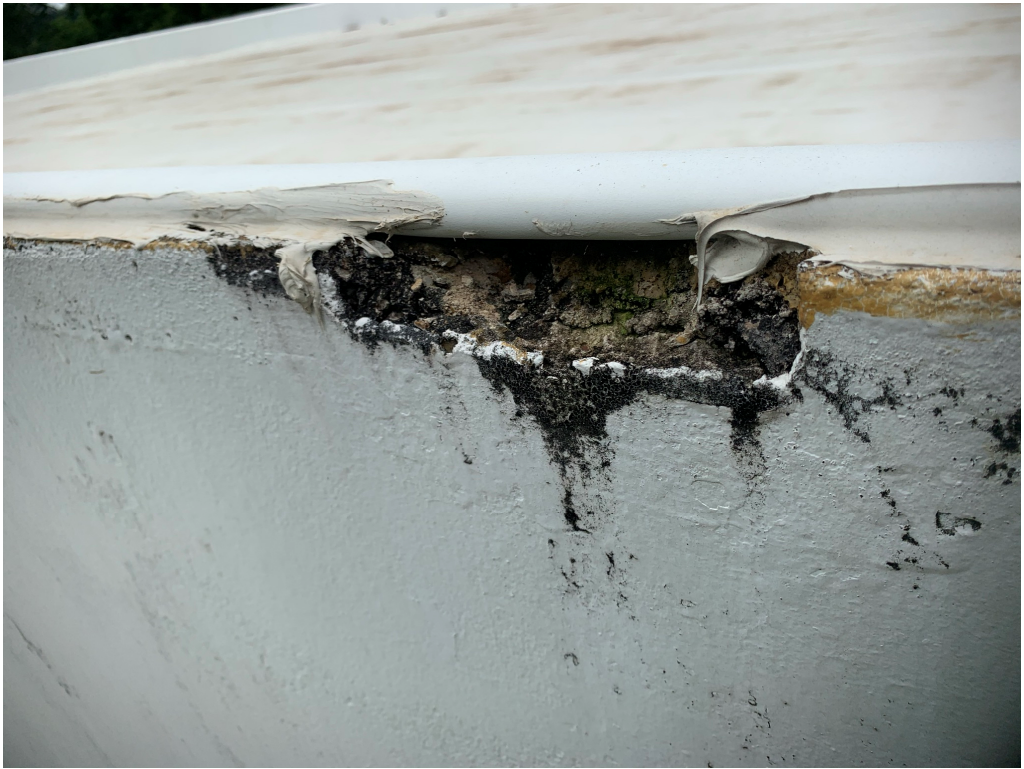
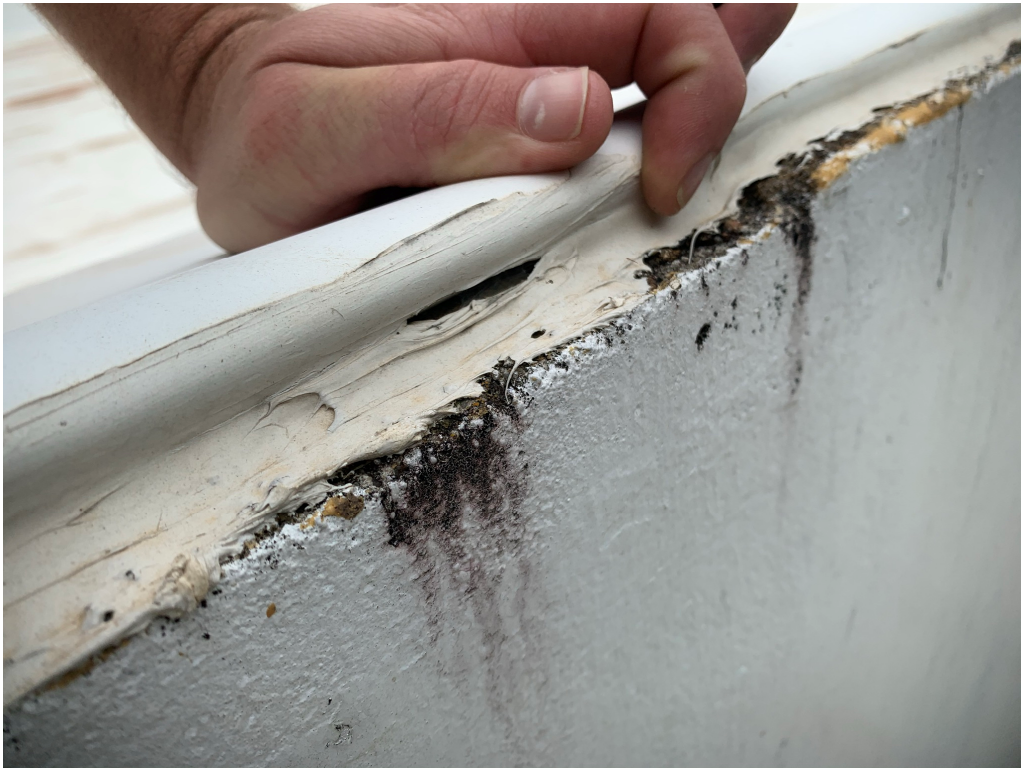
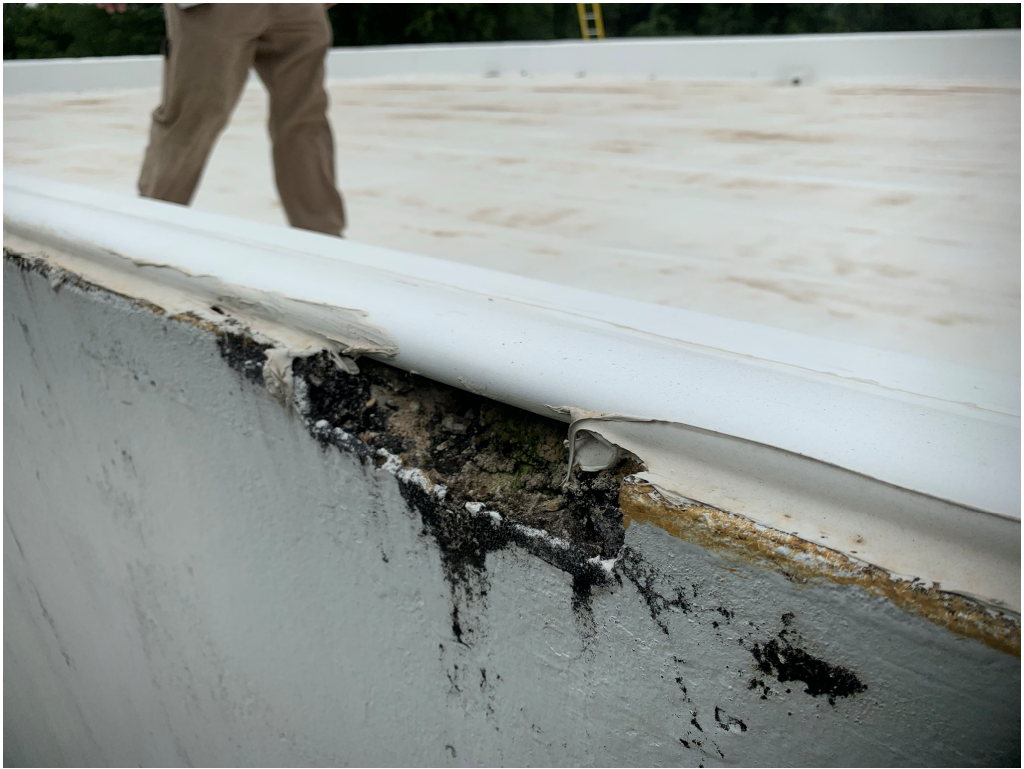
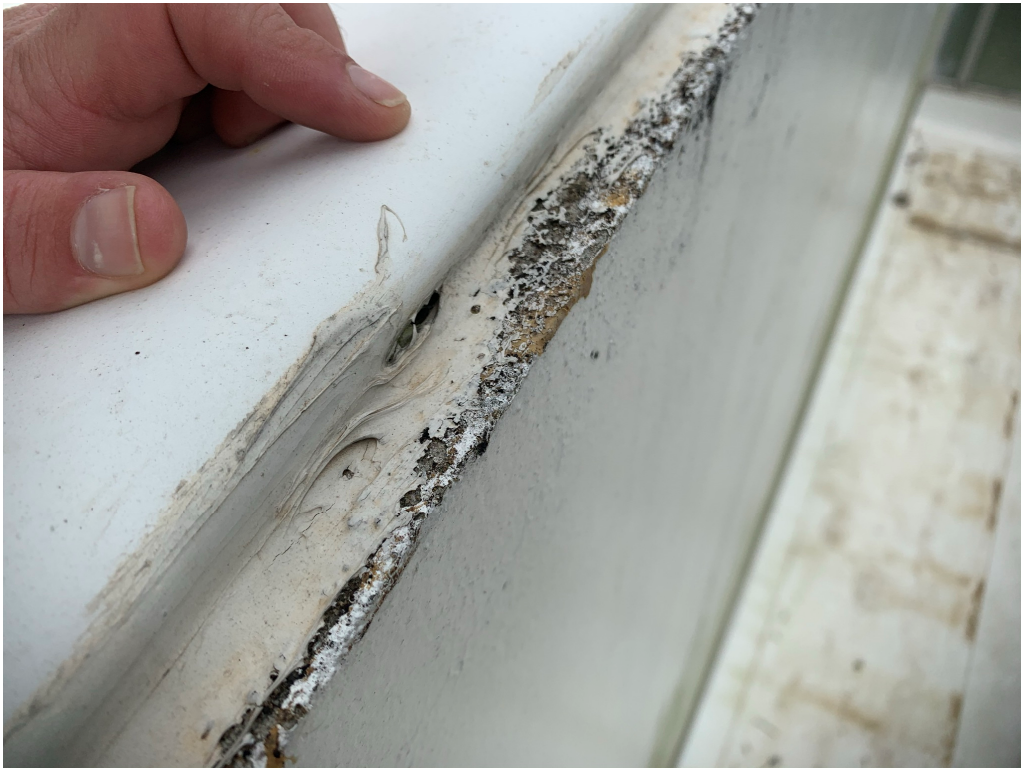
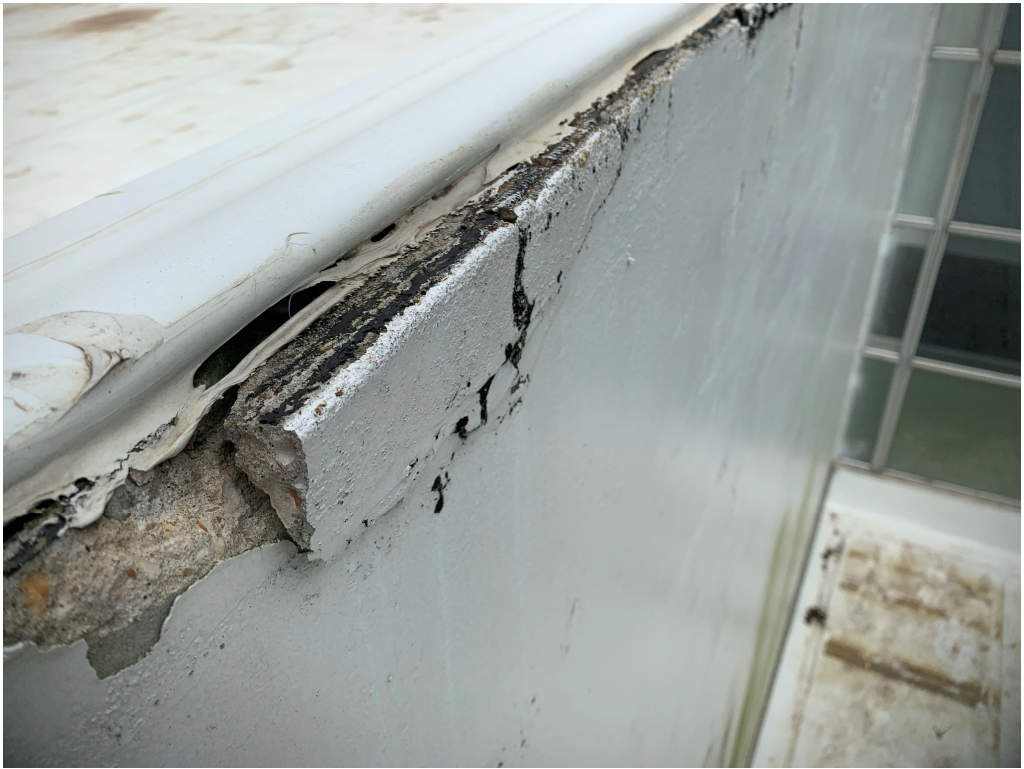
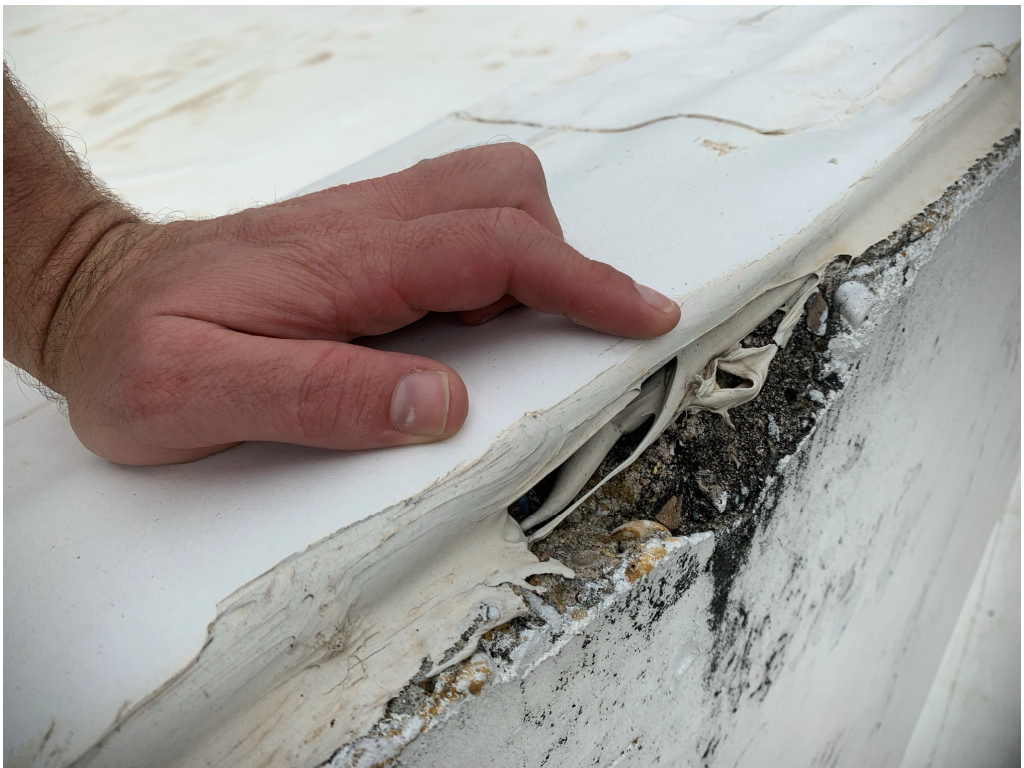
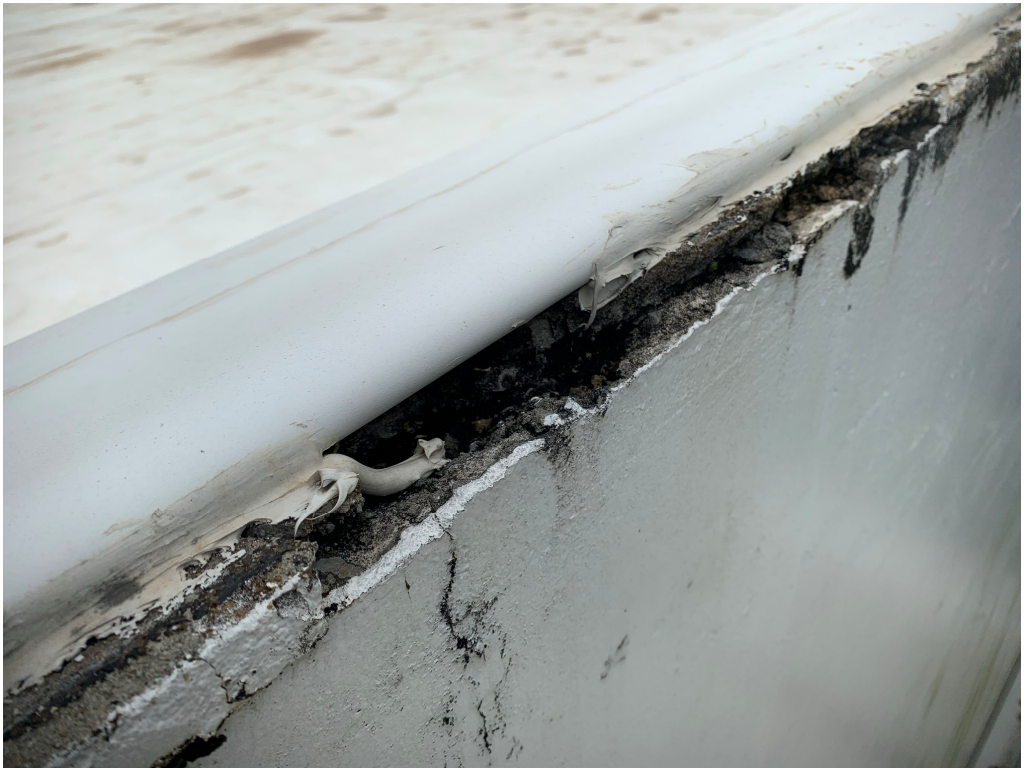
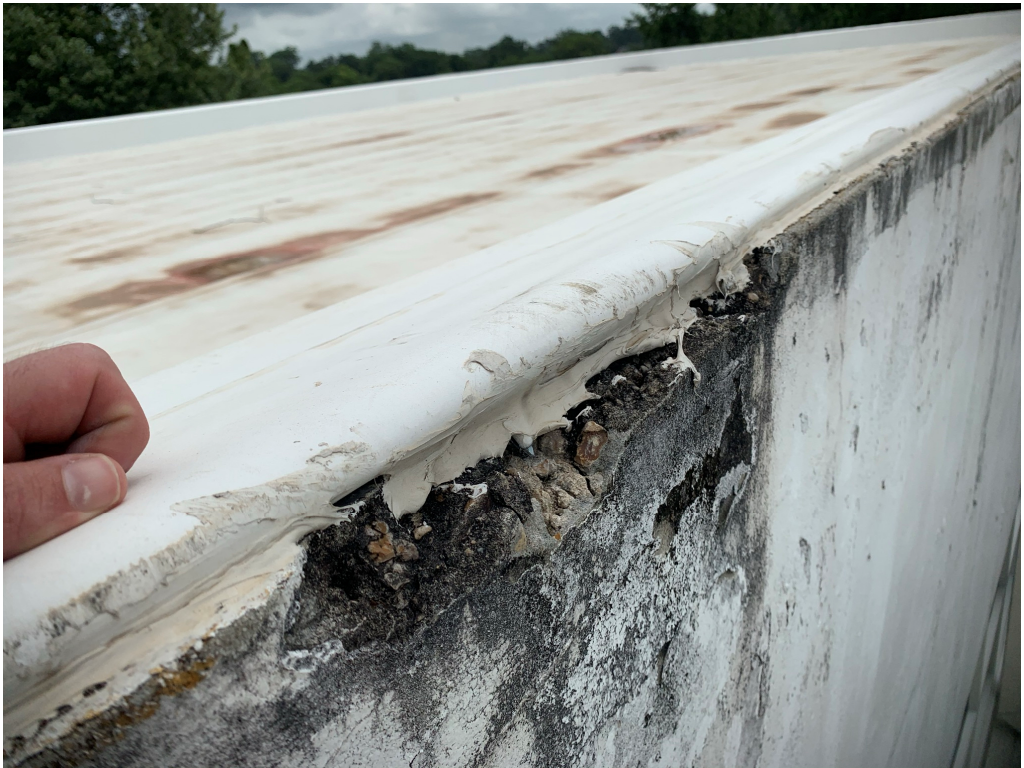
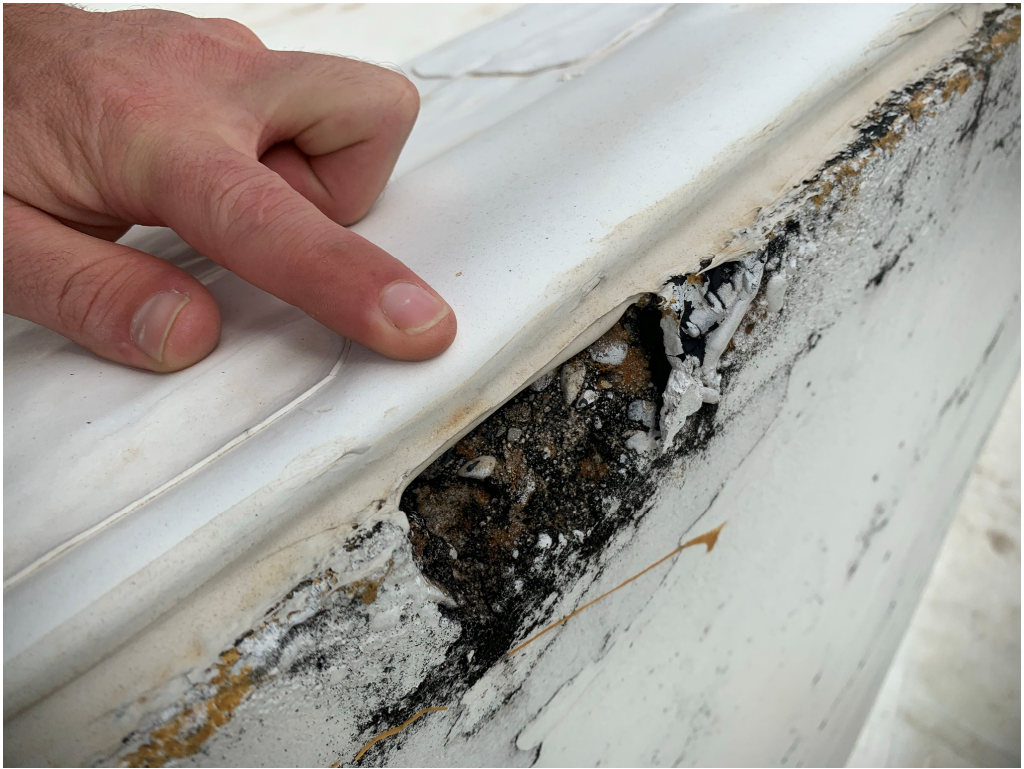
Figure 5 – Mastic does not fully cover connection at Parapet

Figure 6 – Mastic does not fully cover connection at Parapet

Figure 7 – Mastic does not fully cover connection at Parapet

Figure 8 – Mastic does not fully cover connection at Parapet

Figure 9 – Mastic does not fully cover connection at Parapet

Figure 10 – Mastic does not fully cover connection at Parapet

Figure 11 – Mastic does not fully cover connection at Parapet

Figure 14 – Mastic does not fully cover connection at Parapet

Figure 15 – Mastic does not fully cover connection at Parapet

Items to Verify	None
Action Required	Reinstall Mastic carefully to cover any gaps that still exist; fully adhere membrane to any/all parts of the top of the concrete parapet.

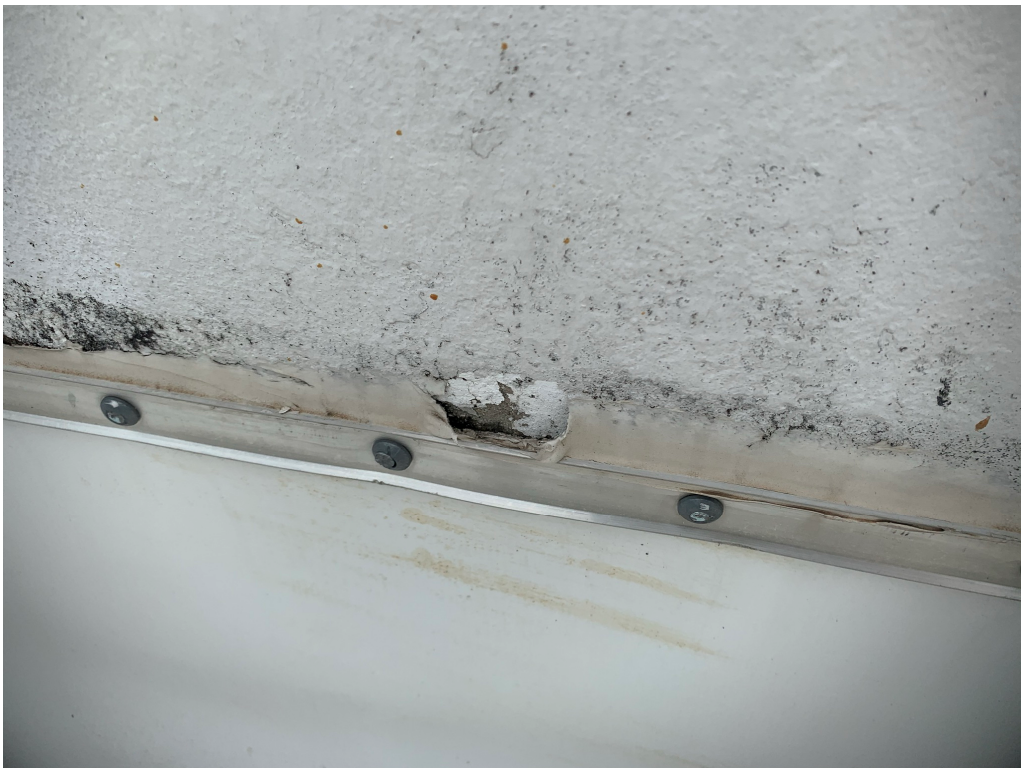
Figure 12 – Break in mastic could cause water leak

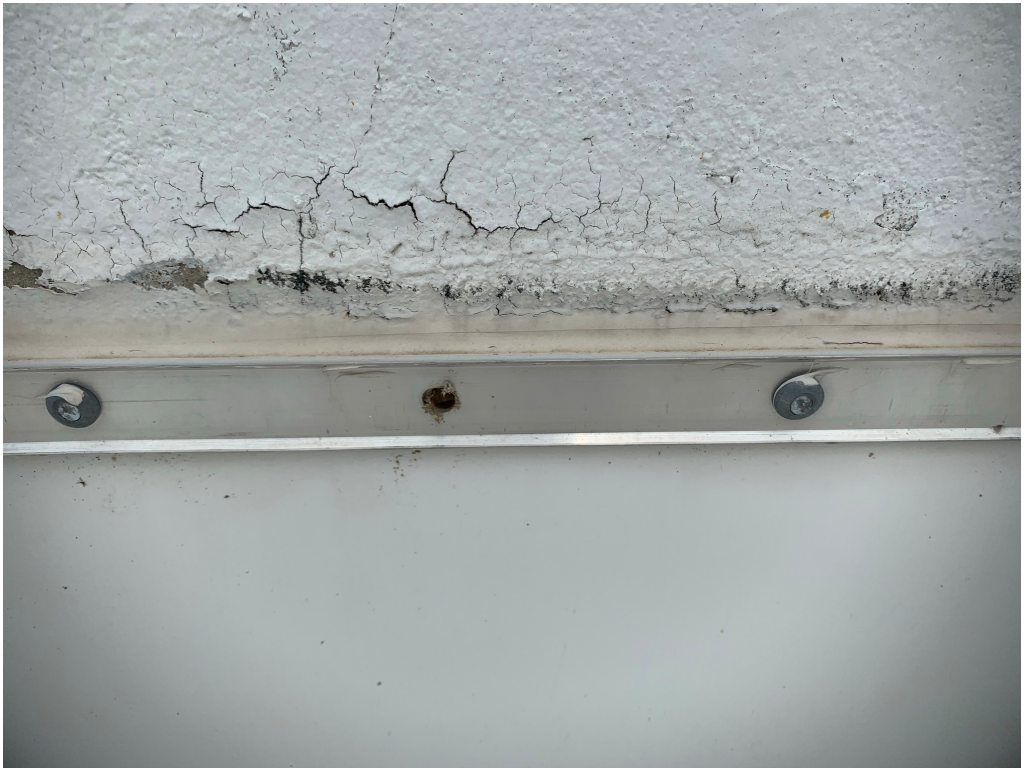
Figure 13 – Screw Missing at termination bar could be water issue

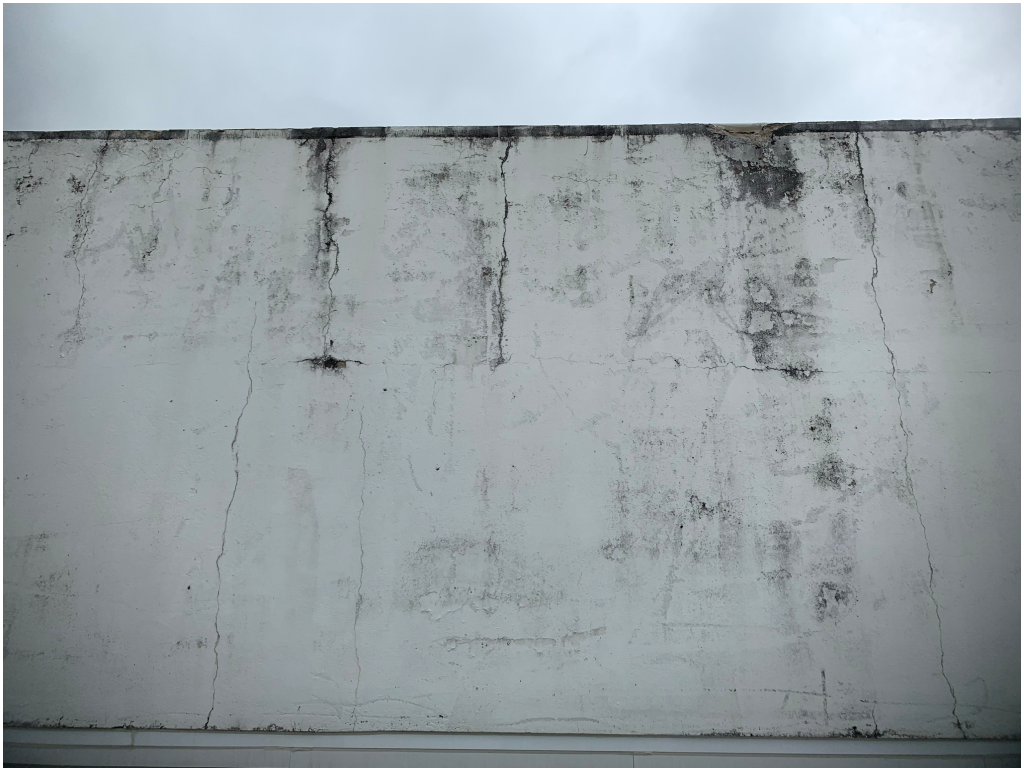
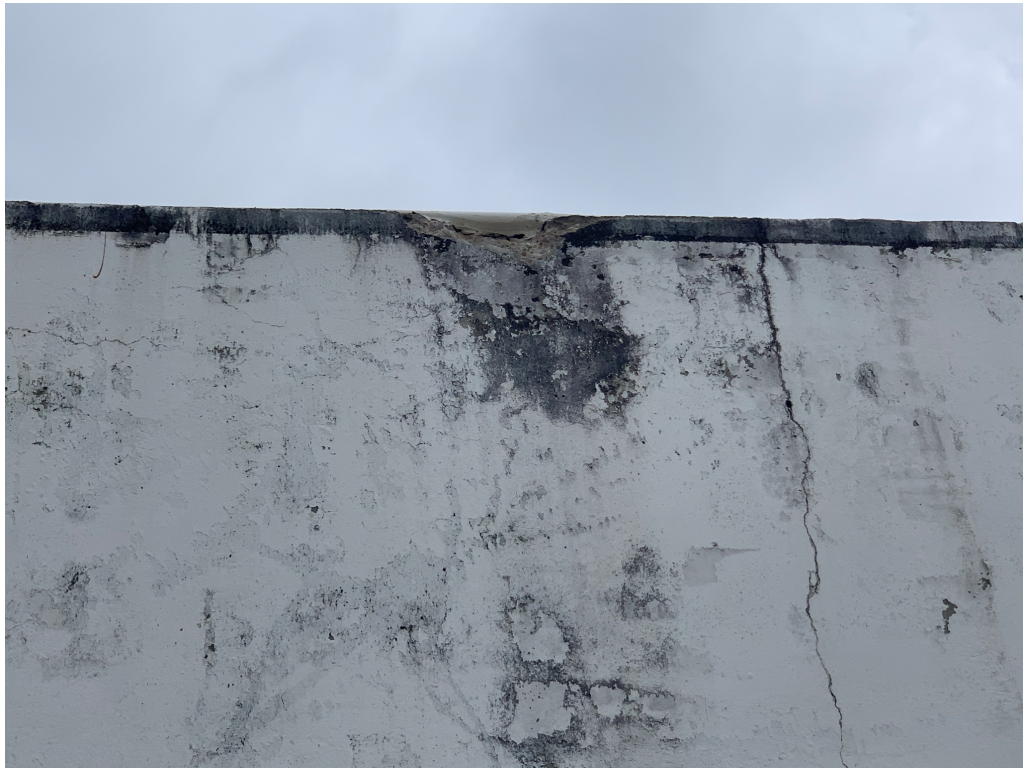
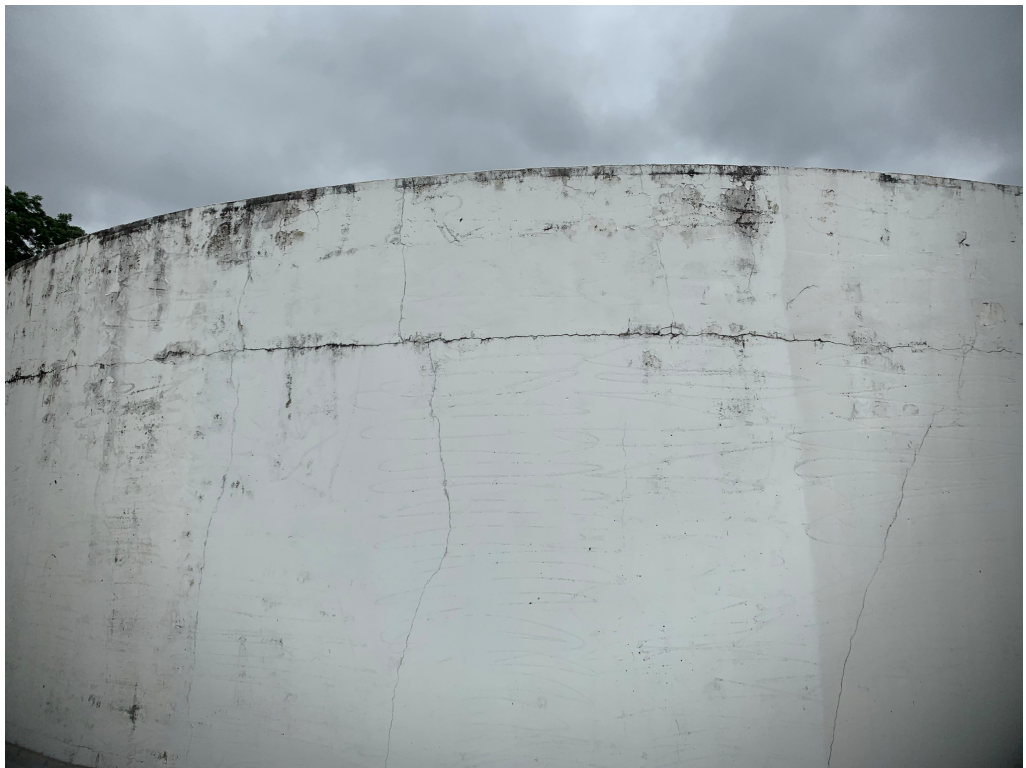
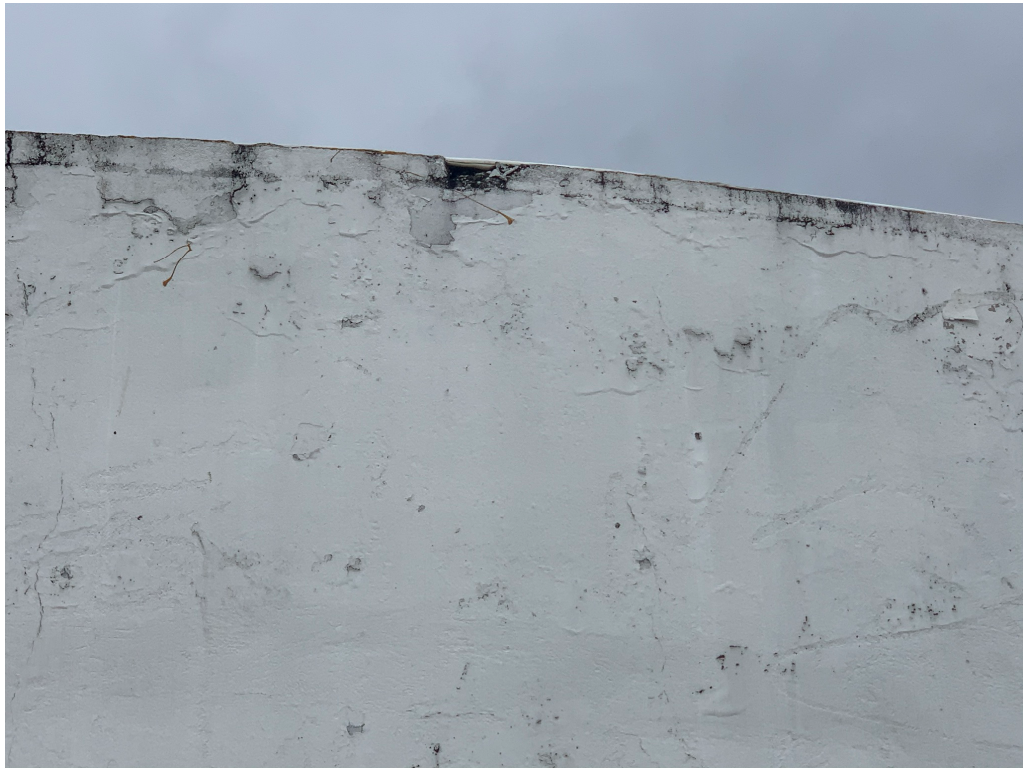
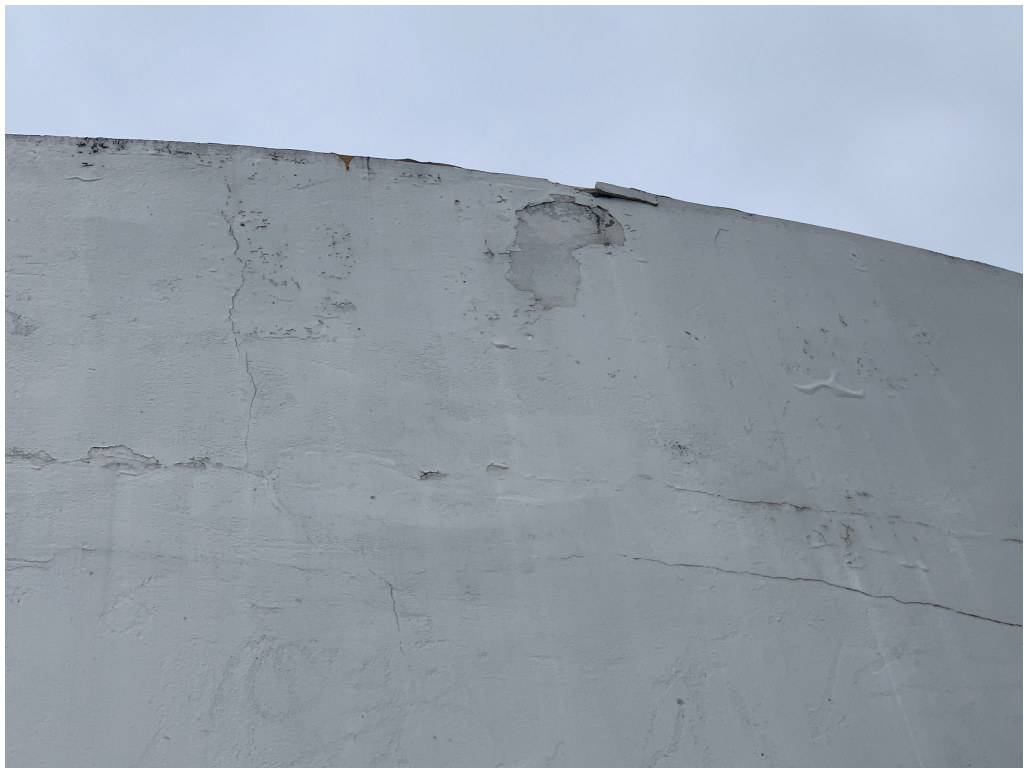
Figure 16 – Existing Wall damage (good potential for water leakage)

Figure 17 – Existing Wall damage (good potential for water leakage)

Figure 18 – Existing Wall damage (good potential for water leakage)

Figure 19 – Existing Wall damage (good potential for water leakage)

Figure 20 – Existing Wall damage (good potential for water leakage)

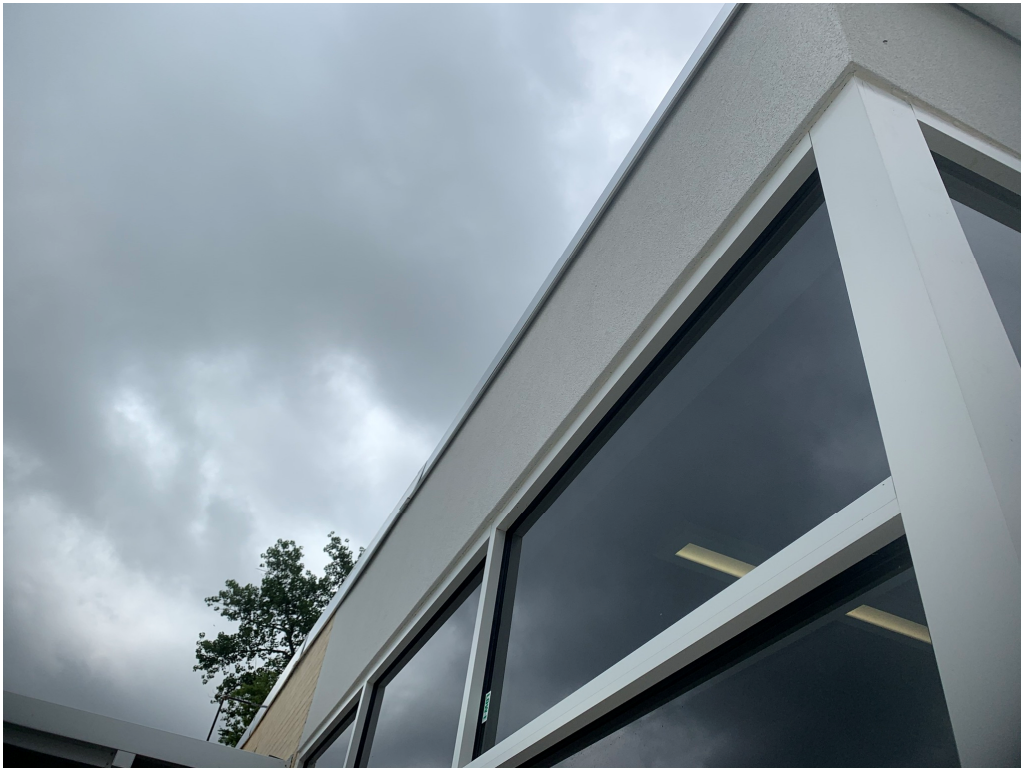
Figure 21 – Stucco to aluminum joint is offset and looks good

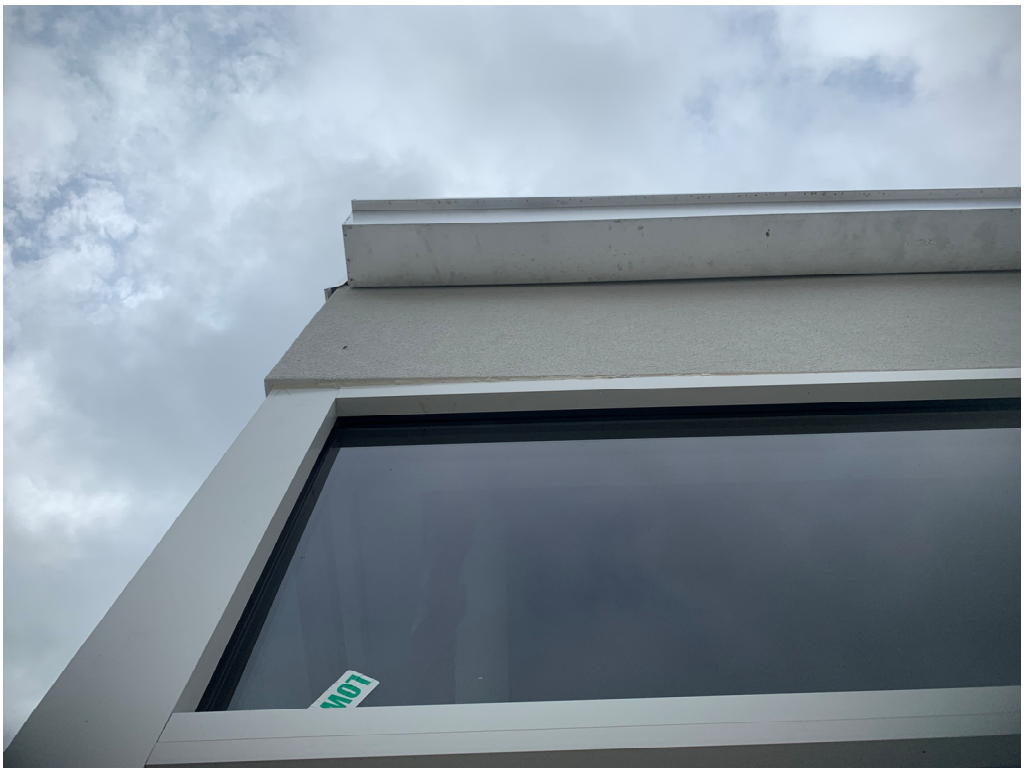
Figure 22 – Stucco to aluminum joint dives from offset to flush

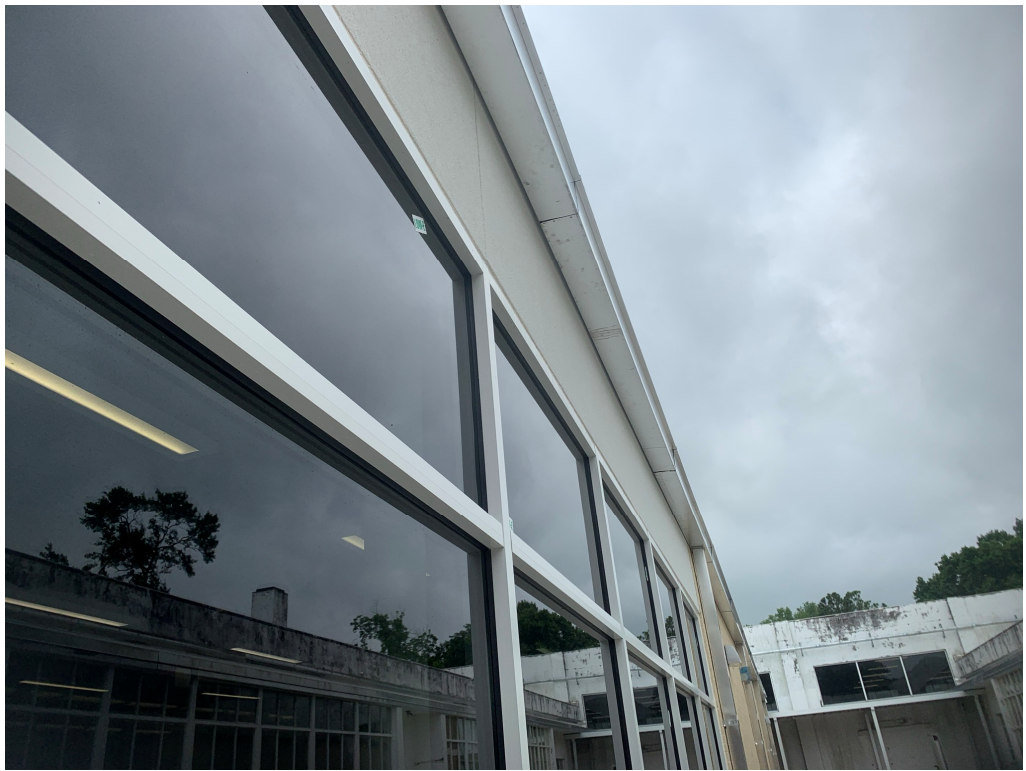
Figure 23 – Stucco to aluminum joint is flush here but offset on east side

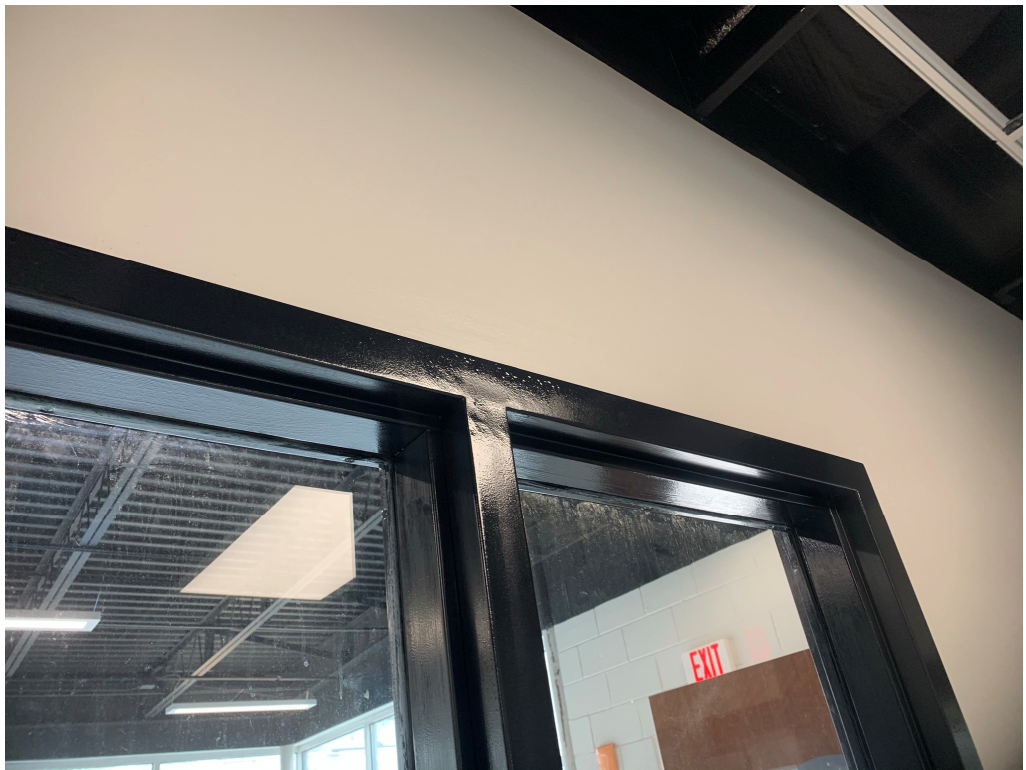
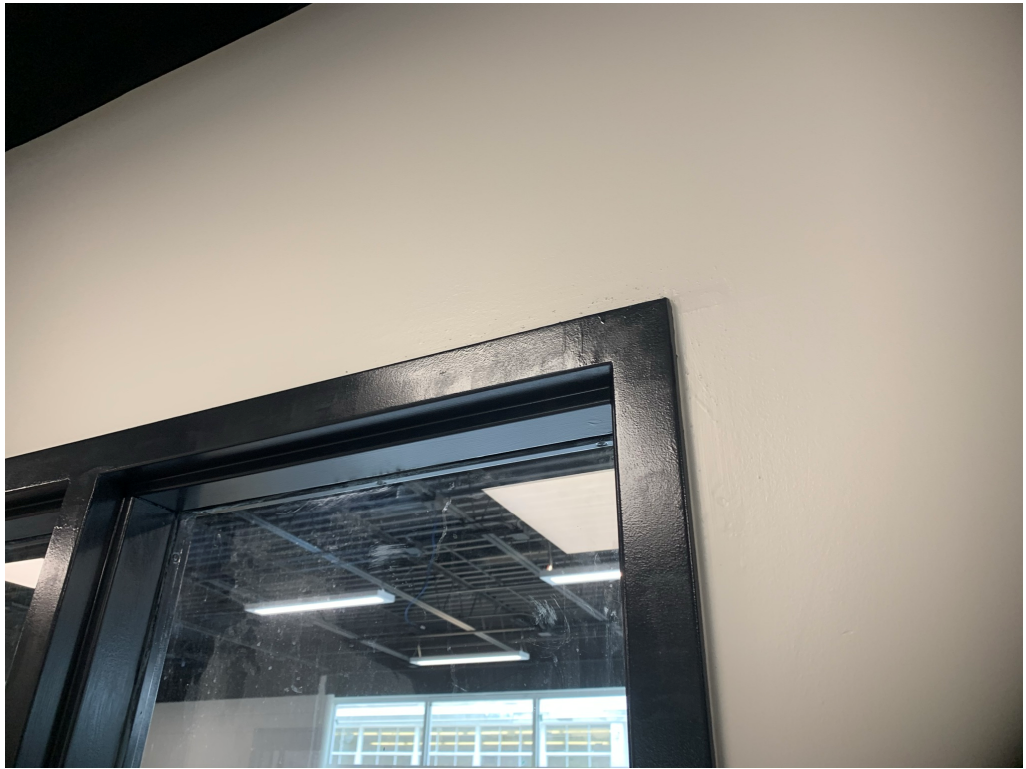
Figure 24 – Paint Drips need to be sanded out for smooth finish

Figure 25 – Paint Drips need to be sanded out for smooth finish

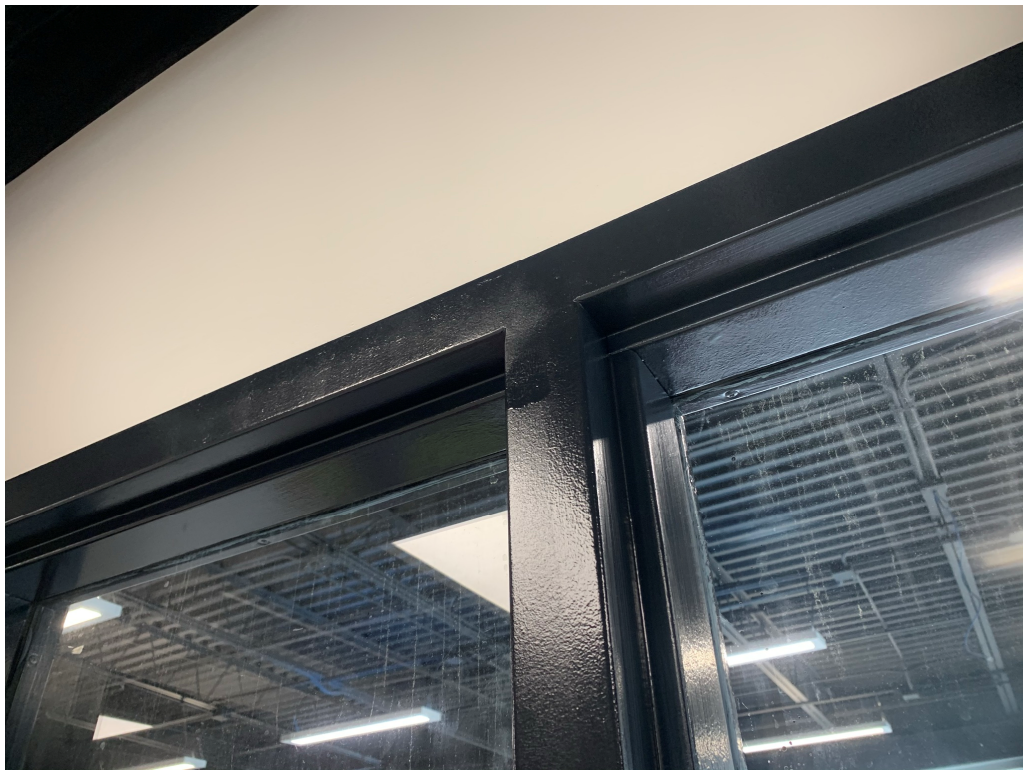
Figure 26 – Paint Build Up needs to be sanded out for smooth finish

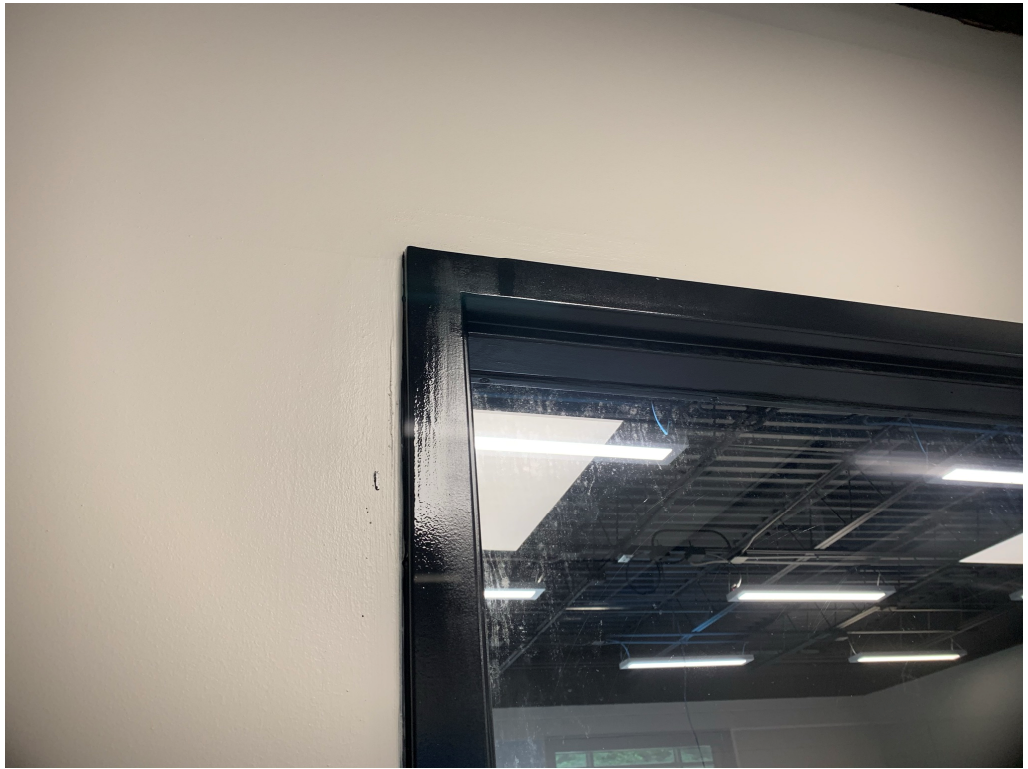
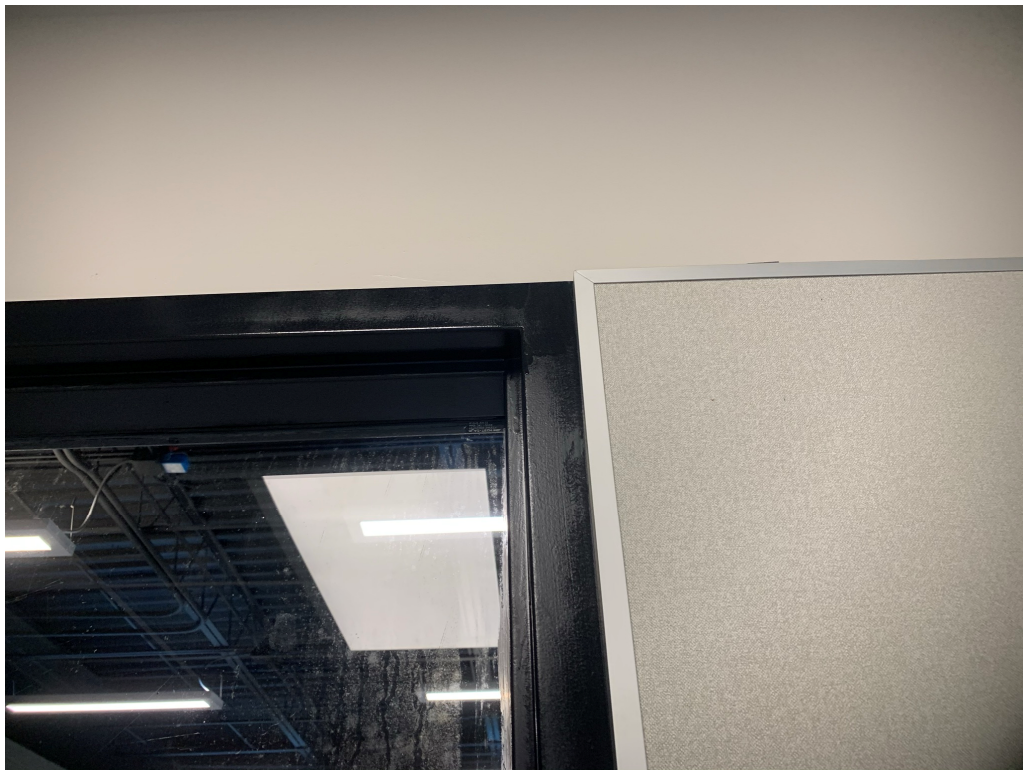
Figure 27 – Sheen Differences (may clear up with top coat)

Figure 28 – Sheen Differences (may clear up with top coat)
