23 June 2021

18045-BOW Bowmar Elementary / Report Number 032

Observations O

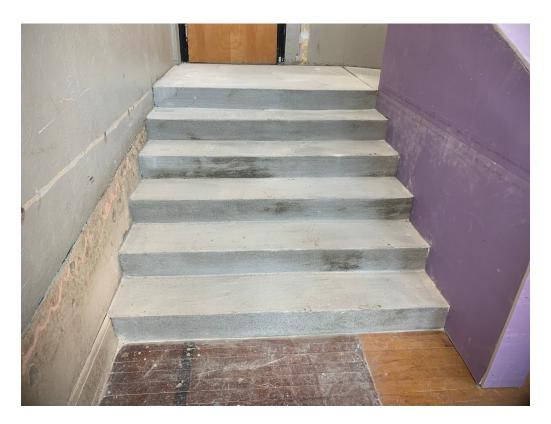
Figure 1 – Stairs at newly installed ADA ramp

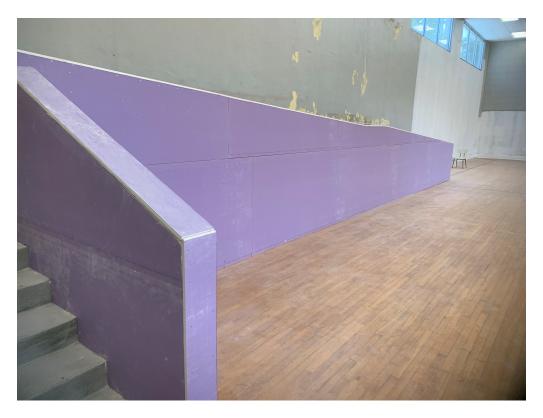
In the playroom, work on the new ADA ramp is coming along. Concrete is in place as well as drywall at our newly framed wall. A worker was in

Figure 2 – Drywall installed at ADA ramp

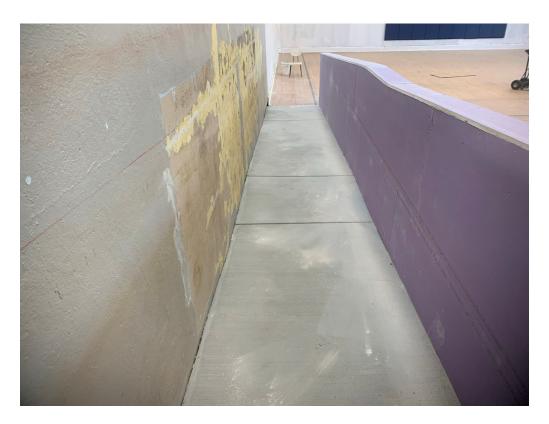
Figure 3 – ADA ramp installed at Playroom

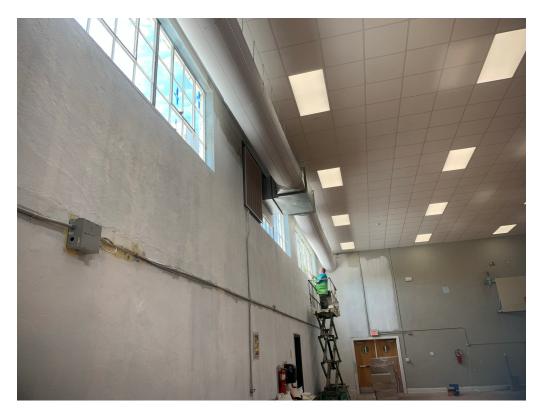
Figure 4 – Sock Duct installed at Playroom

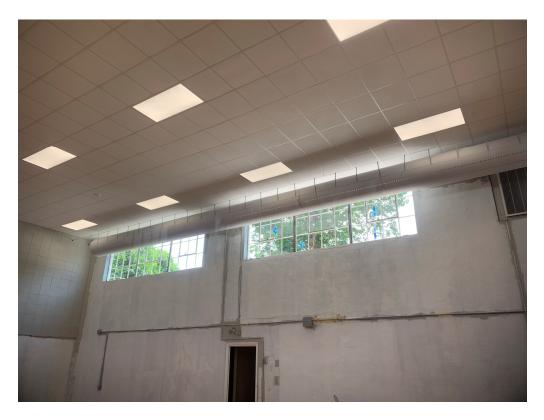
Figure 5 – Sock Duct installed at Playroom

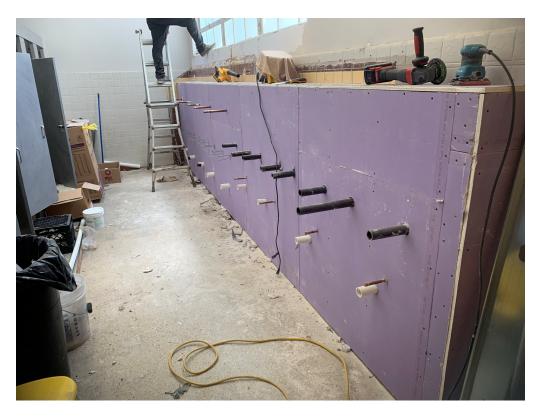
At both hallway bathrooms in the main corridor, work is moving along with drywall installers putting in panels. Floor are being prepped throughout as well, but contractor is awaiting tile to be delivered (I was

Figure 6 – Drywall Installed at Boys 30

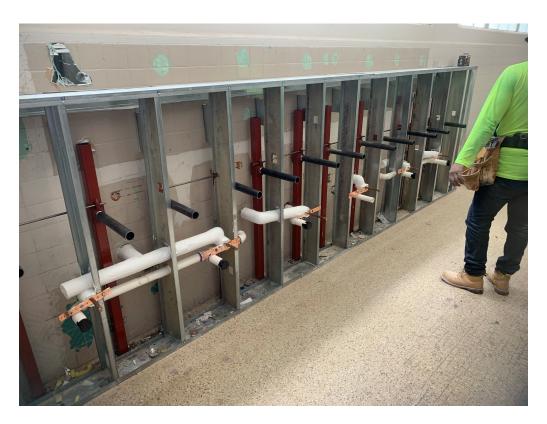
Figure 7 – Plumbing installed at Girls 29

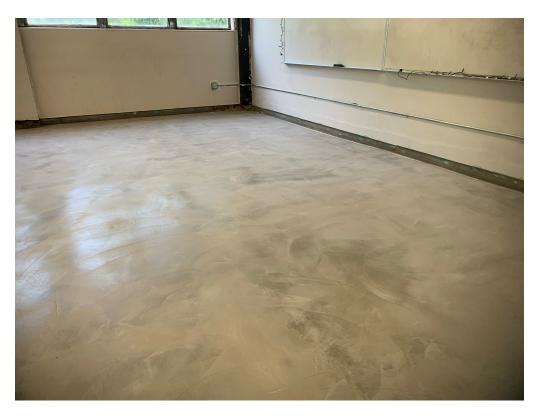
Figure 8 – Floor prep at classroom 24
