01 July 2021

18045-BOW Bowmar Elementary / Report Number 033

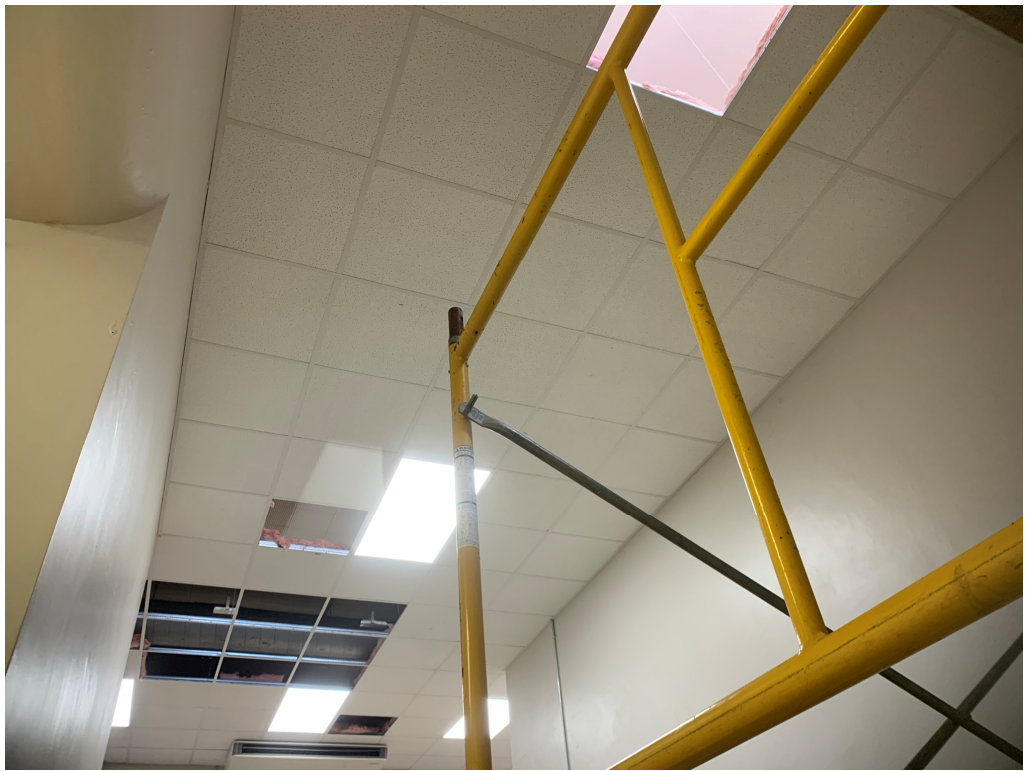
Figure 1 – ACT Installation at 2nd Floor

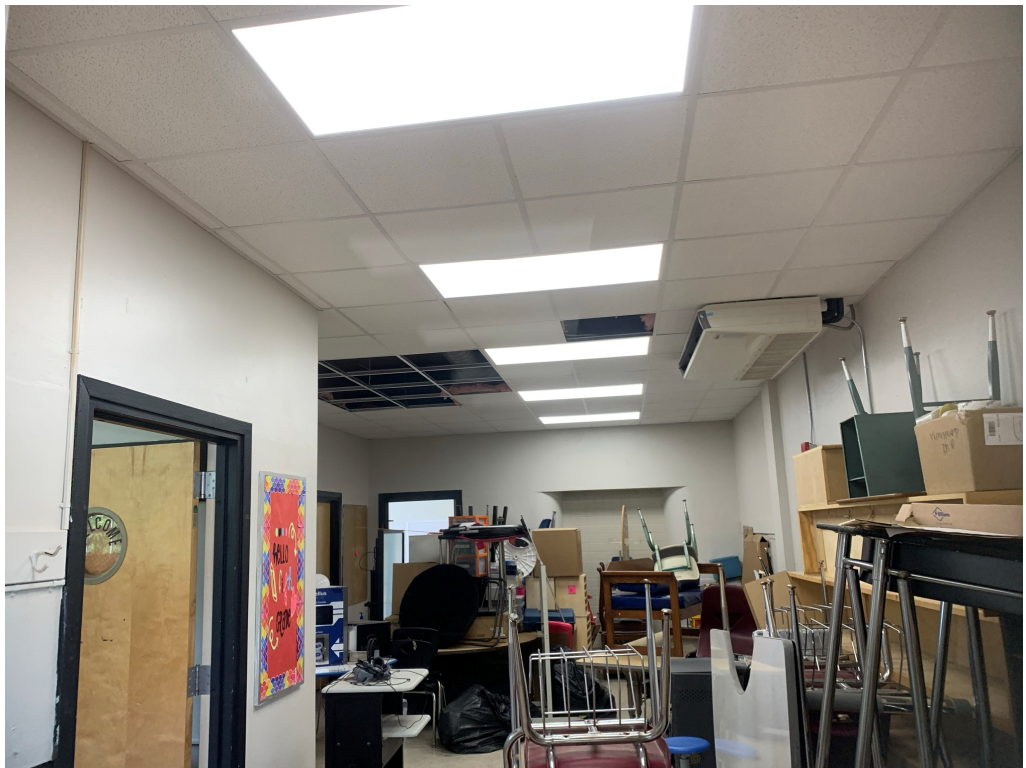
Figure 2 – ACT Installation at 2nd Floor

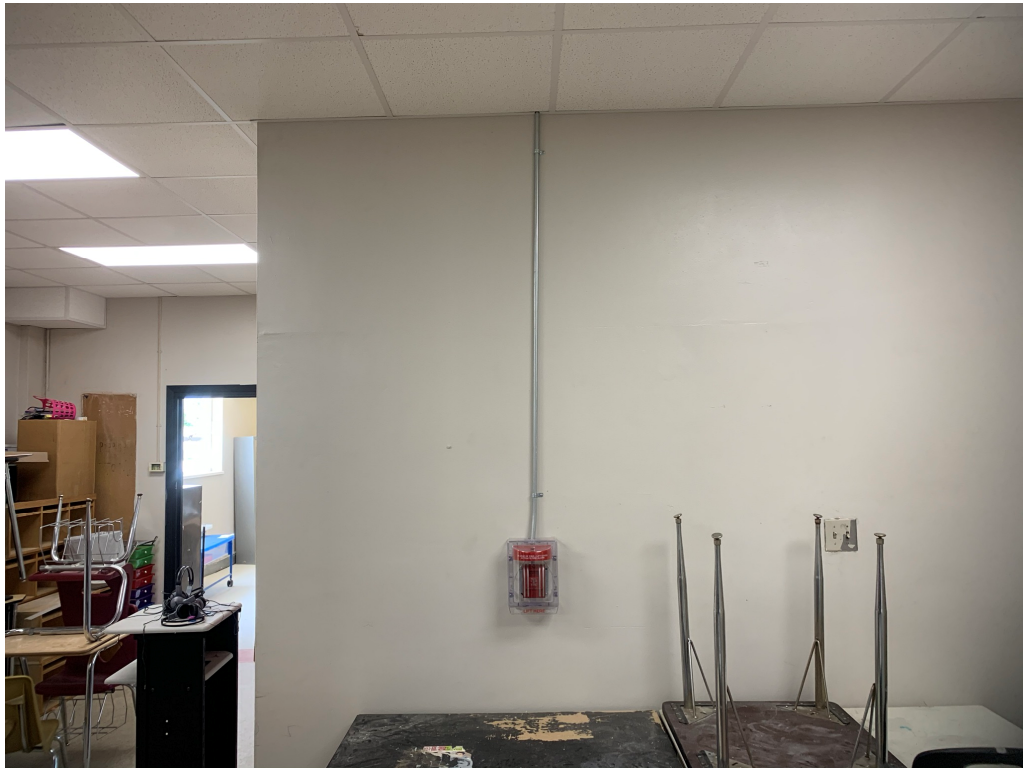
Figure 3 – This Conduit needs to be Straightened

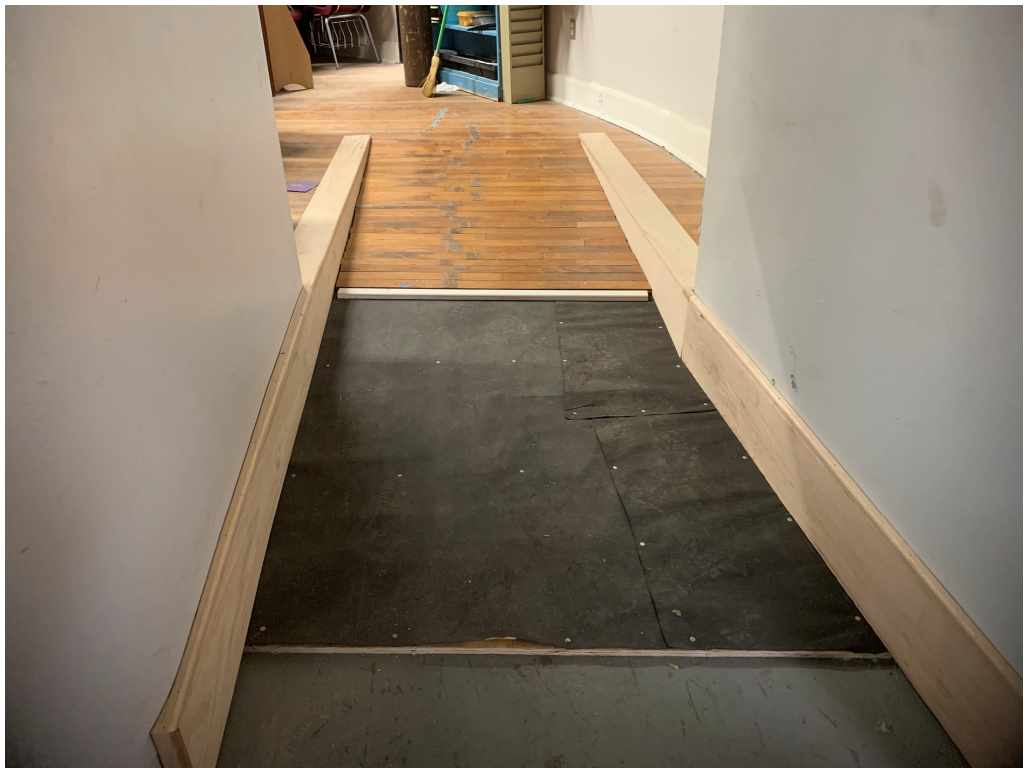
Figure 4 – ADA ramp Installation Progress

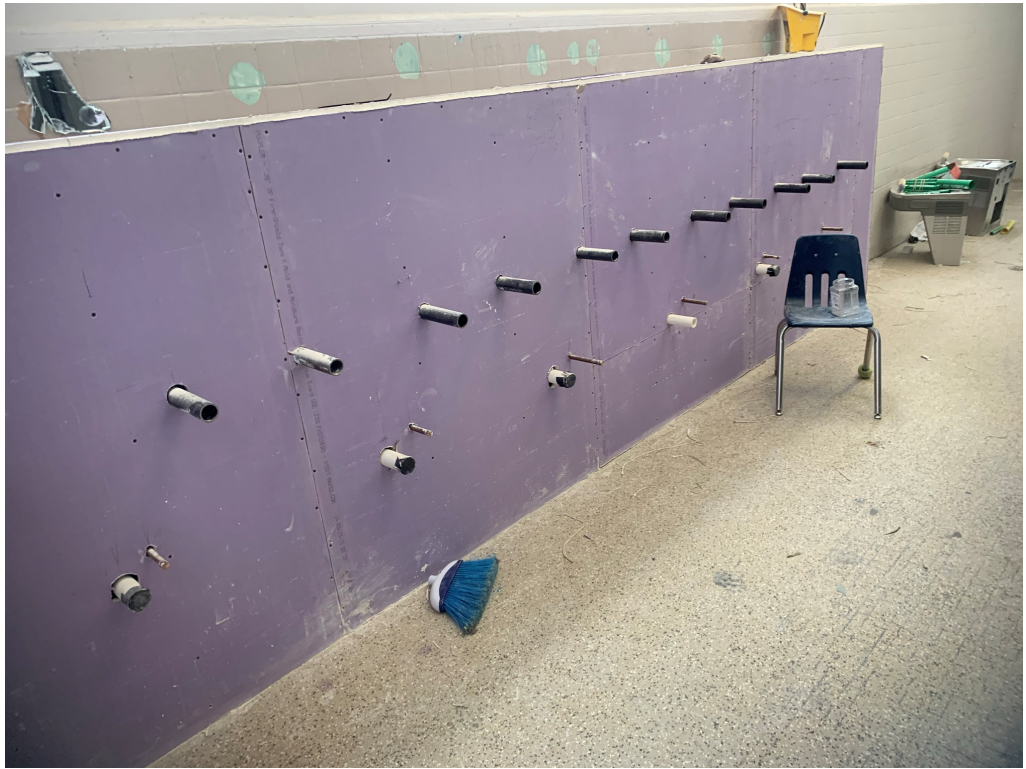
Figure 5 – Drywall Installed at Carrier Wall

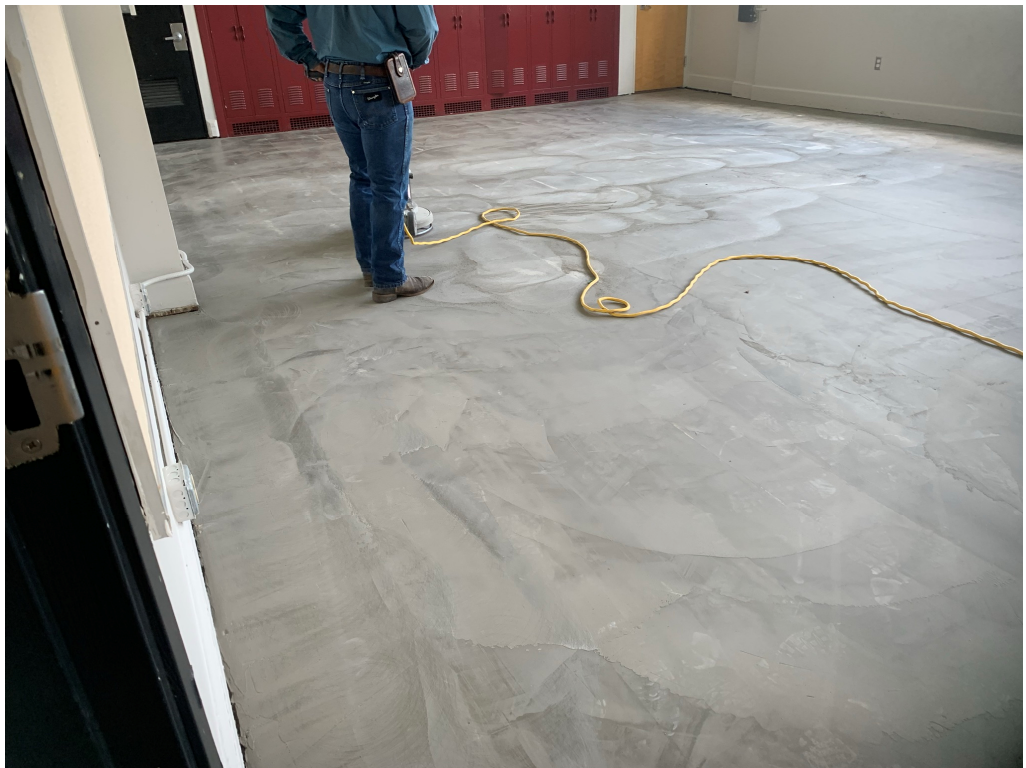
Figure 6 – Floor Prep

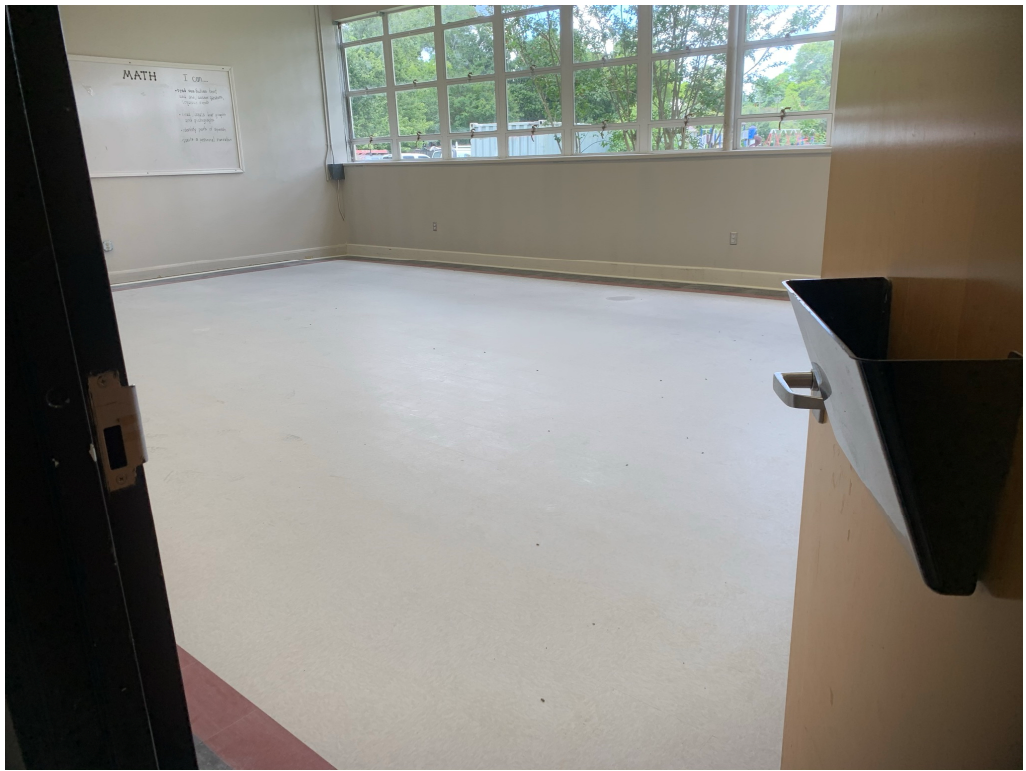
Figure 7 – VCT Installation is Ongoing

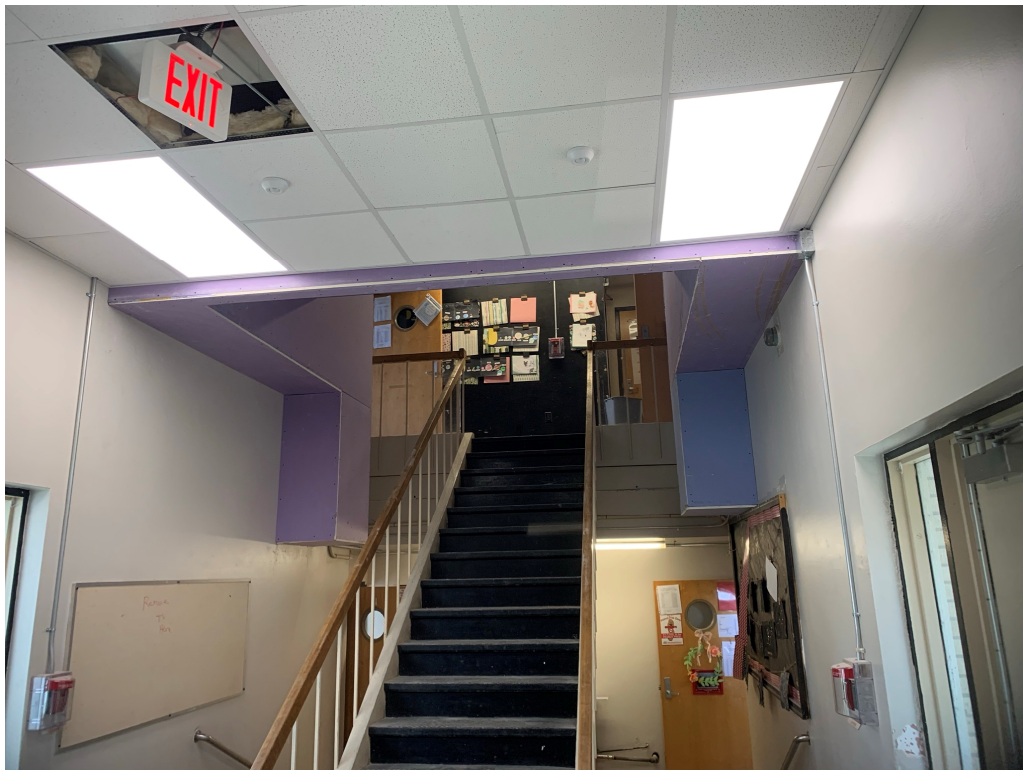
Figure 8 – Drywall Installed at Ducting

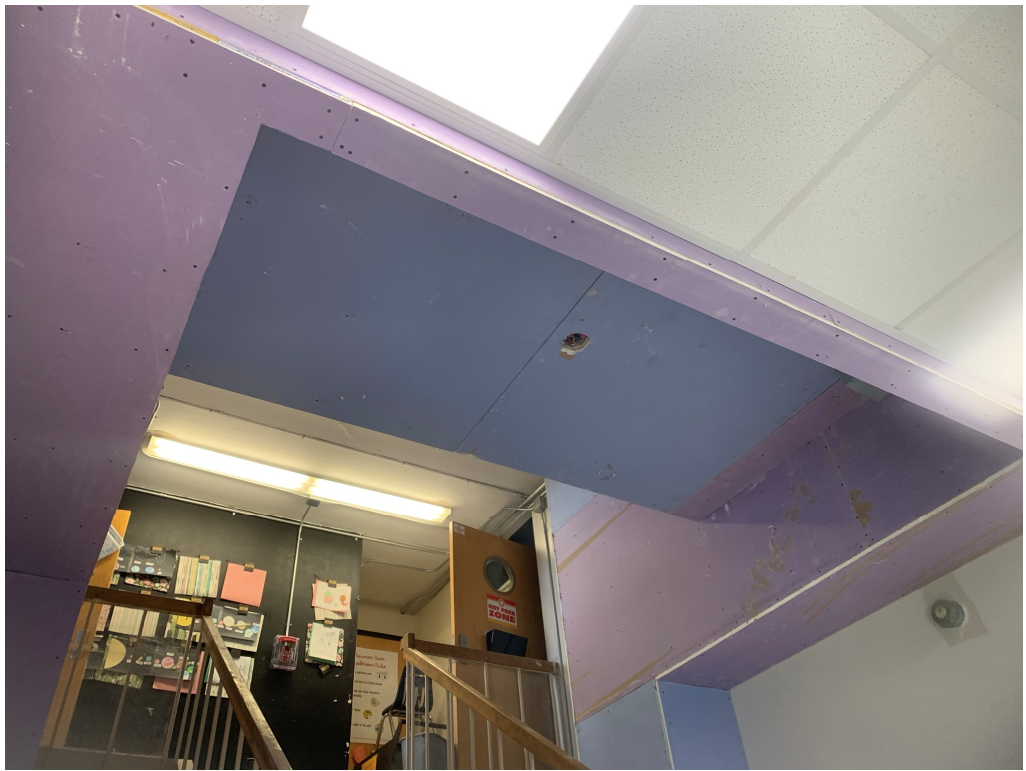
Figure 9 – Drywall Installed at Ducting

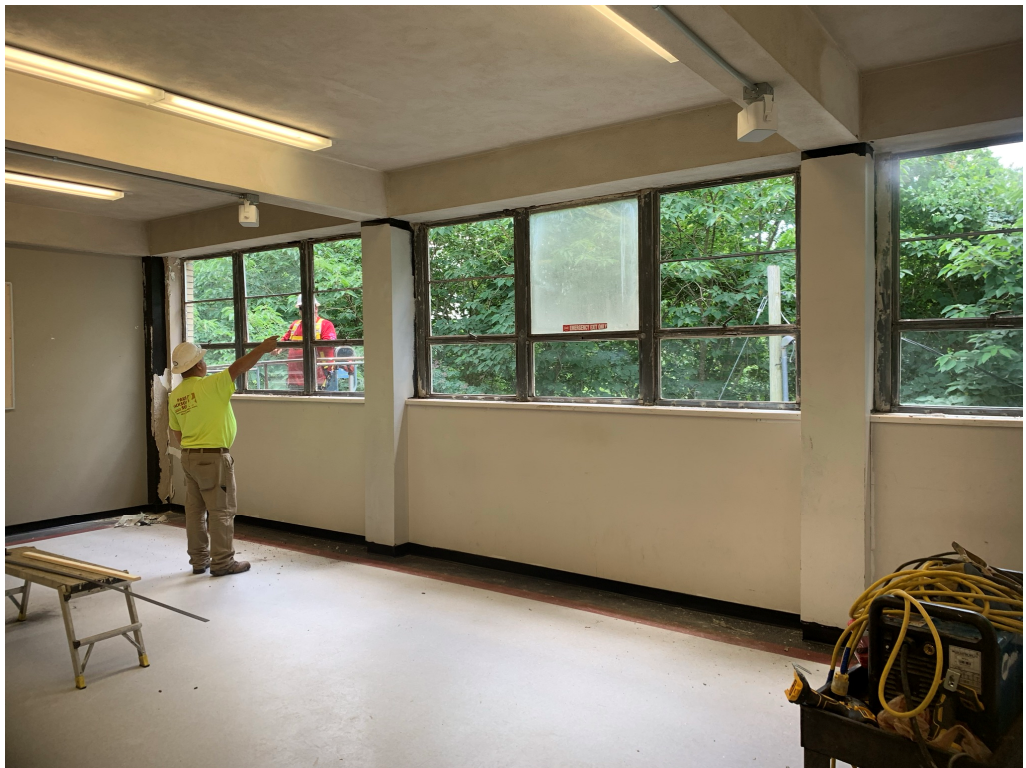
Figure 10 – Window Restoration in Progress
