14 July 2021

18045-BOW Bowmar Elementary / Report Number 034

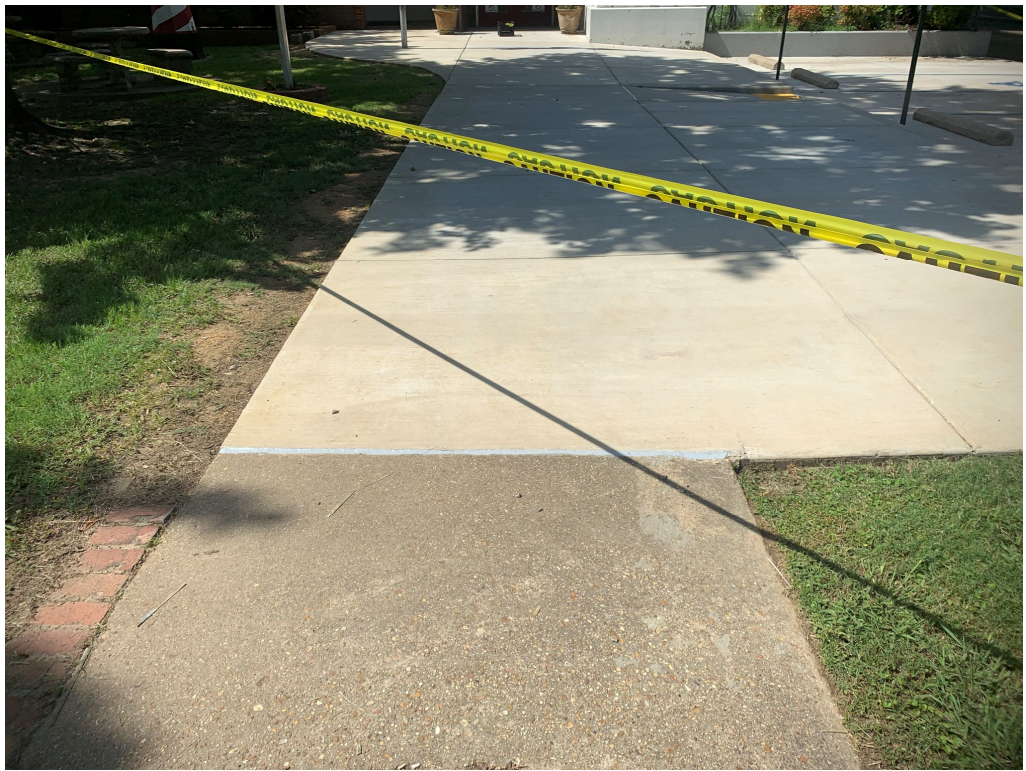
Figure 1 – Caulking at New Concrete

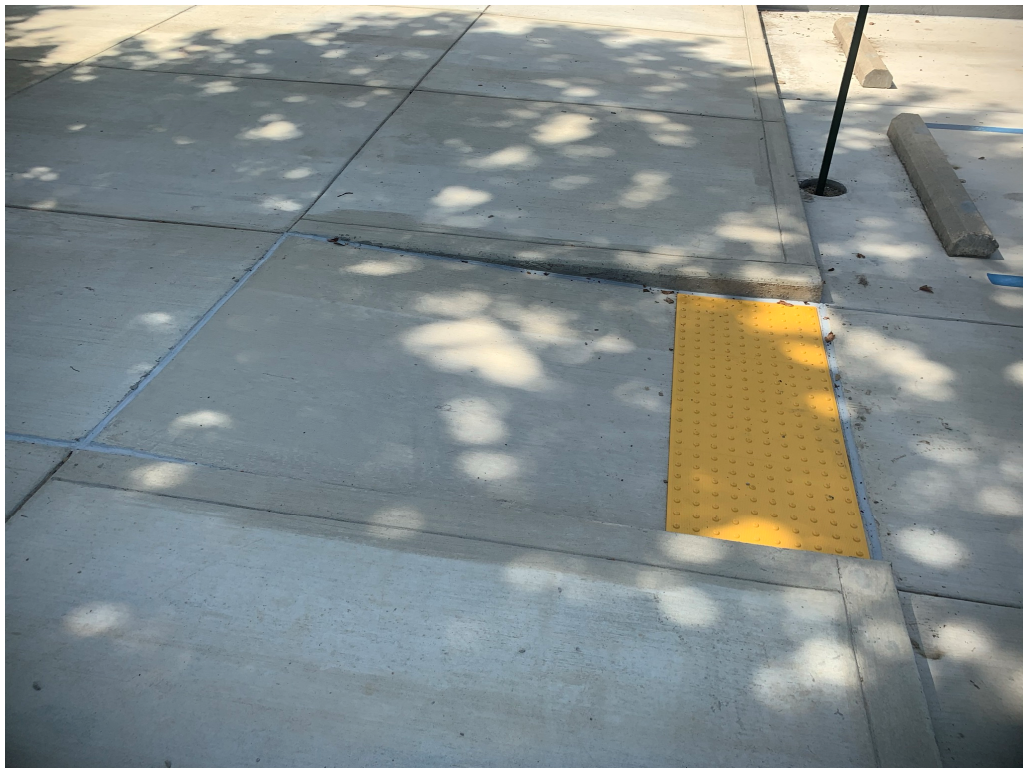
Figure 2 – Caulking at New Concrete

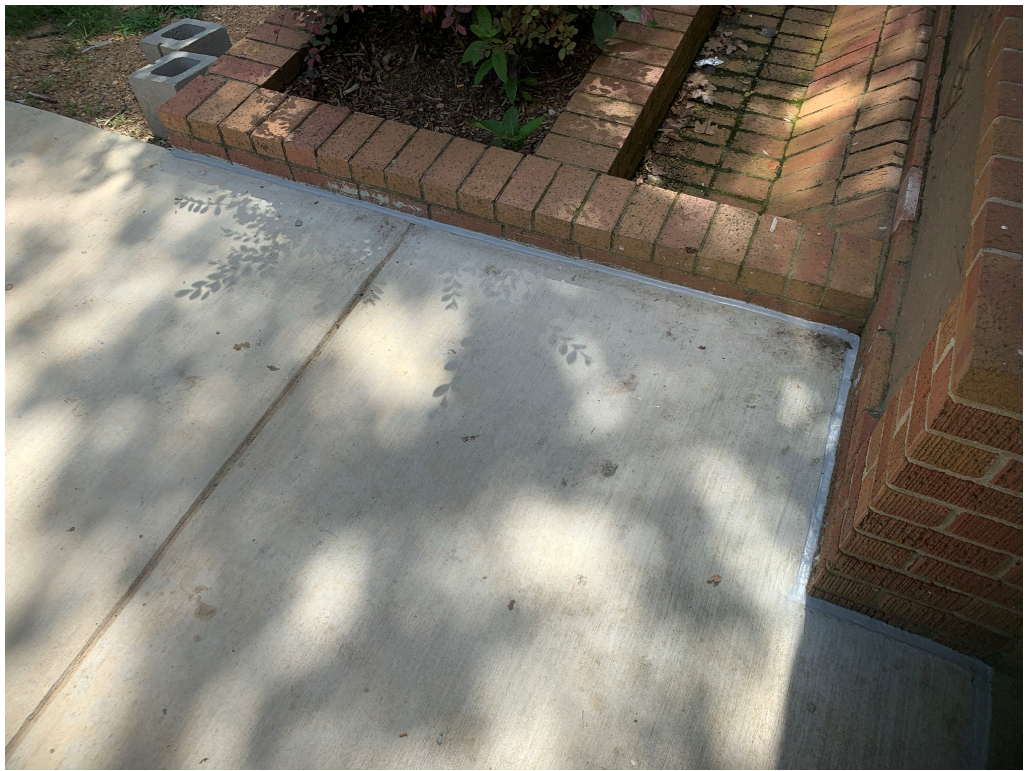
Figure 3 – Caulking at New Concrete

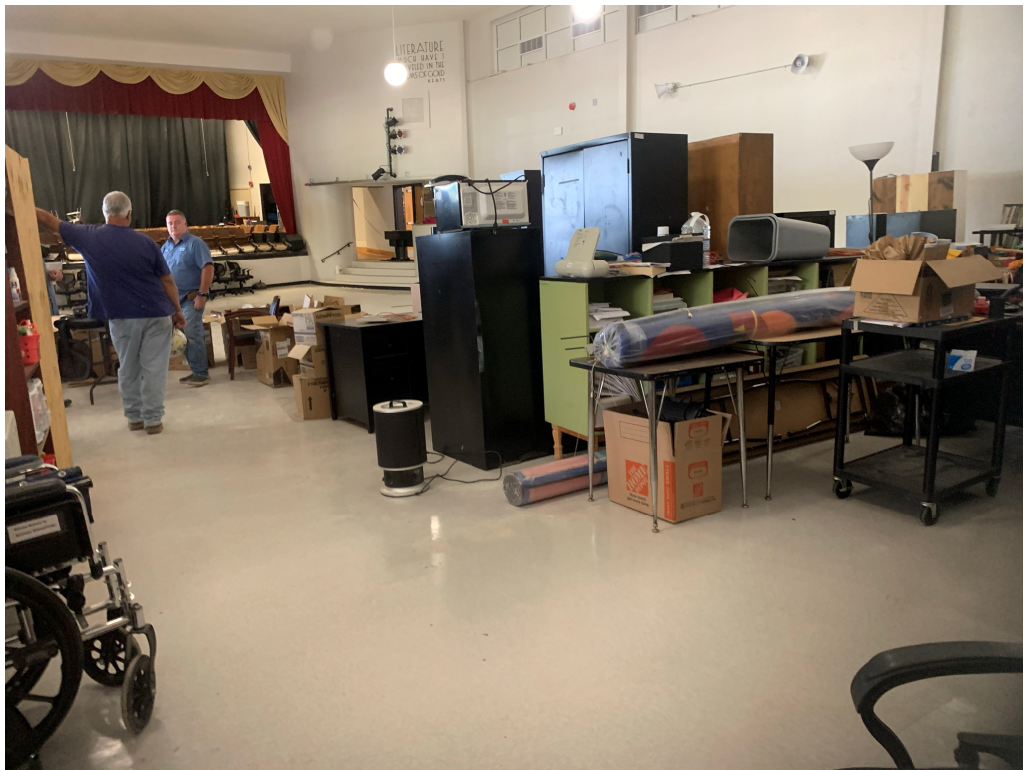
Figure 4 – Auditorium is Being Used for Storage

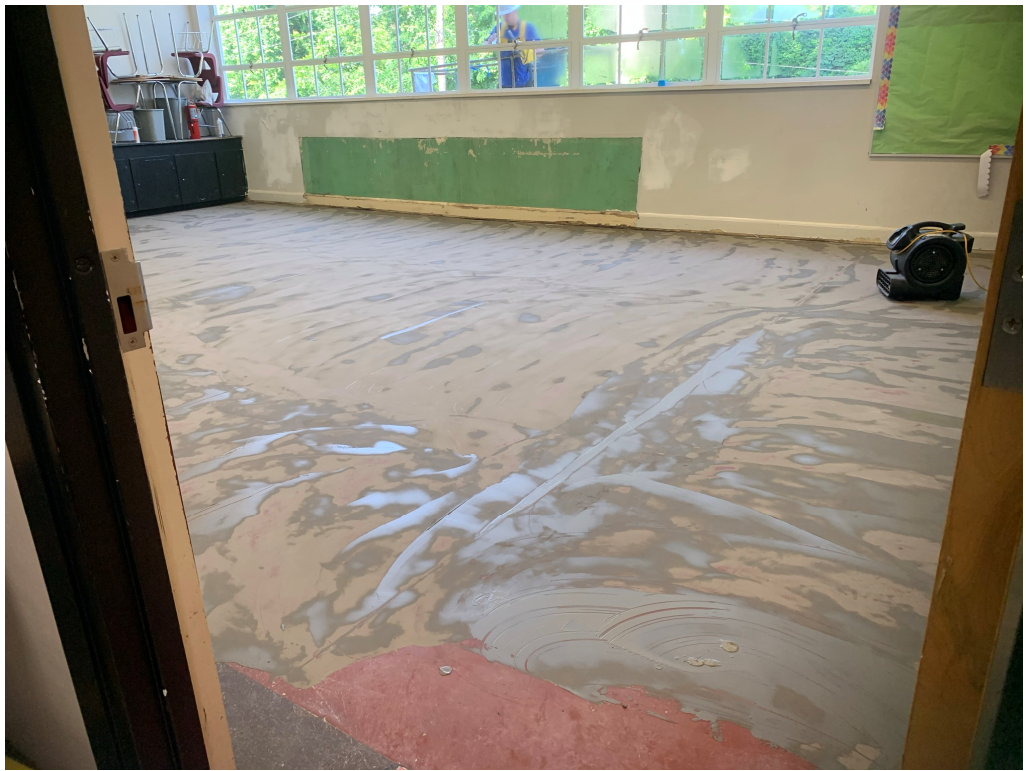
Figure 5 – Floor Prep at Laminate Floor @ 2<sup>nd</sup> Floor

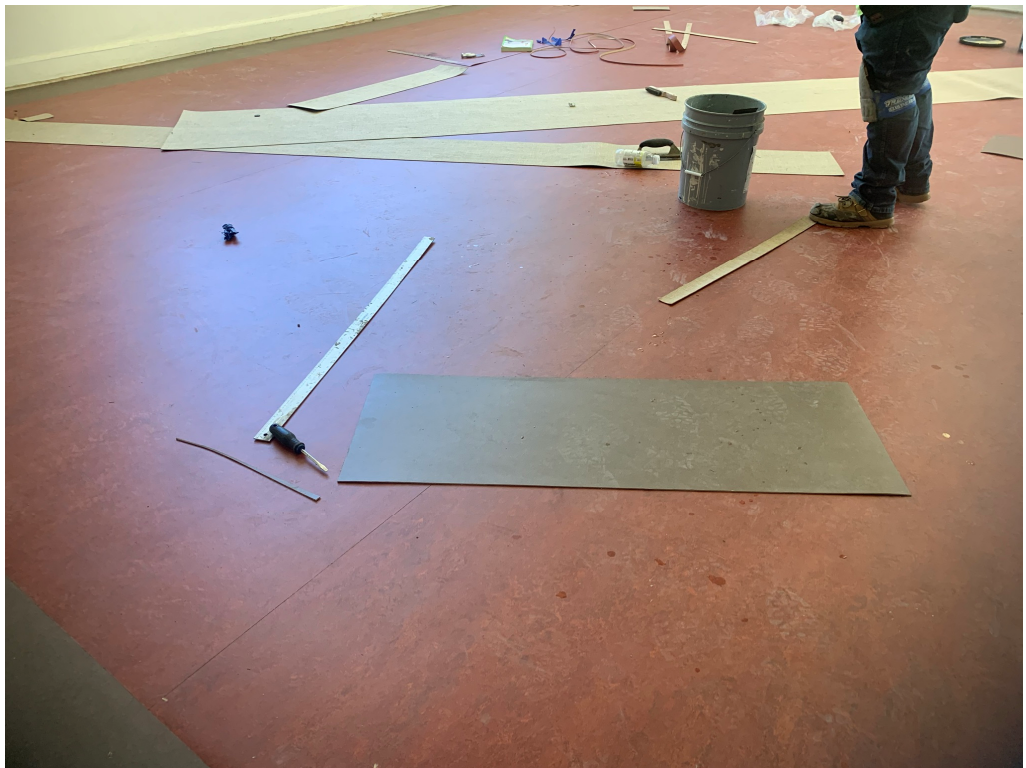
Figure 6 – Linoleum Floor Installation is Ongoing

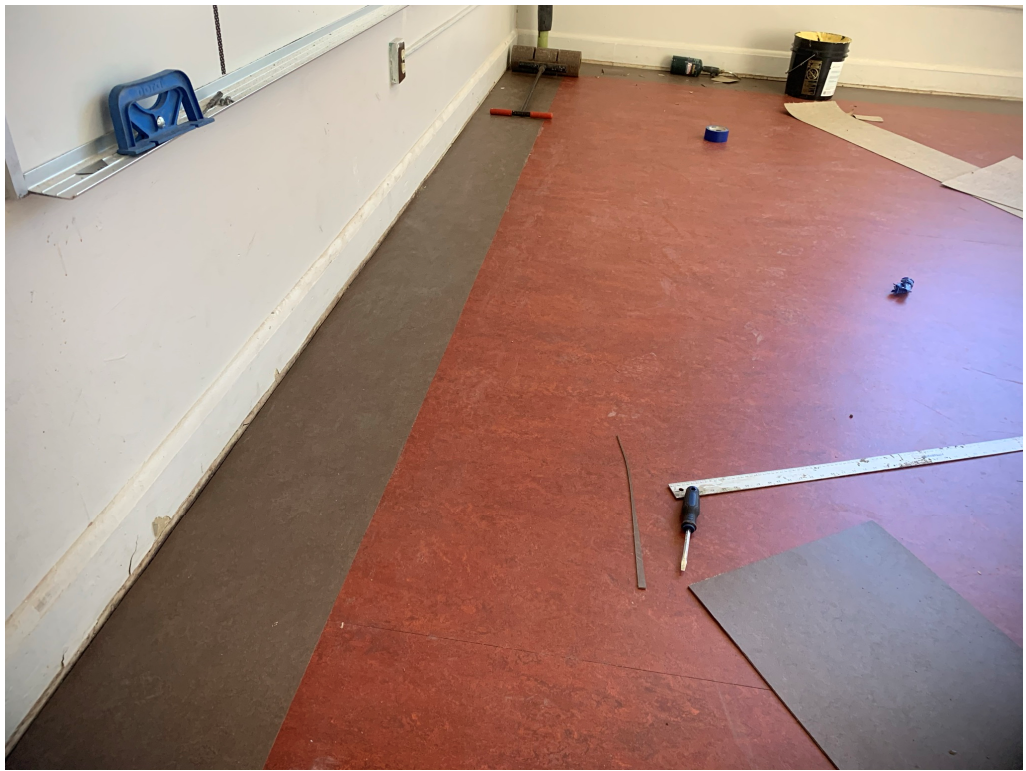
Figure 7 – New Linoleum Floor @ 2nd Floor

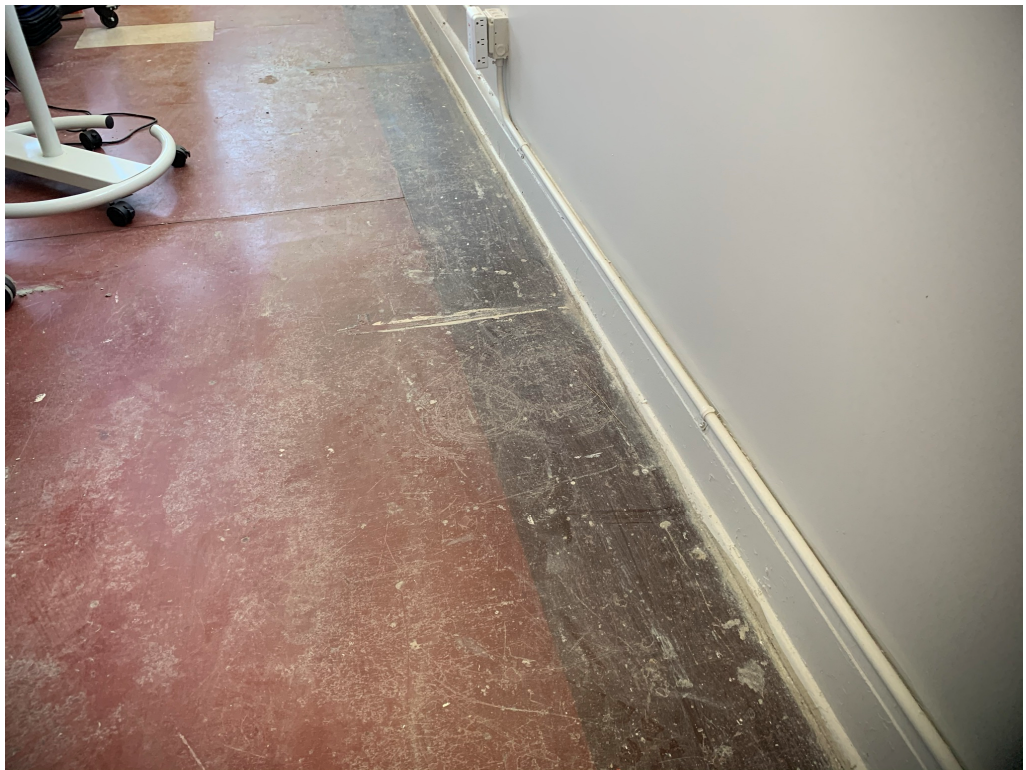
Figure 8 – Existing Floor Condition @ 2<sup>nd</sup> Floor

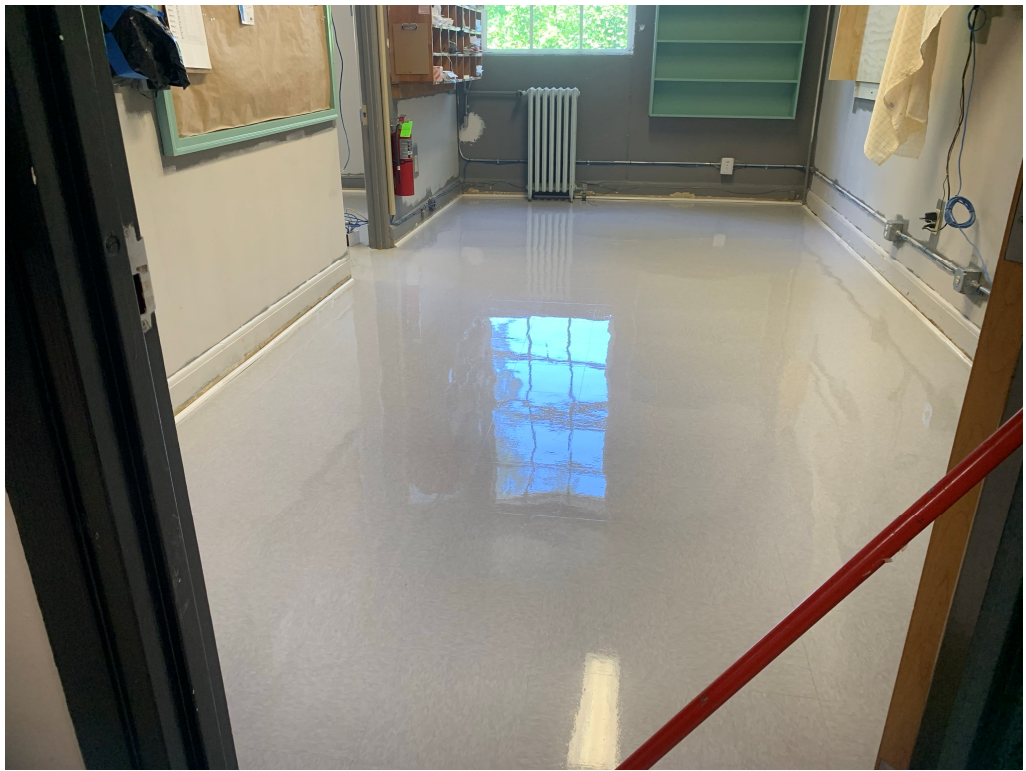
Figure 9 – Floor Wax Installation is Ongoing in Some Rooms

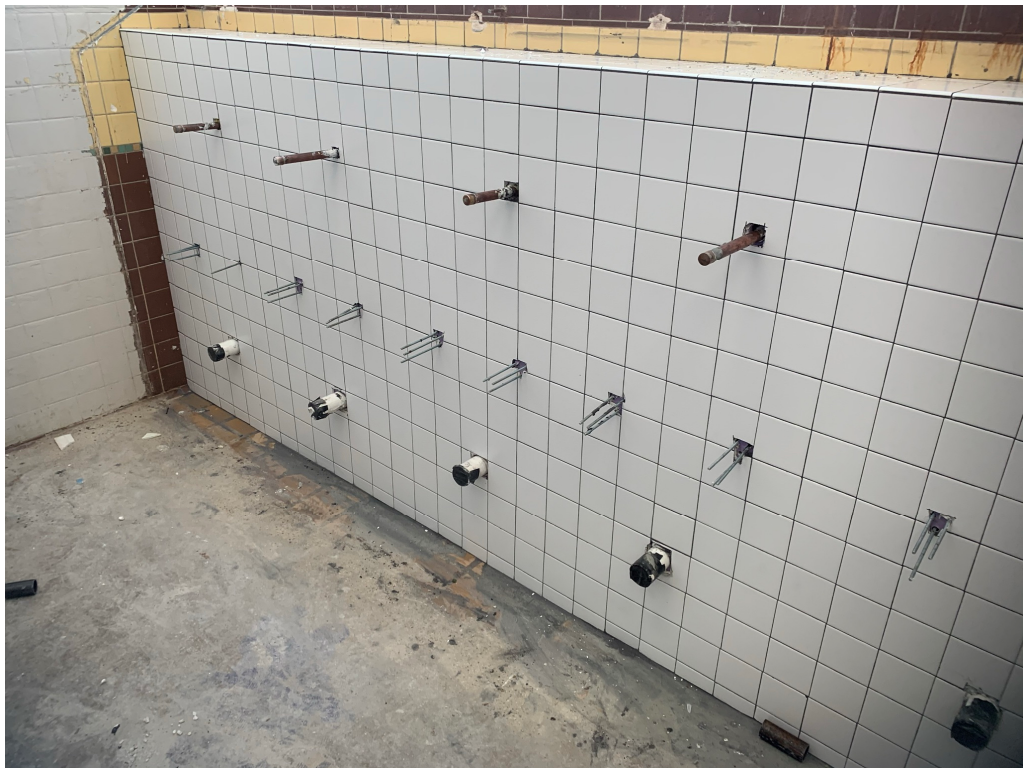
Figure 10 – Tiled wall at Boys Room

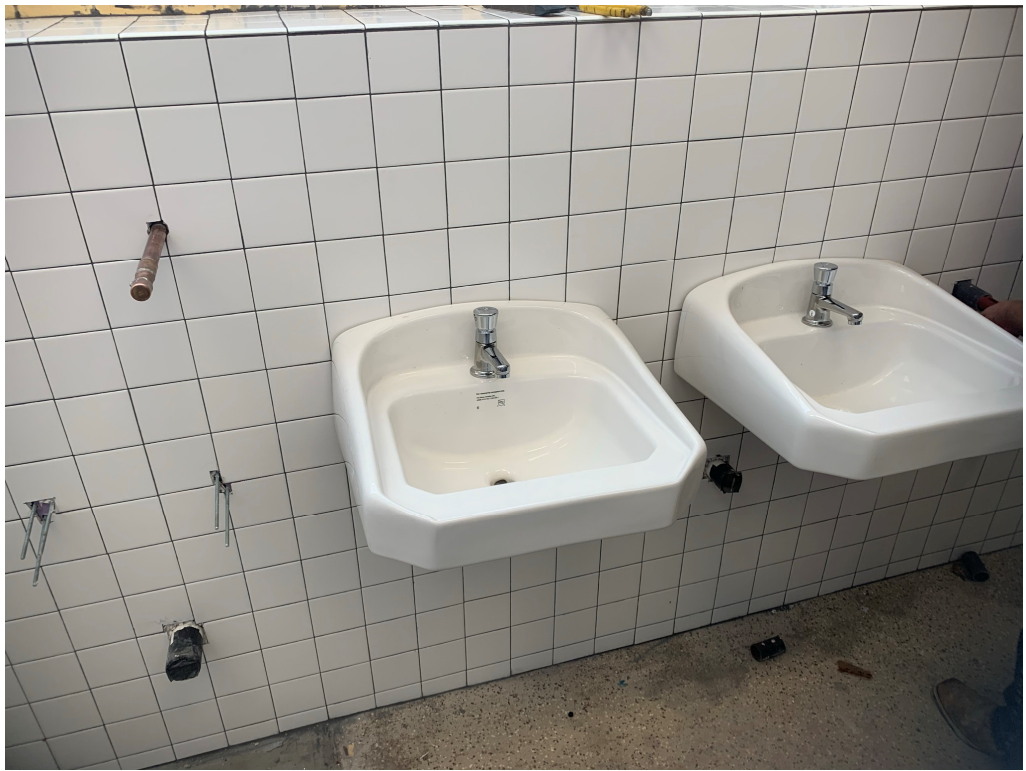
Figure 11 – Sink on left in Boys is Crooked and Requires Adjustment

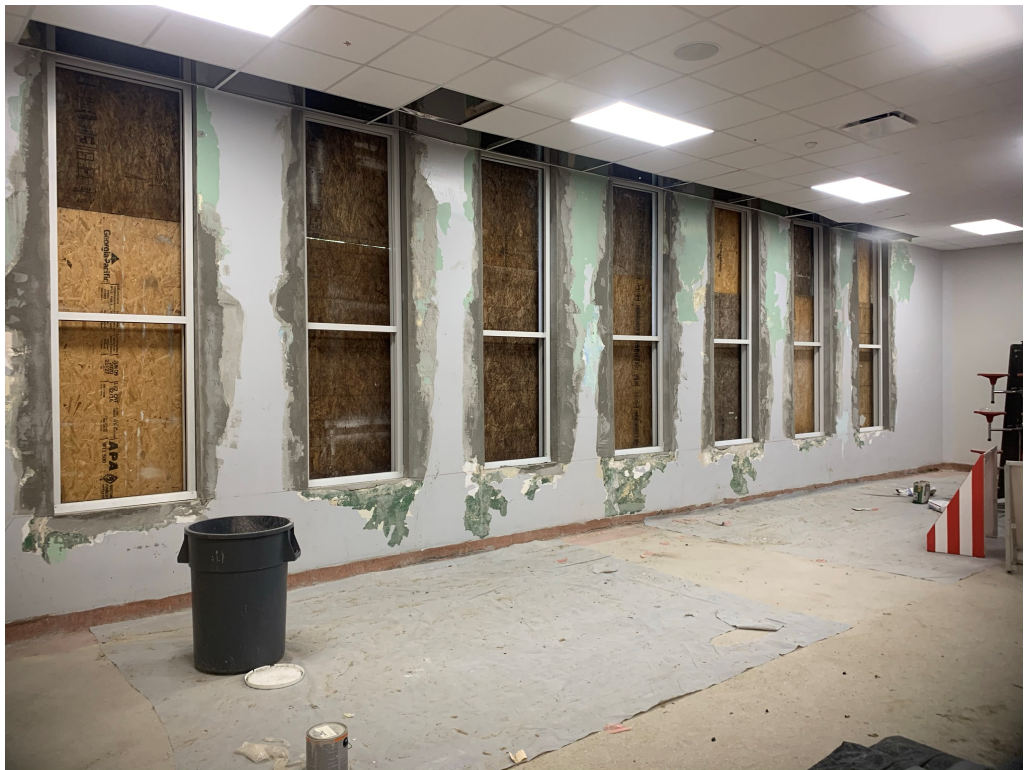
Figure 12 – Window Progress at Cafeteria Wall

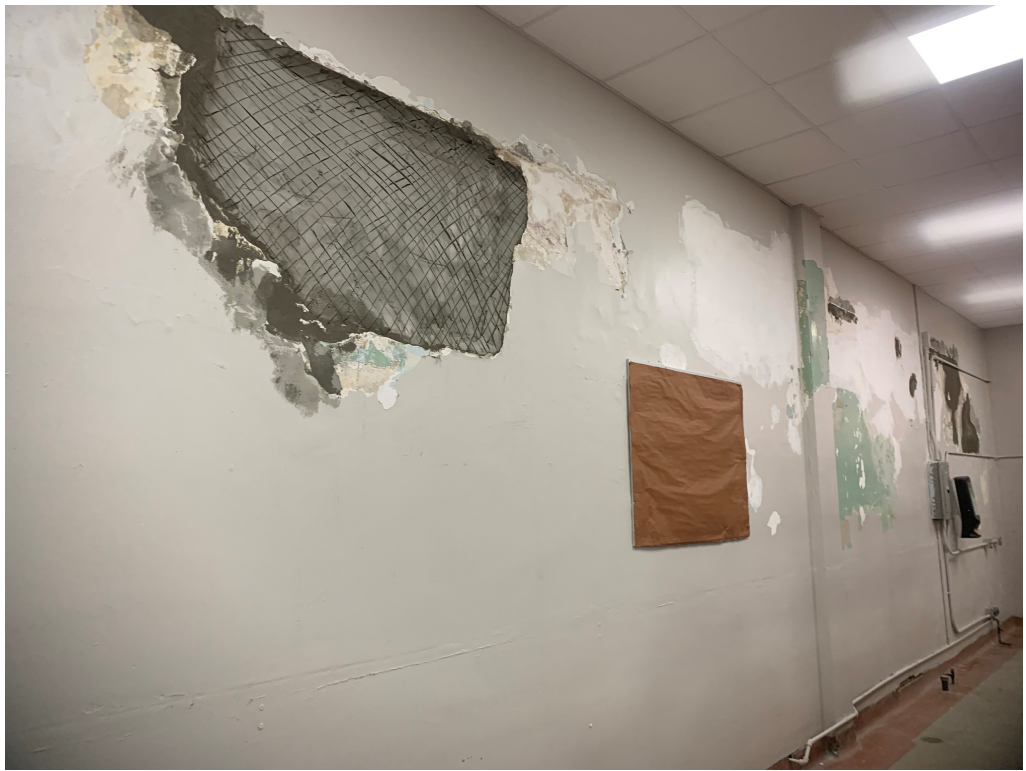
Figure 13 – Wall Patch and Repair in Cafeteria

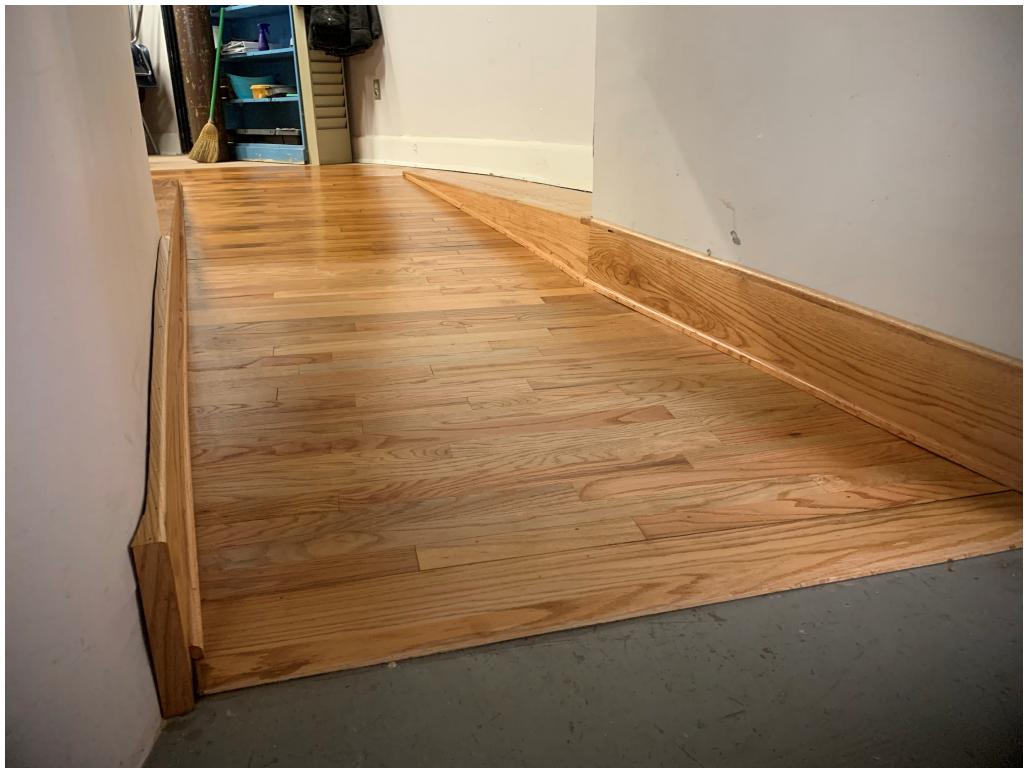
Figure 14 – New ADA ramps installed and Wood Finished

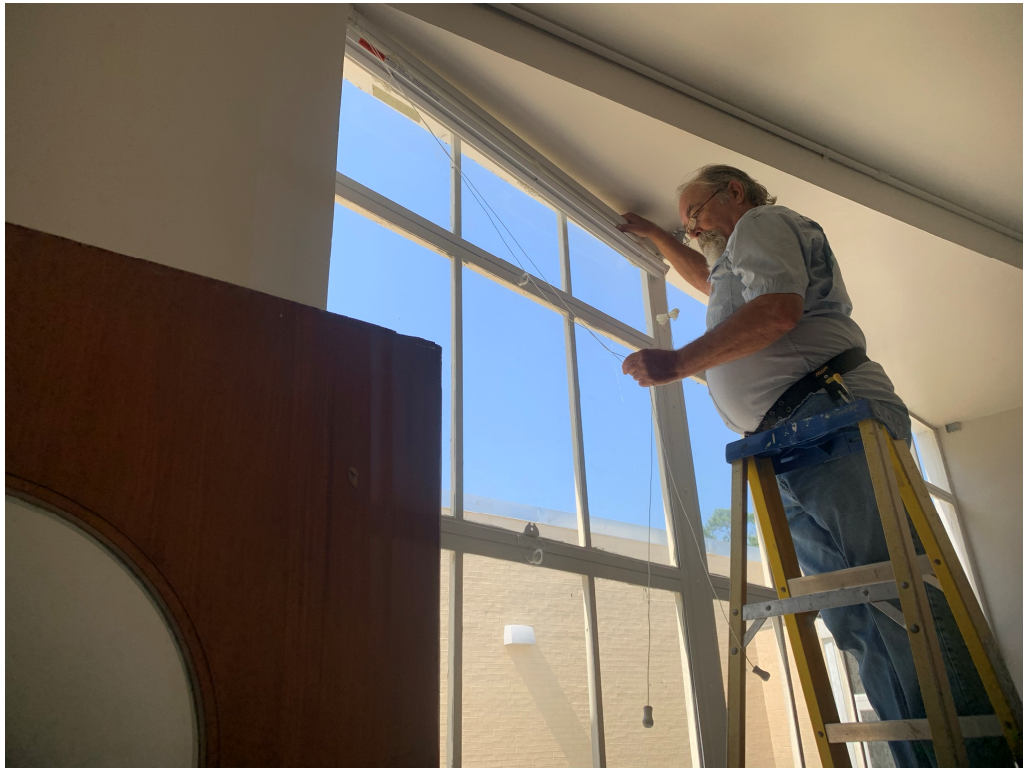
Figure 15 – Blind Installation is Ongoing

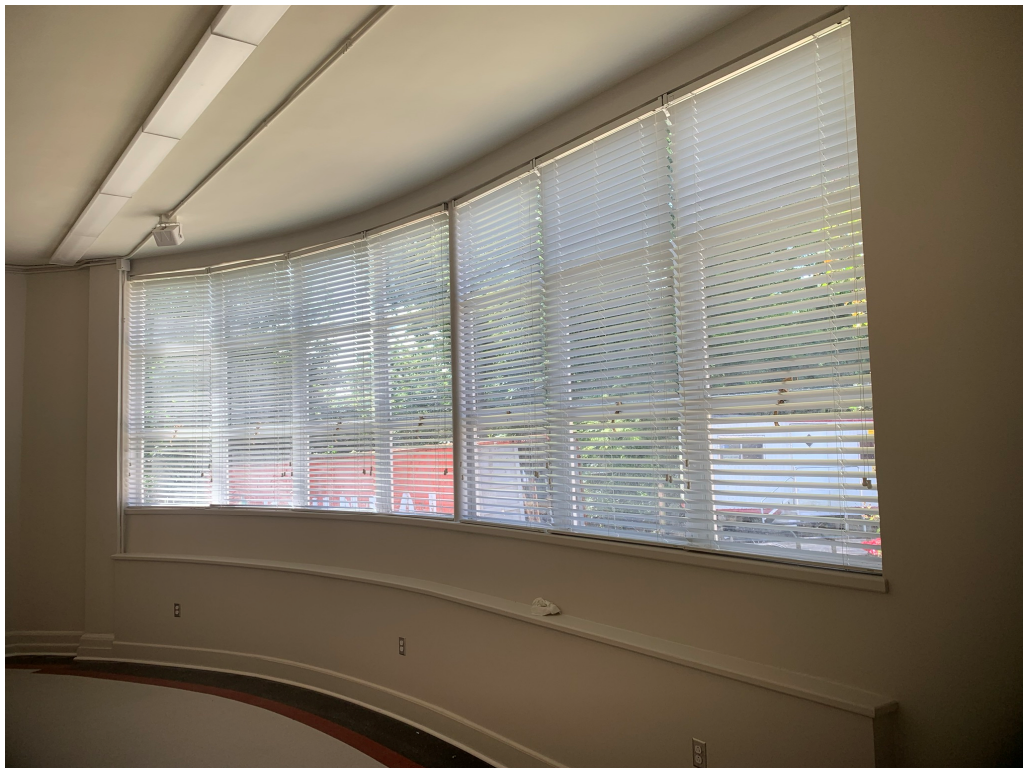
Figure 16 – Blinds Installed

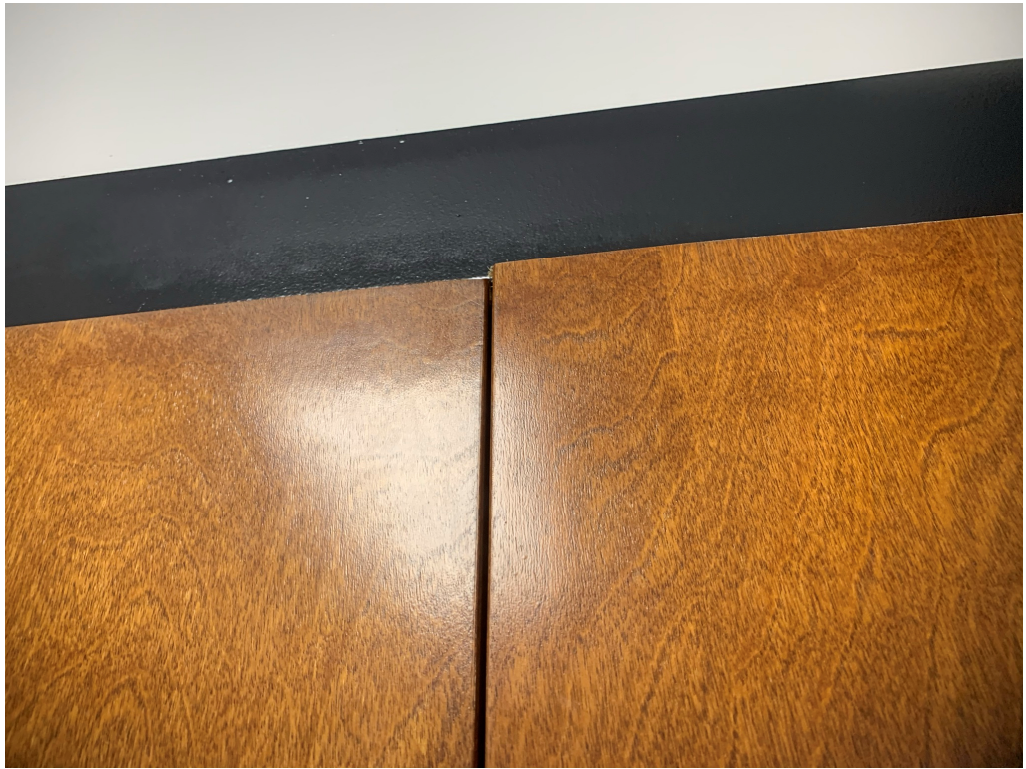
Figure 17 – Doors Require Adjustment; Also stationary leaf requires flush bolt

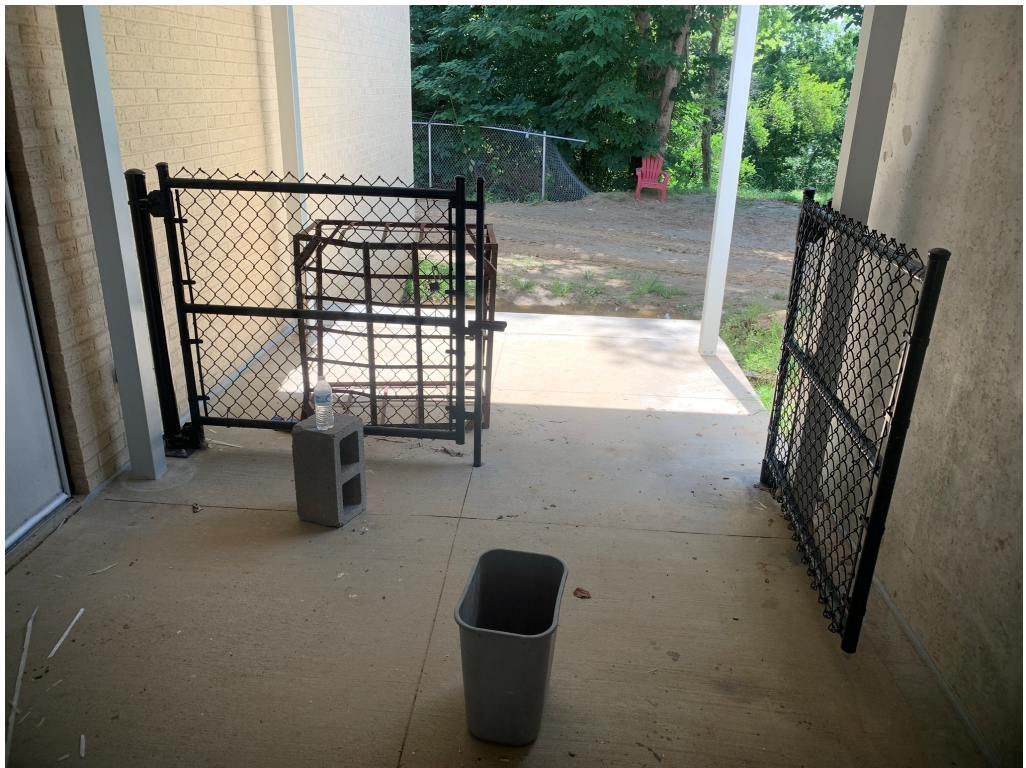
Figure 18 – Gates Installed at Breezeway
