30 September 2021

18045-BOW Bowmar Elementary / Report Number 035

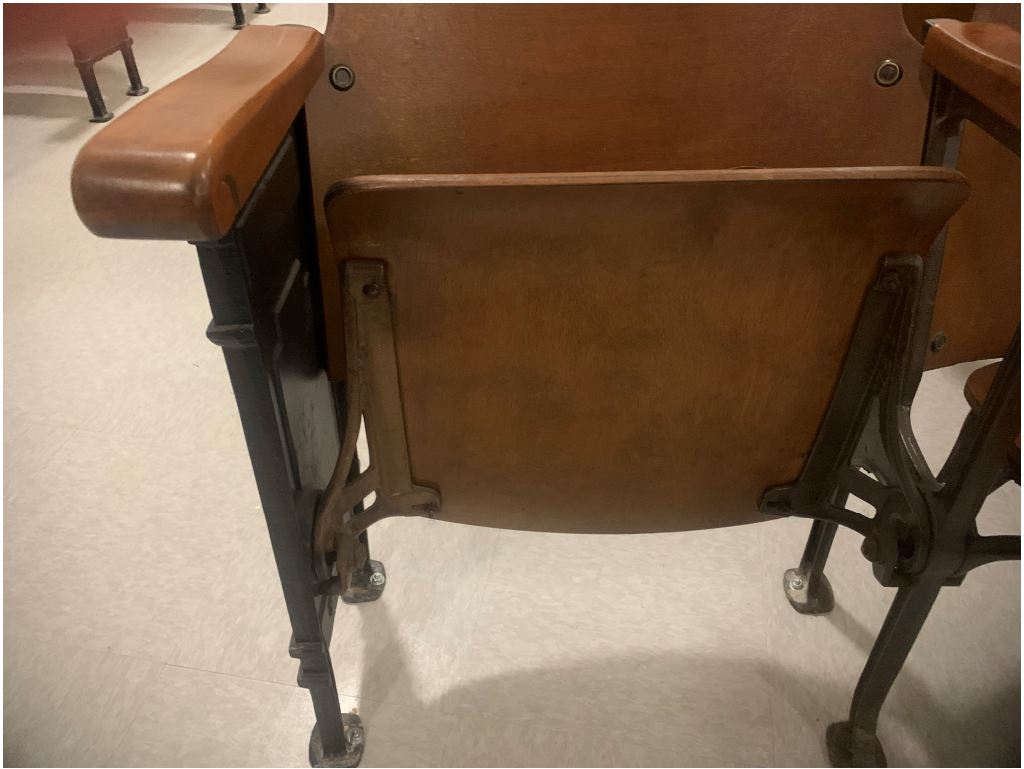
Figure 1 – End pieces at every chair are unfinished

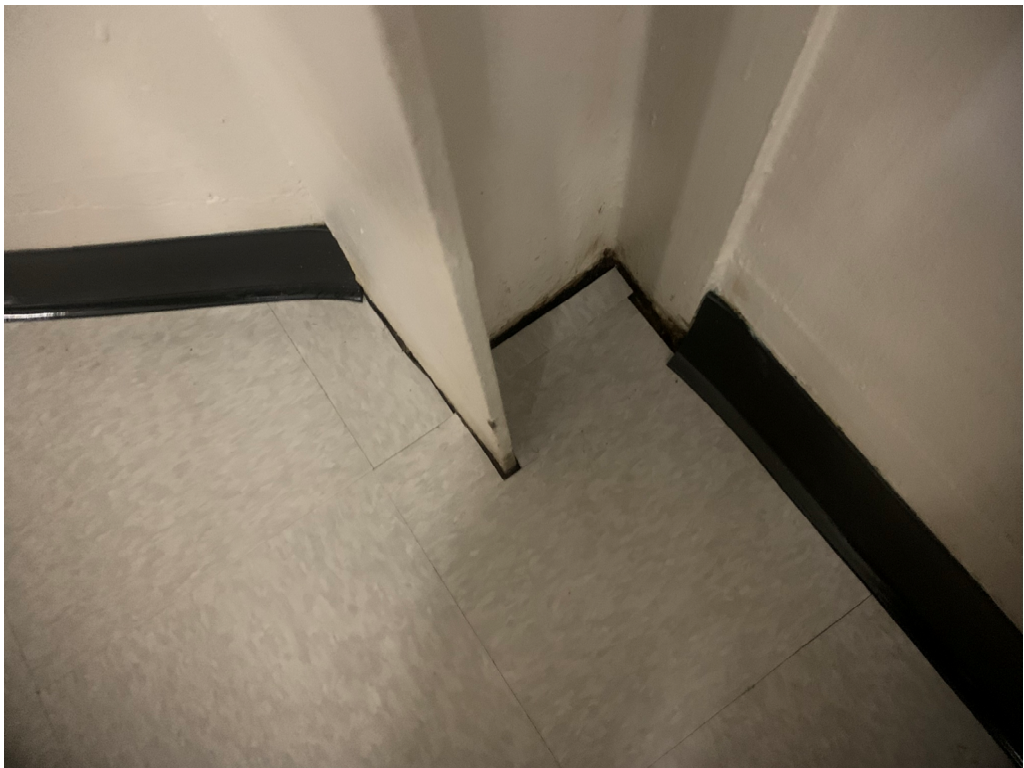
Figure 2 – Fill in around columns with similar color mastic for finished look

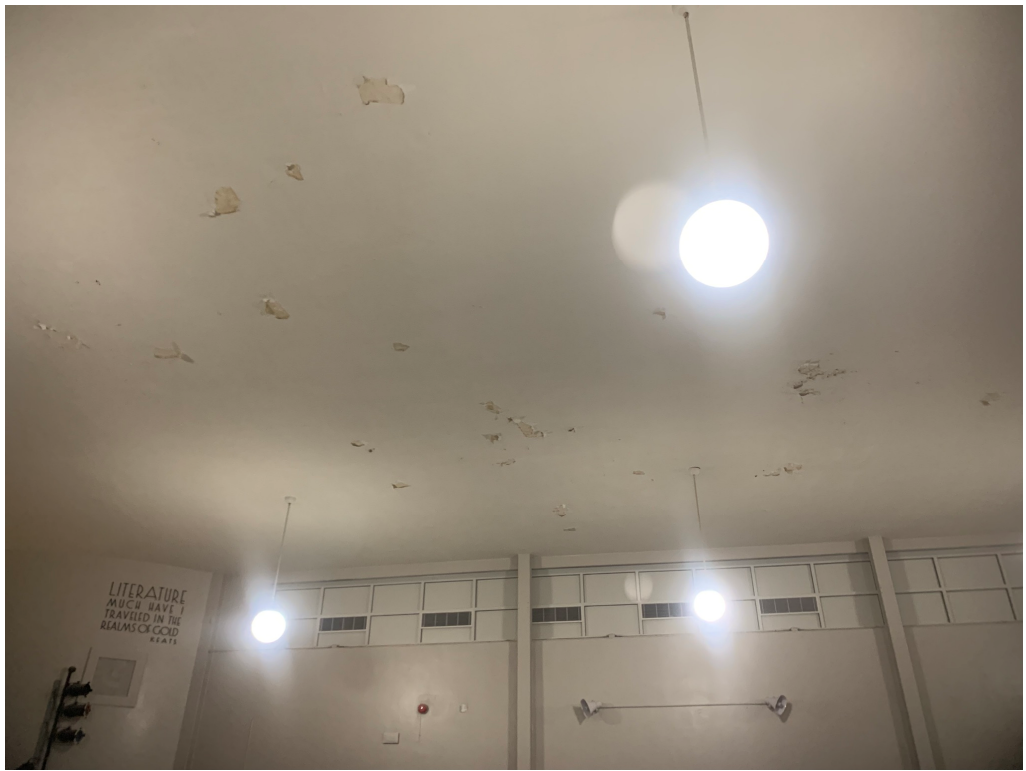
Figure 3 – Unfinished Ceiling

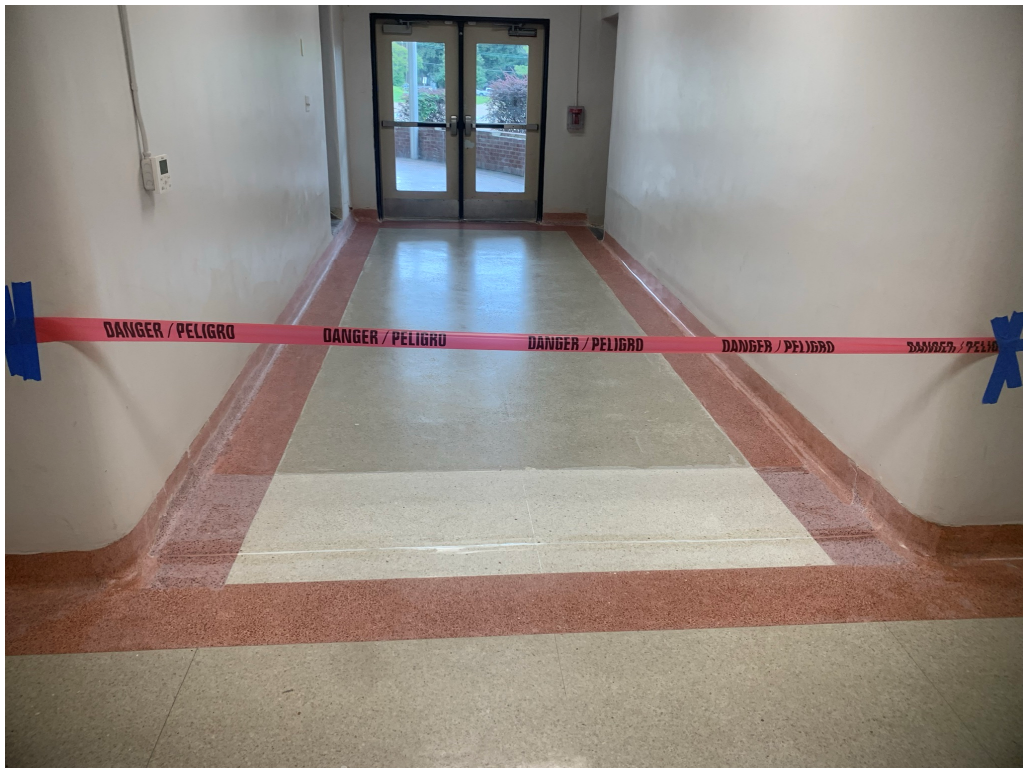
Figure 4 – Terrazzo repair is ongoing

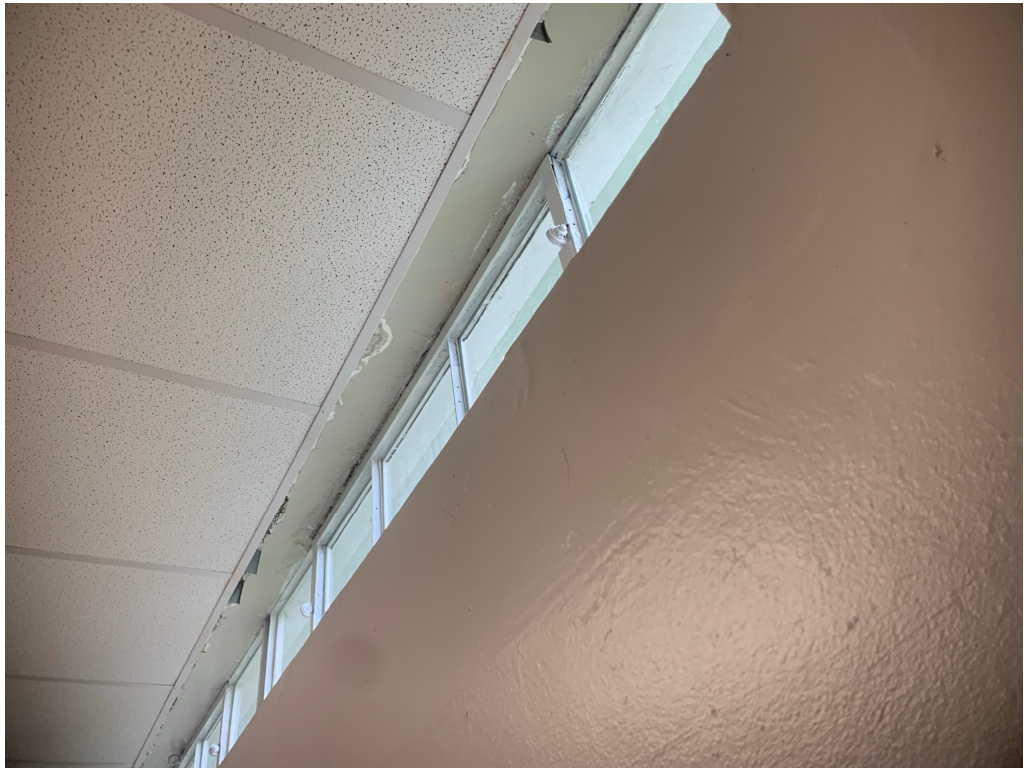
Figure 5 – Unfinished Ceiling

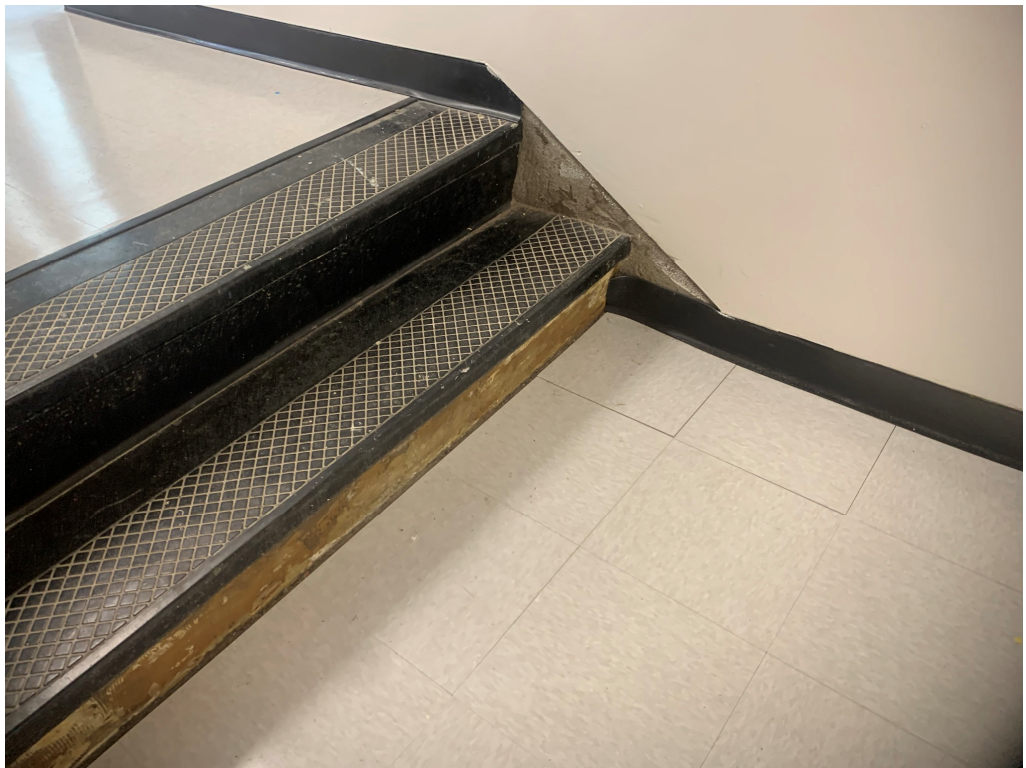
Figure 6 – Rubber base missing at stair and wall

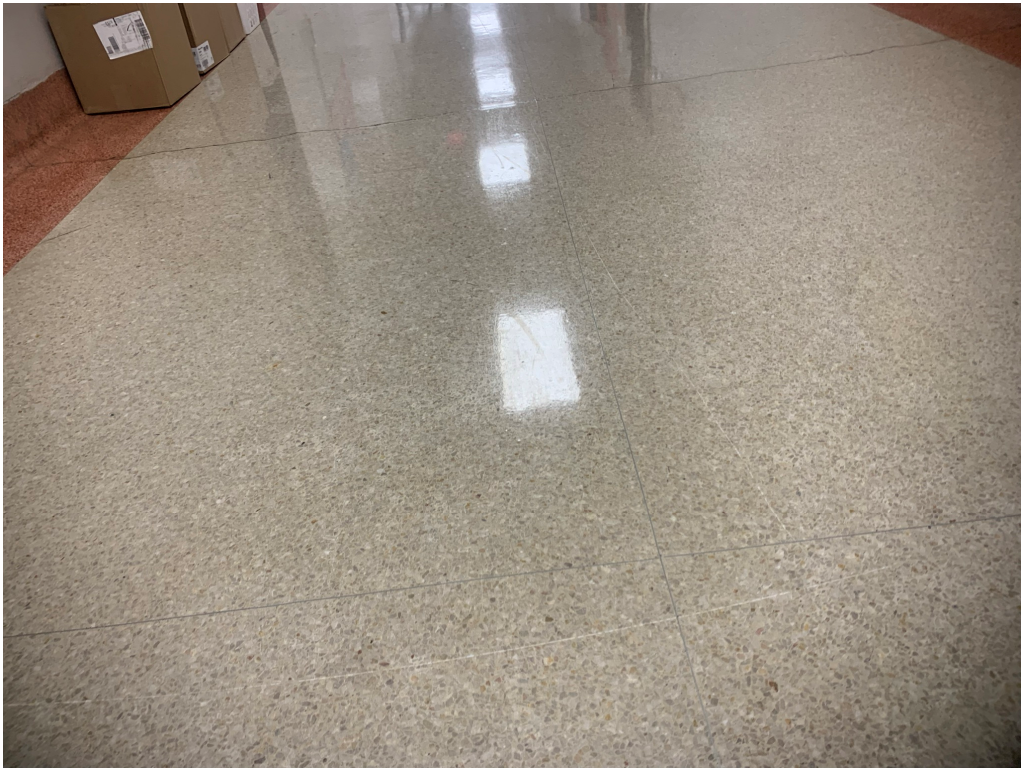
Figure 7 – Scarring below wax level from construction work needs to be buffed out

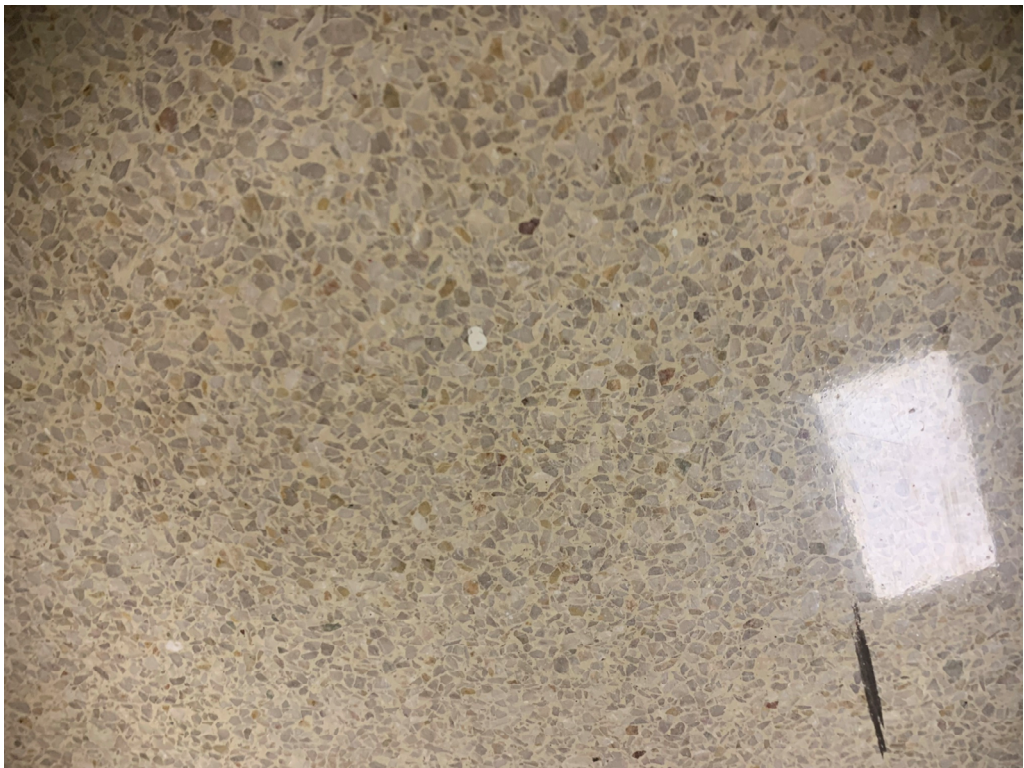
Figure 8 – Paint dripped down main hall below wax

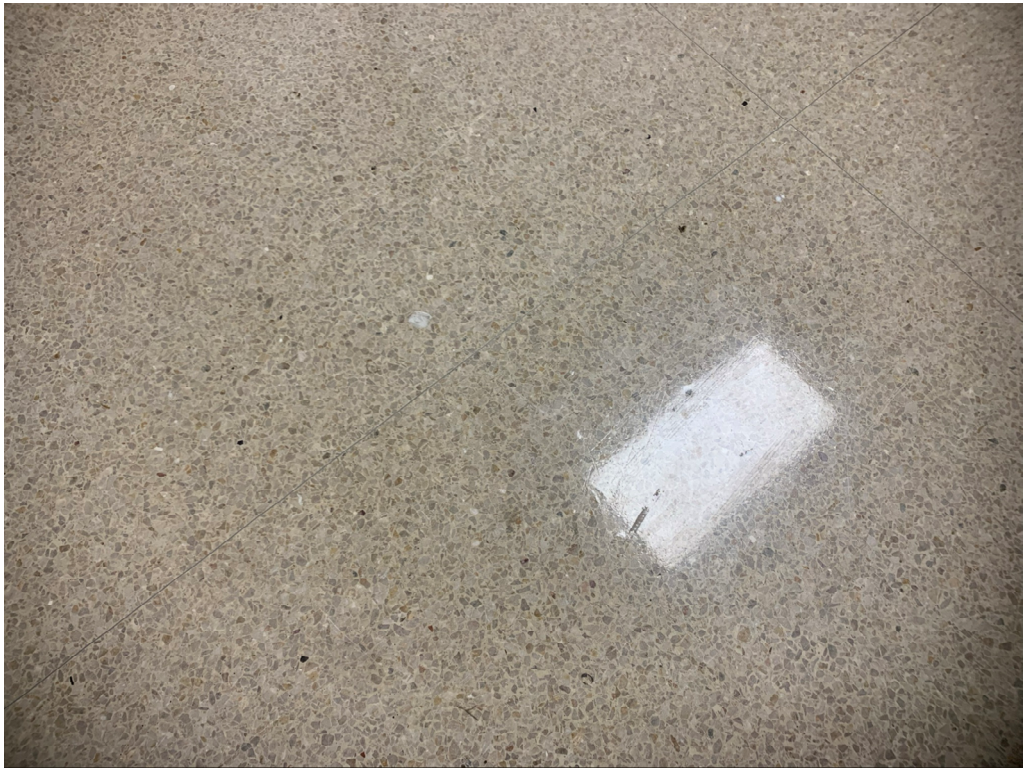
Figure 9 – Paint dripped down main hall below wax

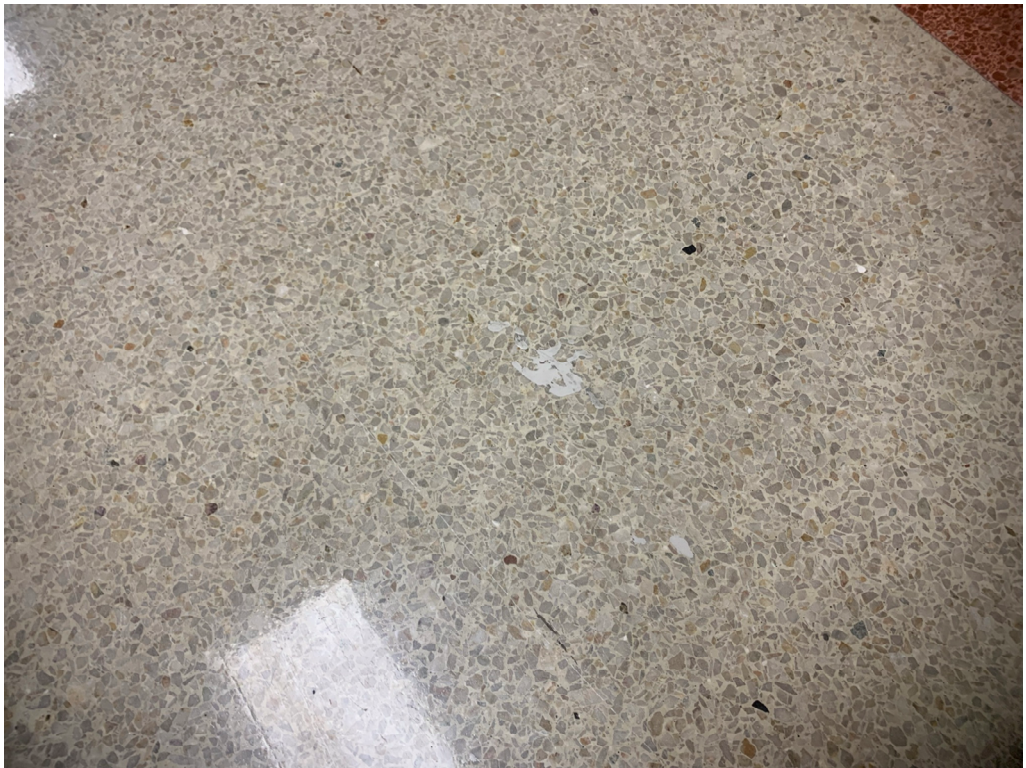
Figure 10 – Paint dripped down main hall below wax

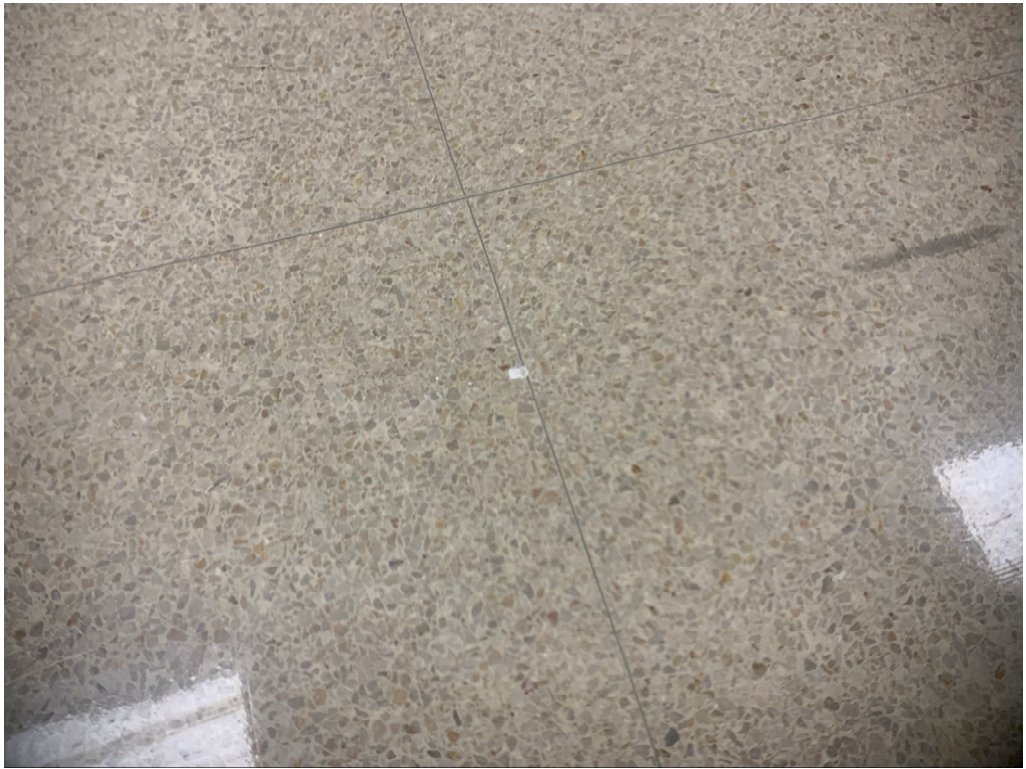
Figure 11 – Paint dripped down main hall below wax

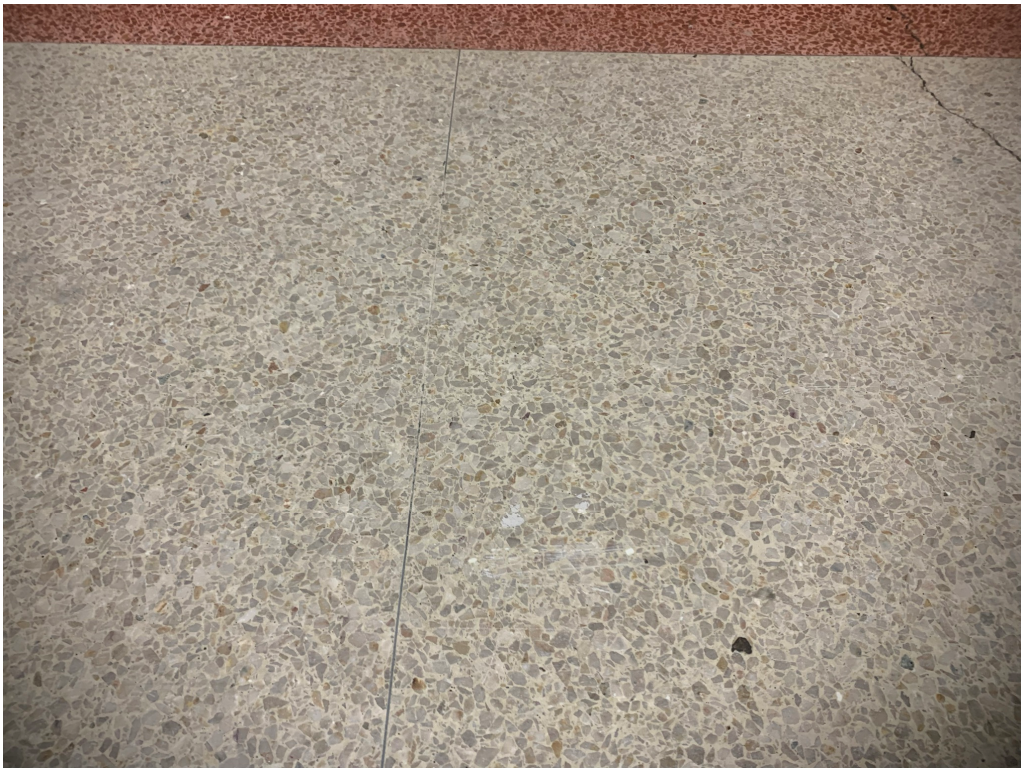
Figure 12 – Paint dripped down main hall below wax

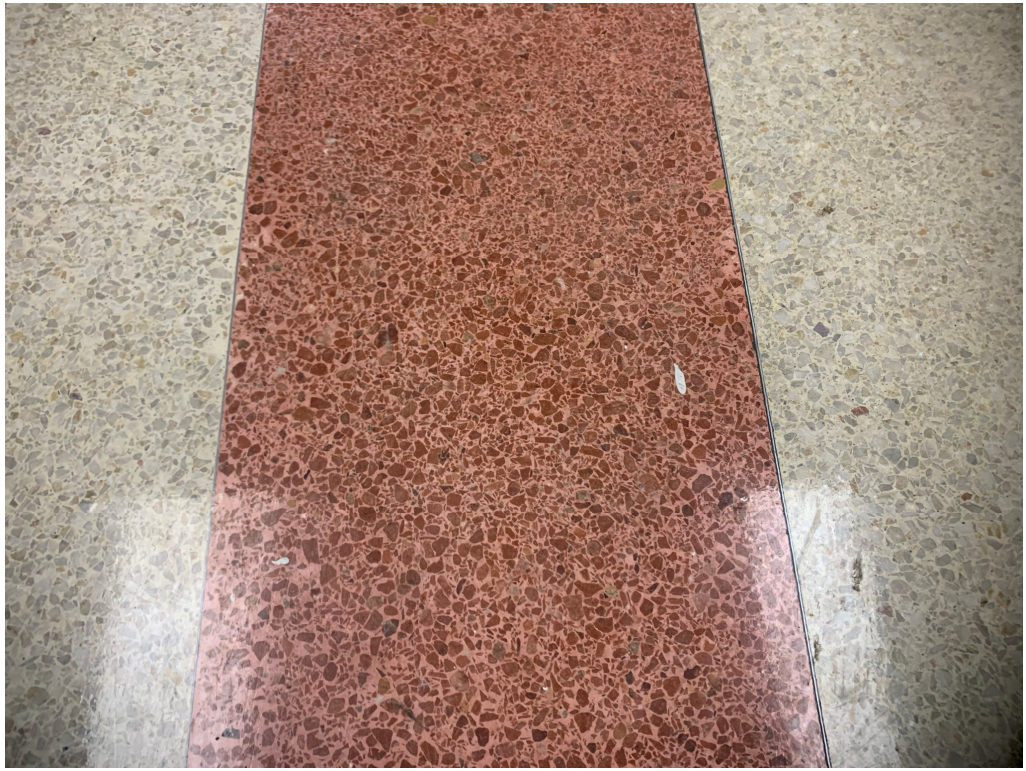
Figure 13 – Paint dripped down main hall below wax

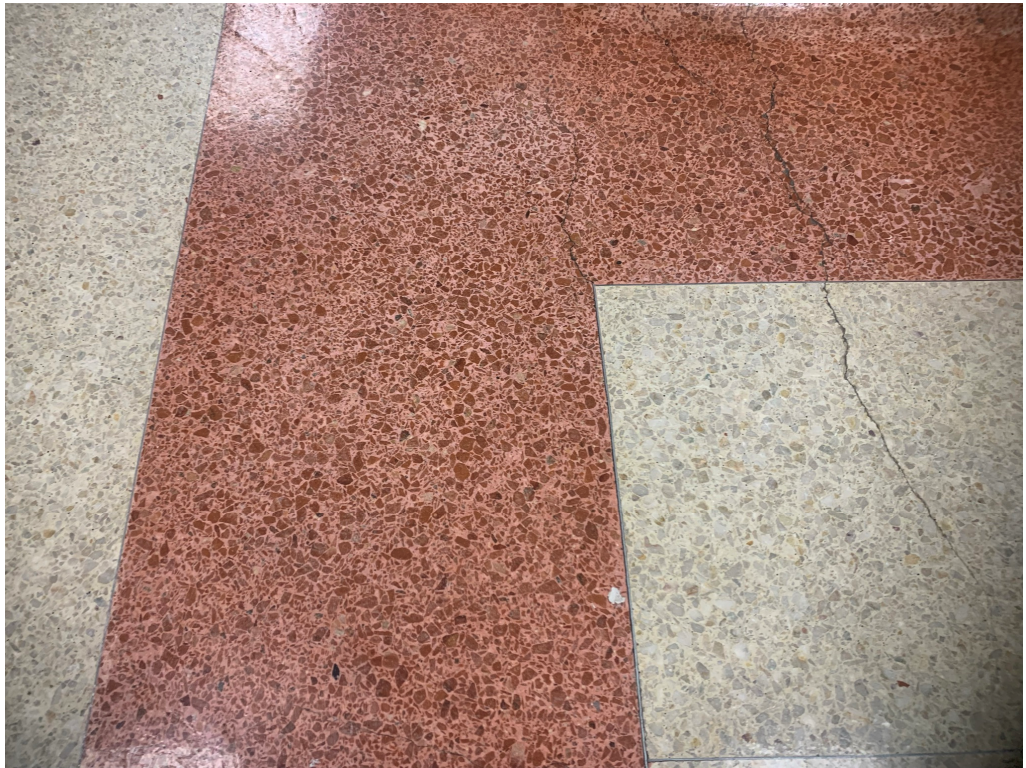
Figure 14 – Paint dripped down main hall below wax

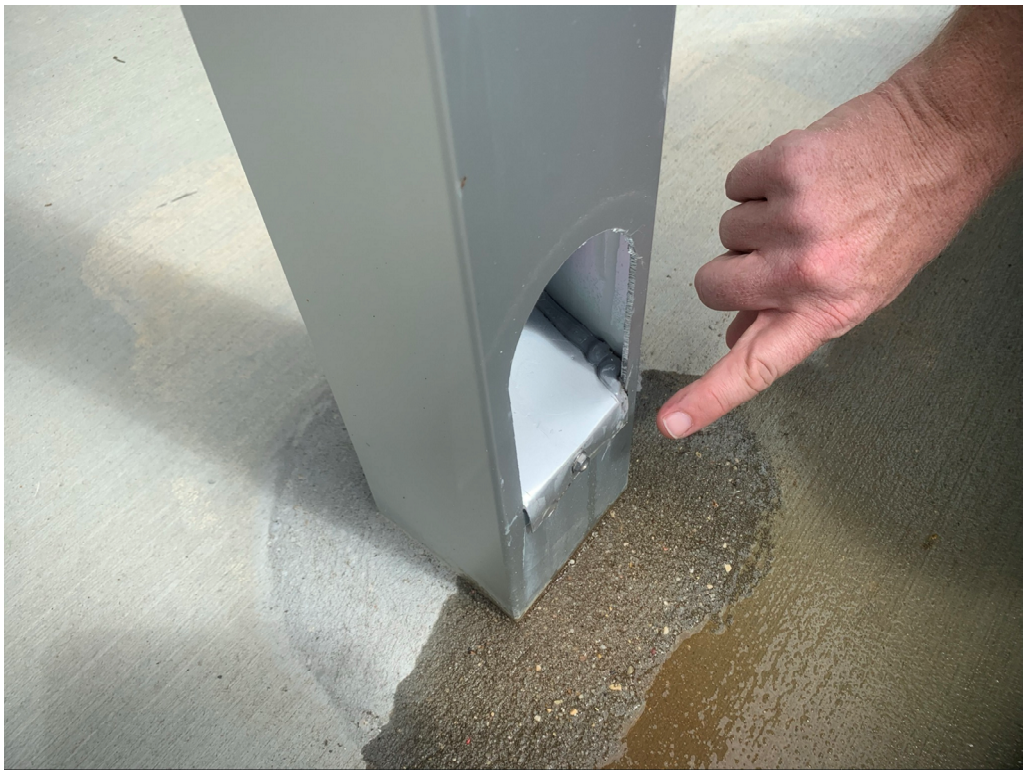
Pay attention to figures 15 and 16 in this report as they are a hazard to the individuals occupying this building.

Figure 15 – Burrs at cut outs create a hazard for young children and should be rounded over

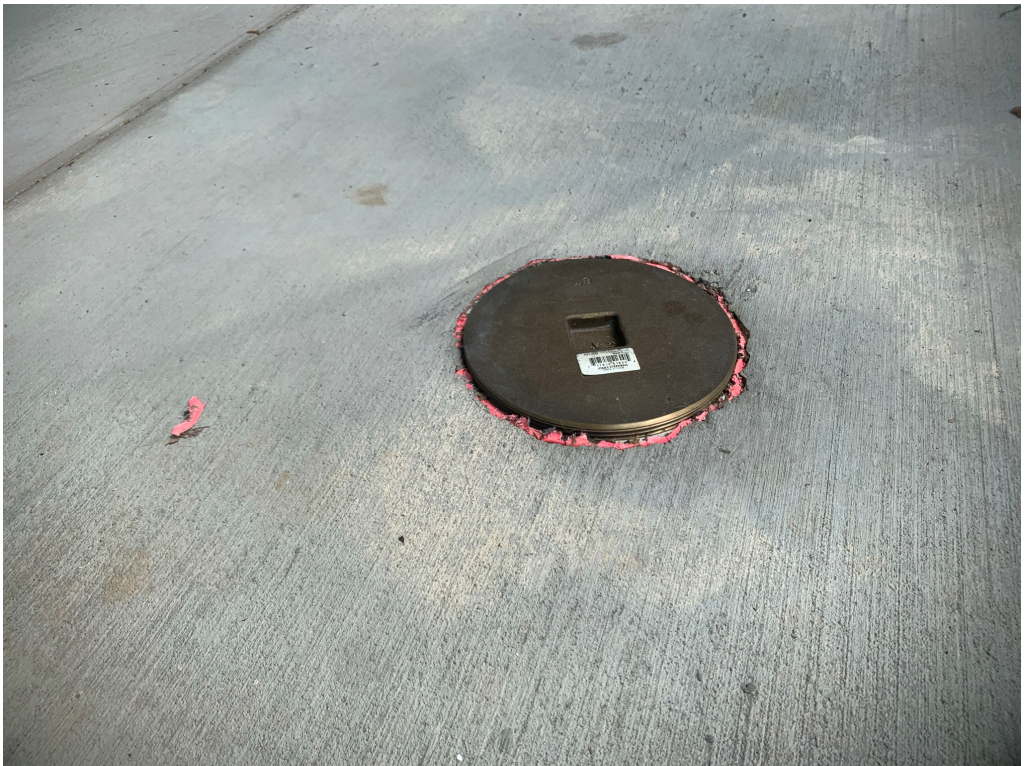
Figure 16 – Installation creates a trip hazard; reinstall flush with concrete
