07 February 2022

18045-BOW Bowmar Elementary / Report Number 036

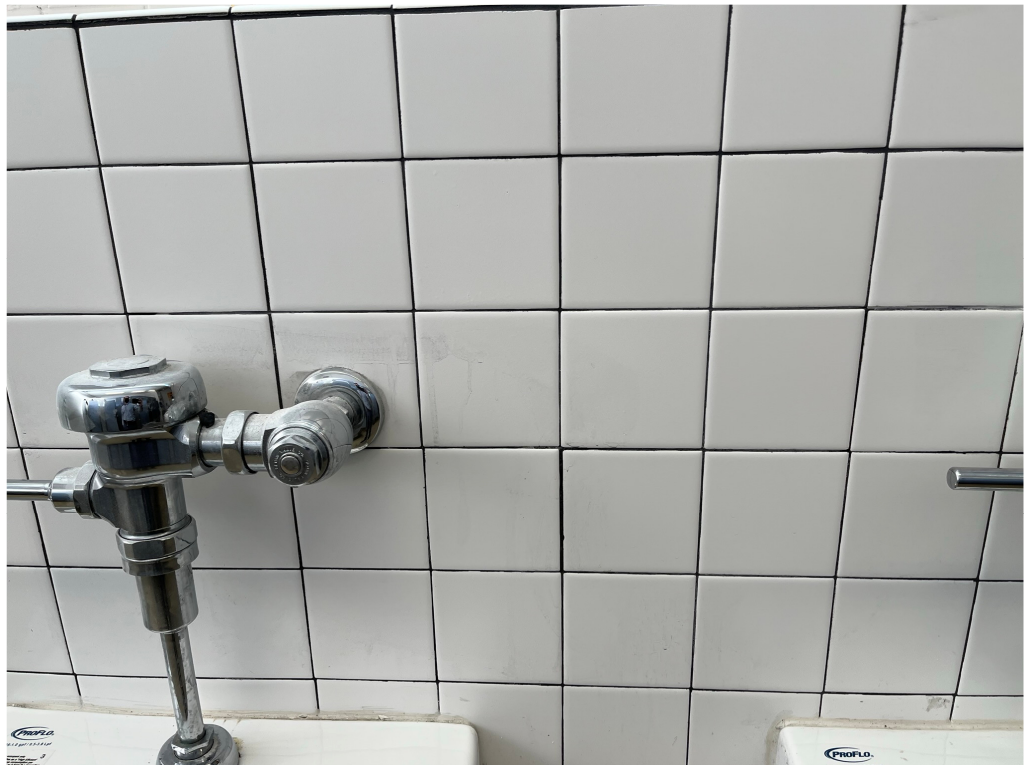
Figure 1 – Poorly done tile work

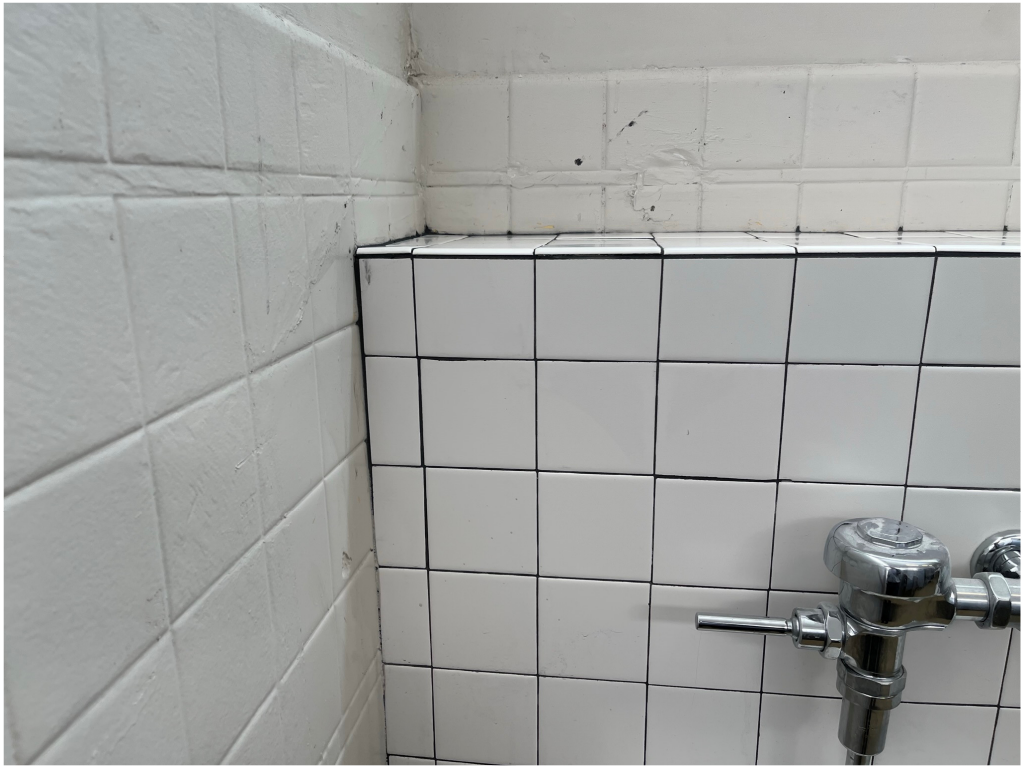
Figure 2 – Poorly done tile work

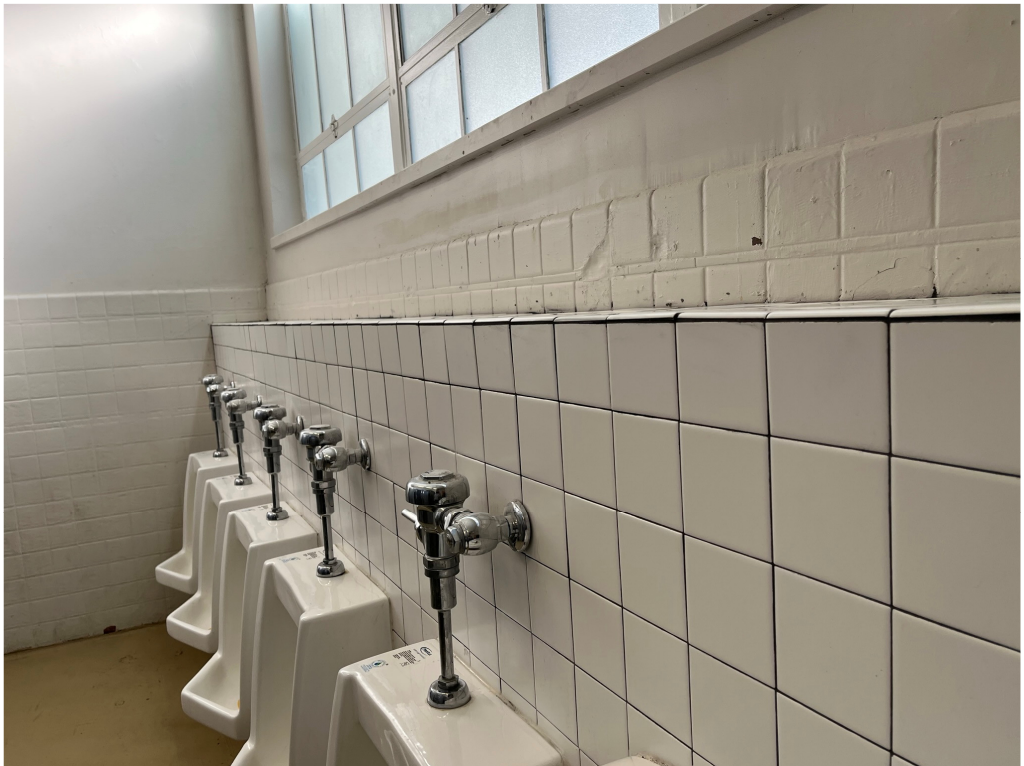
Figure 3 – Poorly done tile work

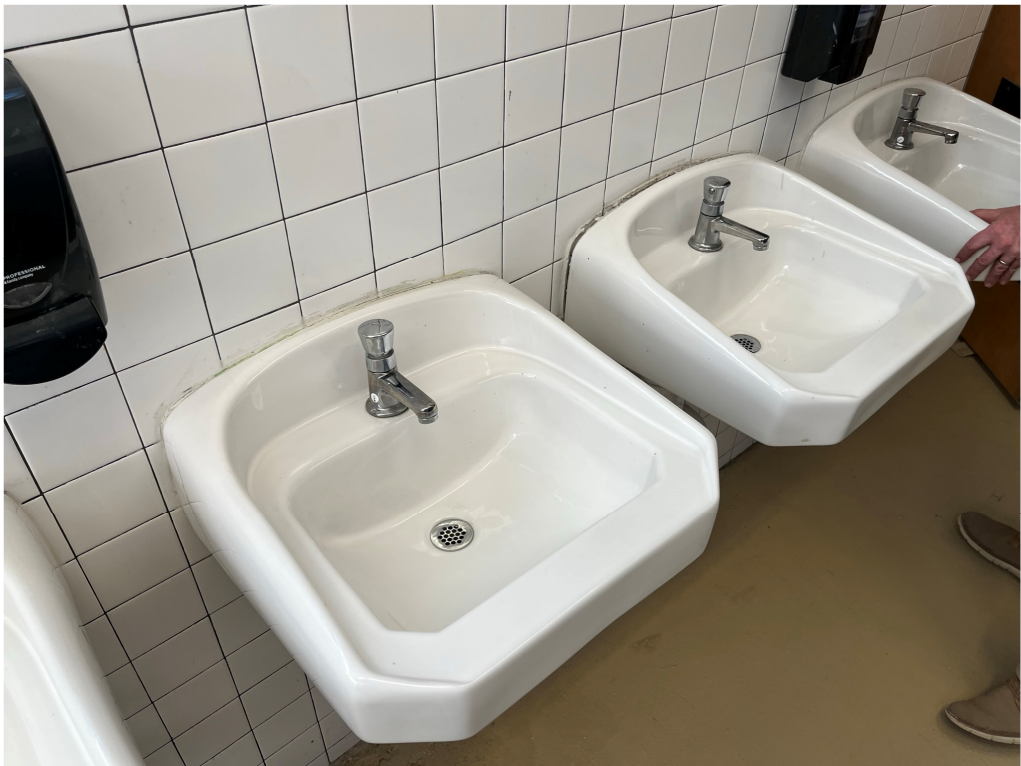
Figure 4 – Loose Lavatories

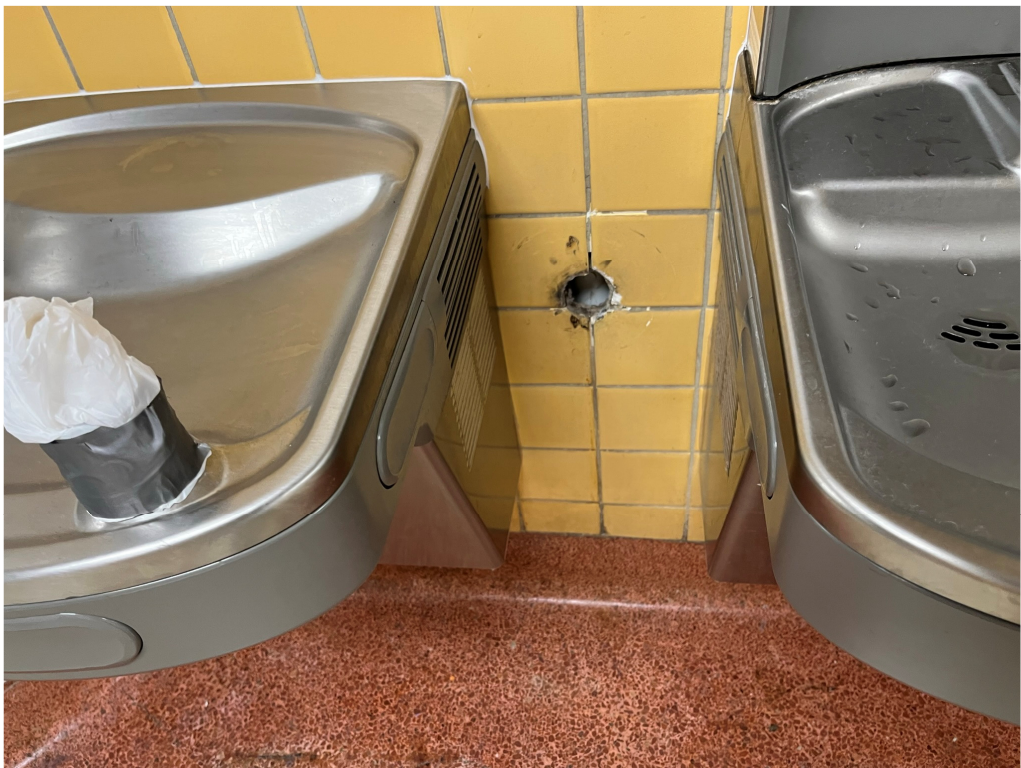
Figure 5 – Exposed Holes between water fountains

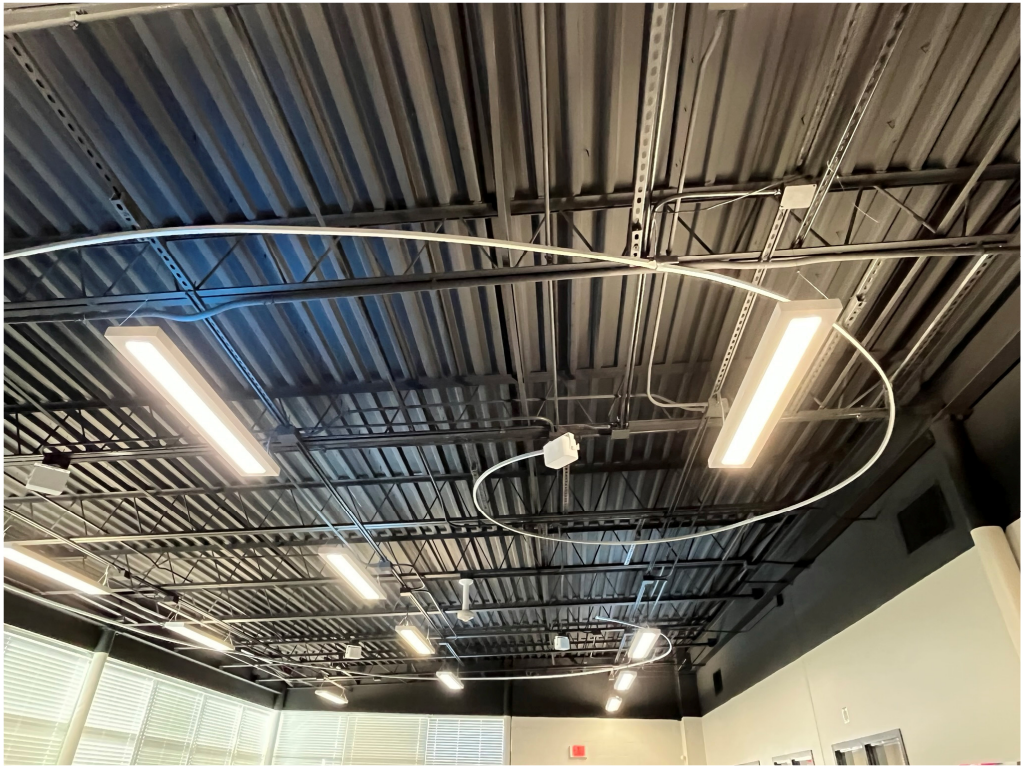
Figure 6 – Library Light

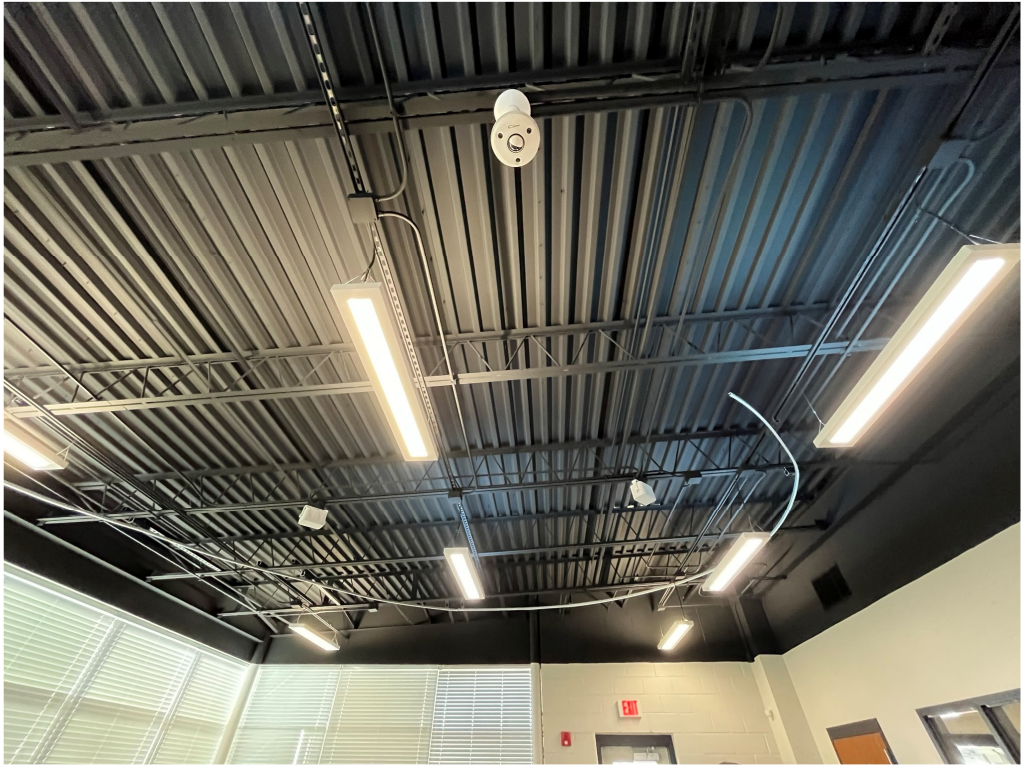
Figure 7 – This end creates a funny shape that does not conform to design

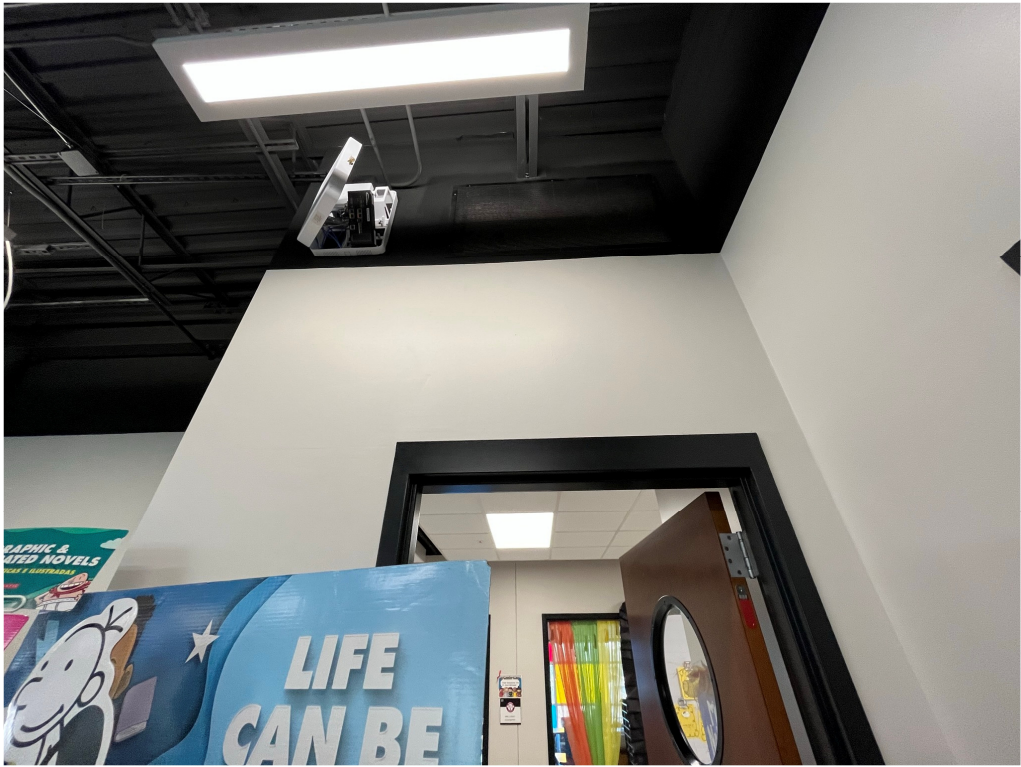
Figure 8 – Rattling Return

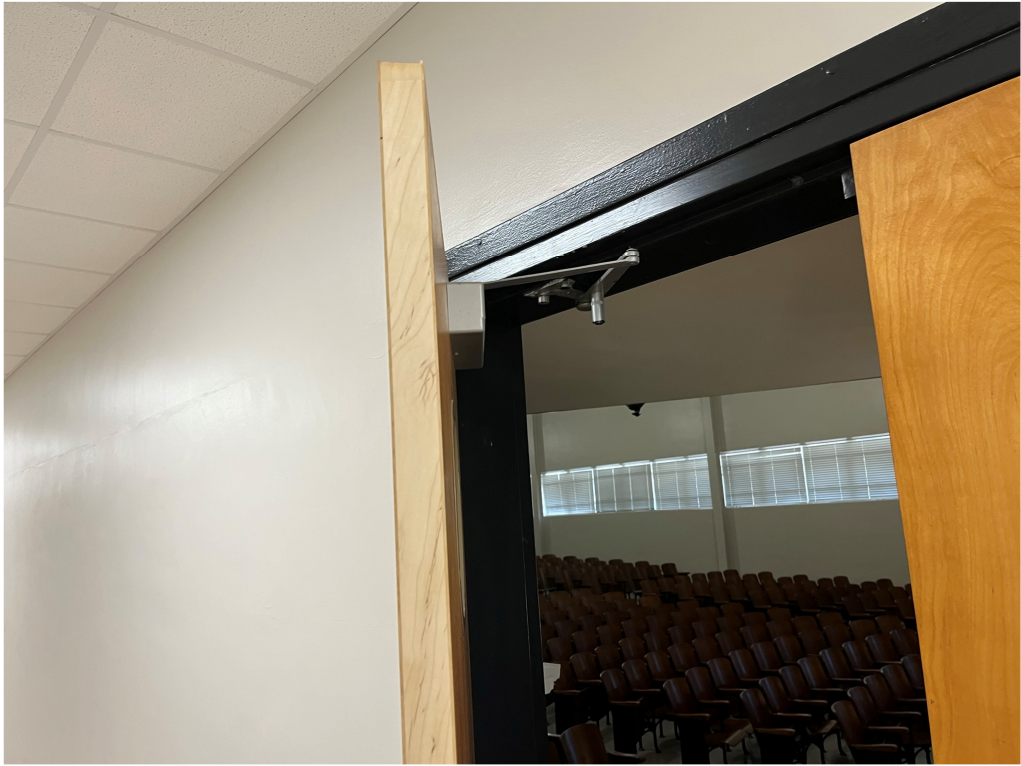
Figure 9 – Unfinished Door Edge

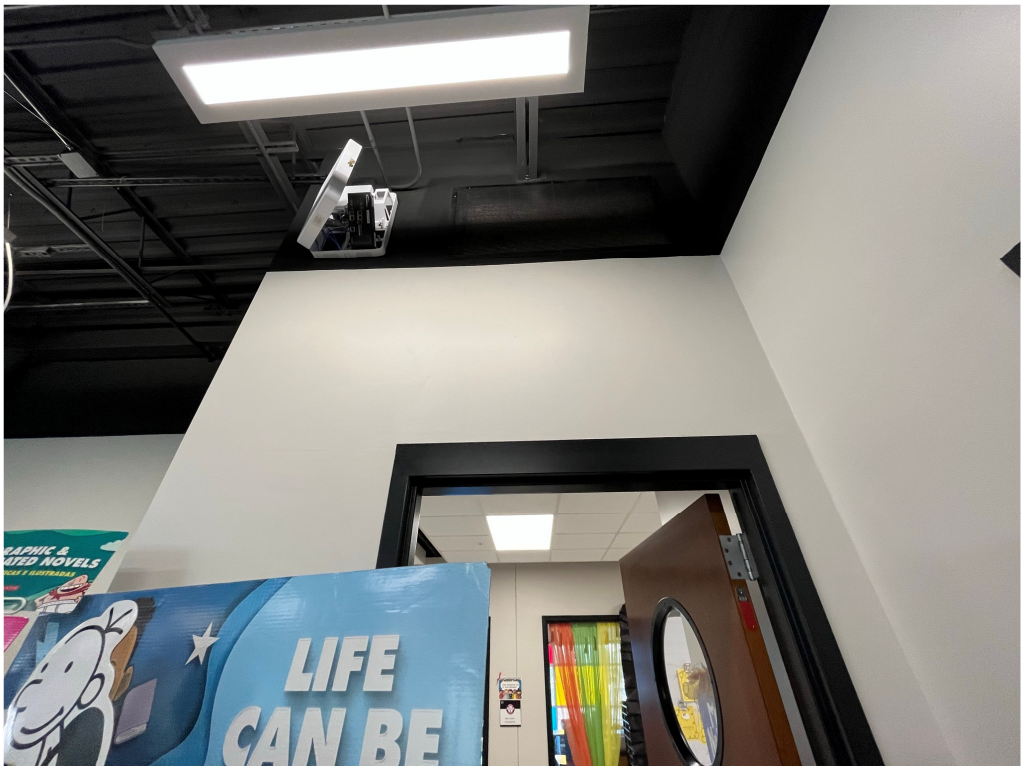
Figure 10 – Rattling Return

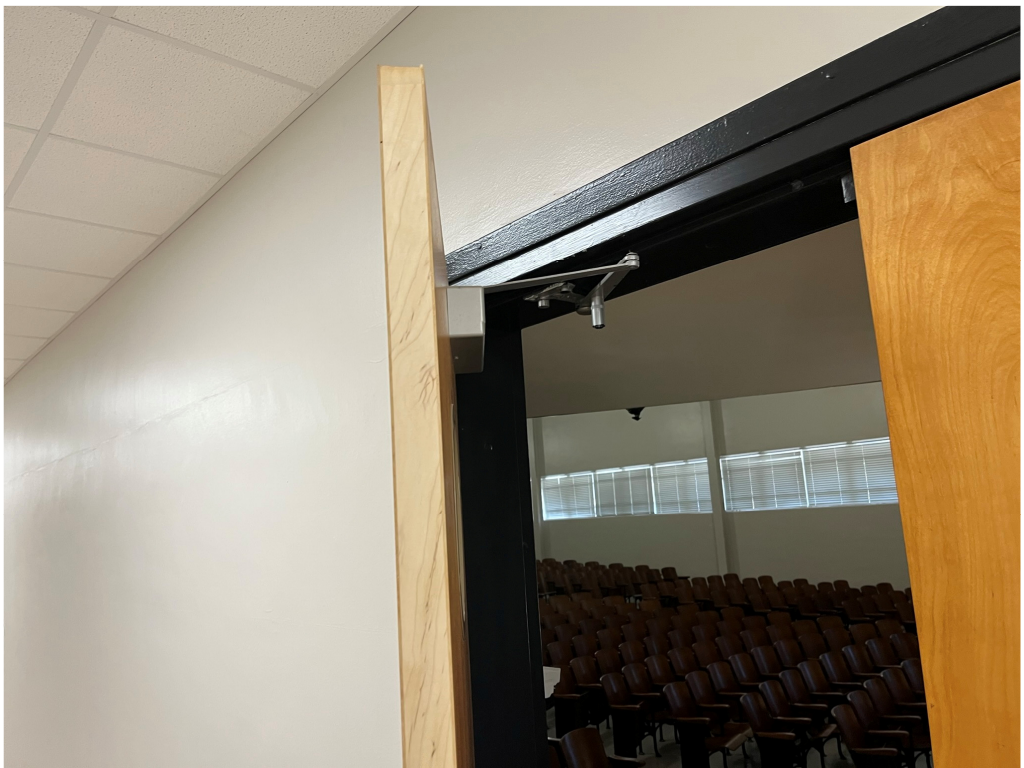
Figure 11 – Unfinished Door Edge

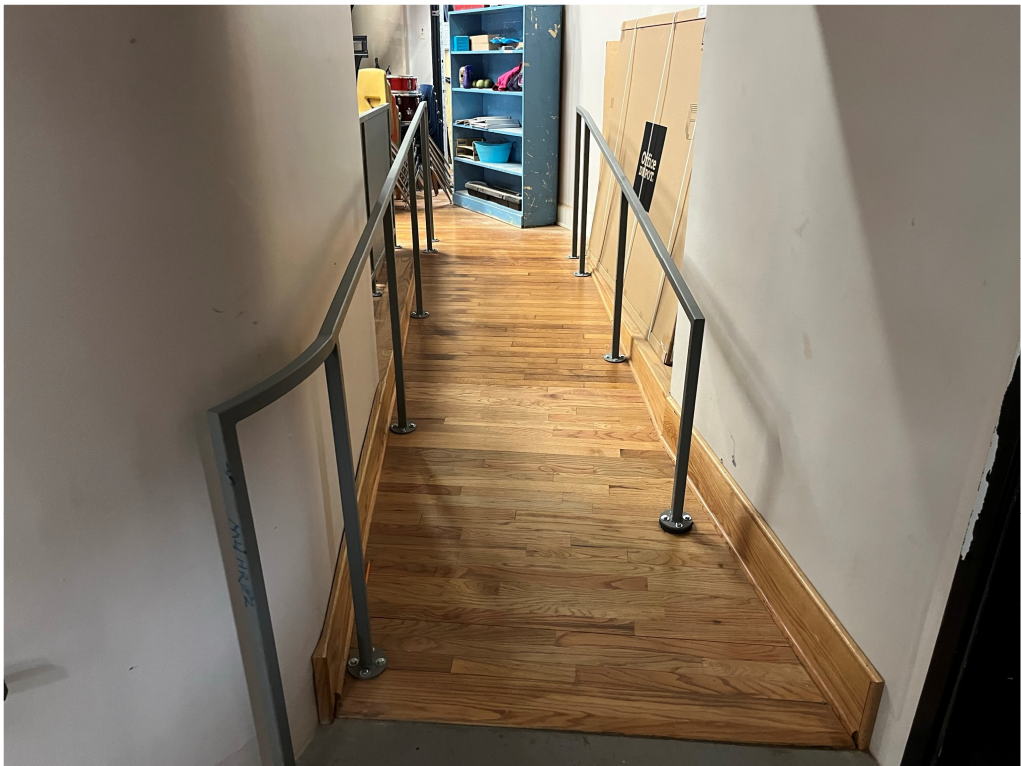
Figure 12 – Rail on right to be ~4" further to the right; should stop at wall

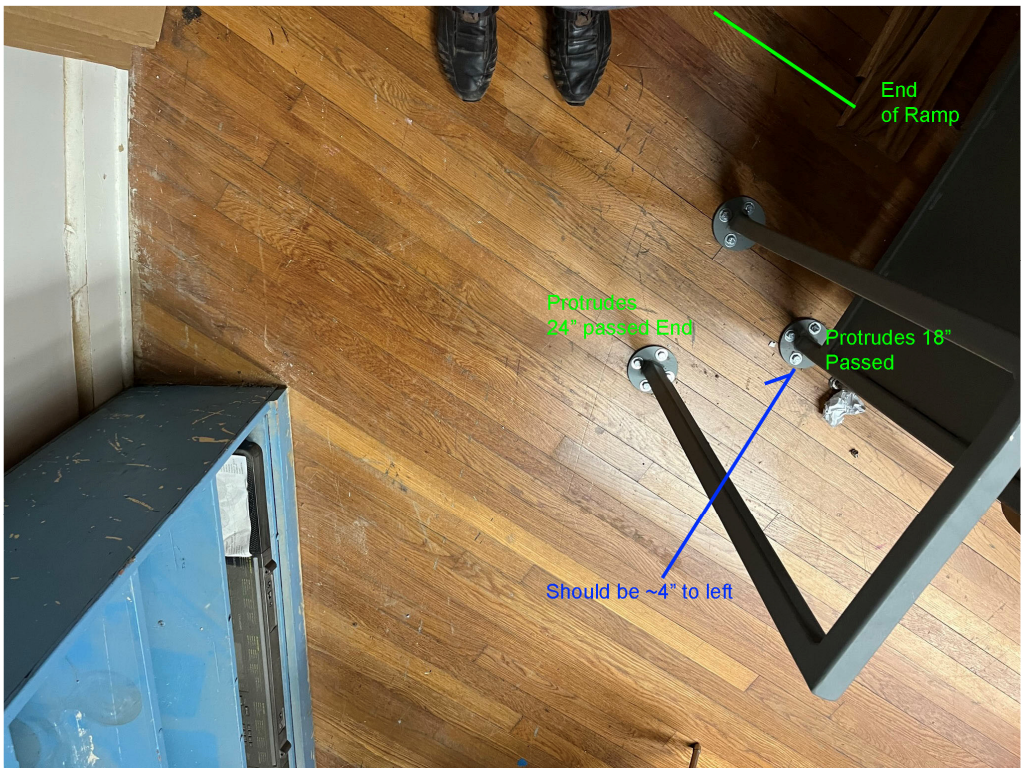
Figure 13 – Rail & Guard to far passed ramp end
