Architect's Field Report

01 June 2020

18048-Redwood Elementary School / Report Number 002

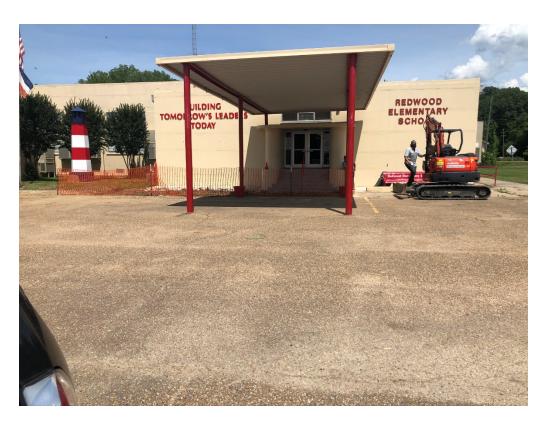
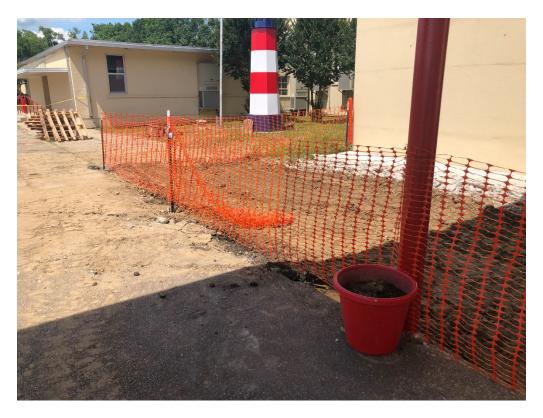
Figure 1 – Entry Demo Work

Figure 2 – Entry Demo Work

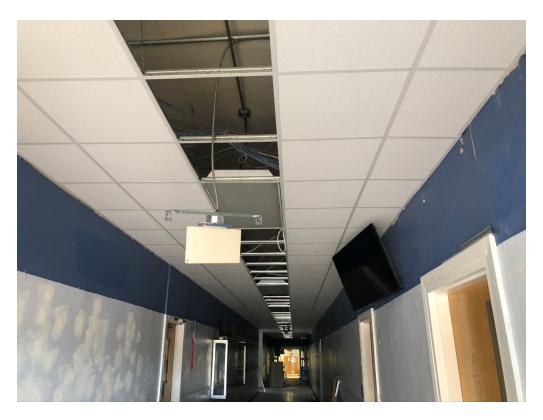
Figure 3 – New Ceiling Installation is Ongoing

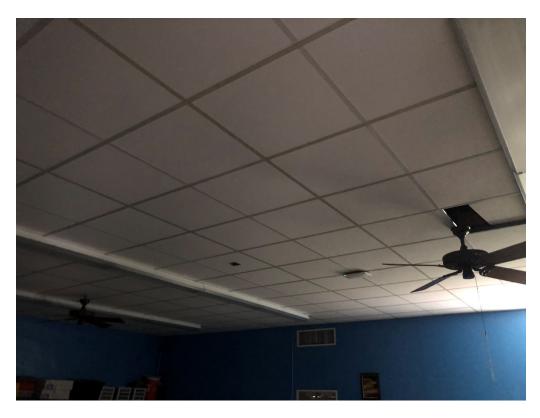
Figure 4 – New Ceiling Installation @ Classrooms is Ongoing

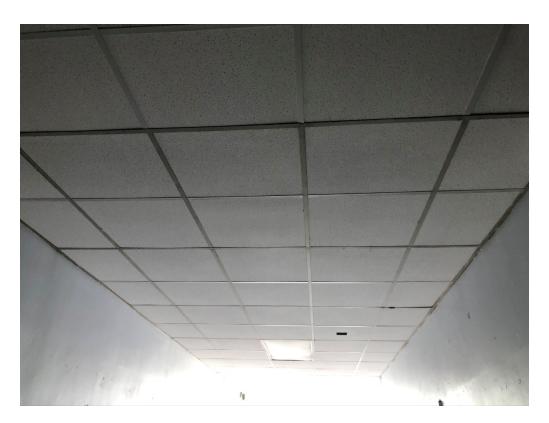
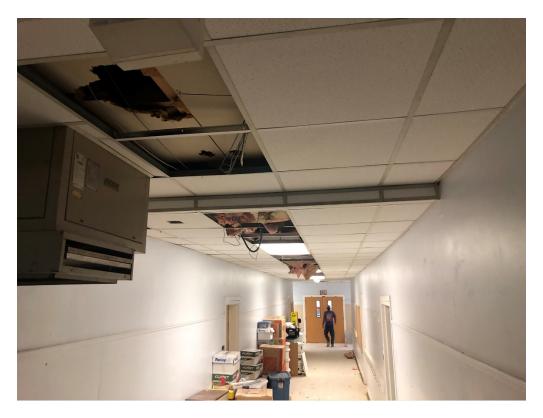
Figure 5 – Ceiling Tile Replacement

Figure 6 – Ceiling Tile Replacement

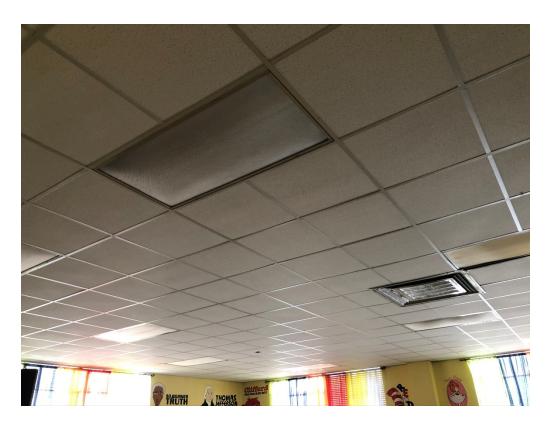
Figure 7 – Library Ceiling Work

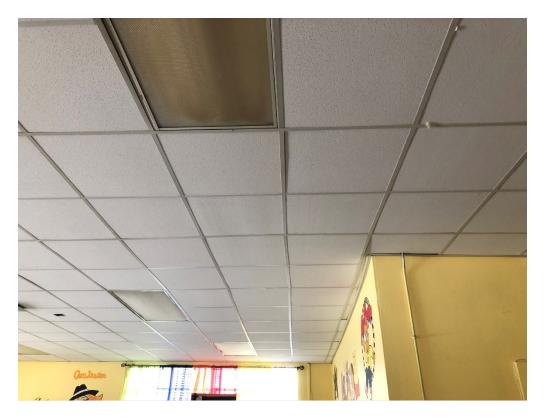
Figure 8 – Some Adjusting Required at the end of this Row at Ceiling Grid

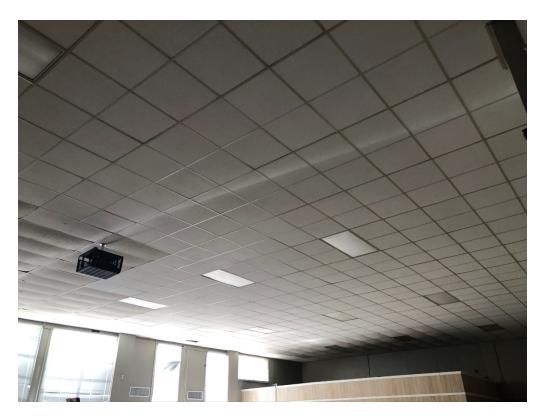
Figure 9 – Auditorium Ceiling Replacement is Ongoing

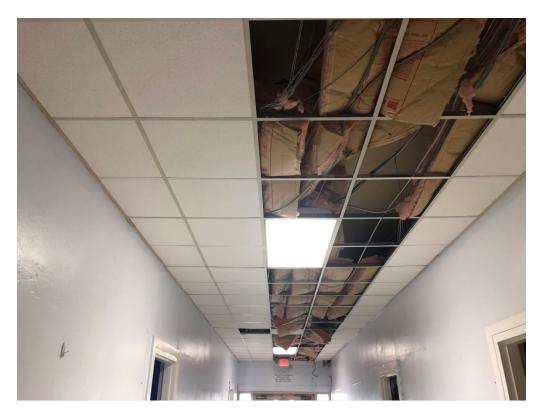
Figure 10 – Hall Ceiling Replacement

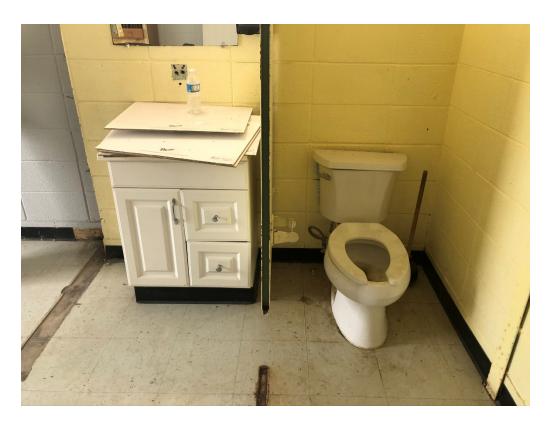
At Teacher's Lounge E-113, we reviewed demolition of a plumbing wall that is indicated on our plans. The concern was brought up that if we removed the wall, we would expose hidden plumbing that is to remain to service fixtures on the other side of the wall. I instructed Mr. Byrd to leave wall in place and block the end of the wall for a finished look.

Figure 11 – Plumbing to be Removed

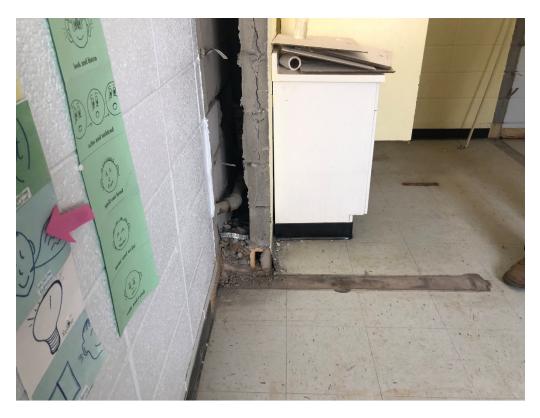
Figure 12 – Wall to Remain to Conceal Plumbing

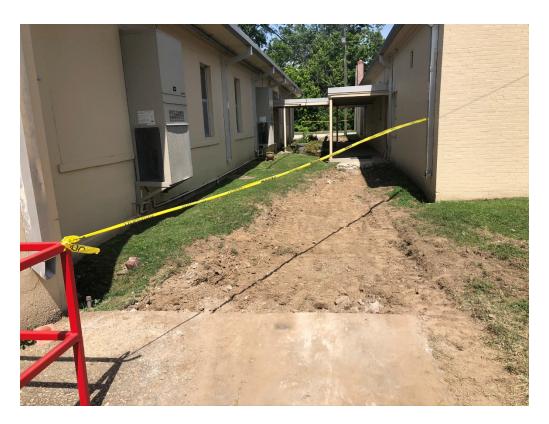
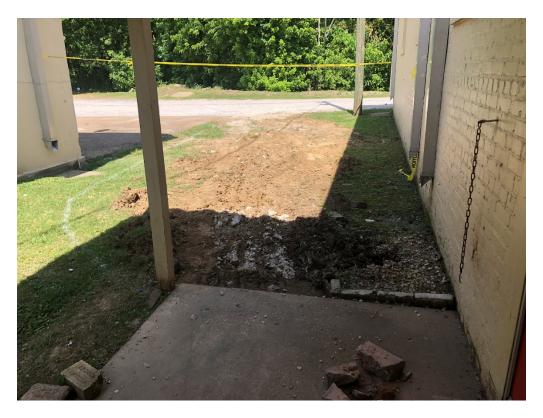
Figure 13 – Sidewalk Demo

Figure 14 – Sidewalk Demo
