Architect's Field Report

201 Park Court, Suite B Ridgeland, MS 39157 P 601.790.9432 F 888.281.0547	30 June 2020	
	18048-Redwood Elementary School / Report Number 004	
	Contract	Harris Construction
One Jackson Place, Suite 250 188 East Capitol Street Jackson, MS 39201-2100 P 601.352.5411 F 601.352.5362	Date / Time	30 June 2020 / 11:00 AM
	Weather / Temp	Clear / 84 ° F
	Est % Complete	5%
	Sched Conformance	+ 00 days
	Work in Progress	Concrete Install Roofing Installation Plumbing
161 Lameuse Street, Suite 201 Biloxi, MS 39530 P 228.374.1409 F 228.374.1414	Present at Site	Michael Byrd, Harris Construction Paul Purser, DBA
	Observations	<p>Arriving on site, I entered through the front entry. Concrete finishers were here, completing the installation of Footings for the new ramp.</p> <p>Inside, I met Michael Byrd, Harris, who was meeting with plumbers. We reviewed plumbing issues in E-128. The Previous Floor was Ramped form the door to the interior of the bathroom; after removal of the existing 2" mud bed, there is still a layer of concrete that is around 1-1/2" high; we discussed the need for a ramp still which will be significantly less than the previous and less than 1:20 slope.</p>

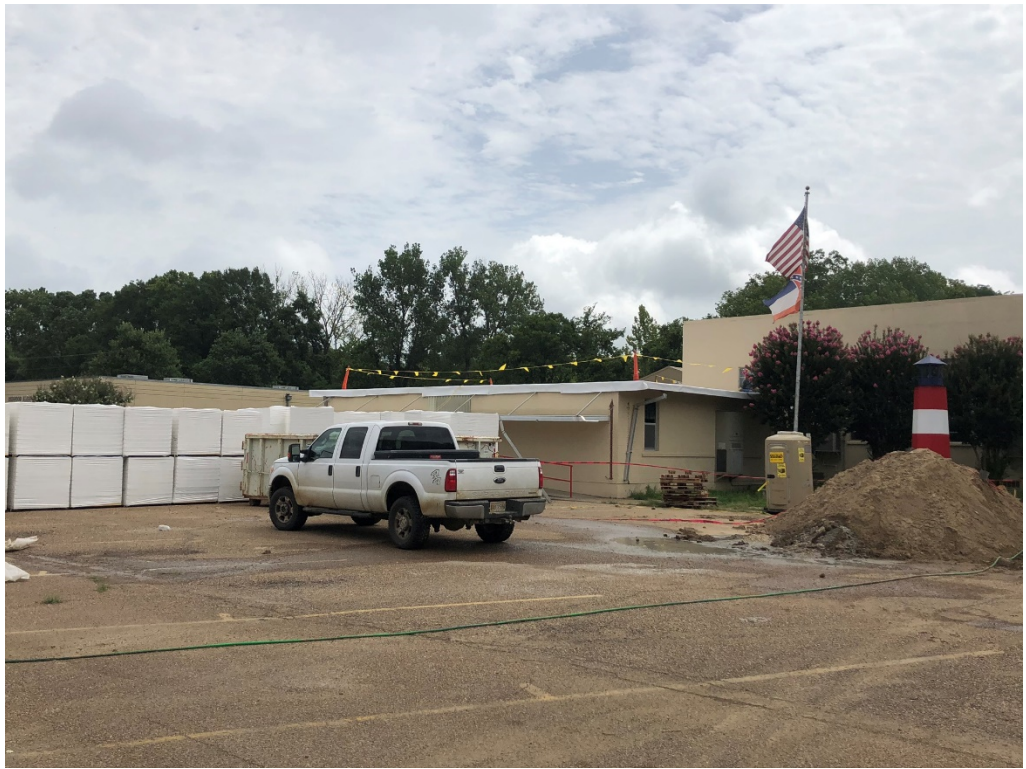
Figure 1 – Roofing Work is Ongoing

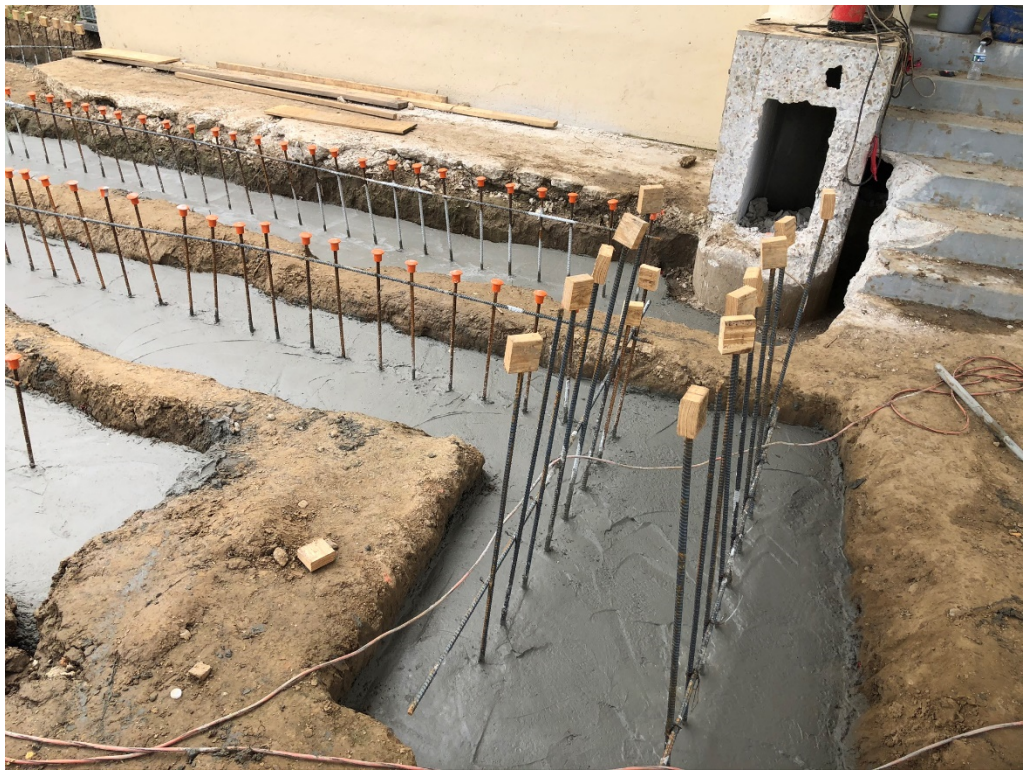
Figure 2 – Footing Concrete Installed

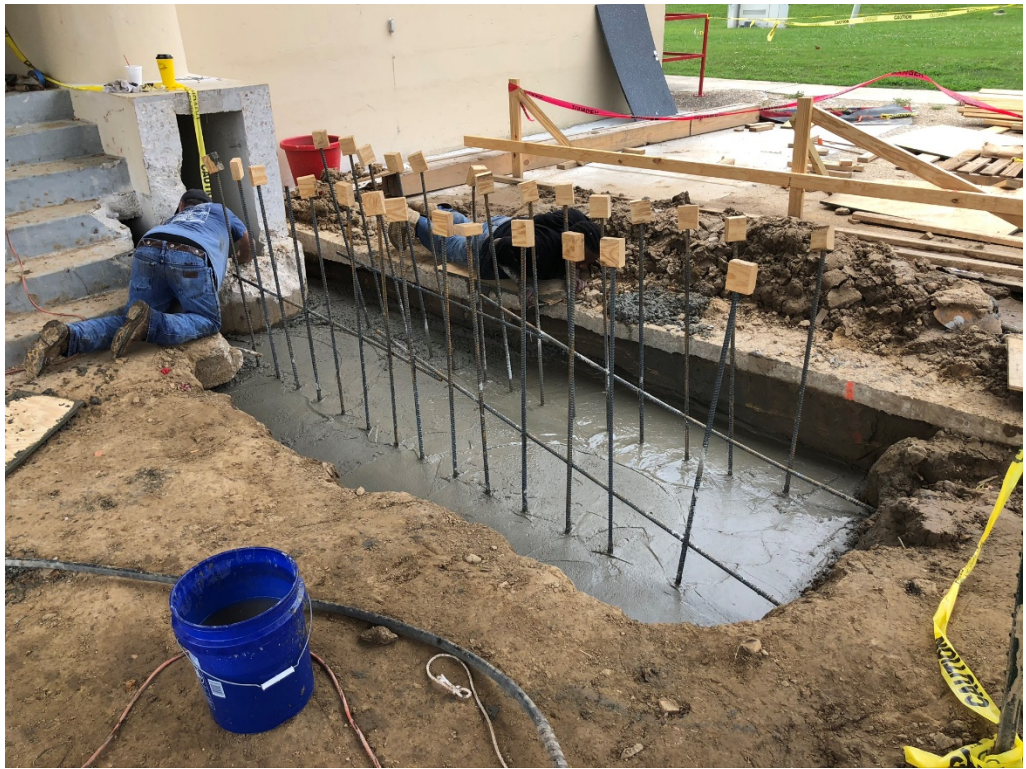
Figure 3 – Footing Concrete Installed

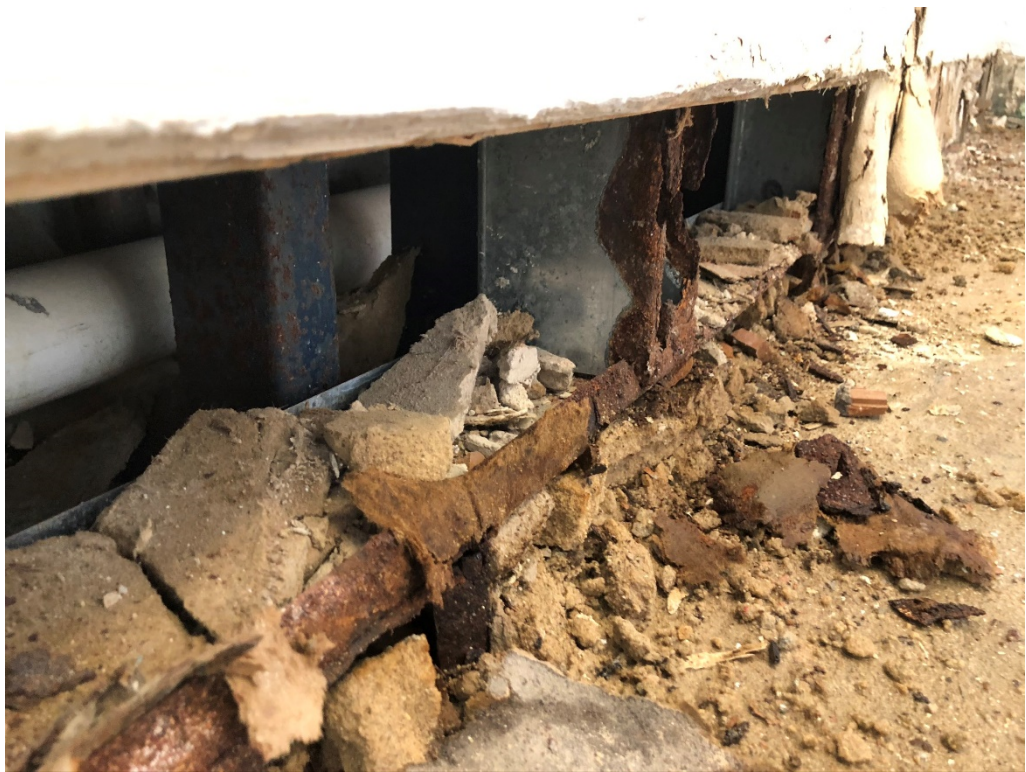
Figure 4 – Some Surface Rust Noted; Contractor should Patch as Needed to Secure Substrate

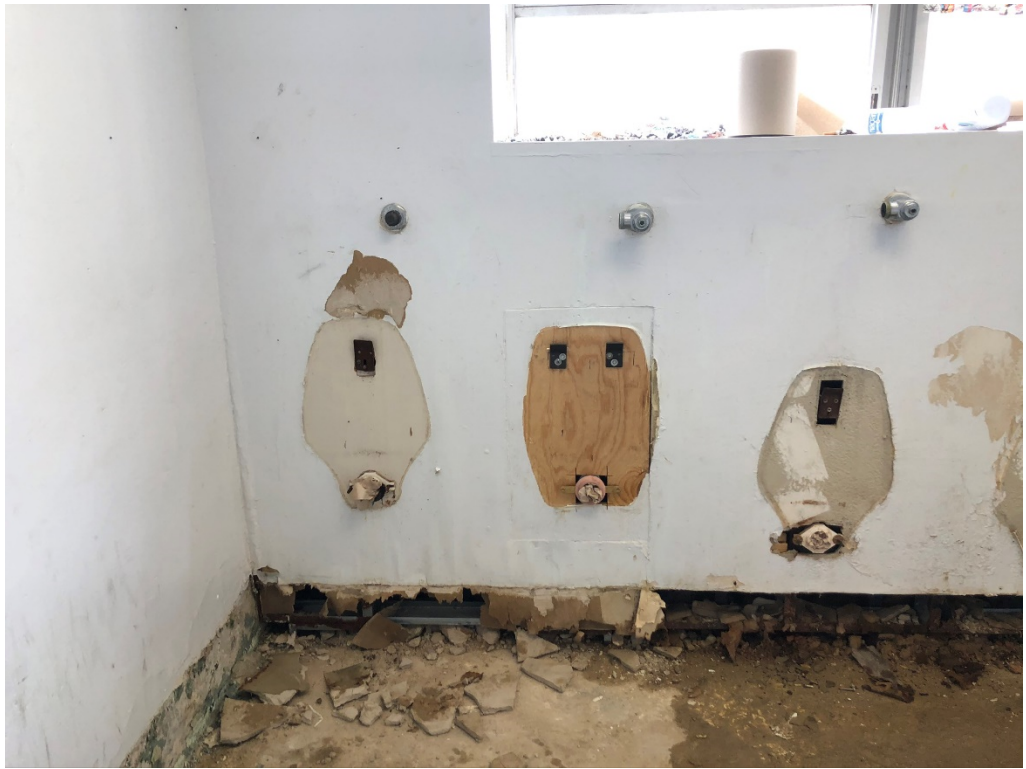
Figure 5 – Bare Plywood should be Sealed with Waterproofing Before Tile Work Begins

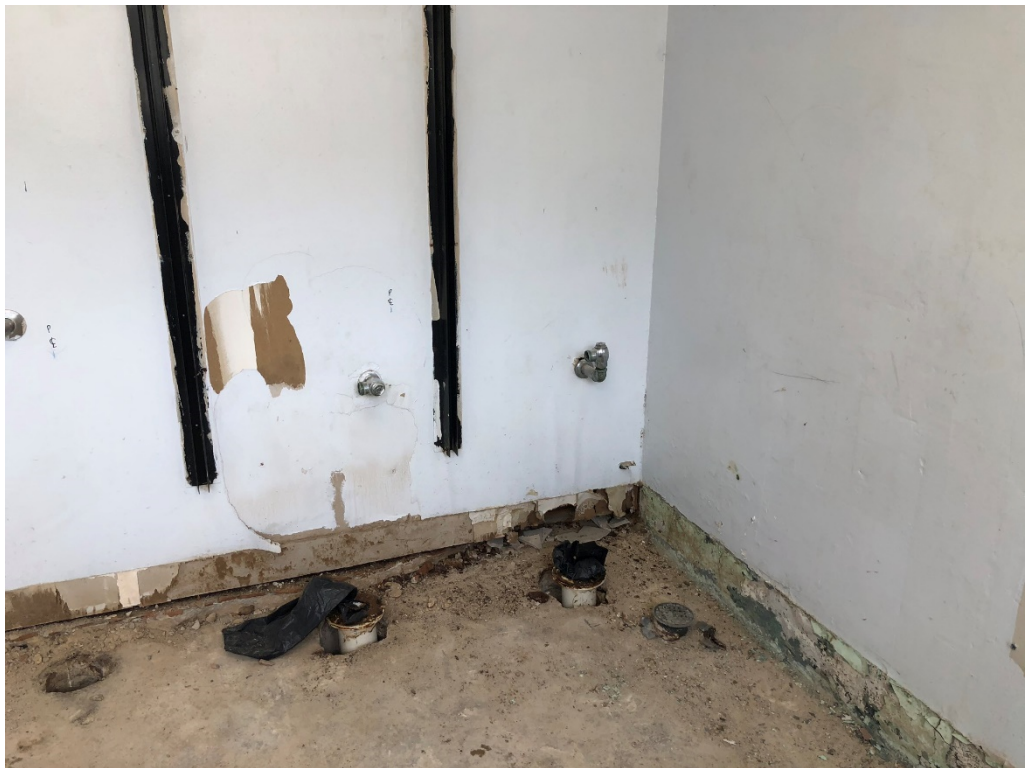
Figure 6 – E-128 Toilets

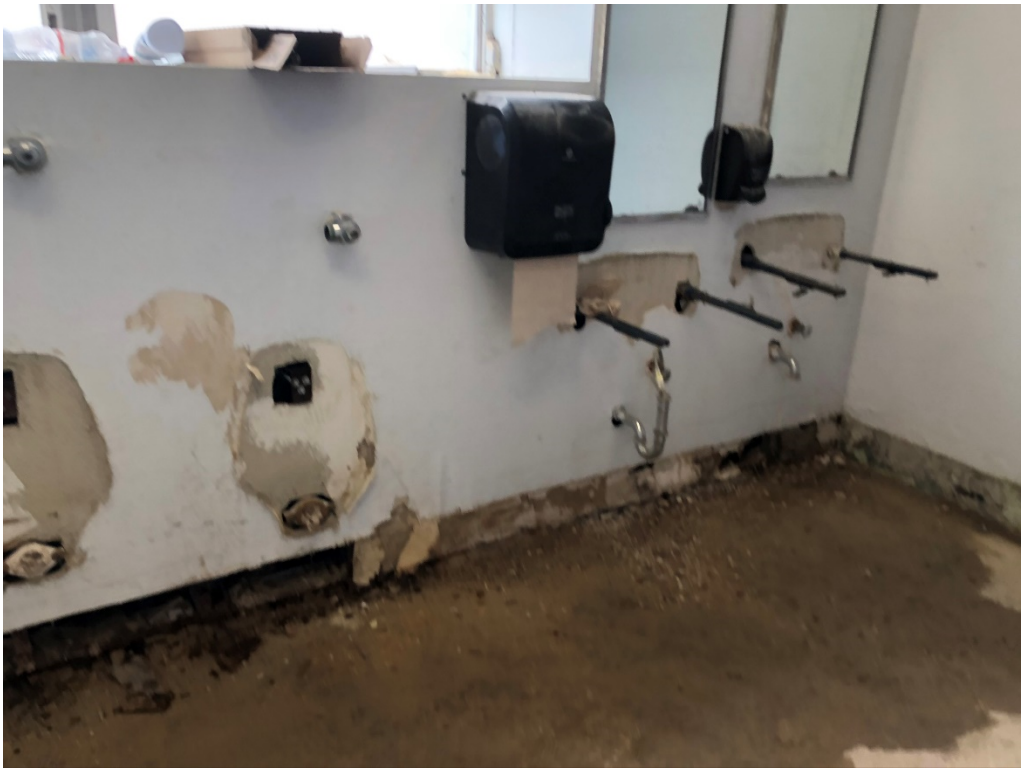
Figure 7 – E-128 Fixtures Removed

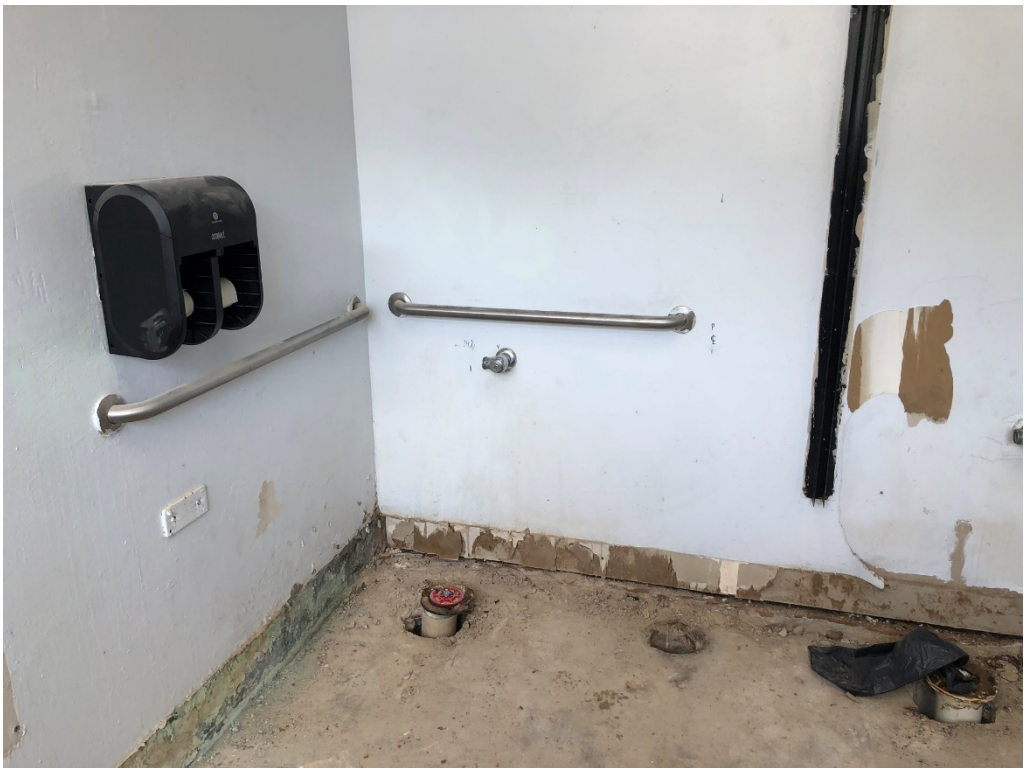
Figure 8 – E-128 ADA Stall

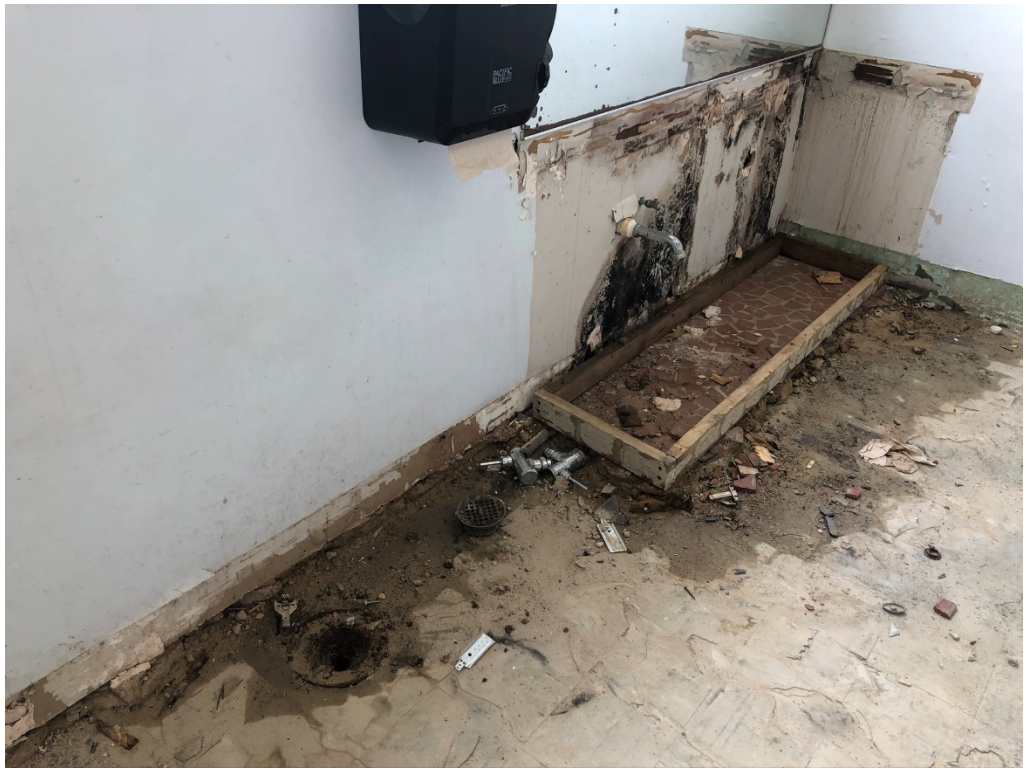
Figure 9 – E-109 Lavatory Demoed

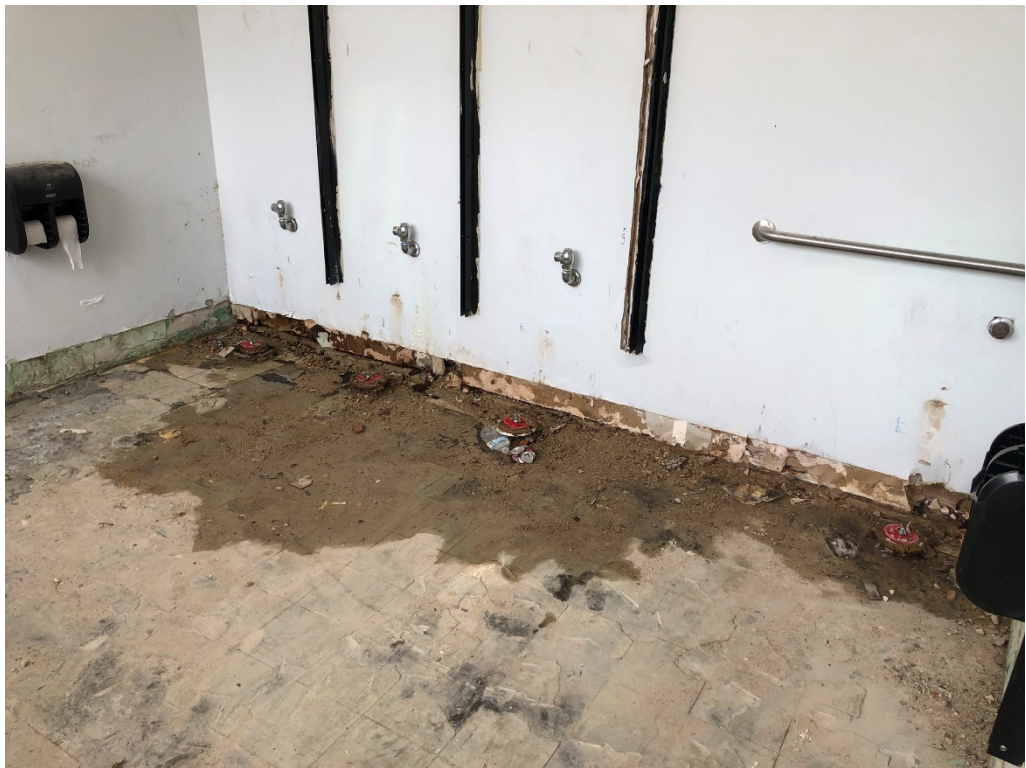
Figure 10 – E-109 Fixtures Removed
