## Architect's Field Report

18048-Redwood Elementary School / Report Number 007

Date / Time 02 September 2020 / 2:45 PM

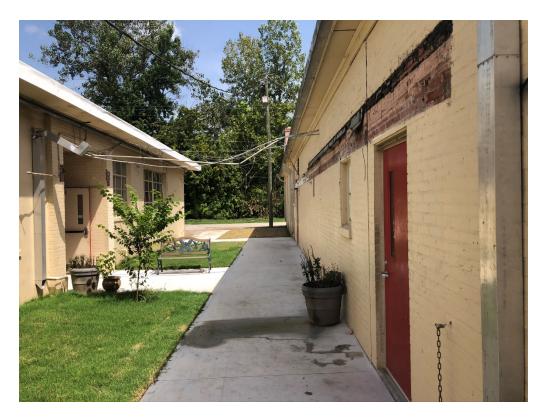
Figure 1 – Demo of Canopy still requires removal of asphalt & asphalt flashing

Remove Asphalt and Flashing at Canopies between Buildings D & B

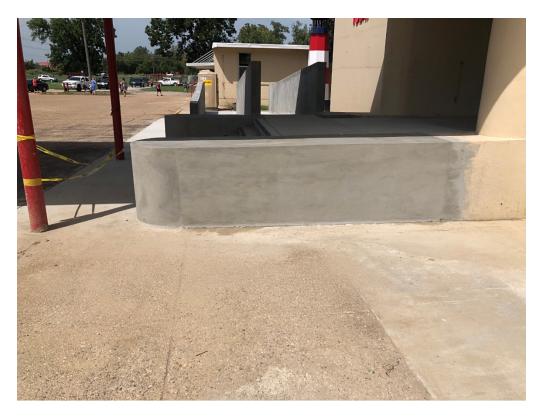
Arriving on site, I parked in the rear. I reviewed work performed at entry. The tops of walls have been smoothed with grinding and appear

Figure 2 – Concrete Work at Entry

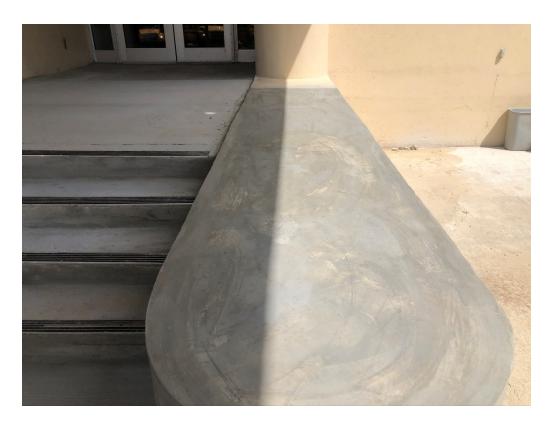
Figure 3 – Tops smoothed

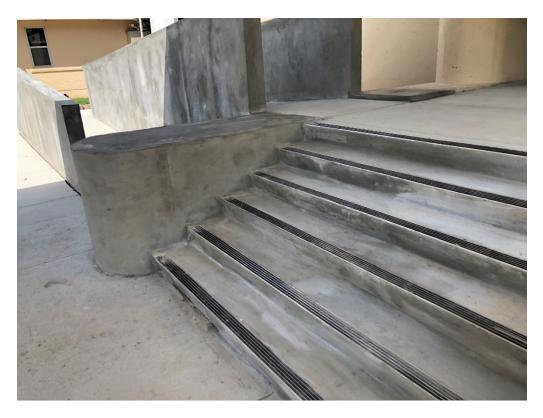
uniform. There is some clean up needed from this work, specifically at

the stair nosing where concrete dust has accumulated.

Figure 4 – Some Clean up still required at Black Stair Nosing

Clean Up Stair Nosing

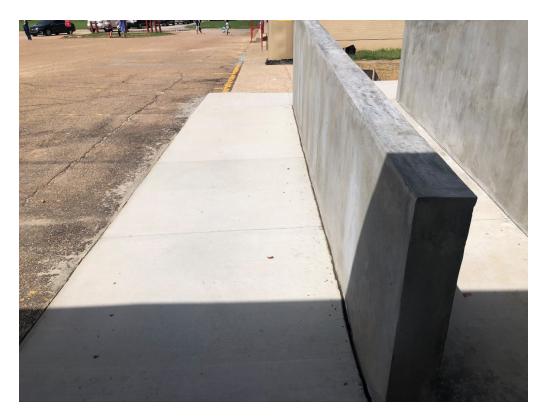
Figure 5 – Front Entry Sidewalks Poured

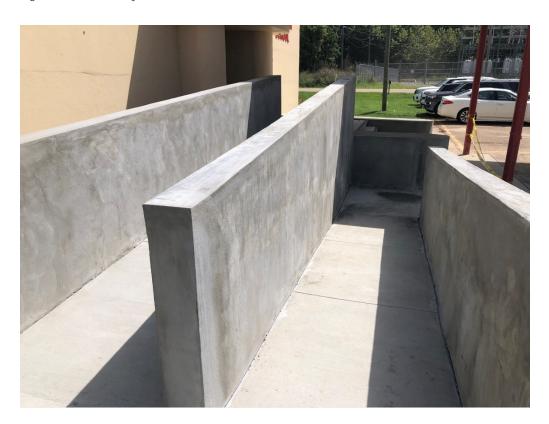
Figure 6 – Wall Tops Smoothed

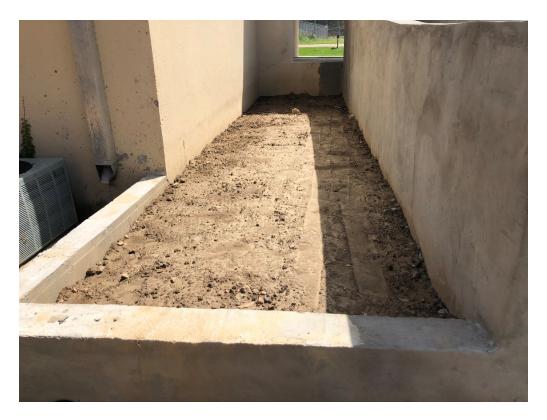
Figure 7 – Planter Filled

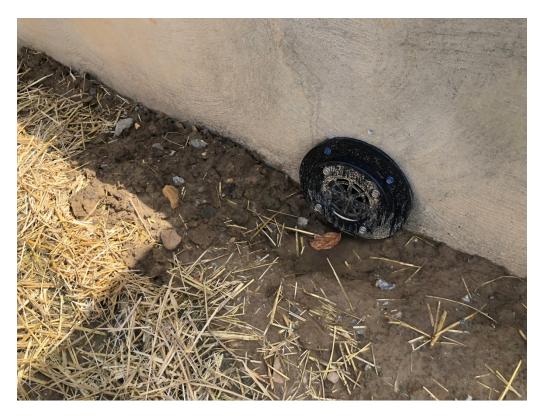
Figure 8 – Drainage Outlets at Planter
