Architect's Field Report

18 June 2020

18050-South Park Elementary / Report Number 013

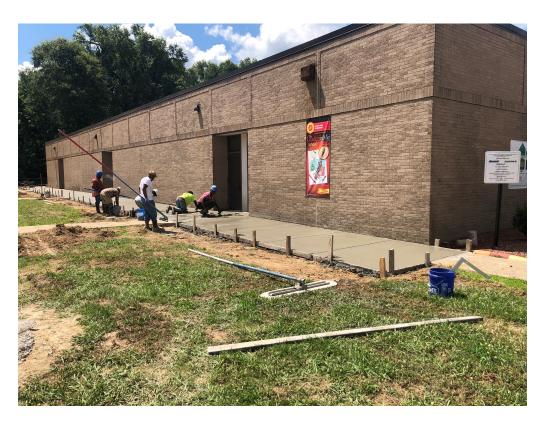
Figure 1 – Concrete Finishers at Work

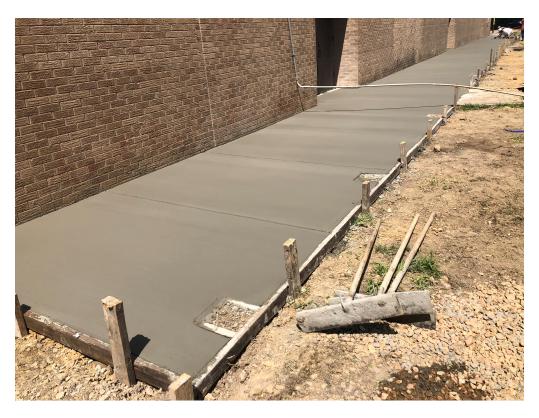
Figure 2 – Sidewalk in Curing Stage

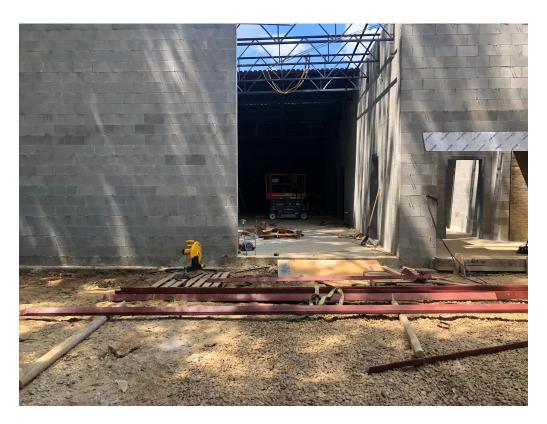
Figure 3 – Structural Steel Fabrication

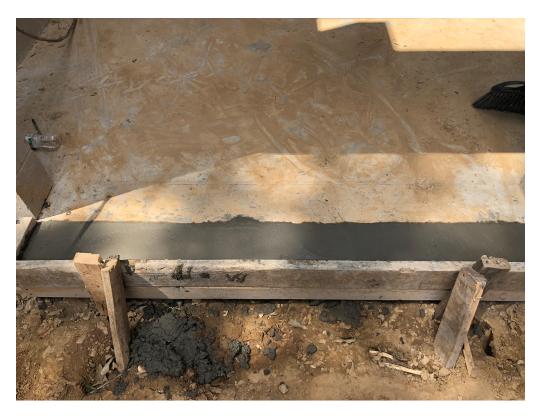
Figure 4 – Concrete Step Through Brick Envelope Added

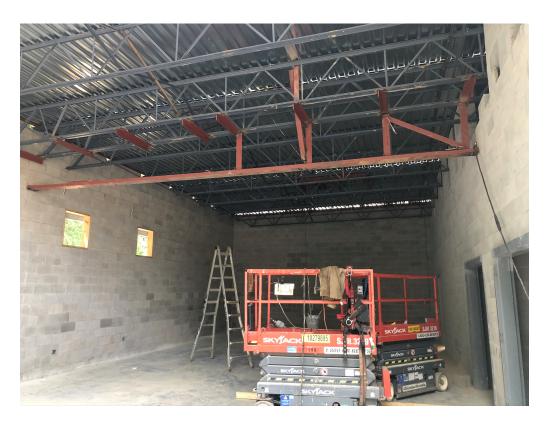
Figure 5 – Structural Steel Installation

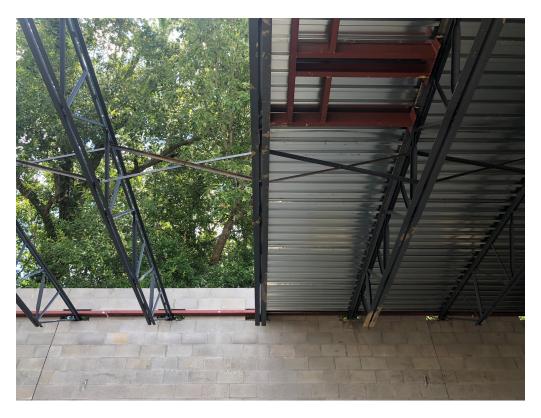
Figure 6 – Deck Installation is Ongoing

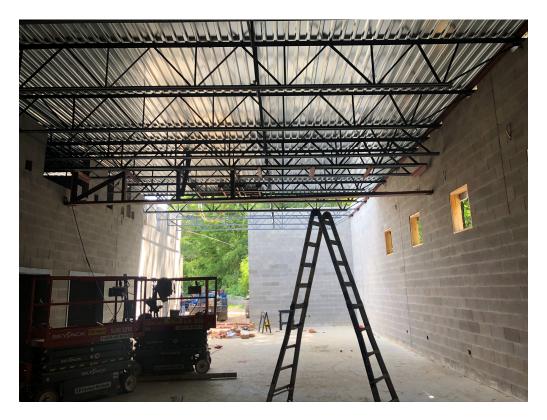
Figure 7 – Ongoing Work From Band Room

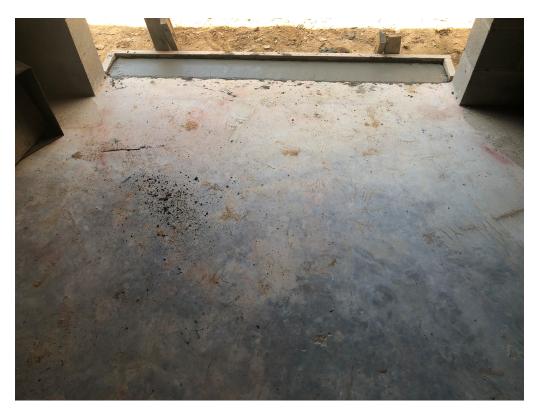
Figure 8 – Opposite End Concrete Step Through Brick Envelope
