## Architect's Field Report

21 July 2020

18050-South Park Elementary / Report Number 015

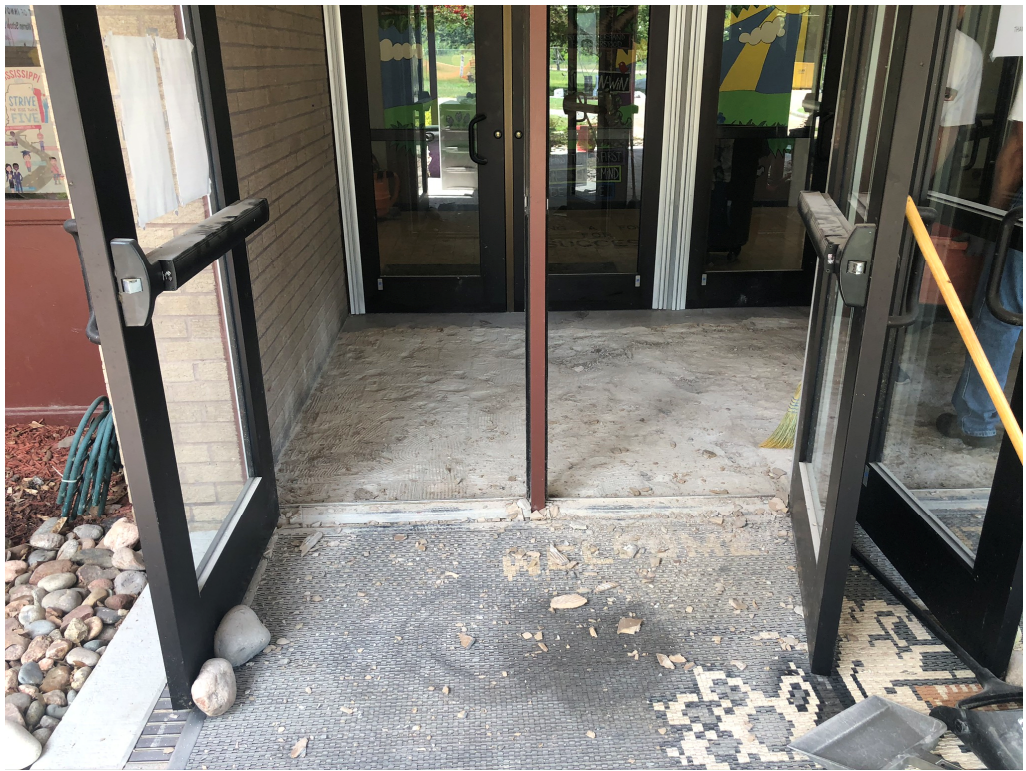
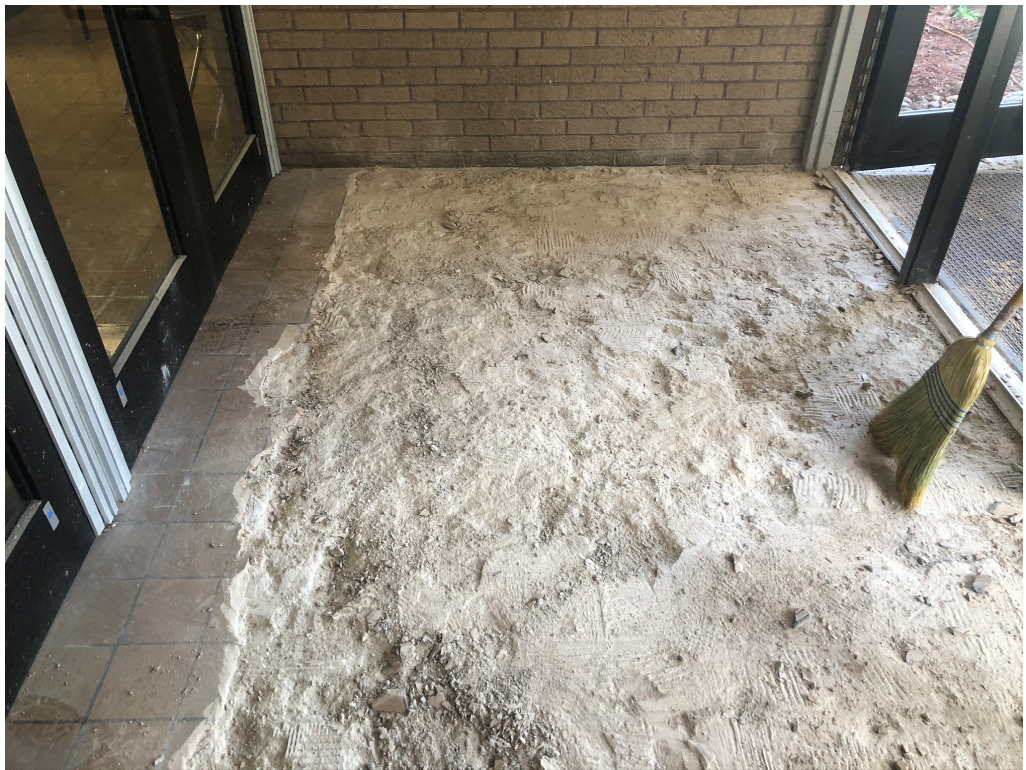
Observations Arriving on site, I entered at the main entry. Workers were demoing the front entry tile. Also, in this area, a worker was prepping tile with a grinder.

Figure 1 – Demoed Floor Tile

Figure 2 – Demoed Floor Tile

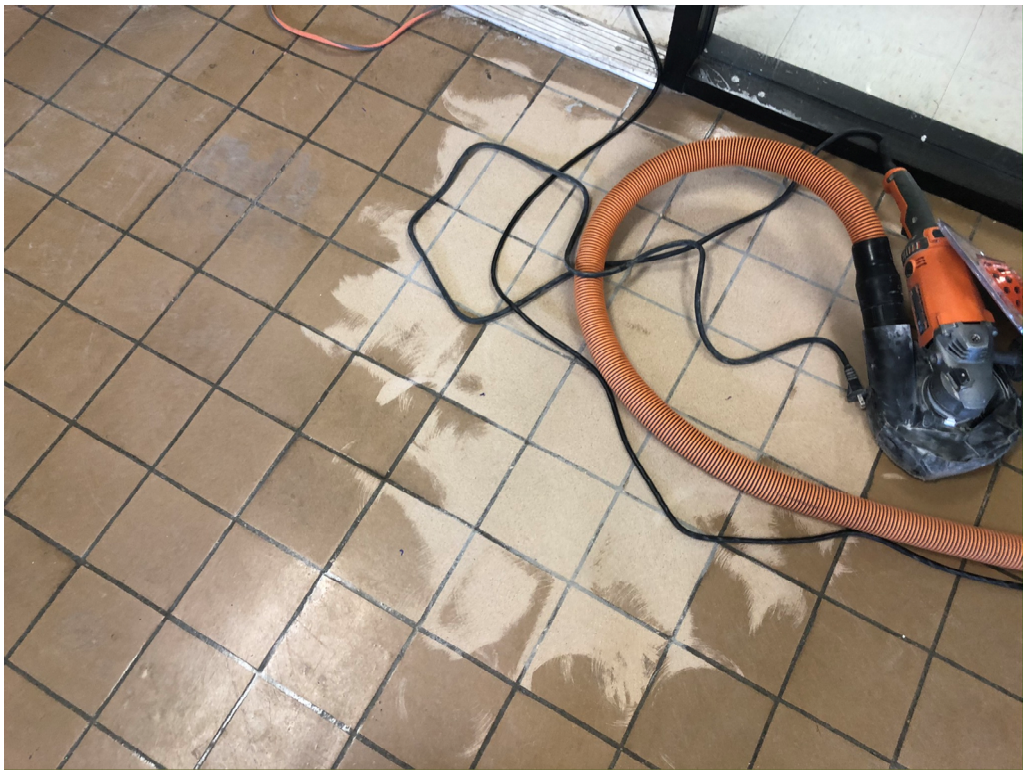
Figure 3 – Tile Grinding for Prep

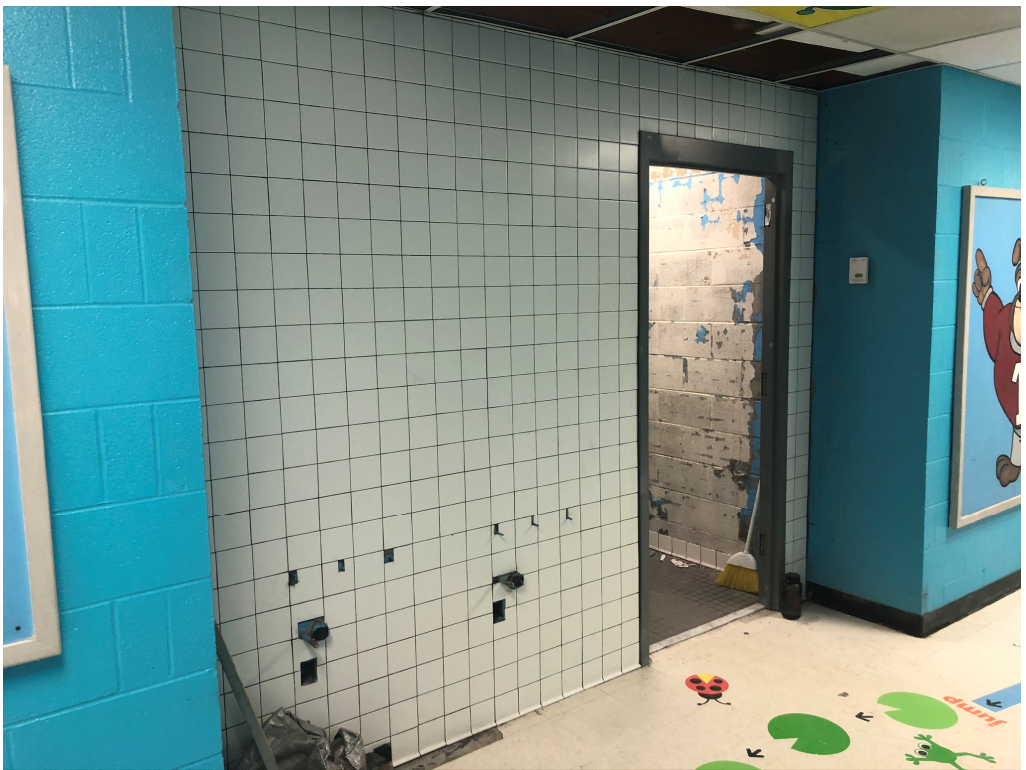
Figure 4 – Tile Installed at Wall

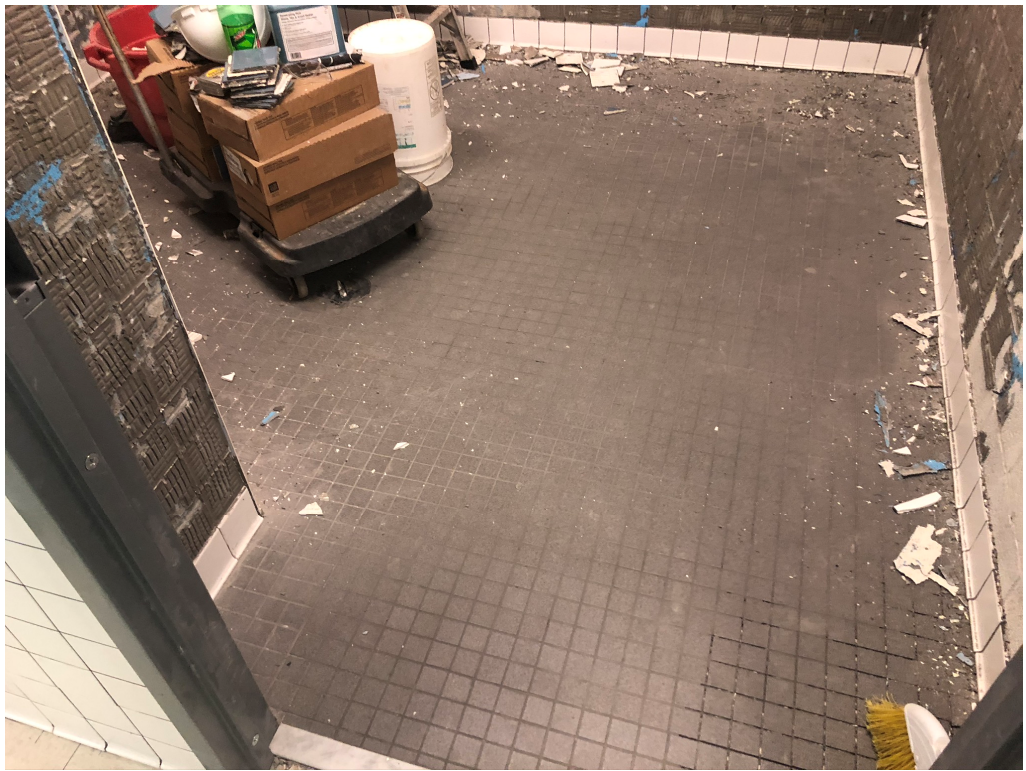
Tile demo is in progress at rejected tile in the new ADA bathroom.

Figure 5 – Floor Tile Installed; Tile rejected is being removed

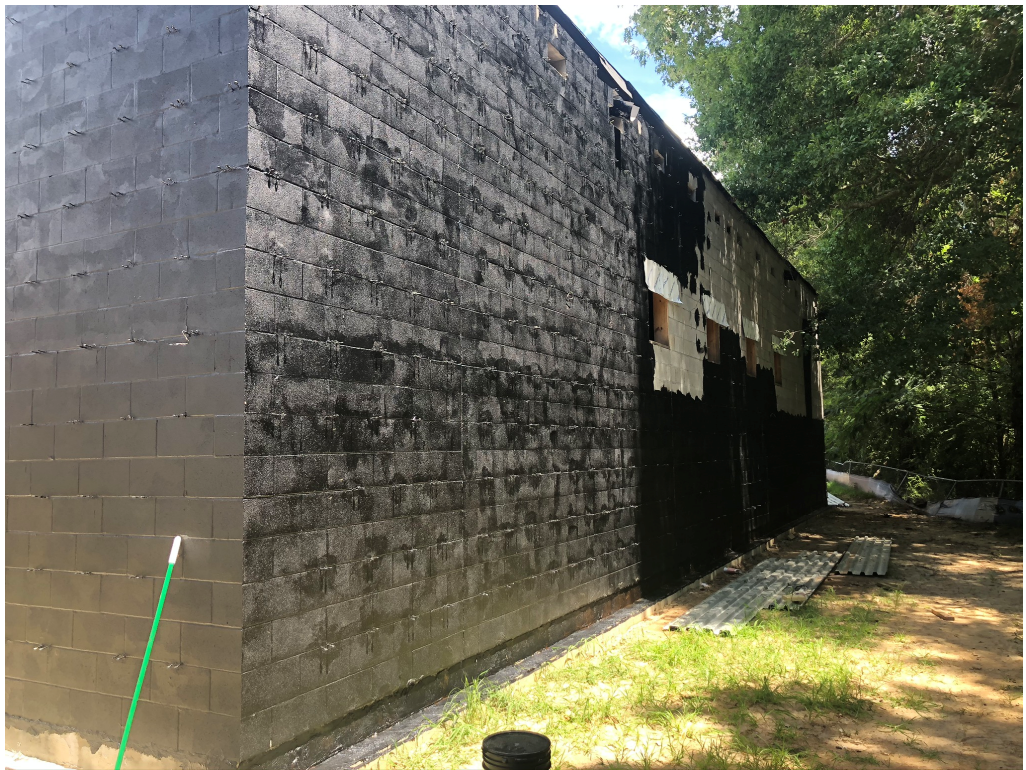
At the addition, damp-proofing is in progress at the exterior CMU walls.

Figure 6 – Damp-proofing at CMU

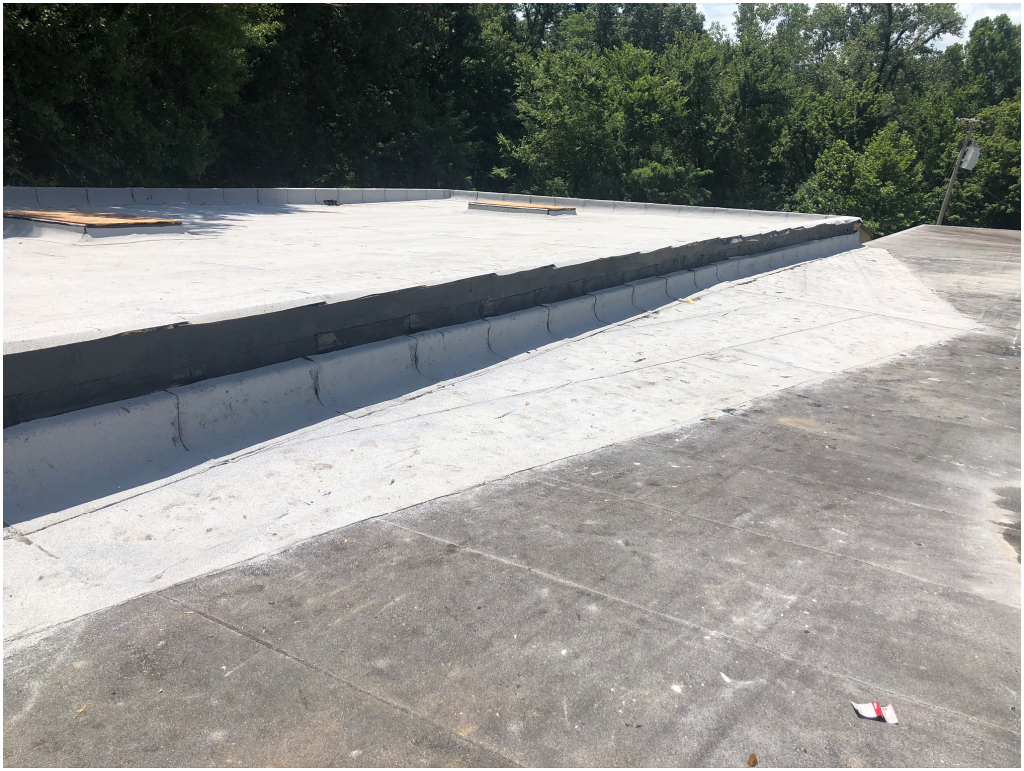
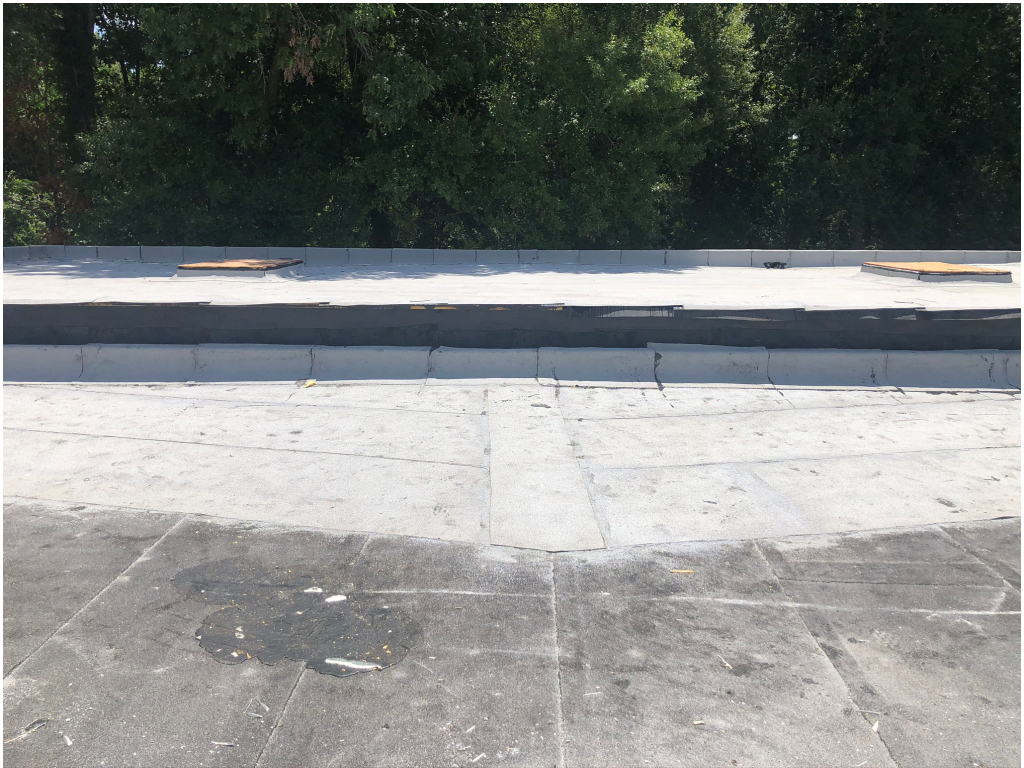
Figure 7 – Roofing at Cricket and New Roof

Figure 8 – Roofing at Cricket and New Roof

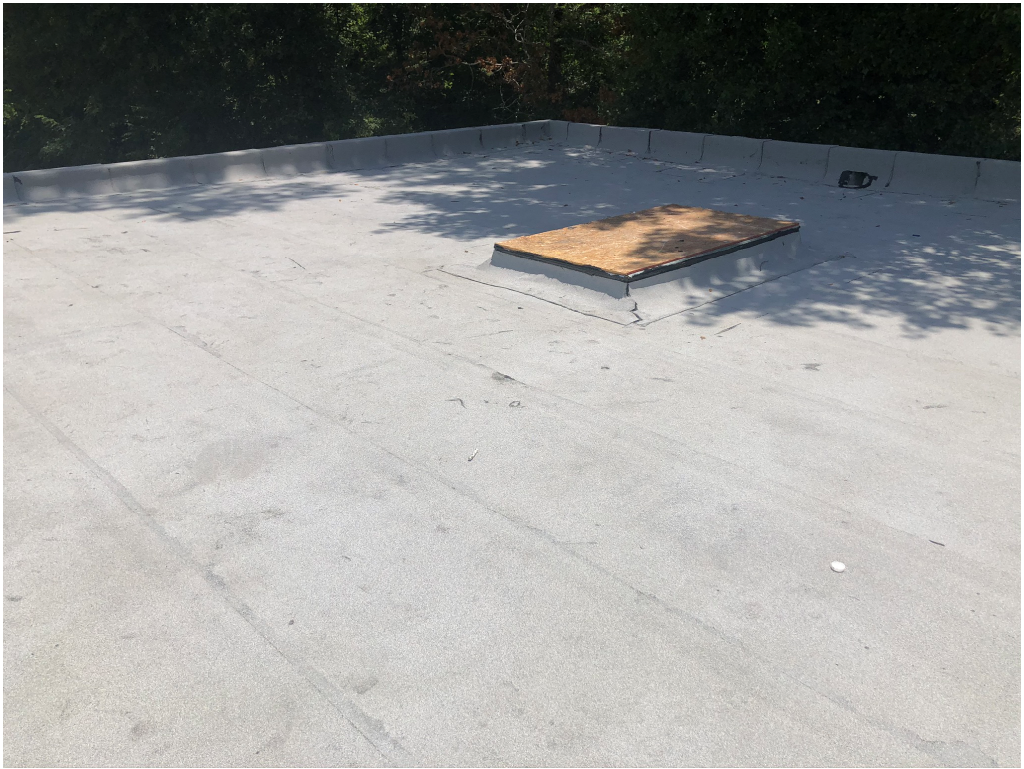
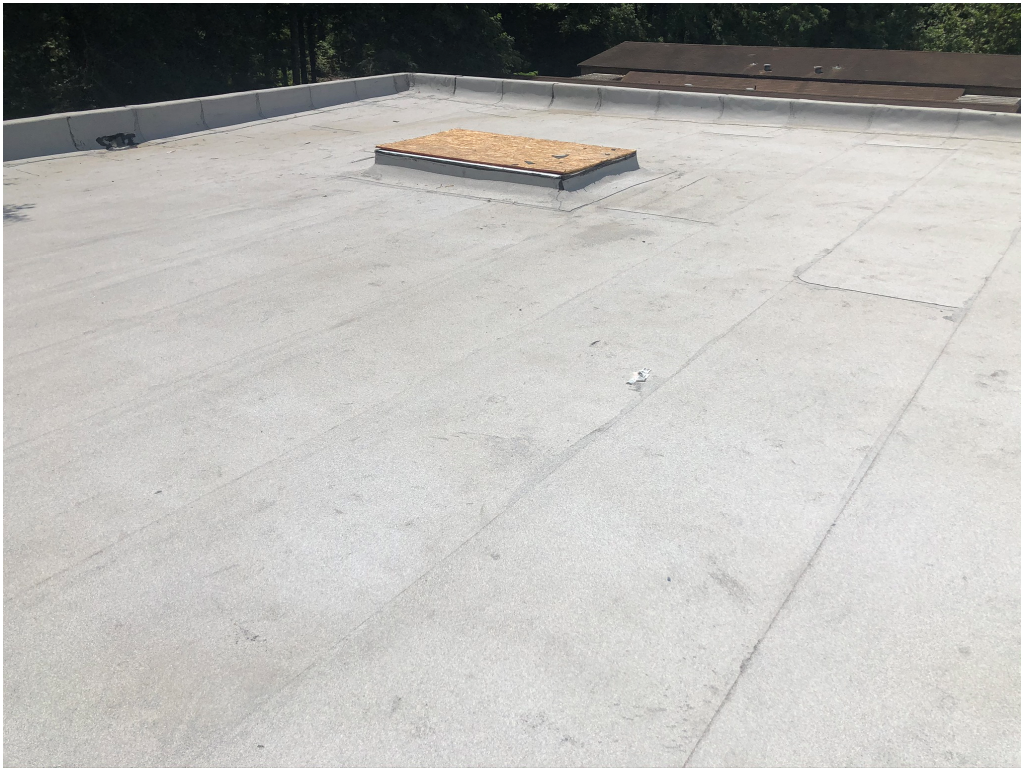
Figure 9 – Roofing Installed

Figure 10 – Roofing Installed

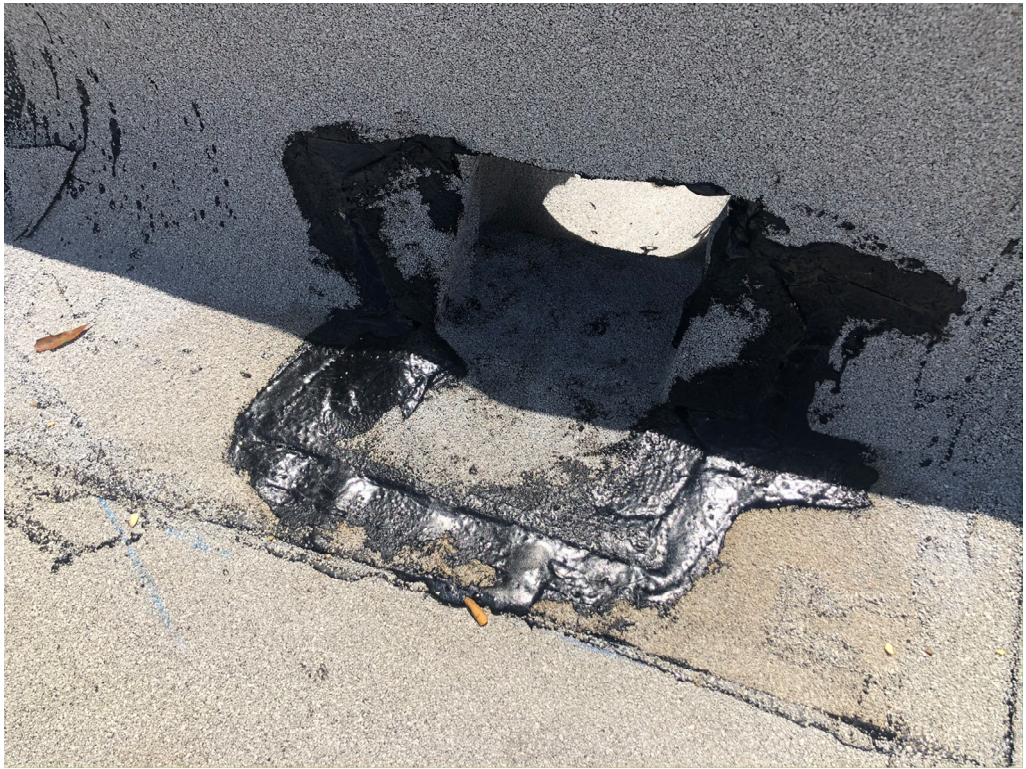
Figure 11 – Roof Drainage Outlet

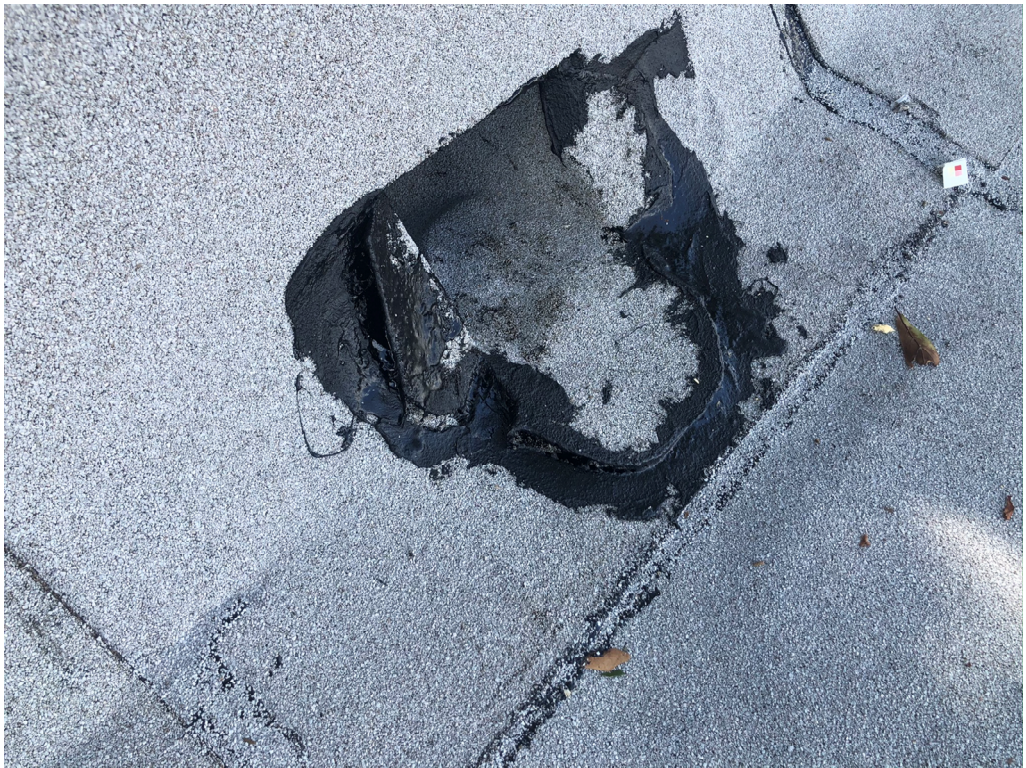
Figure 12 – Roof Outlet; roll roofing needs to be re-adhered

Action Required Re-adhere roll roofing at scuppers

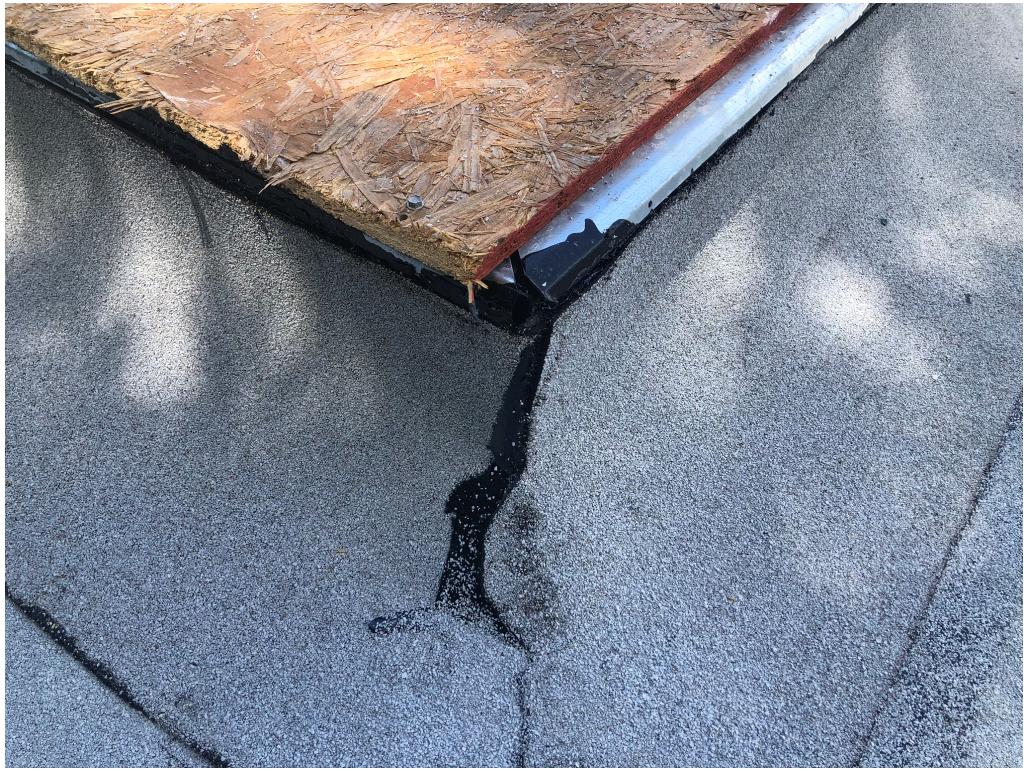
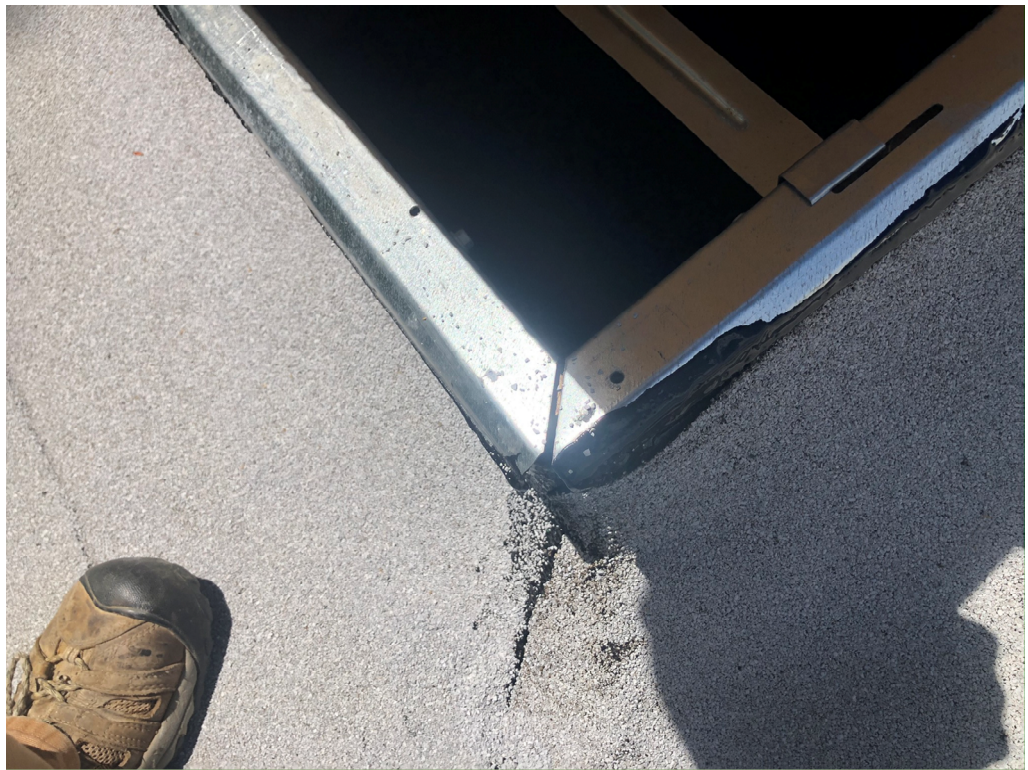
Figure 13 – Corner Detail at Roof Curbs

Figure 14 – Corner Detail at Roof Curbs
