Architect's Field Report

18050-South Park Elementary / Report Number 020

29 September 2020 / 2:45 PM

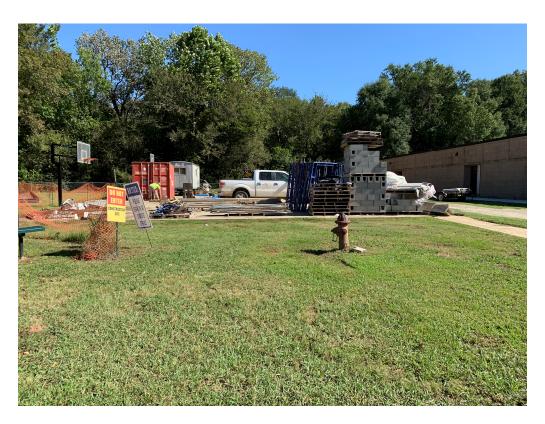
Figure 1 – Lay Down Area

Arriving on site, I met Wes Gill in the lay down area. He was closing up

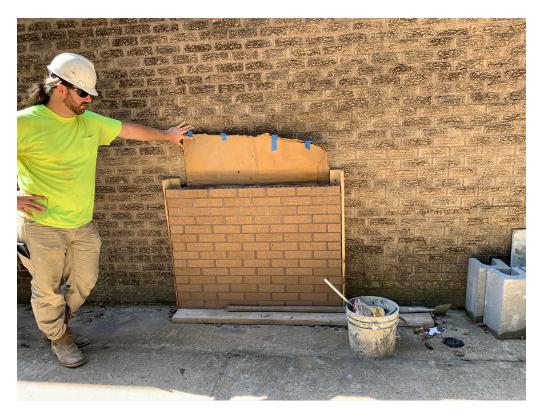
Figure 2 – Mock Up Brick Wall; there's some unevenness in the mortar color

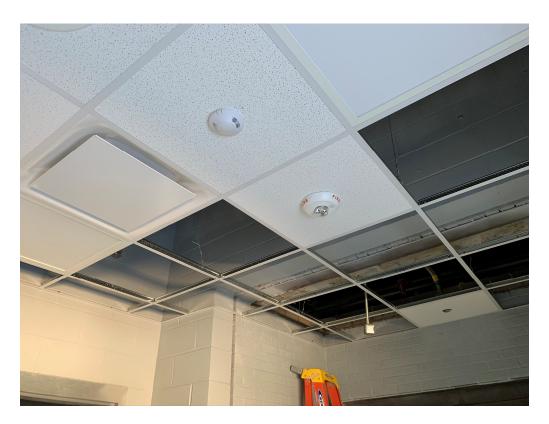
Figure 3 – Ceiling Grid Work

P 228.374.1409 F 228.374.1414 for the day. We walked the addition and reviewed the brick mock-up wall. Grid work is complete and awaiting above ceiling inspections from our engineers. Windows have also been installed at the upper wall

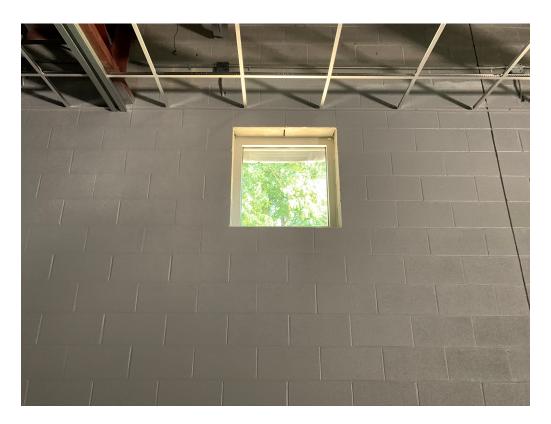
Figure 11 – Windows Installed at CMU Wall

sections of the rear addition.
