Architect's Field Report

21 October 2020

18050-South Park Elementary / Report Number 021

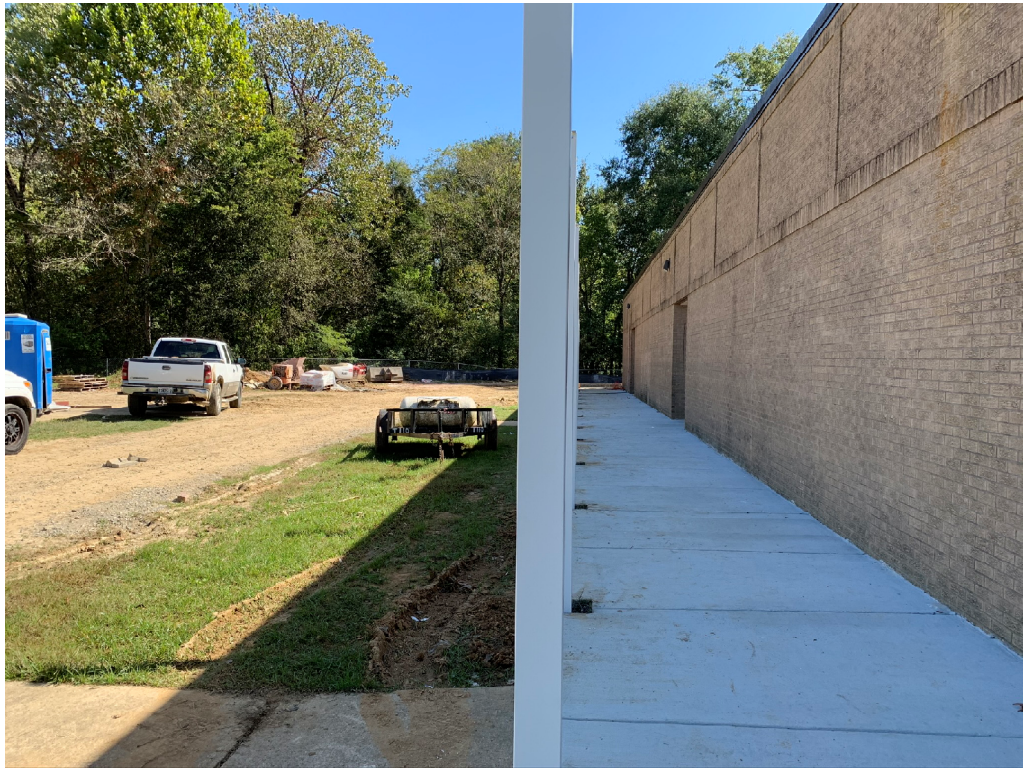
Figure 1 – Awning Columns Set

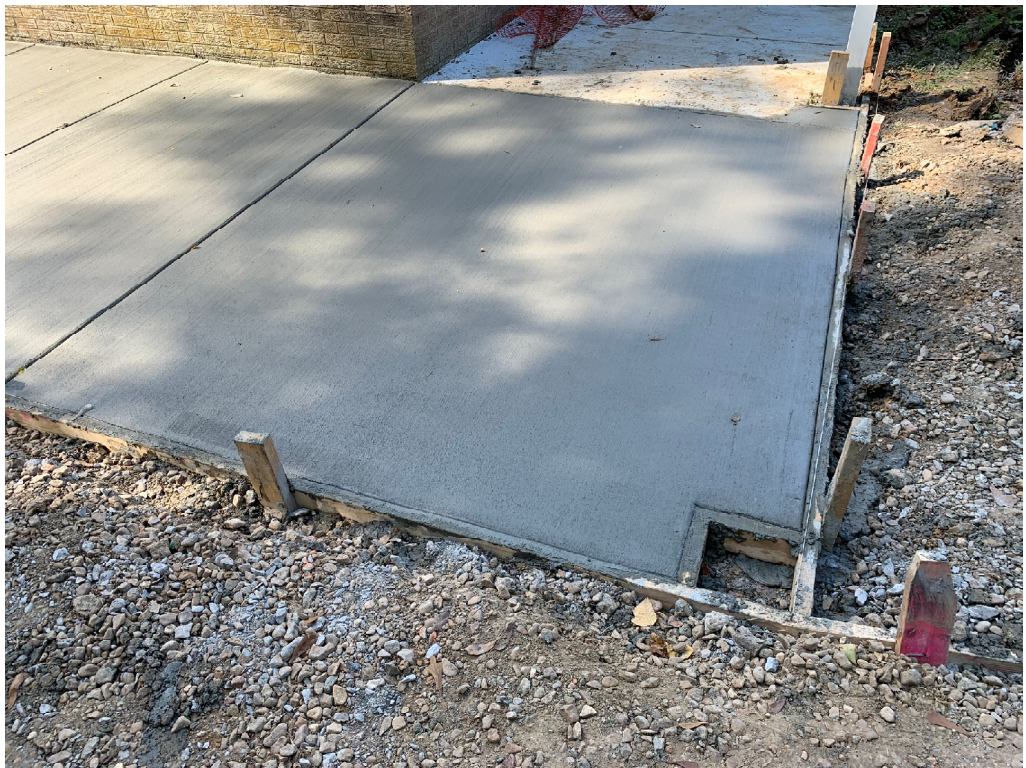
Figure 2 – Sidewalk Install

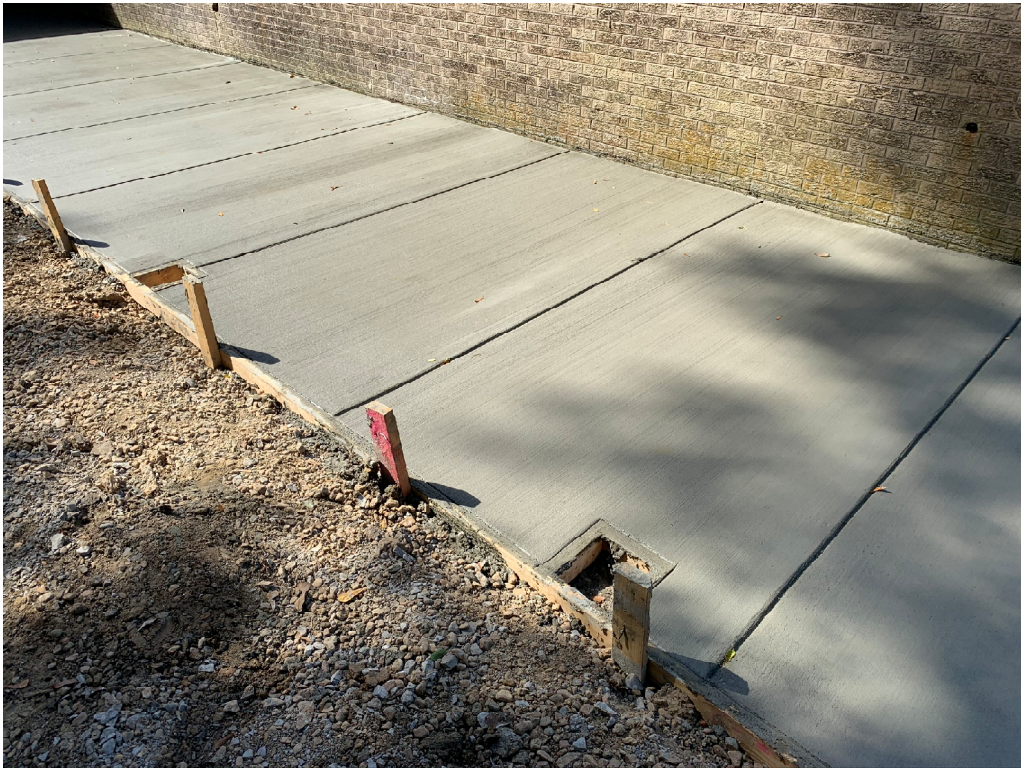
Figure 3 – Sidewalk Install

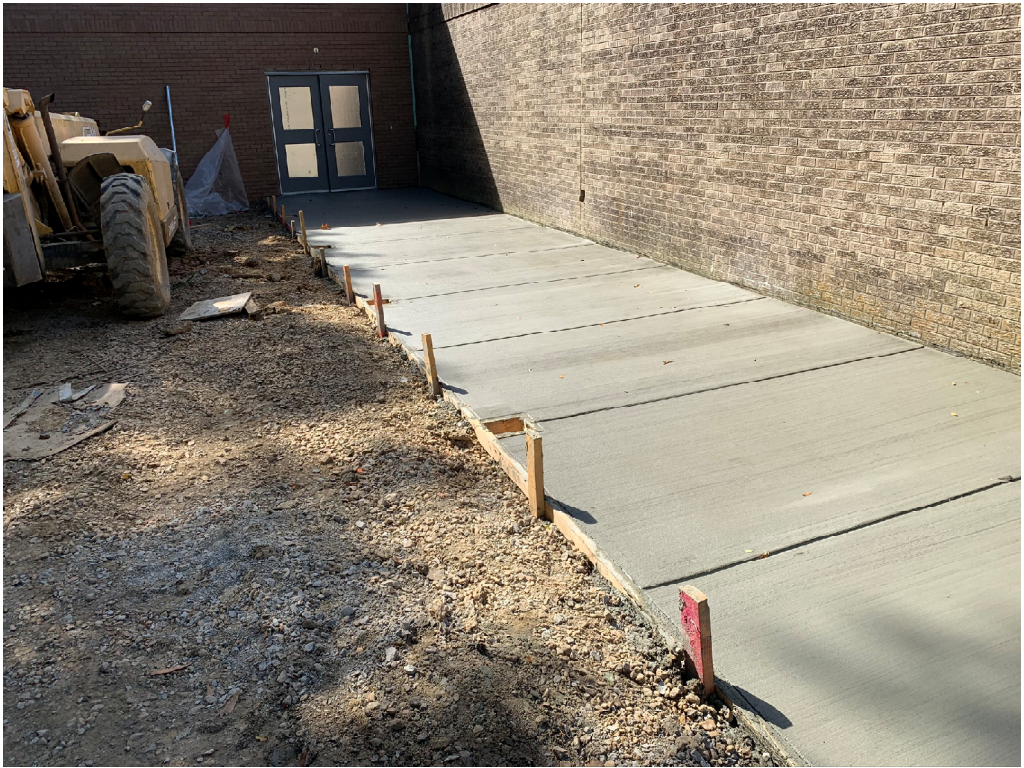
Figure 4 – Sidewalk Install

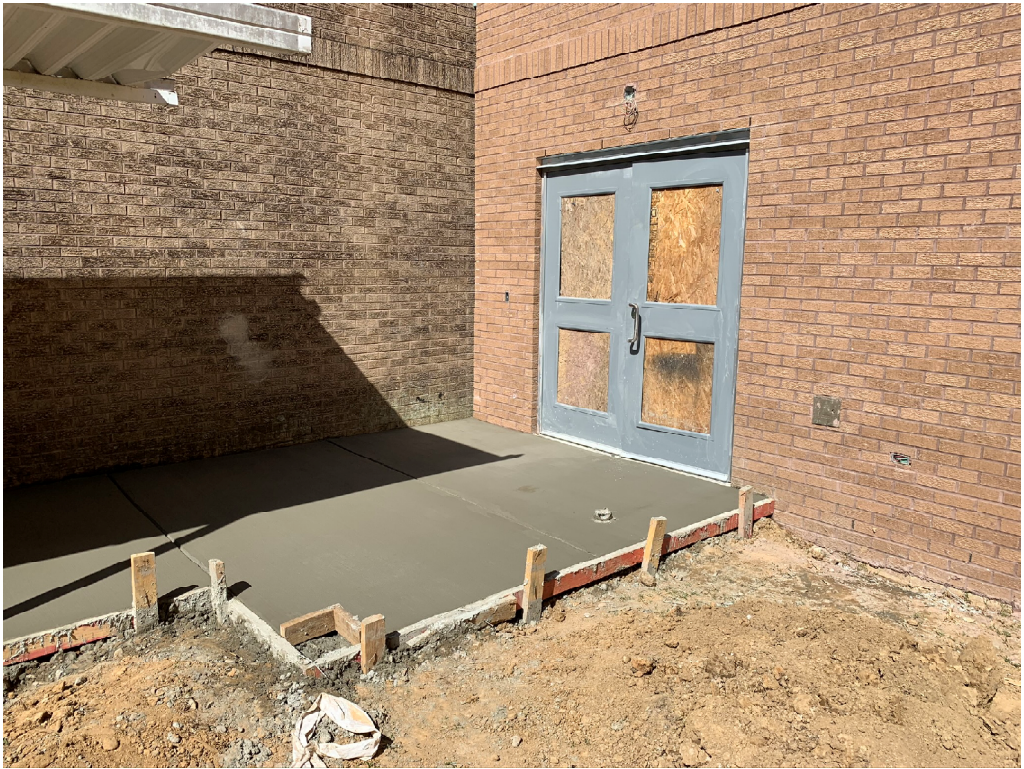
Figure 5 – Sidewalk Install

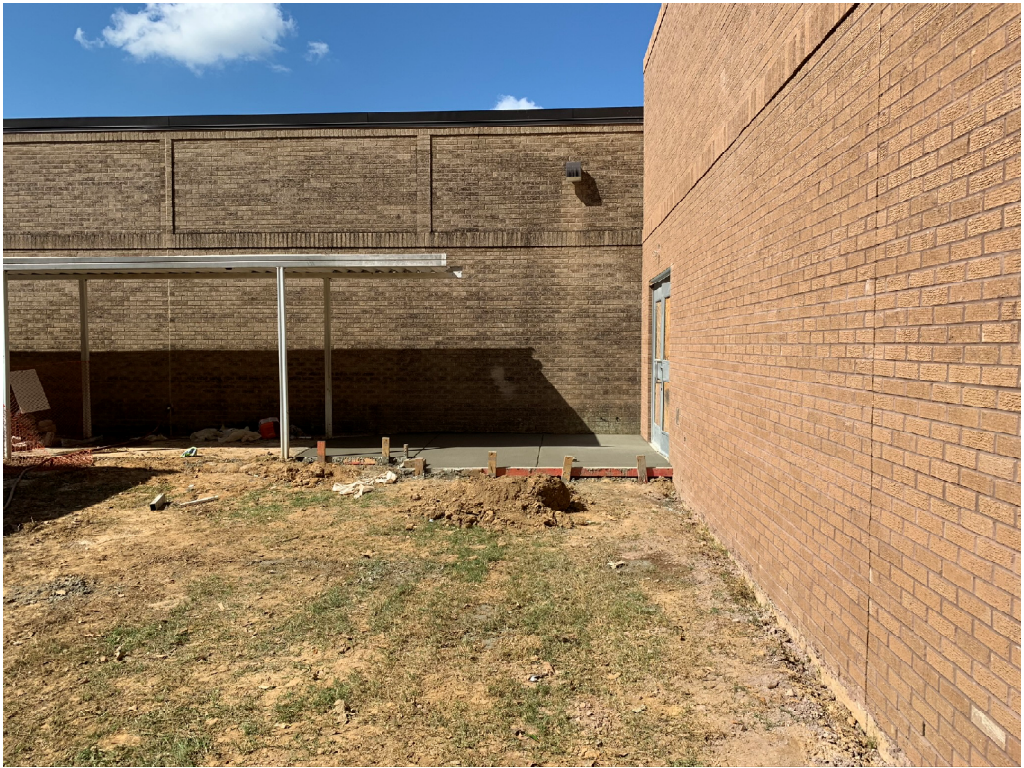
Figure 6 – Sidewalk Install

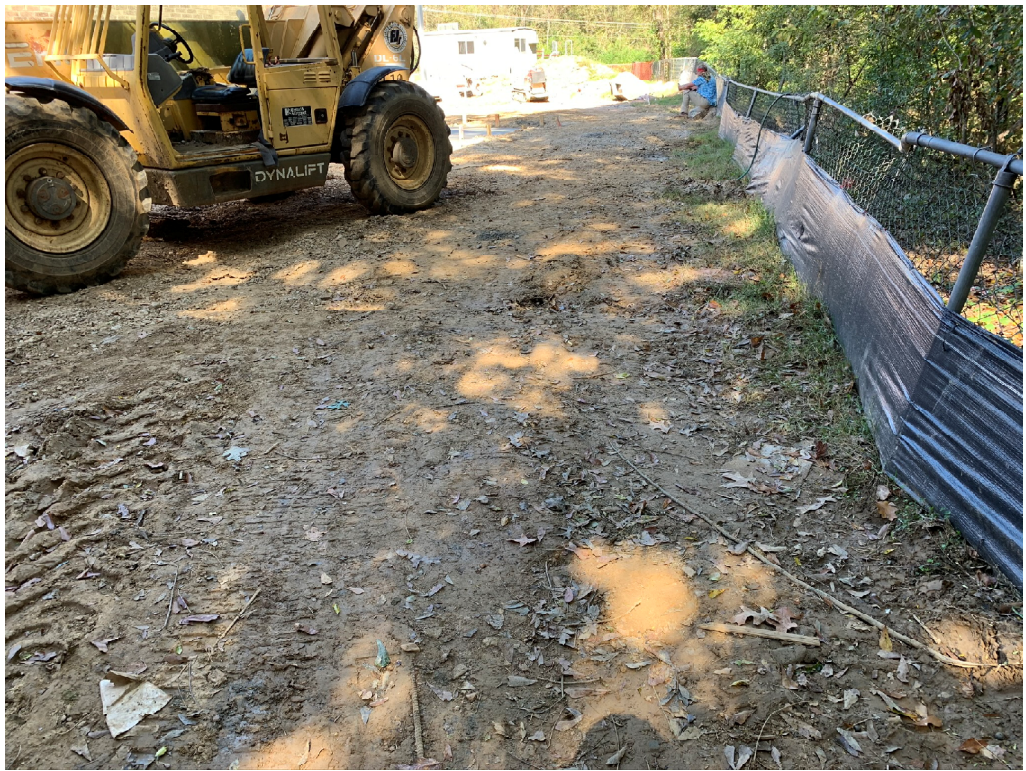
Figure 7 – Back Corner of Addition

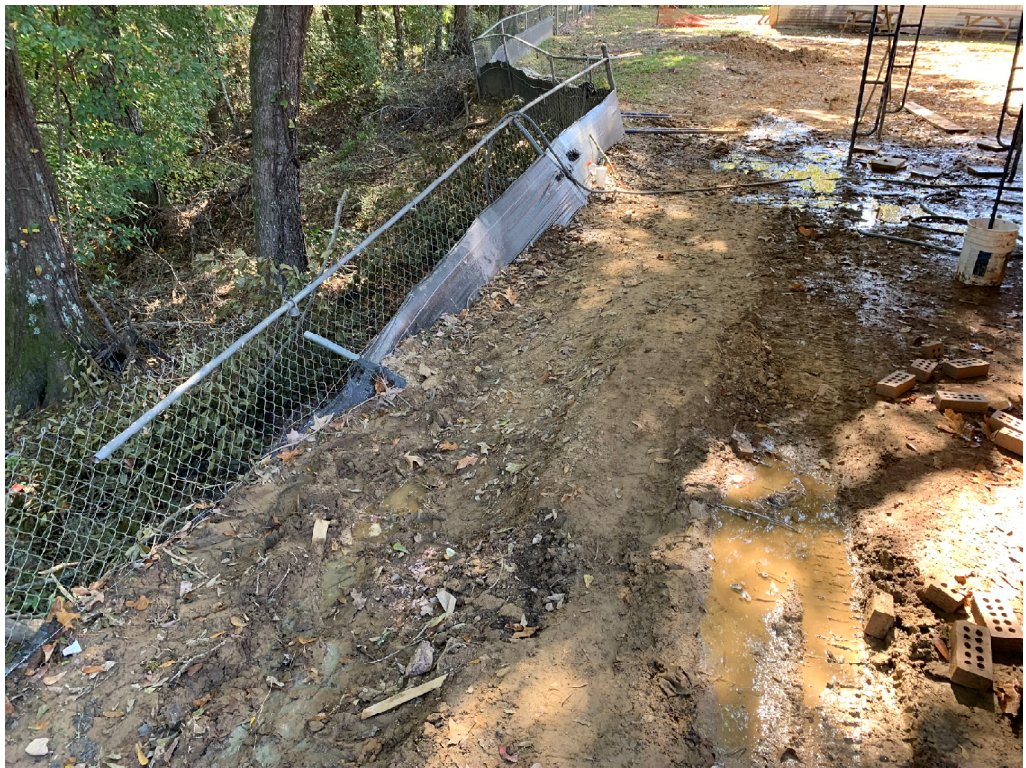
Figure 8 – Back Corner of Addition

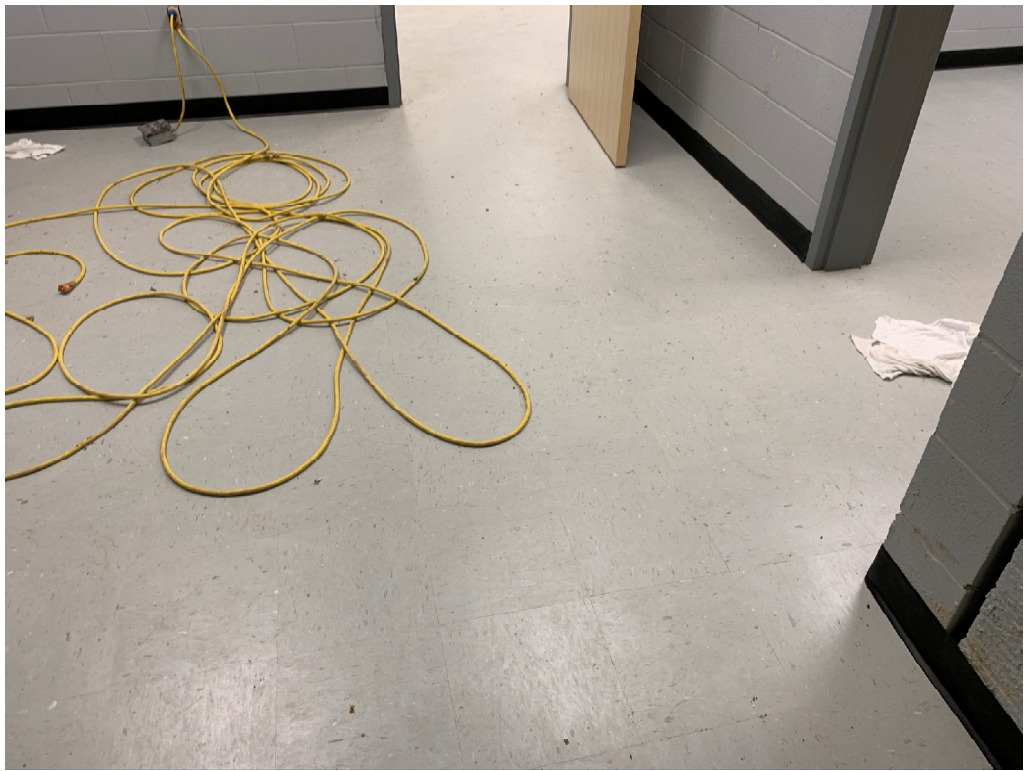
Inside, flooring has been installed and painters were at work touching up. Base at the new floor is of good workmanship, however it does not have preformed corners as required in specifications.

Figure 9 – Base Installed; preformed corners are required at inside and outside corners per spec

Items to Verify None
Action Required Install Preformed Corners

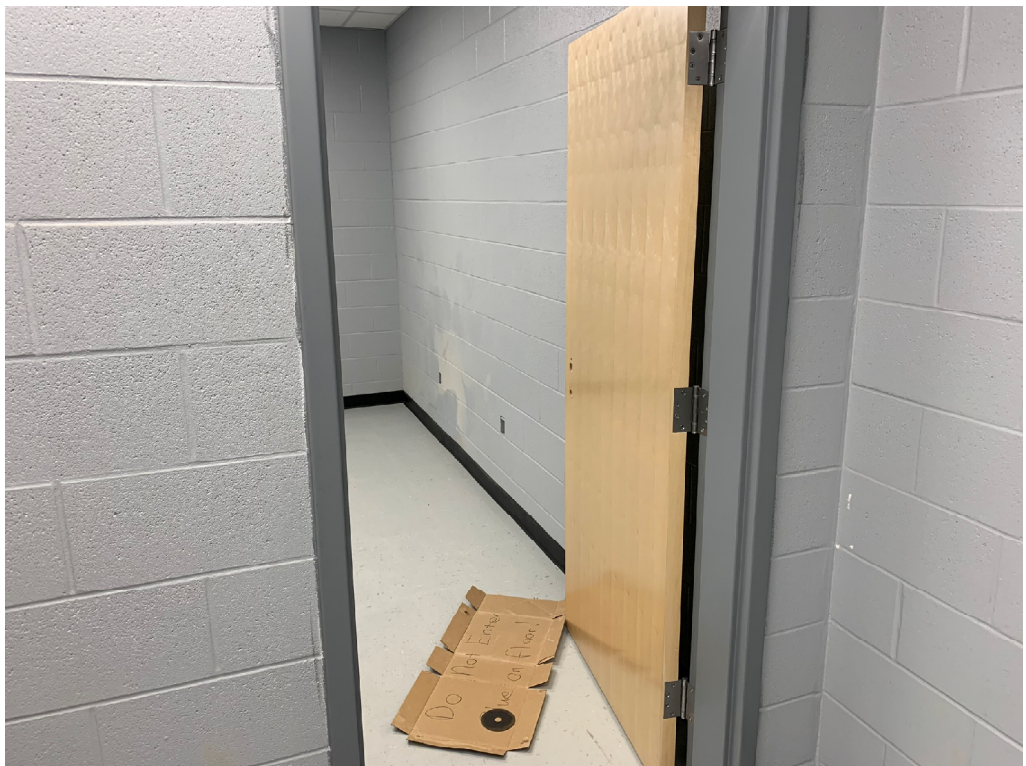
Figure 10 – Interior Door Panels Installed

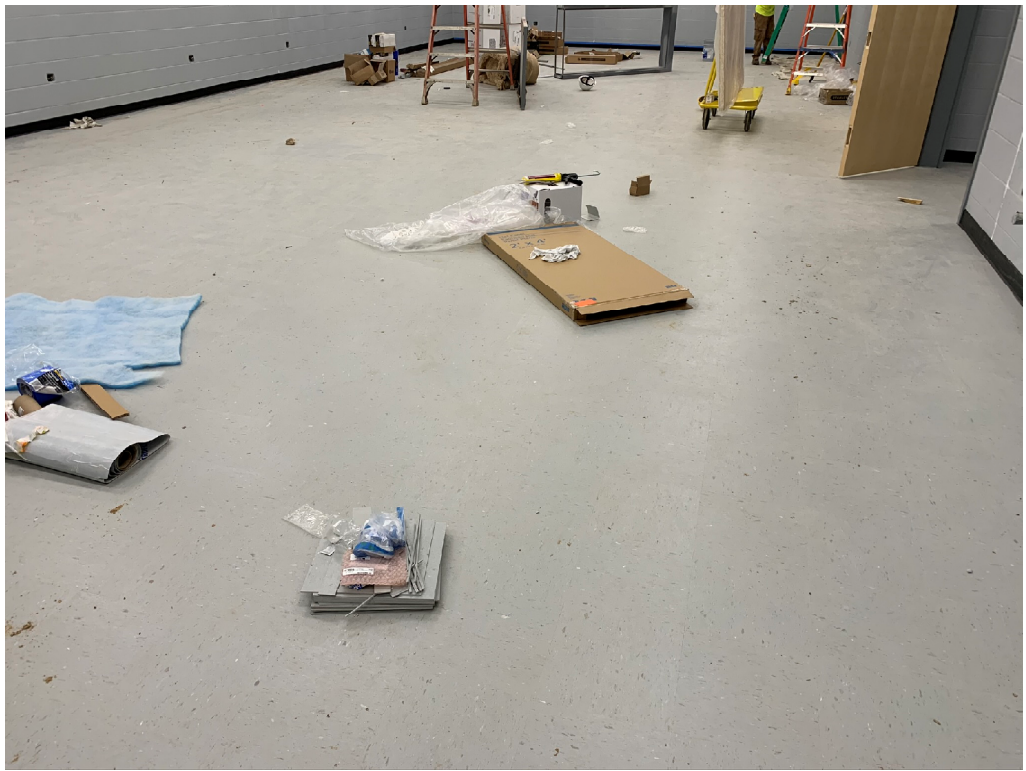
Figure 11 – VCT Flooring Installed

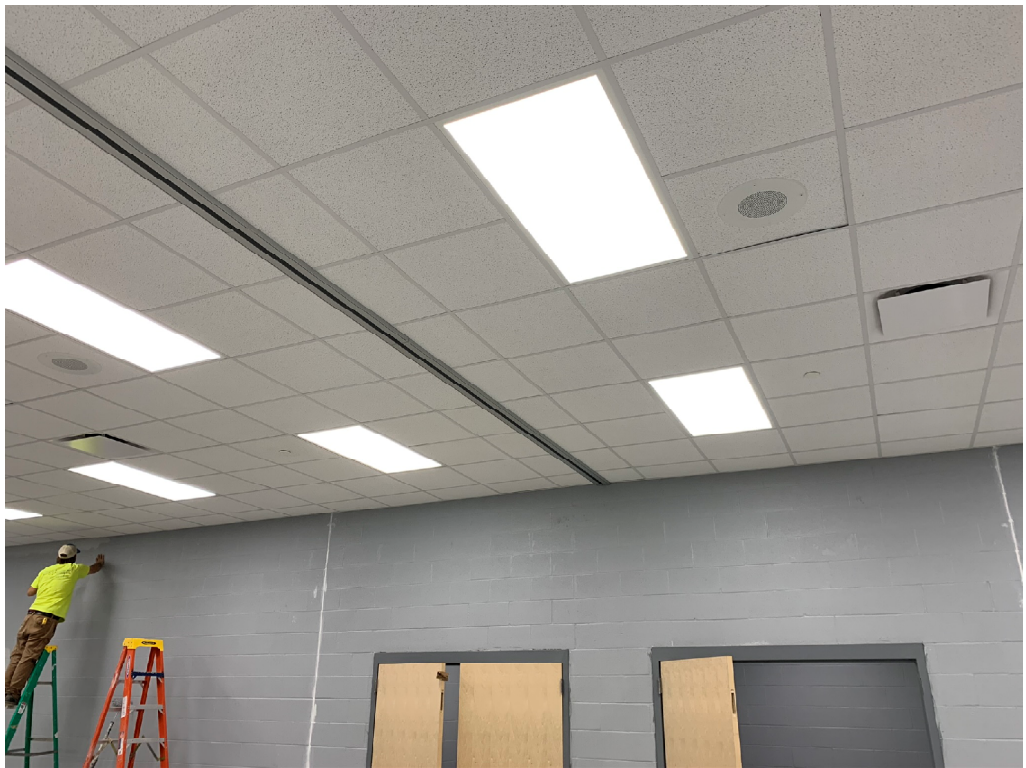
Figure 12 – Ceiling Tile Installed

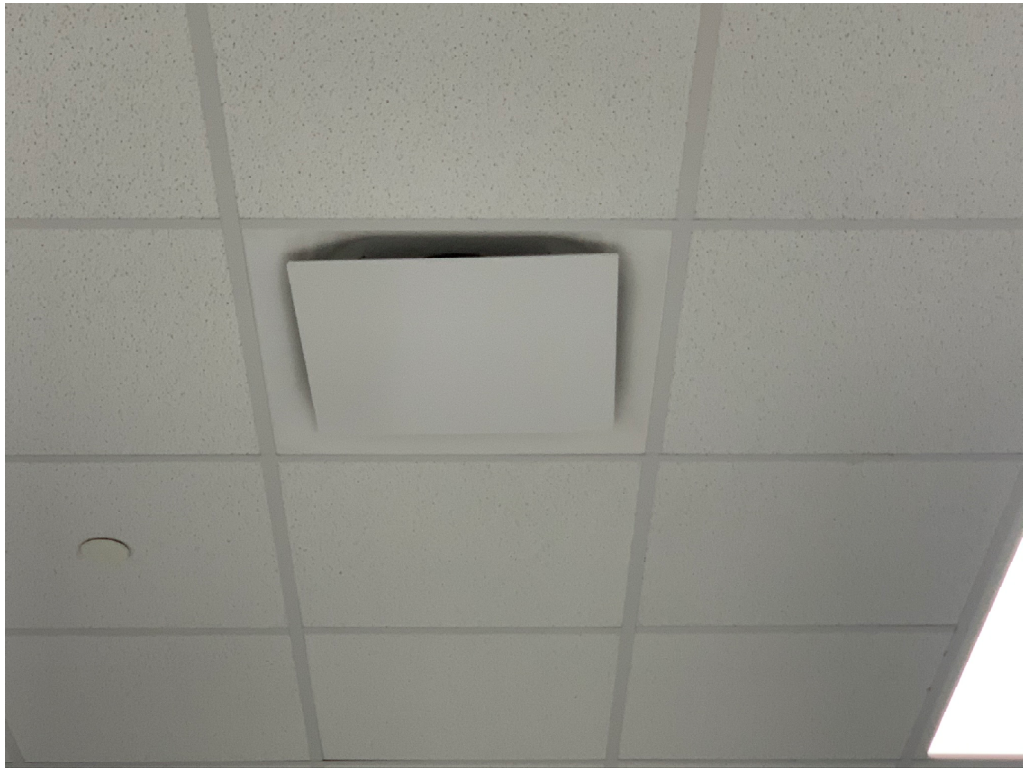
Figure 13 – Crooked Vent at Ceiling Requires Correction

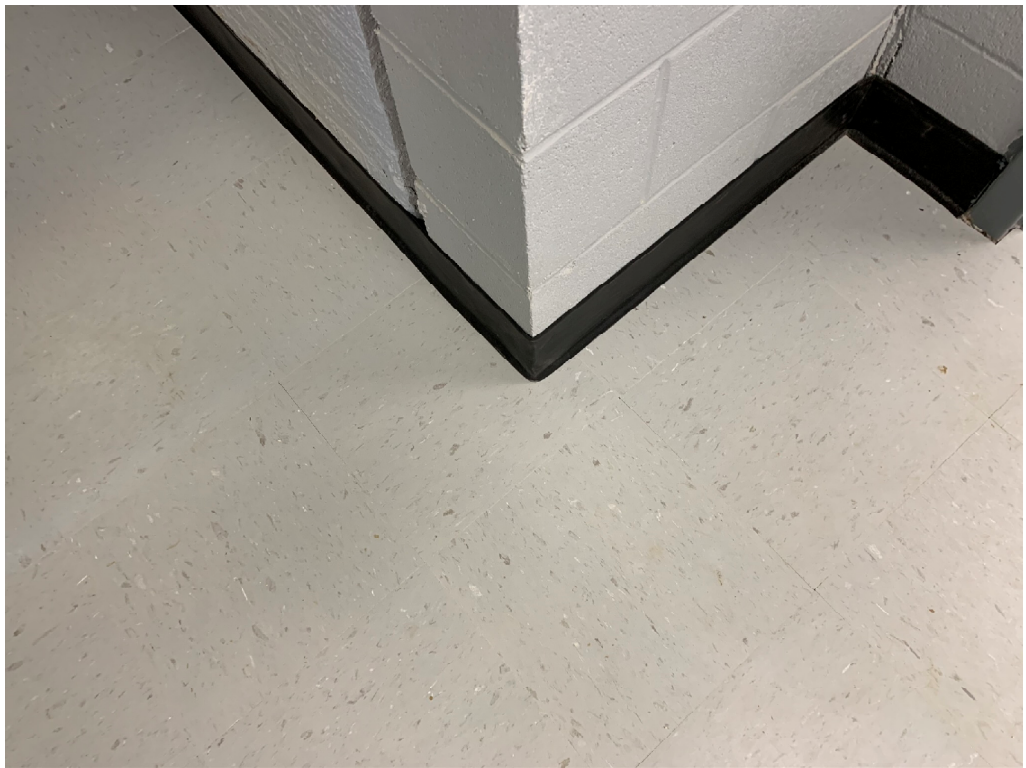
Figure 14 – Preformed Corners Required
