## Architect's Field Report

02 April 2020

18053-Vicksburg Junior High School / Report Number 004

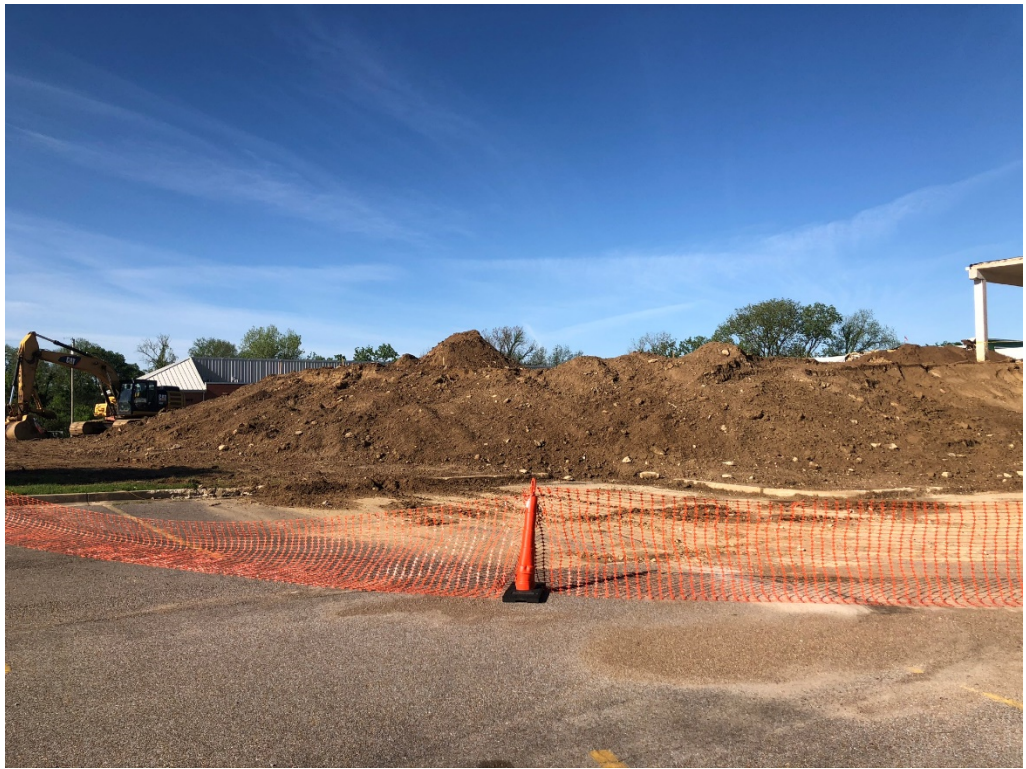
Observations Arriving, I entered the site from the front main parking area. I noted progress on site work and demolition of the front retaining wall. Saw cuts have been made and concrete slab removed at Upper walk.

Figure 1 – Retaining Wall Removed

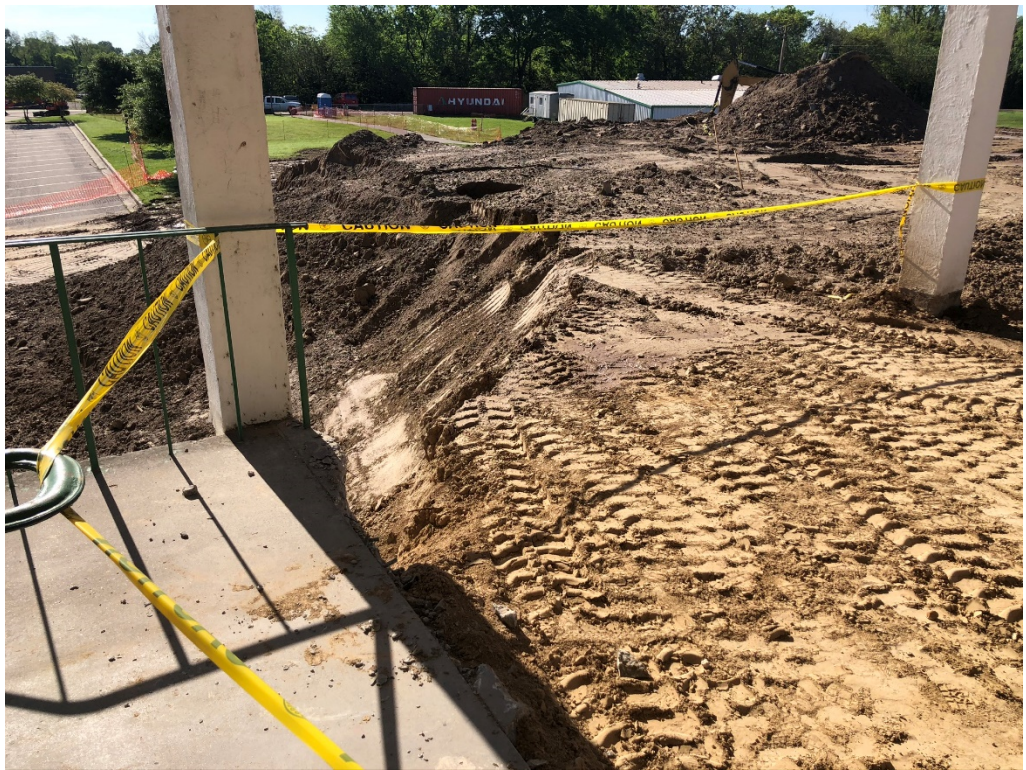
Figure 2 – Retaining Wall Removed

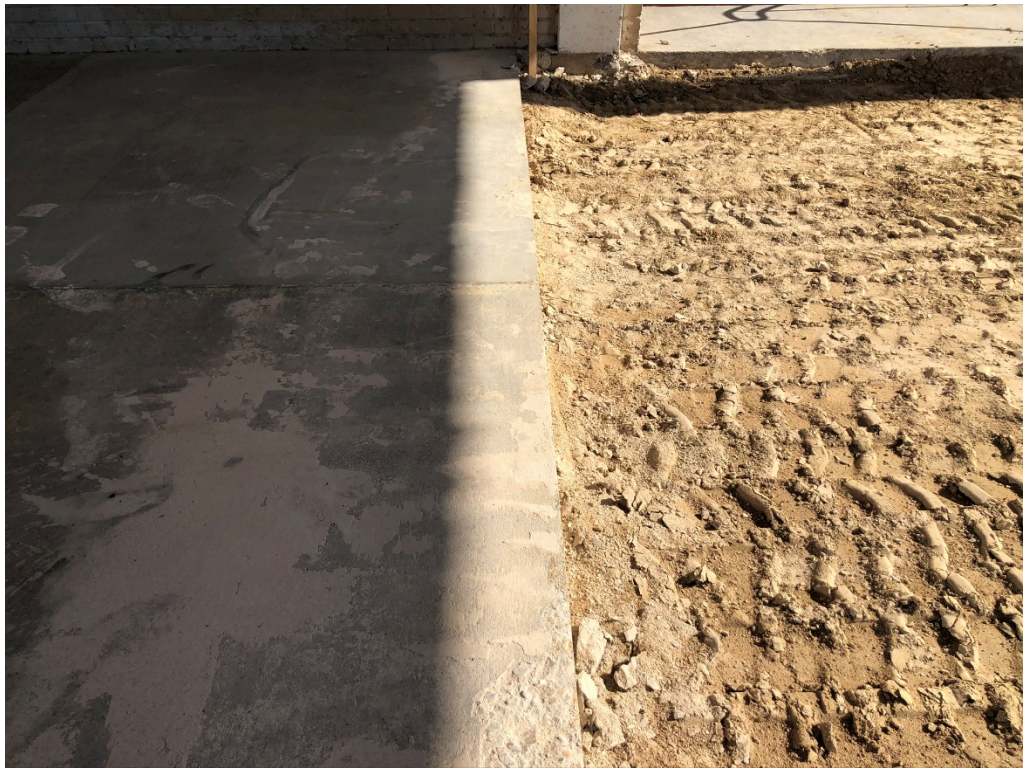
Figure 3 – Saw Cut at Removed Slab (Will Additional Saw Cut be made for 2'-0" Offset?)

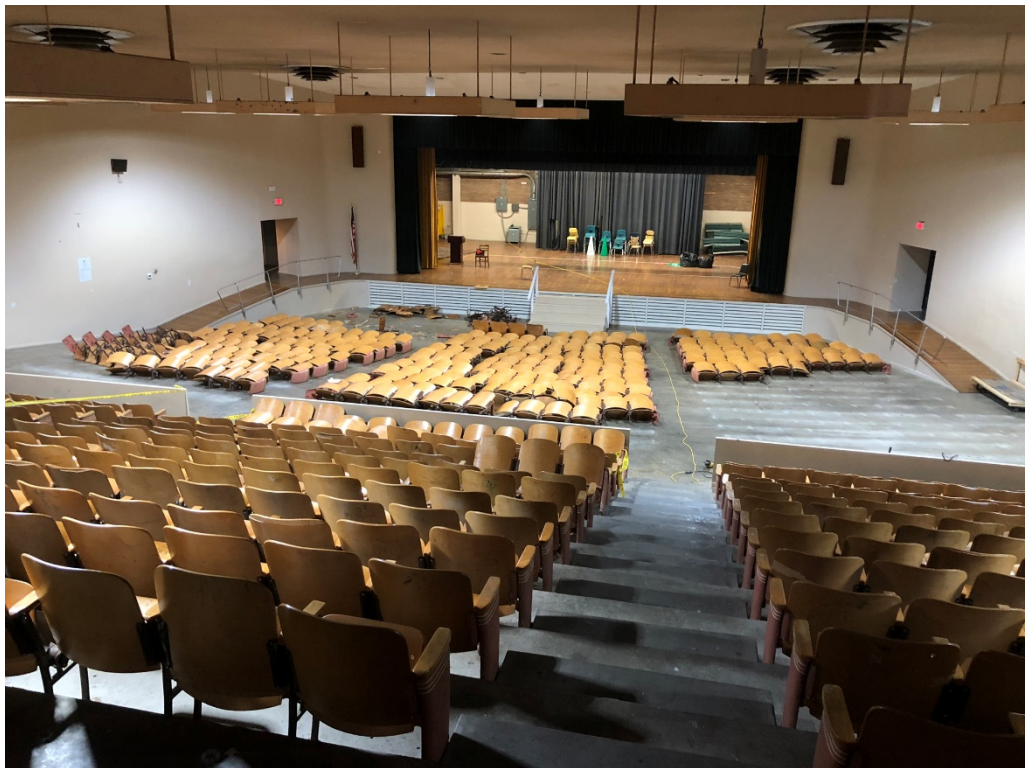
I entered building through auditorium as door was propped open from upper courtyard; at the auditorium, seats are being removed and metal studs holding them in place are being ground down to floor.

Figure 4 – Chair Demo at Auditorium

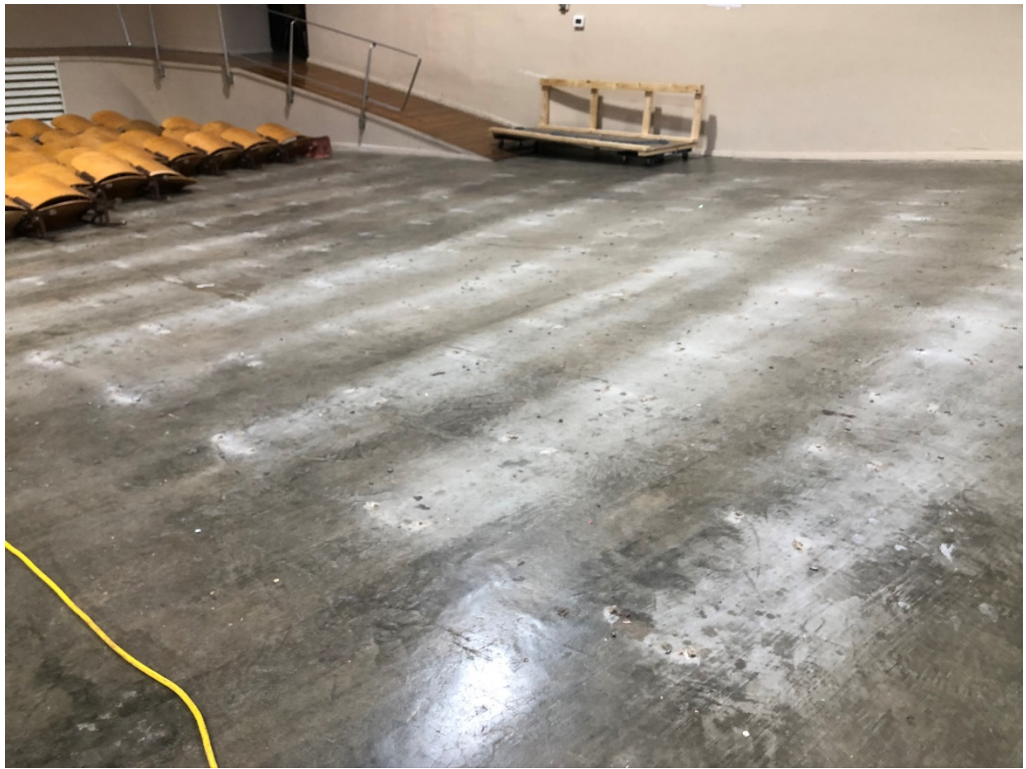
Figure 5 – Seats Removed from auditorium and metal studs ground to floor

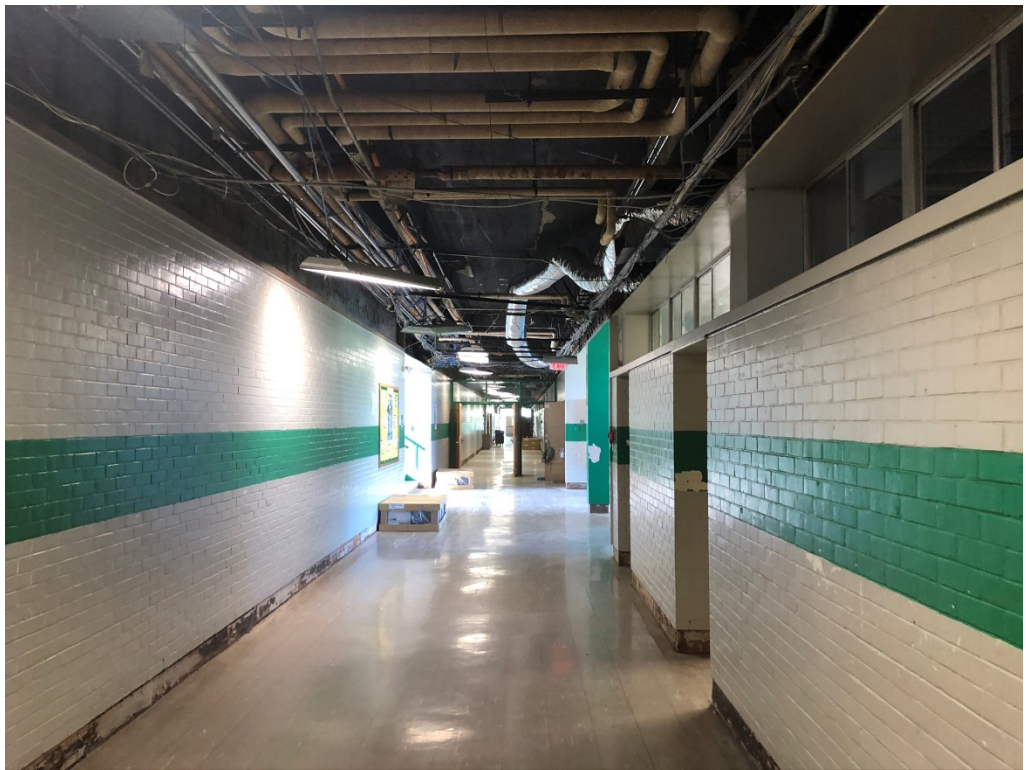
Entering the main hall from here, I see that mechanical installers have demoed ducting and are now organizing and preparing for installs of new HVAC equipment.

Figure 6 – Ducting Demo at Hallways

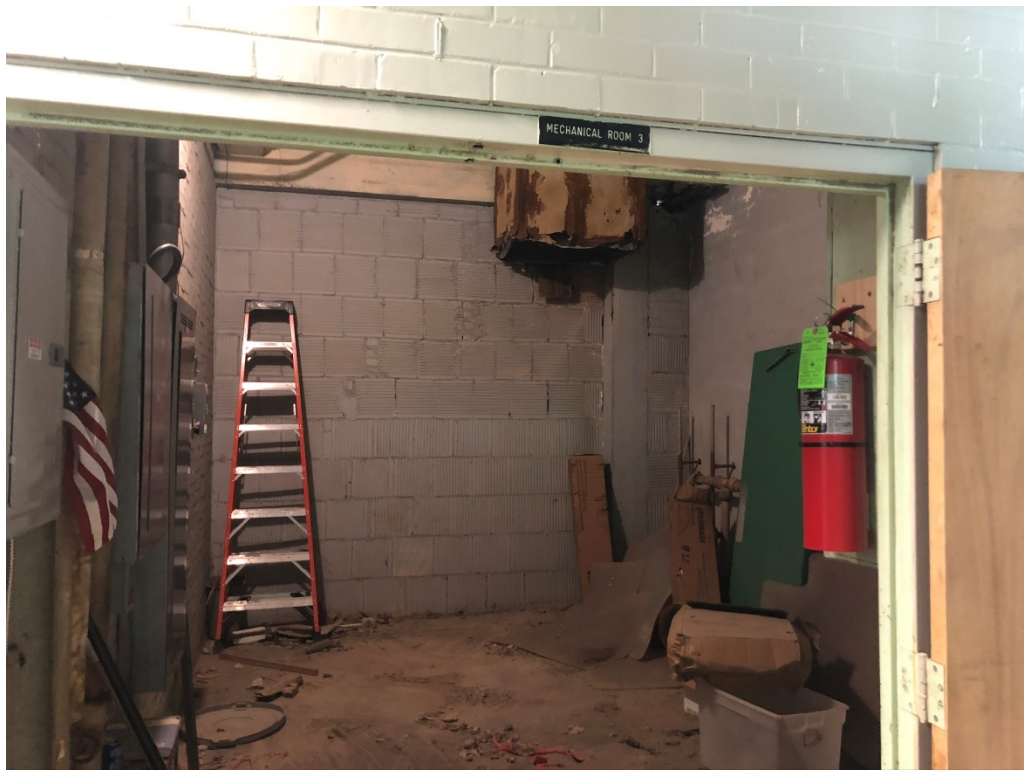
Figure 7 – Mechanical Room Demo

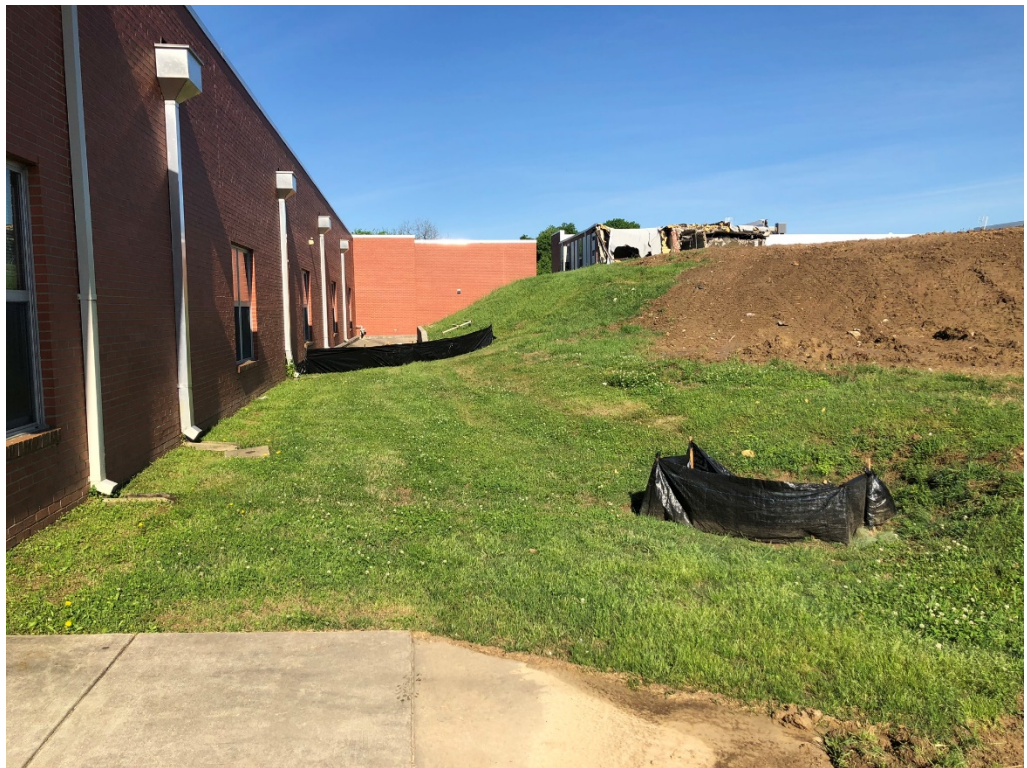
Figure 8 – Silt Fencing Installed

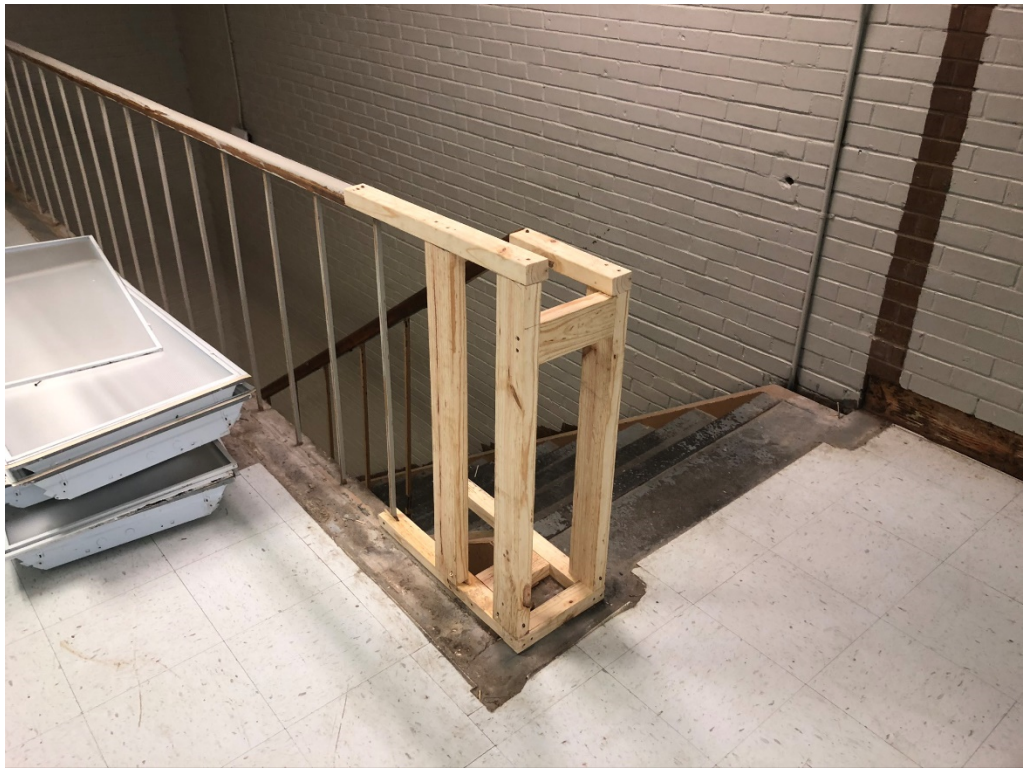
Figure 9 – Temp Handrails

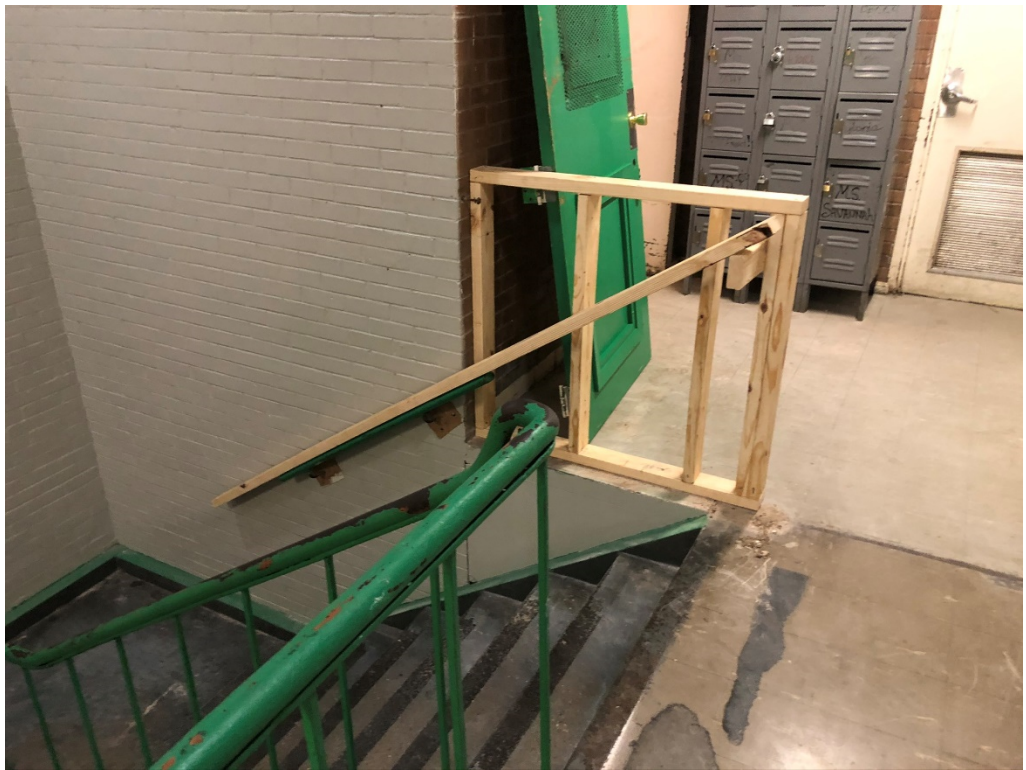
Figure 10 – Temp Handrails

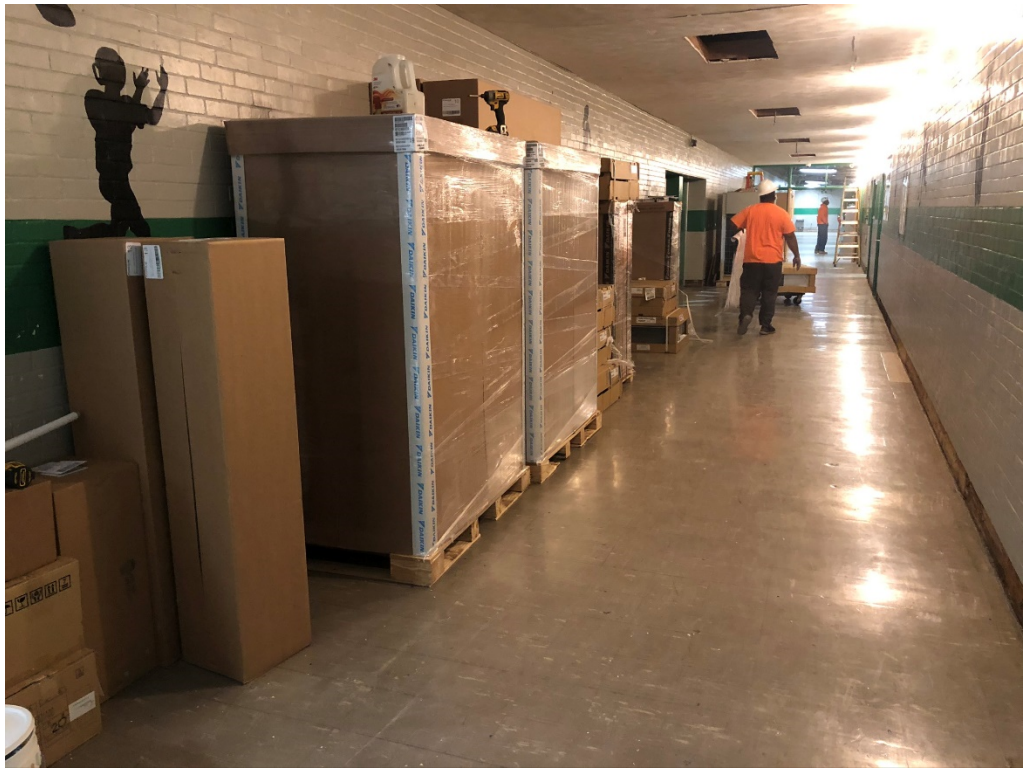
Walking the halls, I noted that lights in corridor E-200 have been removed and this hall is being used for staging of HVAC equipment at the moment.

Figure 11 – HVAC Equipment on Site Ready for Install

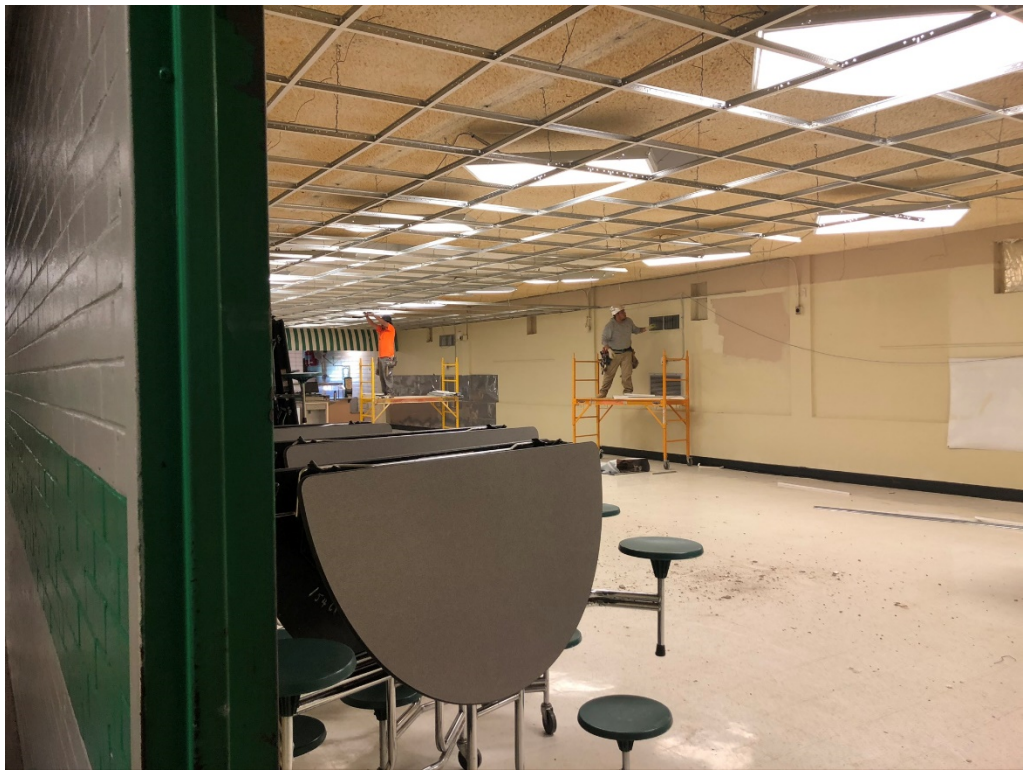
Ceiling grid demo at the cafeteria is also ongoing.

Figure 12 – Ceiling Grid Demo at Cafeteria
