## Architect's Field Report

23 April 2020

18053-Vicksburg Junior High School / Report Number 006

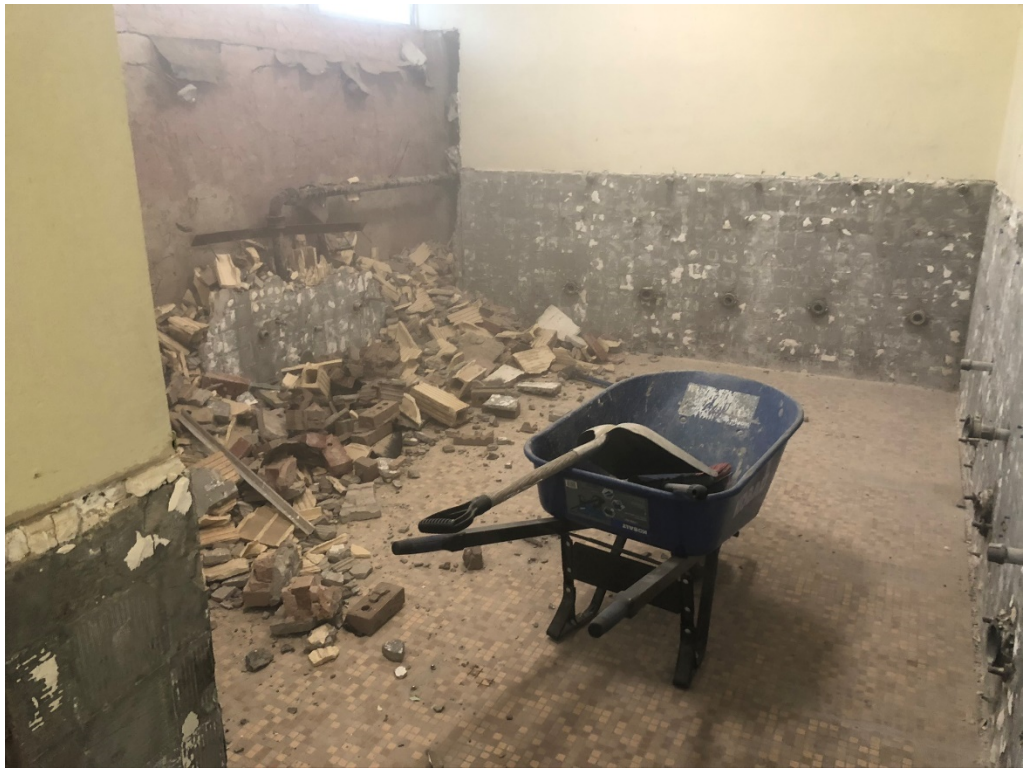
Observations Arriving on site, I entered at main entry and walked the main floor; I met Jay Wilson at the bathroom area that is under renovation. Workers were demoing a chase wall. We discussed this work and some outstanding RFI's.

Figure 1 – Bathroom Demo of Chase Wall

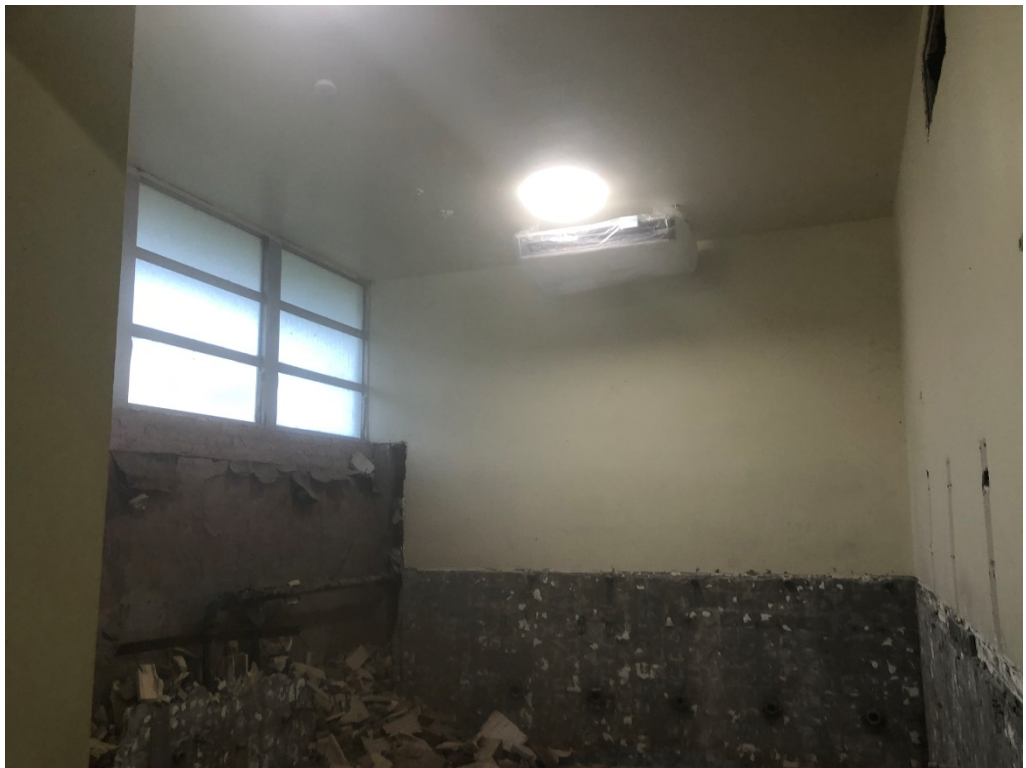
Figure 2 – Windows at Bath Area

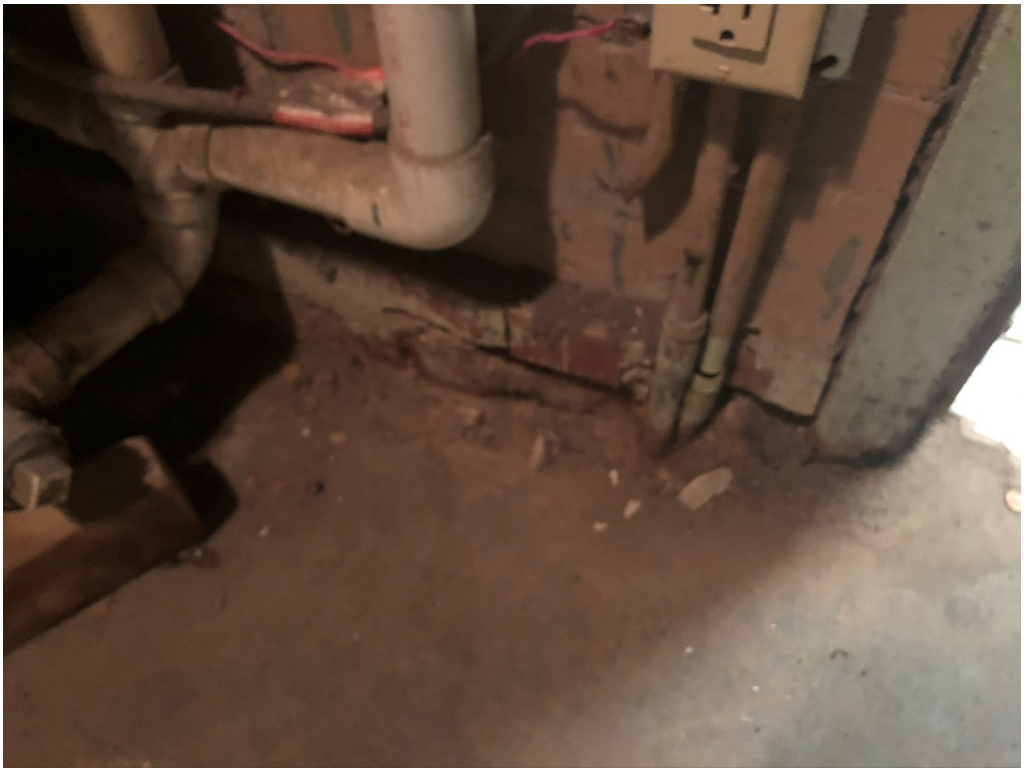
Figure 3 – Offset in lower 2 courses of brick (note mop sink in upper left)

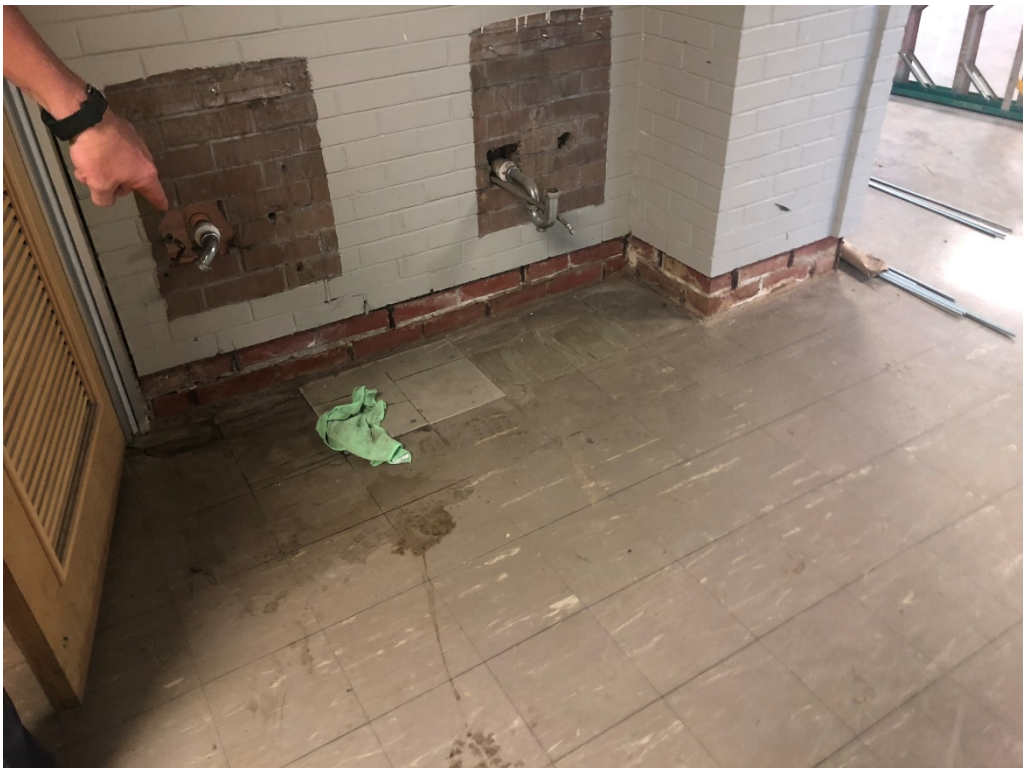
Figure 4 – Alcove for Fountains

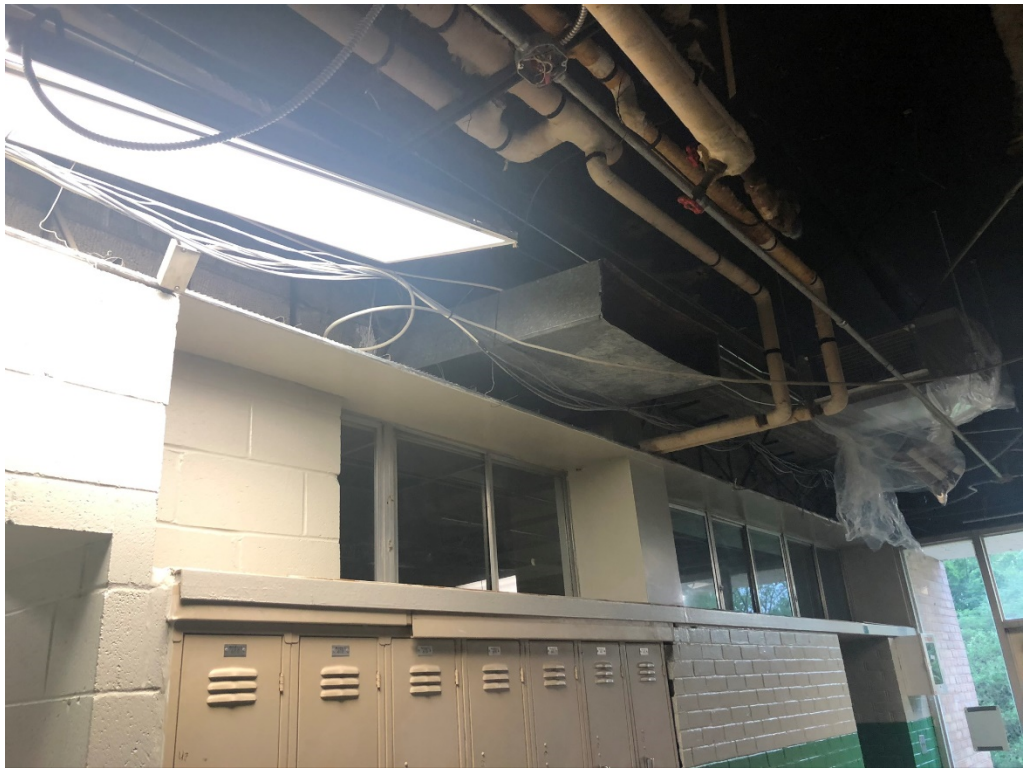
Figure 5 – Return to Sped E-227 (Contractor proposes to cap, leaving room without return)

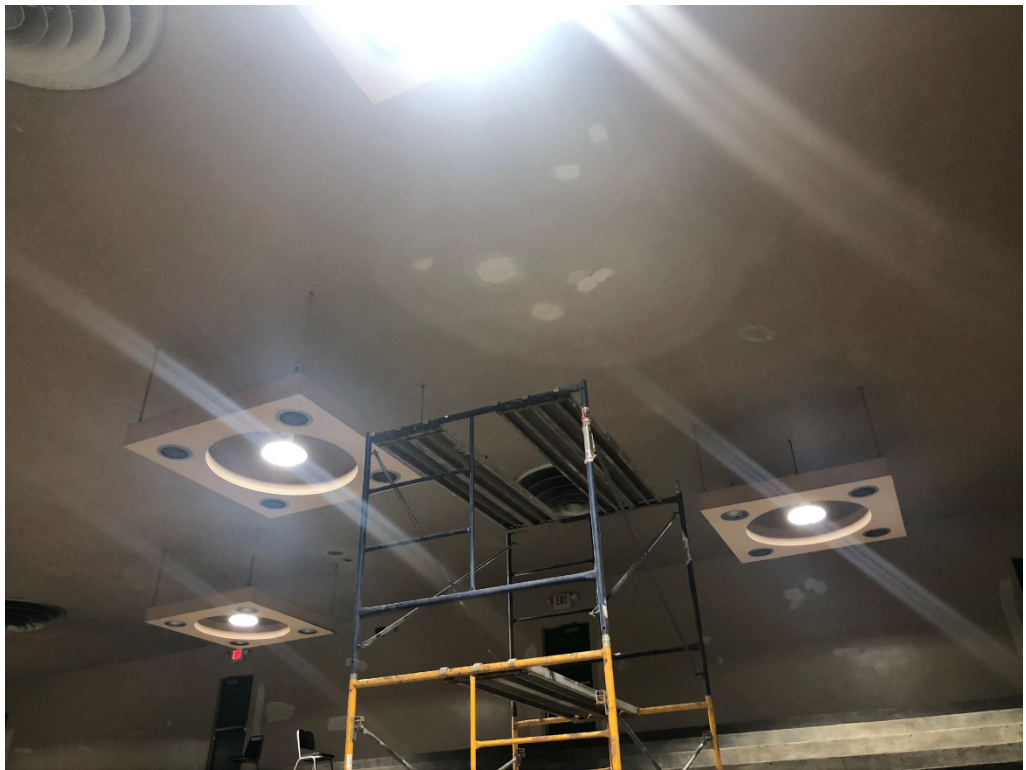
Figure 6 – Plaster patching @ Auditorium

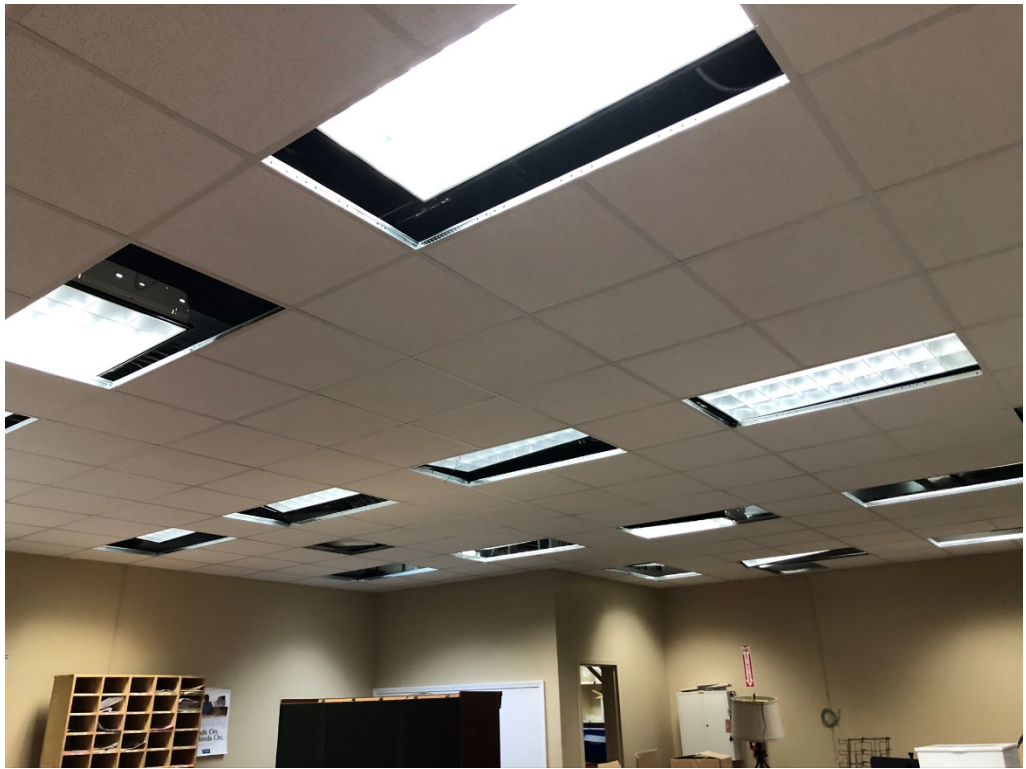
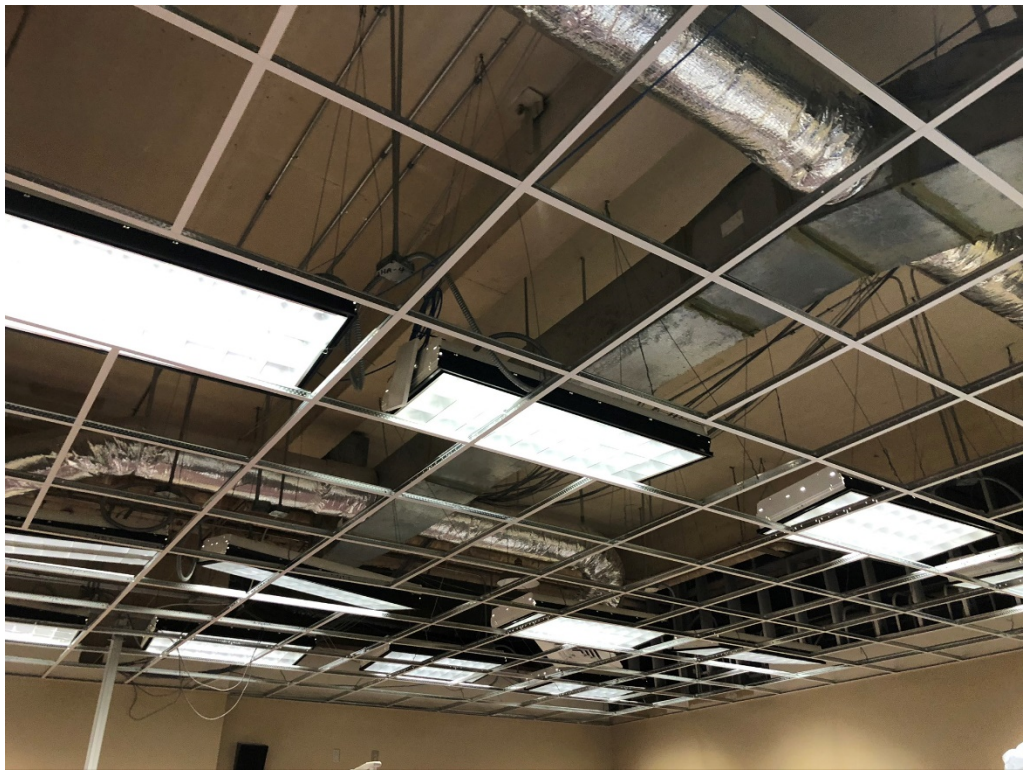
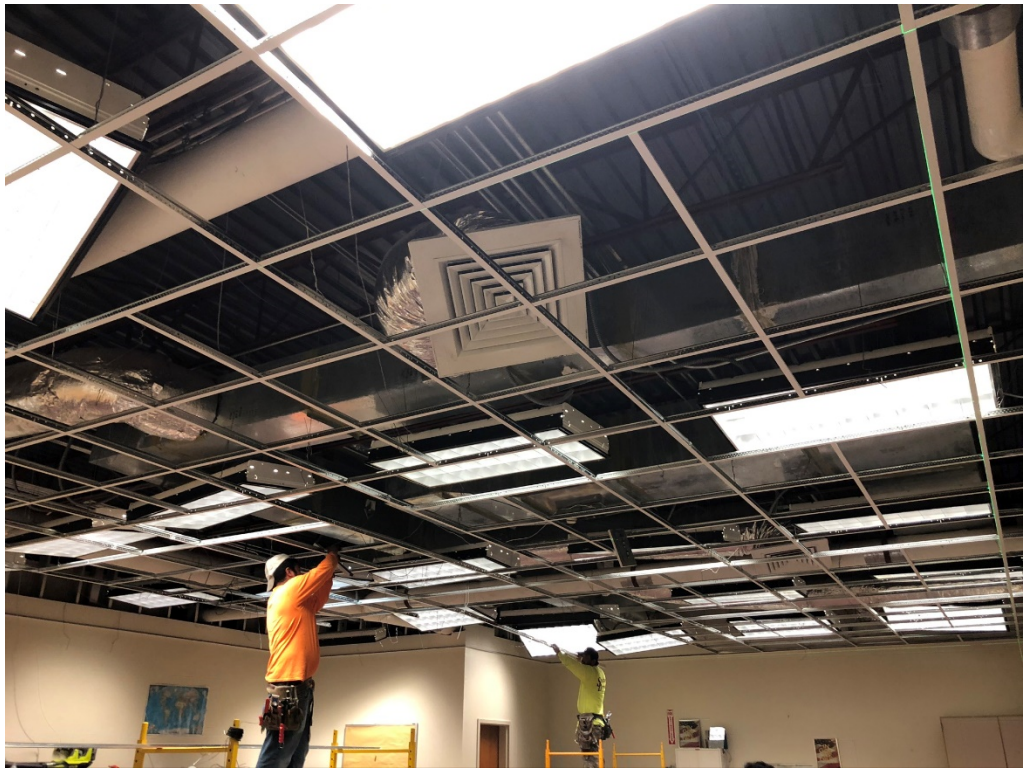
We walked the auditorium and the lower level to review work. Ceiling grid work was being performed at the lower level. It seemed to be about 40% complete.

Figure 7 – Lower Level Ceiling Grid and New Tile Work

Figure 8 – Lower Level Ceiling Grid and New Tile Work

Figure 9 – Lower Level Ceiling Grid and New Tile Work

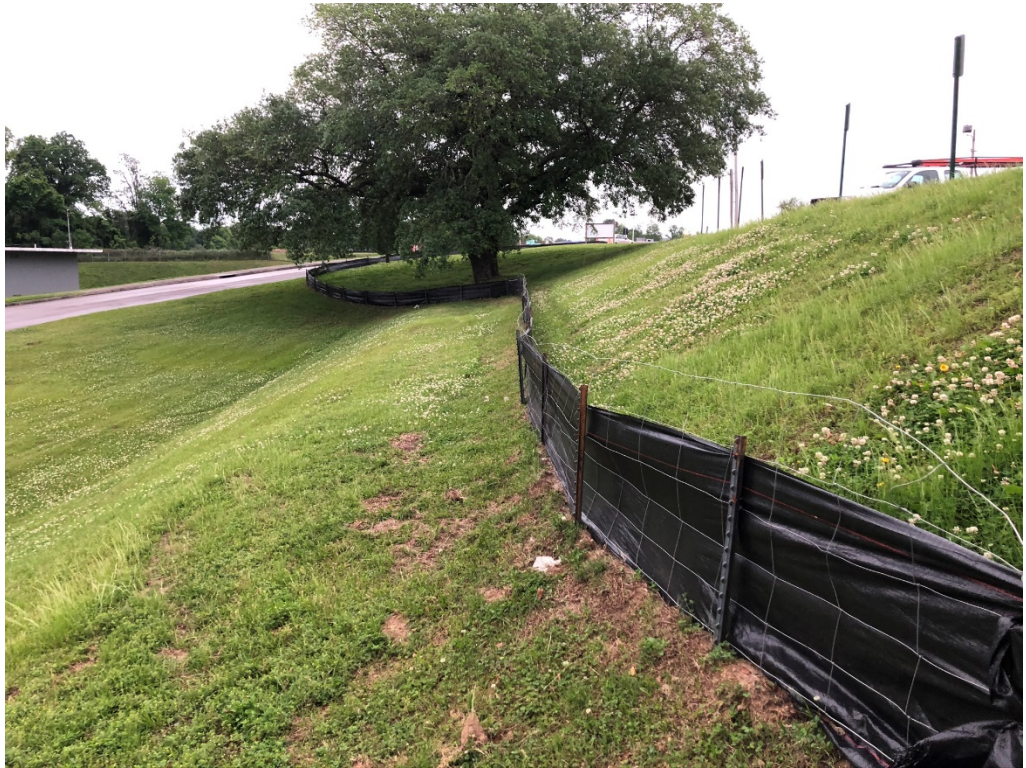
Figure 10 – North Hill Sediment Control In Place
