Architect's Field Report

19 May 2020

18053-Vicksburg Junior High School / Report Number 010

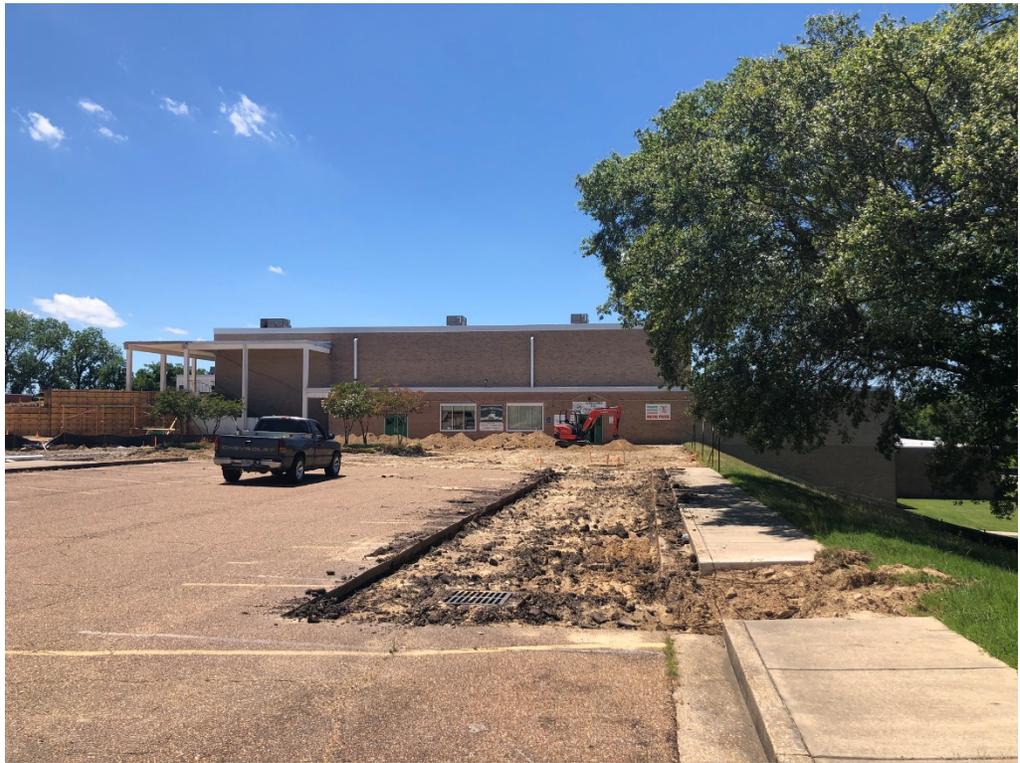
Figure 1 – Asphalt Cut for 12" RCP

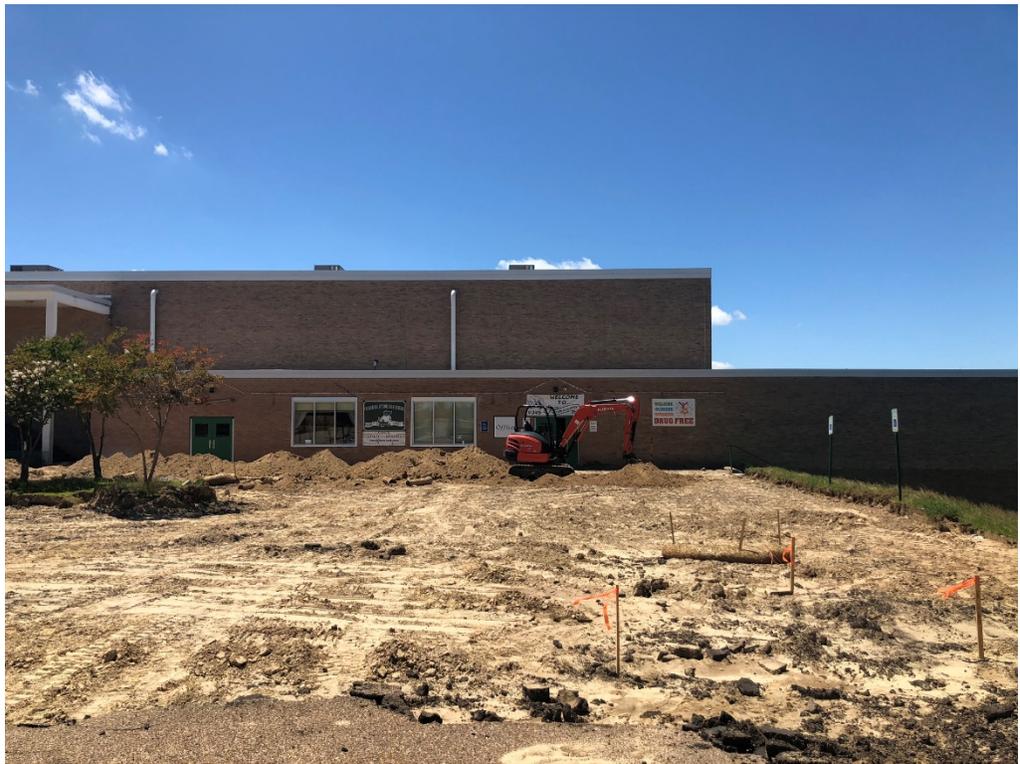
Figure 2 – Dirt Work at ne Entry Addition

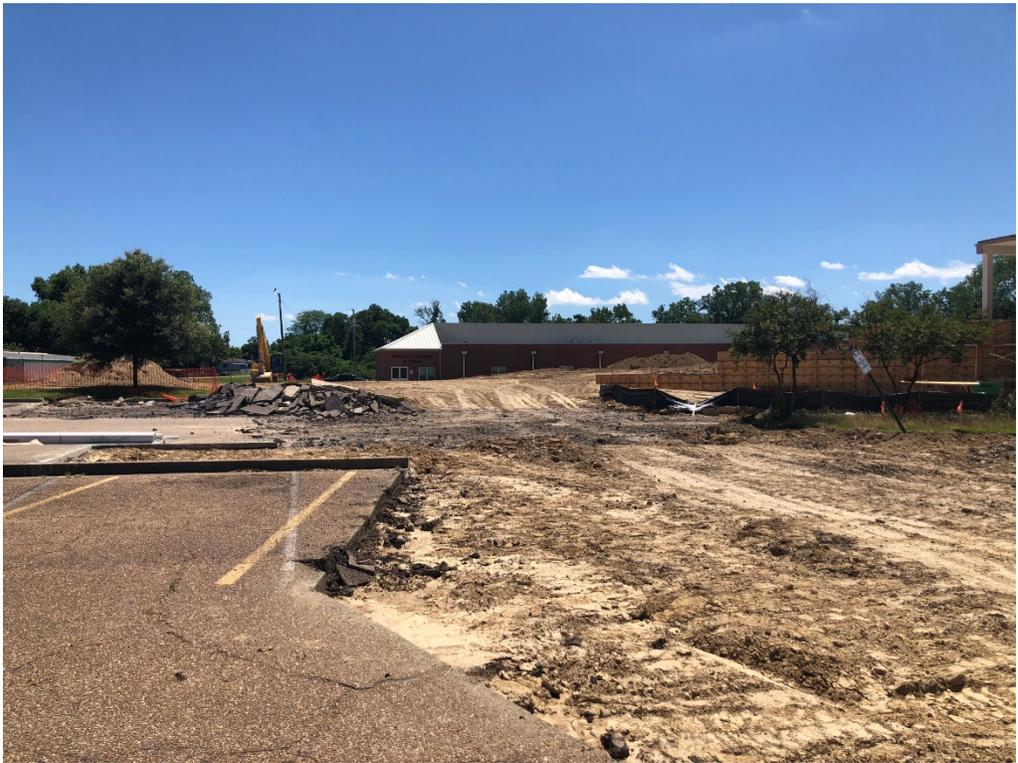
Figure 3 – Demoed Asphalt

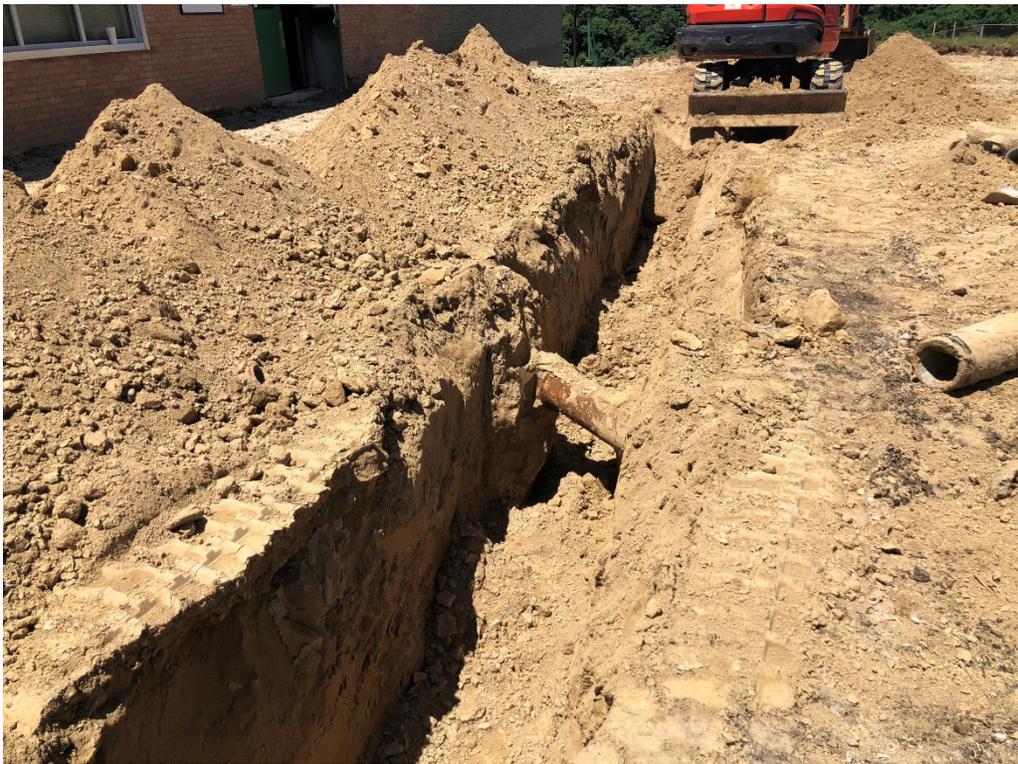
Figure 4 – Is this our Roof Drain?

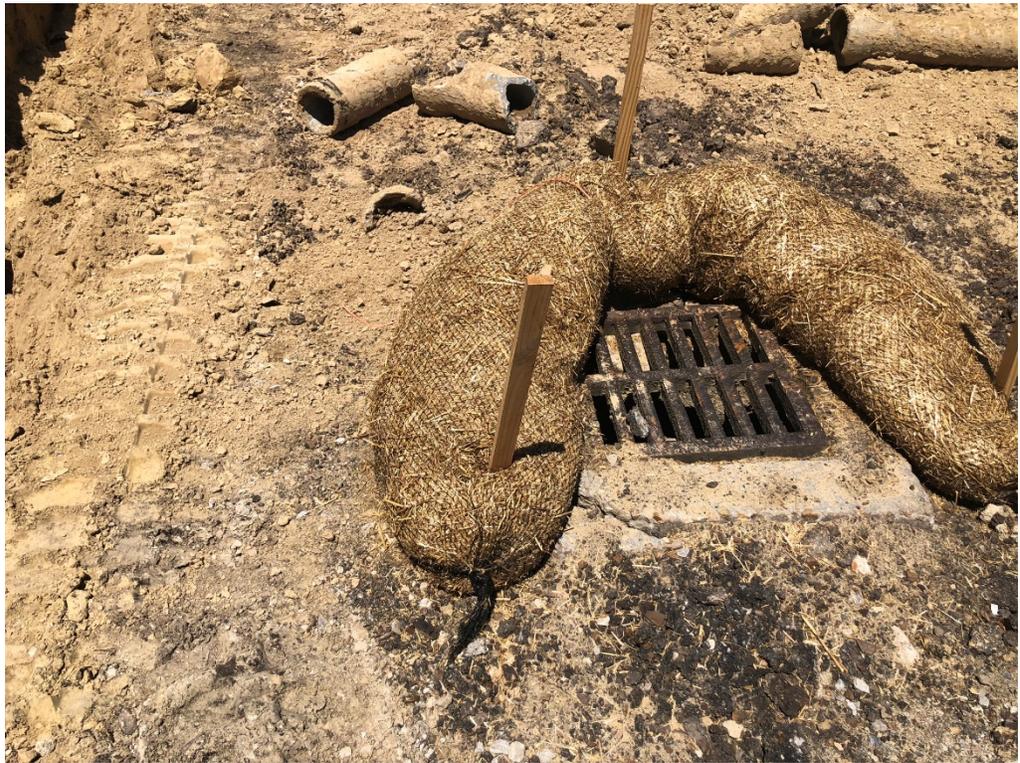
Figure 5 – Sediment should be Continuous around Grate Per Civil Drawings

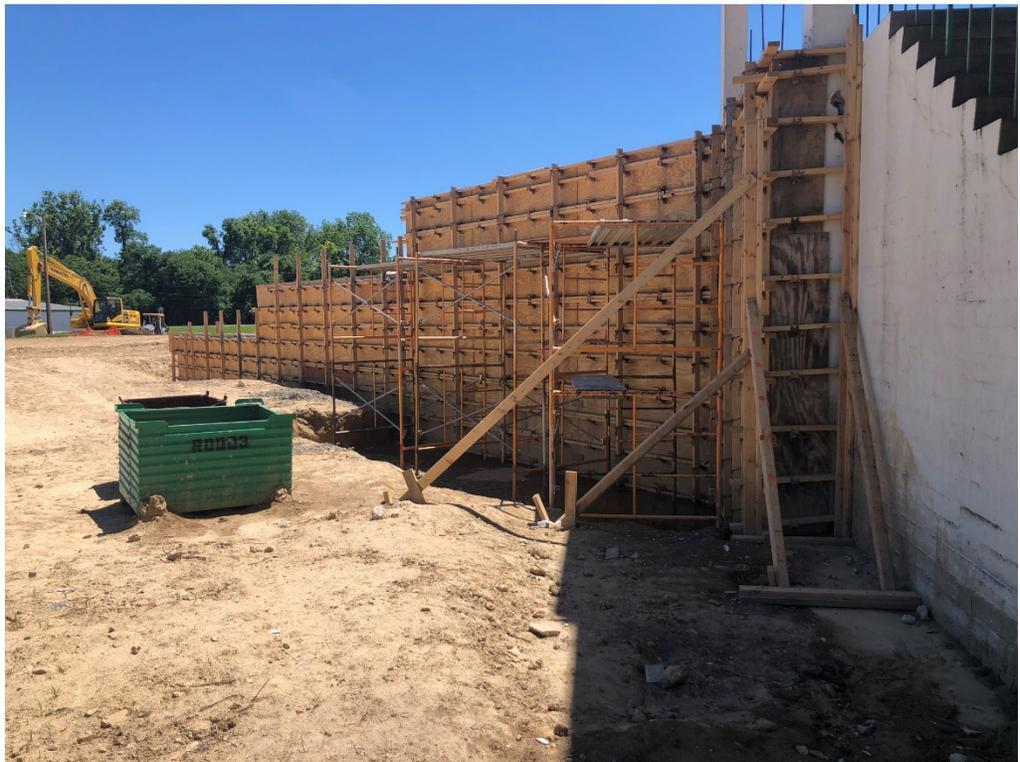
Figure 6 – Foundation Formwork

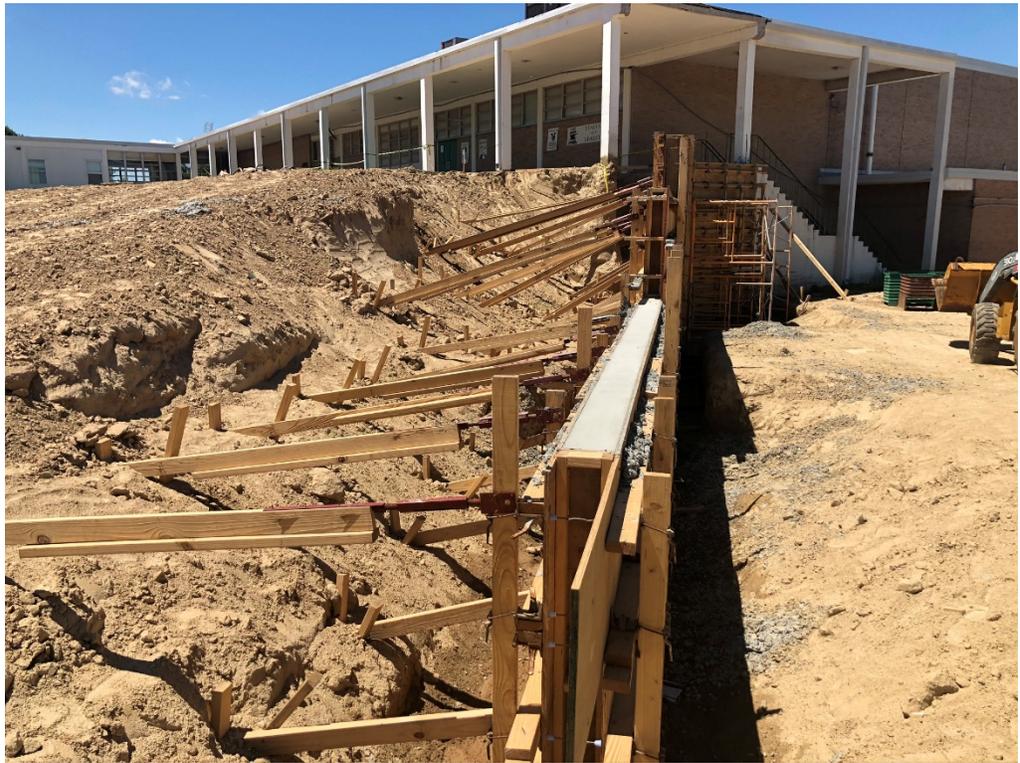
Figure 7 – Cast in Place Wall, Poured

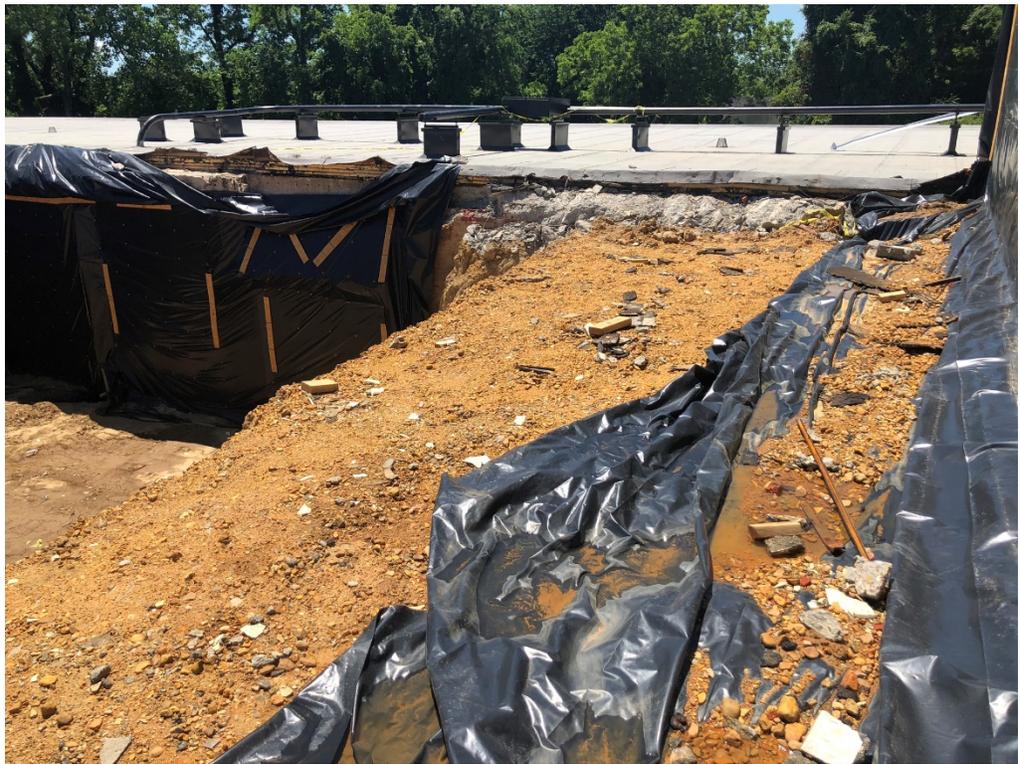
Figure 8 – Roof and Wall @ Corridor E-226

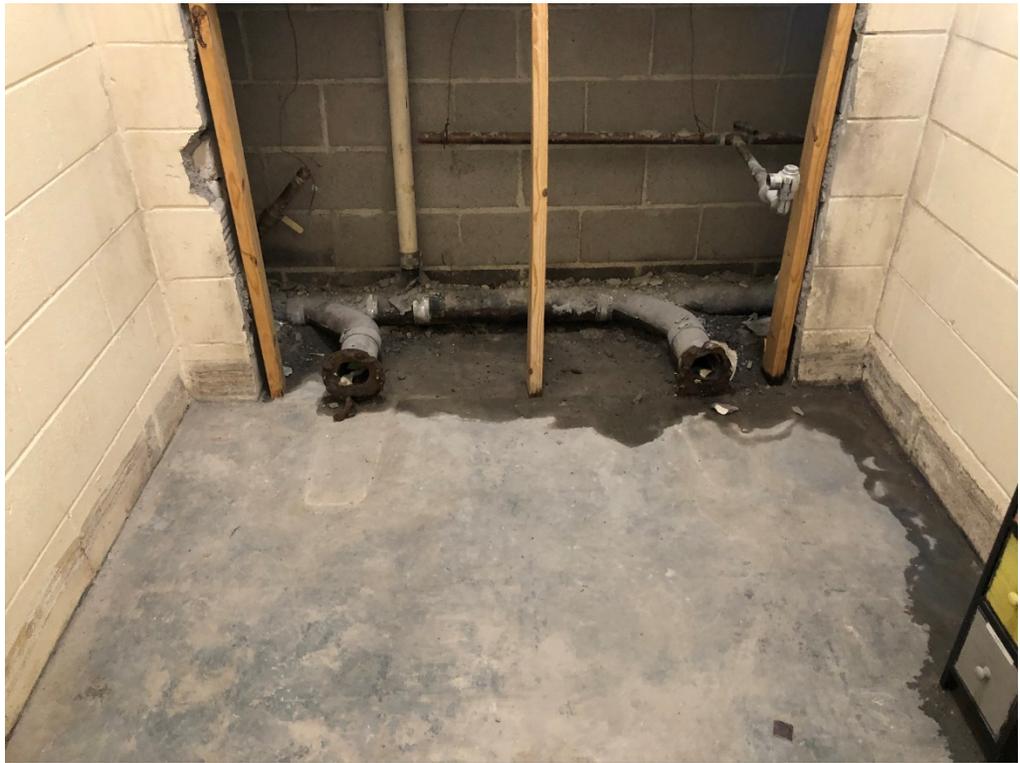
Figure 9 – Demo at E-202B

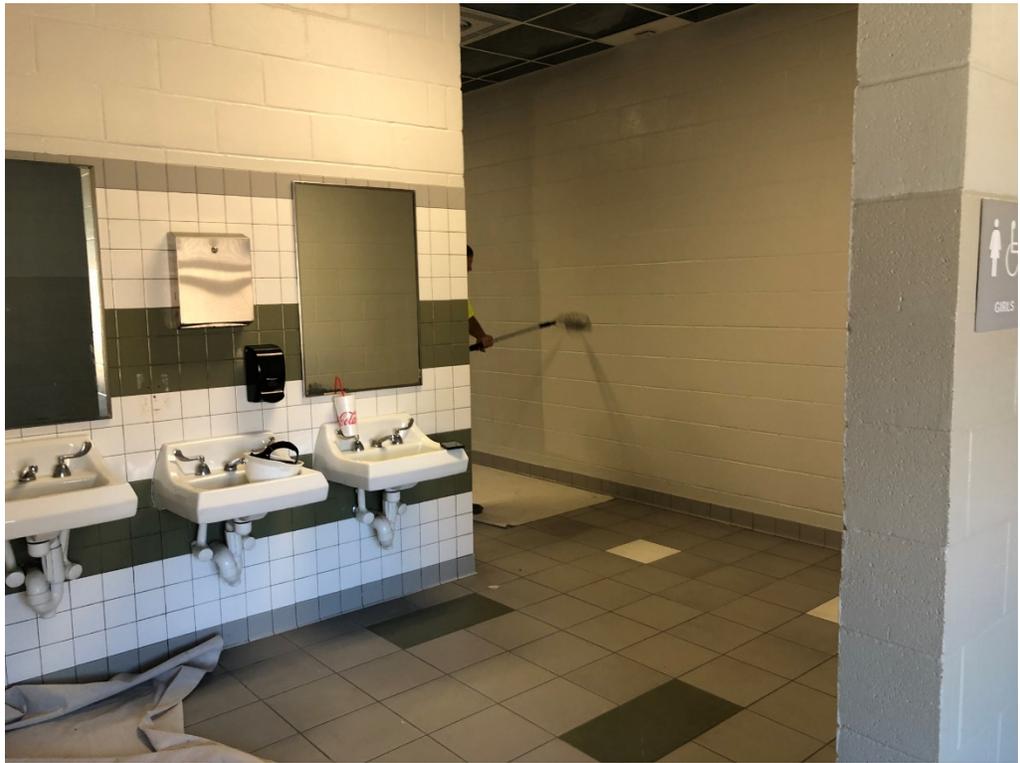
Figure 13 – Paint is ongoing in Southern Hall

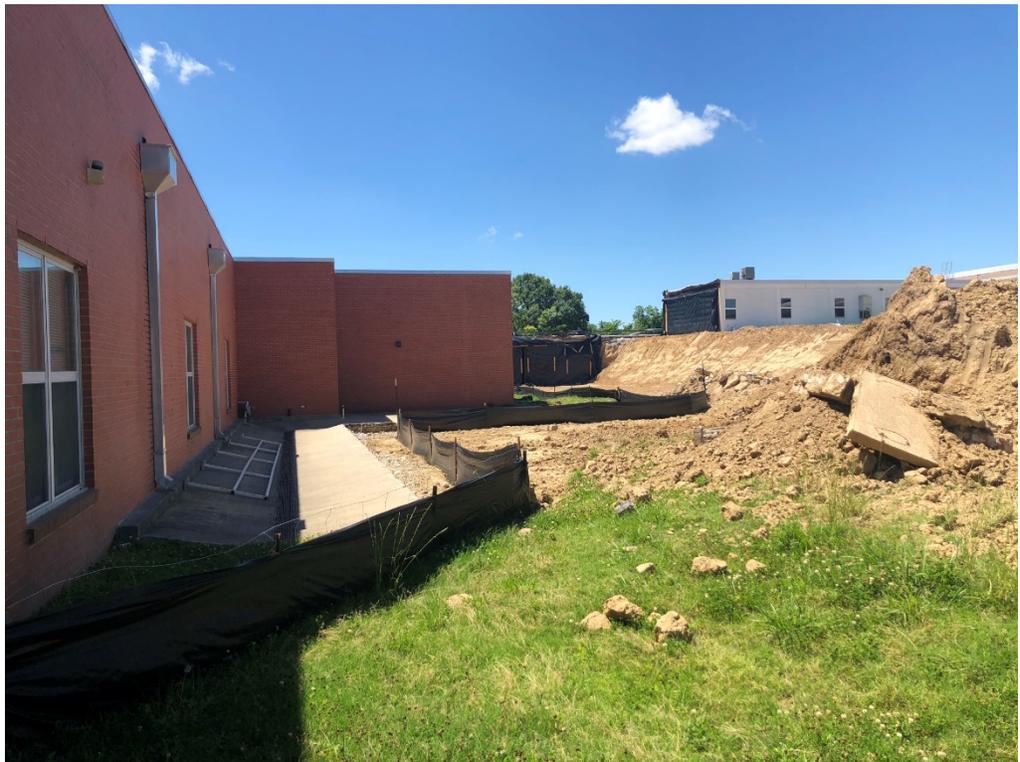
Figure 14 – Lower Concrete Wall Removed
